STEEL BUILDING DAMAGE FROM THE CHRISTCHURCH EARTHQUAKE SERIES OF 2010 and 2011

Charles Clifton¹, Michel Bruneau², Greg MacRae³, Roberto Leon⁴, and Alistair Fussell⁵

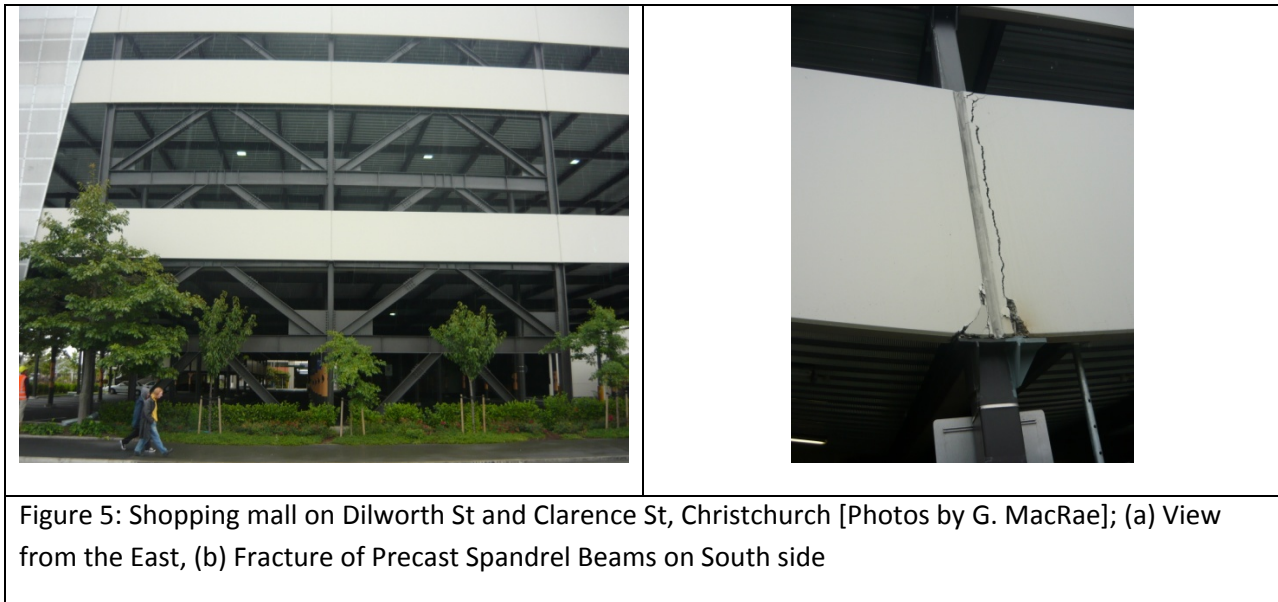
The EBFs in a three level parking garage of a shopping mall west of the CBD did not exhibit inelastic deformations (Figure 5a), however there was evidence of very minor movement of the bolted splice connections in the braces. The basically elastic response of the EBFs is not surprising in this case, given that these frames had been designed to accommodate three additional parking levels to be added at a later time and the intensity of shaking was lower than in the CBD. Live load present at the time of the earthquake may also have been less than considered in design, although it was higher than in the September earthquake when the shopping mall was not occupied. Movement of precast units

previously reported was observed to have intensified. This resulted in fracture of the spandrel panels beside the epoxy mastic connection between panels, presumably indicating that the epoxy mastic was stronger than the precast panels in tension (Figure 5b). These fractures occurred in all panels over the height of the structure. These spandrel panels were also designed to carry gravity loads in the parking structure so their fracture compromised the serviceability of the building. No further damage is reported from the three June earthquakes.

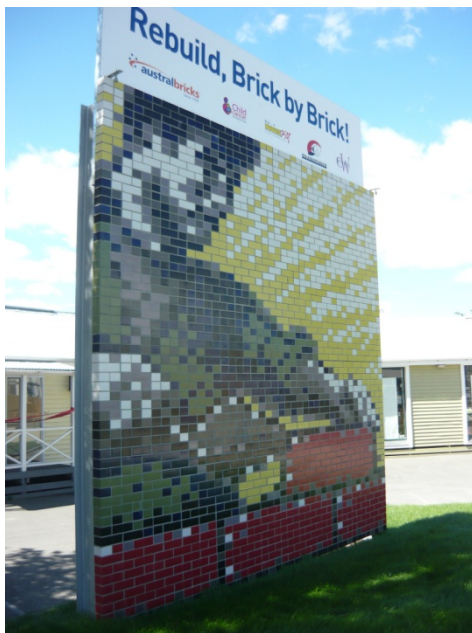
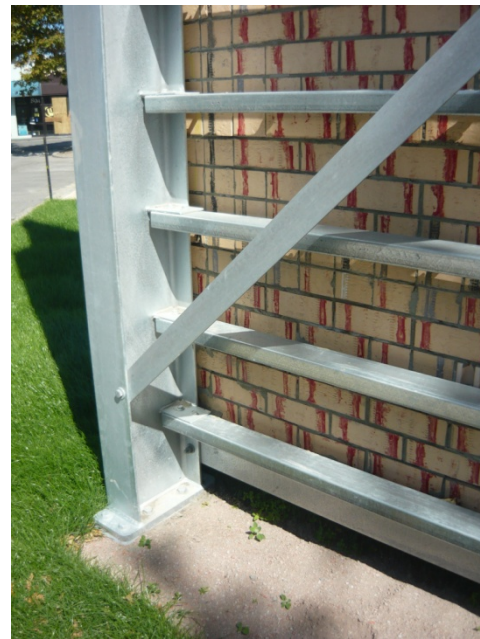
Figure 21. September 2010 Rebuilding Stand Consisting of Bricks Supported by Steel Frame (Photos: MacRae)

A steel framed wall with a brick façade was erected in a small park as shown in Figure 21, in a part of town that where significant overall structural damage occurred. The wall was placed there after the September 2010 earthquake as states “Rebuild, Brick by Brick”. The wall suffered no damage during the

subsequent earthquakes and the brick ties between the steel framing and the bricks showed no signs of distress.

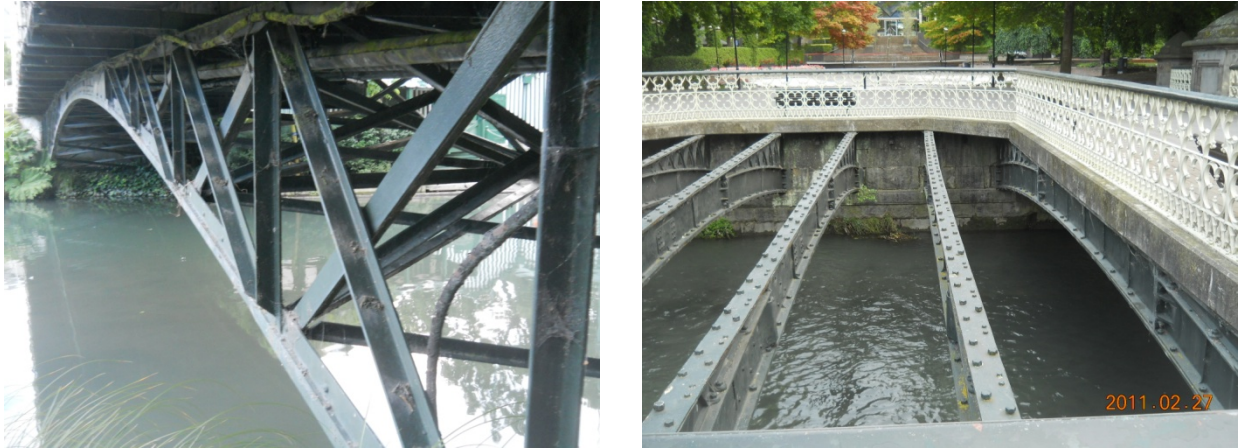
There are relatively few steel bridges in the Christchurch area. A pedestrian arch bridge at the Antigua Boatsheds and one at Victoria Square showed no visible damage (Figure 22).

Figure 22 – Undamaged older steel pedestrian bridges on the Avon River near the CBD (Leon)

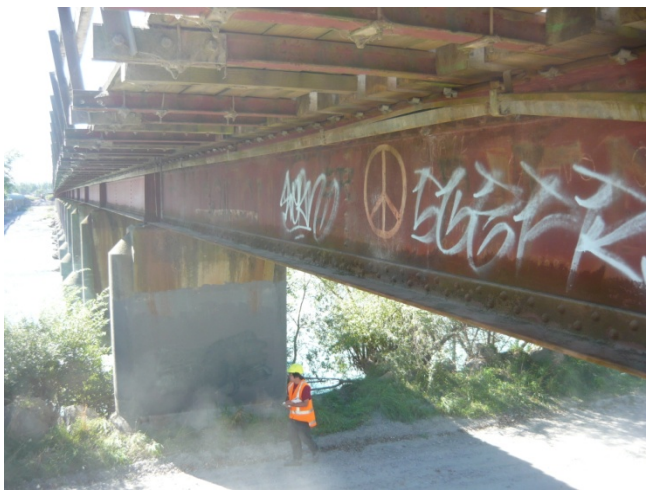
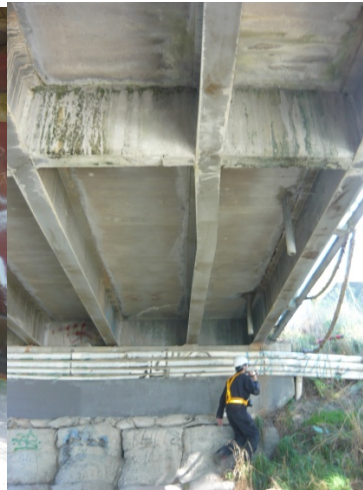
Figure 24 – Waimakariri Bridges, South end (a) Old Rail Bridge, (b) Old road bridge (MacRae)
