CANTERBURY EARTHQUAKE ROYAL COMMISSION

Statement of Marton David Sinclair in relation to Building at 603 – 615 Colombo Street, Christchurch

Re: Post Earthquake Structural Report - 603 Colombo Street, Christchurch

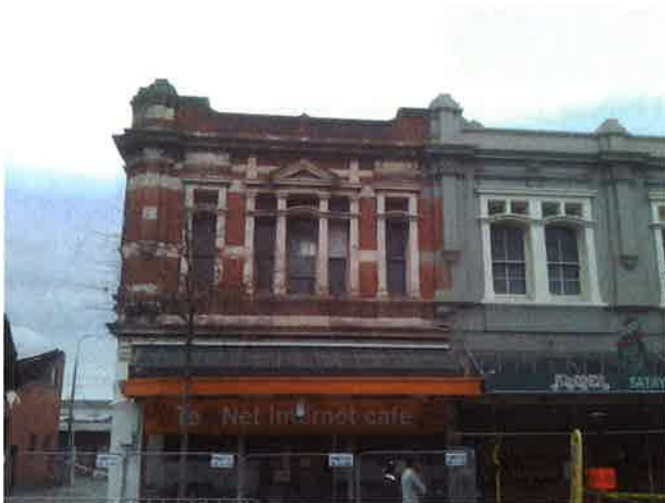
Figure 6 - Colombo Street frontage 16th Sept 2010

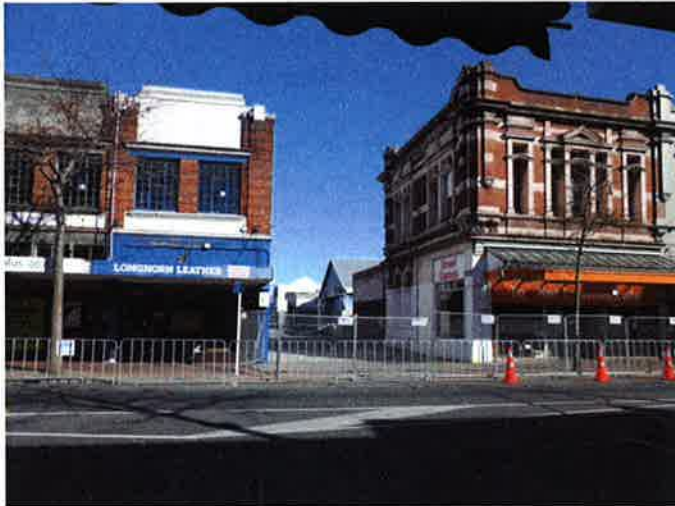
Inspection of the exterior of the southernmost unit revealed significant cracking on the Mollett Street façade and deterioration of the ornate plasterwork. The Colombo Street façade is in much better condition and no major cracking is evident.

Figure 7 - 601A Mollett Street and 603 Colombo Street 9th September 2010

At the present time the southern unit is potentially unsafe given the extensive cracking in the Mollett Street façade and it should remain unoccupied until investigation and structural strengthening can be undertaken.

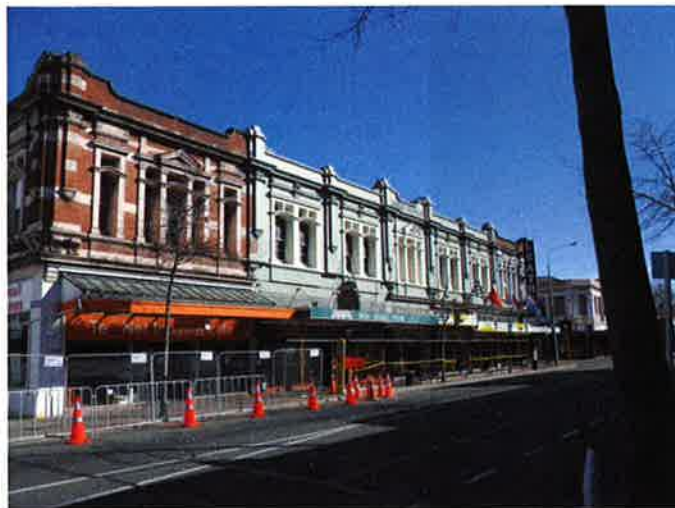
The façade of the five central units has been recently renovated and the brickwork plastered and painted. It also appears that the ornate window facings and detailing has been repaired. It is not known what interior restoration has been done in these units. The two units occupied by Leather Direct at the north end and an Internet Café at the south have not been renovated.

Figure 8 - Austral Buildings Colombo Street, 9th September 2010

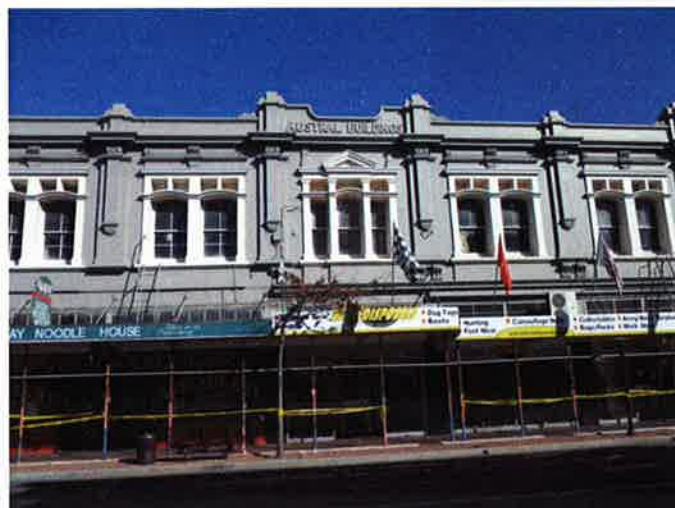
Figure 9 - Benson Chen Holdings Units, 9th September 2010
