**INDEPENDENT ASSESSMENT ON EARTHQUAKE PERFORMANCE
OF
391-391A Worcester Street**

**FOR
Royal Commission of Inquiry into building failure
caused by the Canterbury Earthquakes**

**Report prepared by Peter C Smith and Jonathan W Devine
OF
Spencer Holmes Ltd**

November 2011

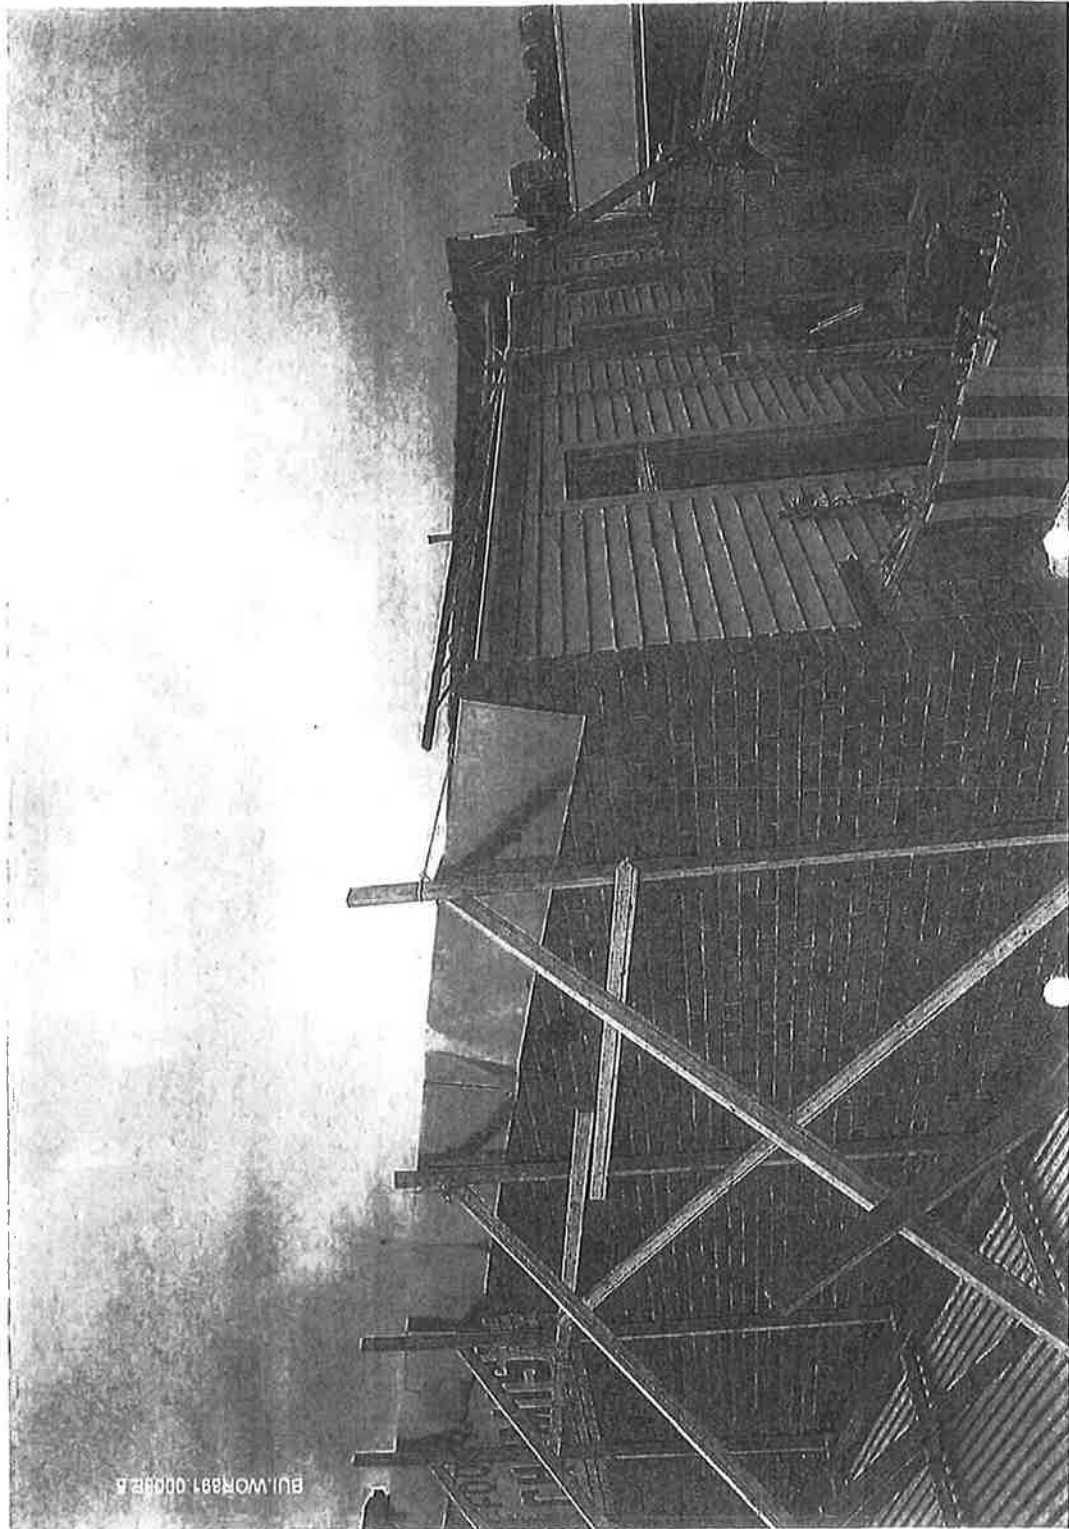
Mr Loke advises that the insurers appointed TM Consultants, as structural engineers to inspect and report on the building. TM Consultants report of the 11 October, 2010 records that at the time of inspection, the roof and upper west side walls were covered in tarpaulins and that the upper portion of the front brick façade had fallen onto the roof of the building, badly damaging the roofing and framing. The parapet to the eastern wall had been removed to just above roof level. The report records that the eastern brick wall near the front façade had several cracks, some old and some new, and that a portion of the east wall parapet had fallen on the adjoining building. The mortar in the brick joints was reported to be very soft and crumbly in this area. The west brick wall above the adjacent lower roof was recorded as being plastered and the wall reported to be in good condition. (Refer photos in Appendix 2).

Photo 2 : After the Sept 04, 2010 quake.

Mr Loke hired the services of Contract Holdings Ltd to undertake temporary repairs following the 4th September, 2010 earthquake. This work involved removal of the top of the damaged chimney along the west wall, removal of east wall parapet and over-flashing, removal of debris from failure of front parapet, repair and propping of roof framing and provision of tarpaulins for temporary waterproofing of the building.
