FORSYTH BARR TOWER POST-EARTHQUAKE ASSESSMENT AND REPAIR REPORT

This report covers the structural damage sustained by the Forsyth Barr Tower at 764 Colombo Street, Christchurch, as a result of the Darfield Earthquake that struck at 4:36am on 4th September, 2010.

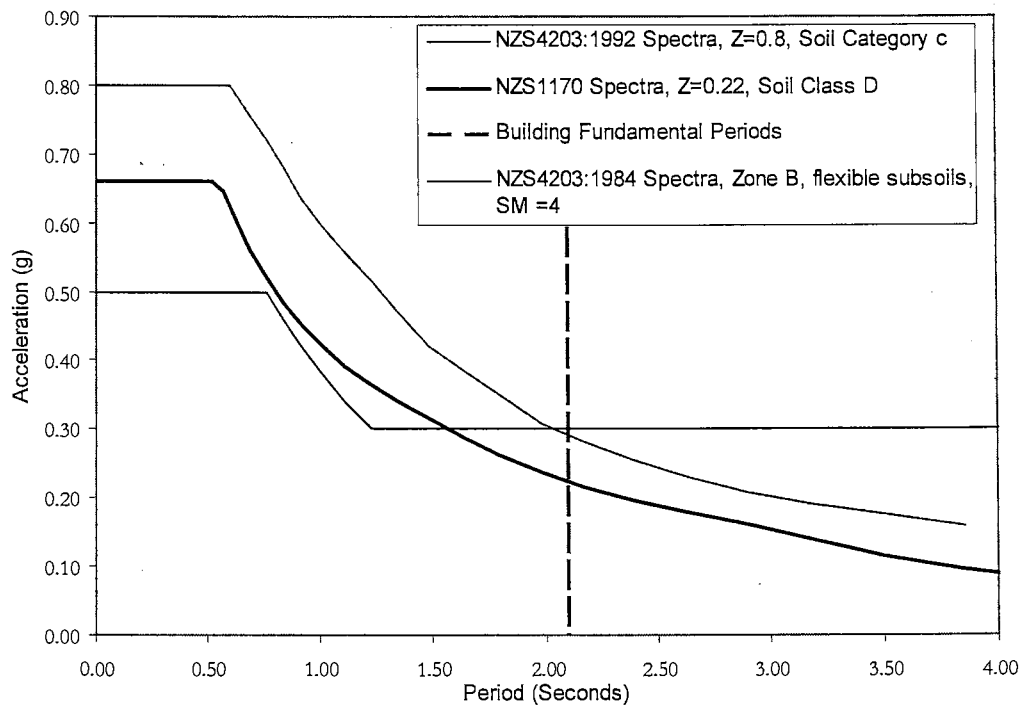
Figure 3-1: Comparison of Design Codes

The loadings standard, NZS4203 has now been replaced by NZS1170.5:2004 [5]. A comparison of the load levels represented by these two standards is plotted below and shows that the seismic design load has been reduced with the introduction of the new loadings standard. Therefore, the Forsyth Barr Tower is considered to have a capacity in excess of current code levels.

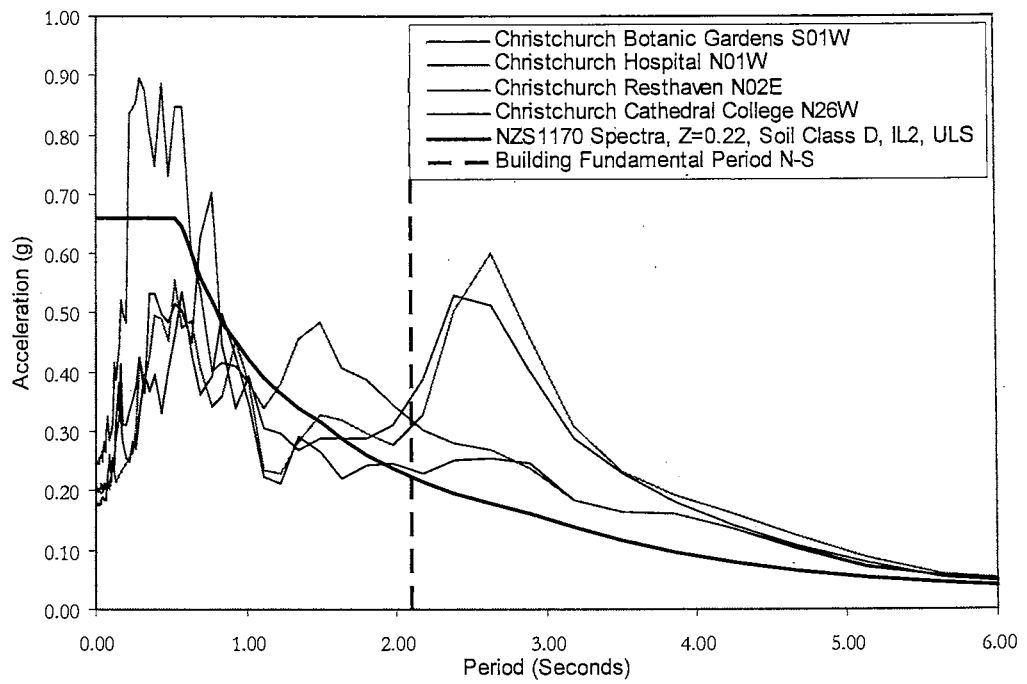
Figure 4-2: 5% Damped Spectra – North-South

It is apparent that in the North-South direction, there is significant variation in the shaking experienced at the different monitoring sites, particularly in the 2 second to 3 second period range. This is due to the highly variable ground conditions around Christchurch.

Previous analyses of the Forsyth Barr Tower have determined the buildings fundamental periods to be between 2.0 and 2.2 seconds for the primary directions. Based on the strong motion data downloaded, it is possible that the earthquake produced accelerations in the north-south direction significantly in excess of the design spectra for this building.

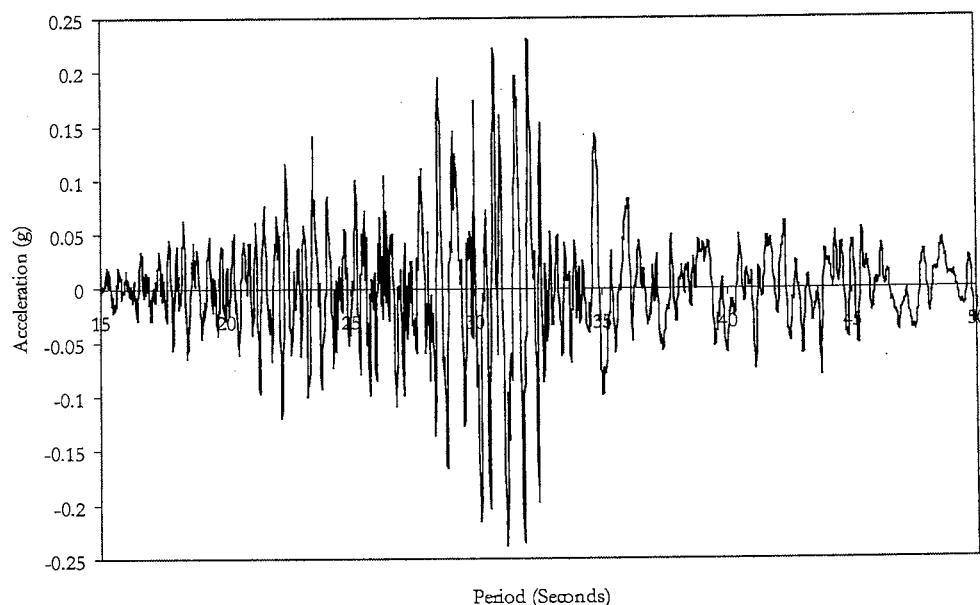
Figure 4-4: Earthquake Record from Christchurch Resthaven Site

However it should also be noted that this earthquake was relatively short in terms of the strong shaking produced. The following plot of the earthquake record from the Christchurch Resthaven monitoring station at 4:36am on 4th September shows that the strong motion only lasted for a duration of approximately 10-15 seconds.

Because of this the building has only gone through a limited number of inelastic cycles. A full design earthquake for Christchurch (eg rupture of the Alpine Fault) is expected to have a significantly longer record of strong shaking, resulting in increased damage to buildings. As an indication, a large (design level) earthquake in Christchurch is expected to contain in excess of 60 seconds of strong motion.
