**IN THE MATTER OF ROYAL COMMISSION OF INQUIRY INTO BUILDING  
FAILURE CAUSED BY CANTERBURY EARTHQUAKES**

**STATEMENT OF EVIDENCE OF STEPHEN JAMES MCCARTHY IN RELATION TO  
382 COLOMBO STREET**

**DATE OF HEARING: WEEK BEGINNING 12 DECEMBER 2011**

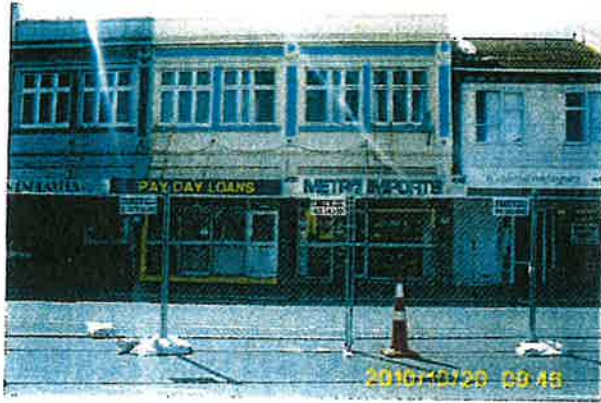
Two storey building southern end unit of Kashmir buildings

Payday Loans & Metro Imports

There was no apparent significant earthquake damage to the 382 Colombo Street building. There was damage to the buildings further north in the block with very noticeable front facade separation occurring to the buildings from about 398 Colombo Street north. My opinion at the time was that the 382 Colombo Street building looked to be in a similar structural condition to what it was before the September earthquake. I recommended that before the protective fencing in front of the building was removed that the veranda be propped essentially as a reasonable means of covering any unobserved structural damage that may have occurred.
