CTV BUILDING

CTV BUILDING COLLAPSE INVESTIGATION FOR DEPARTMENT OF BUILDING AND HOUSING 5TH DECEMBER 2011

CTV BUILDING COLLAPSE REPORT

Report Issue Date: 7 December 2011

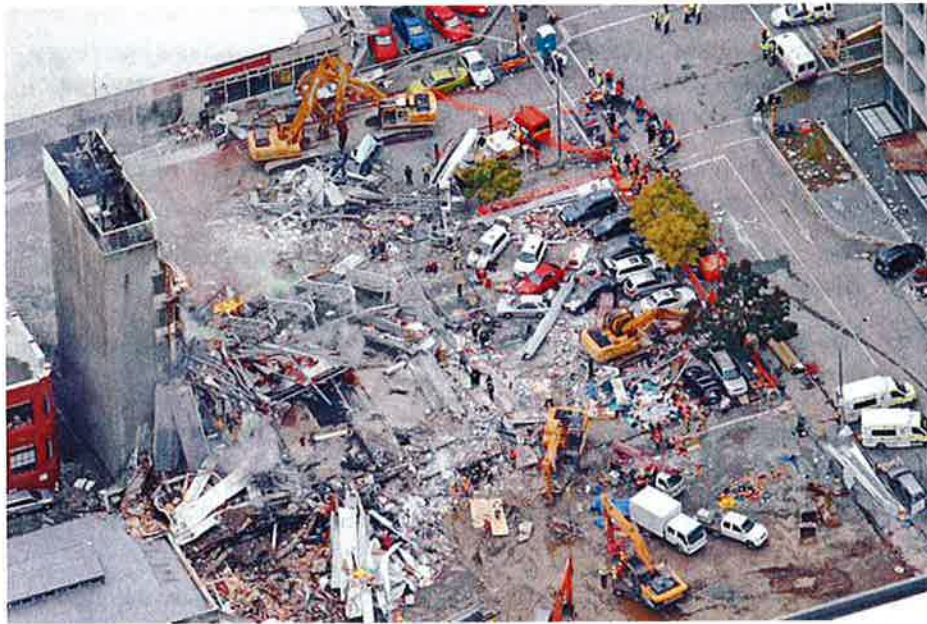
The 22 February 2011 Aftershock caused the sudden and almost total collapse of the CTV building. Shortly after the collapse of the building a fire broke out in the stairwell and continued for several days.

Figure 4 - The CTV Building collapse shortly after machinery began to remove debris. (NZ Herald)

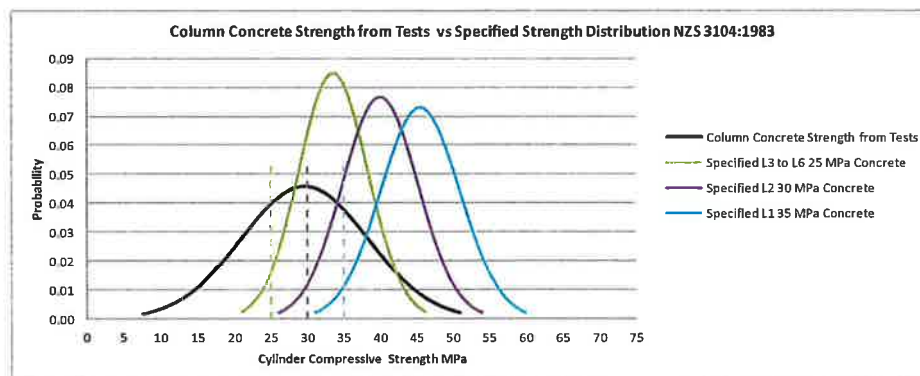
Figure 8 – Column concrete test strengths adjusted for test orientation vs 28-day concrete strength distribution according to NZS3104:1983. This indicates that the concrete in a significant proportion of the columns would have had strengths less than the minimum specified.

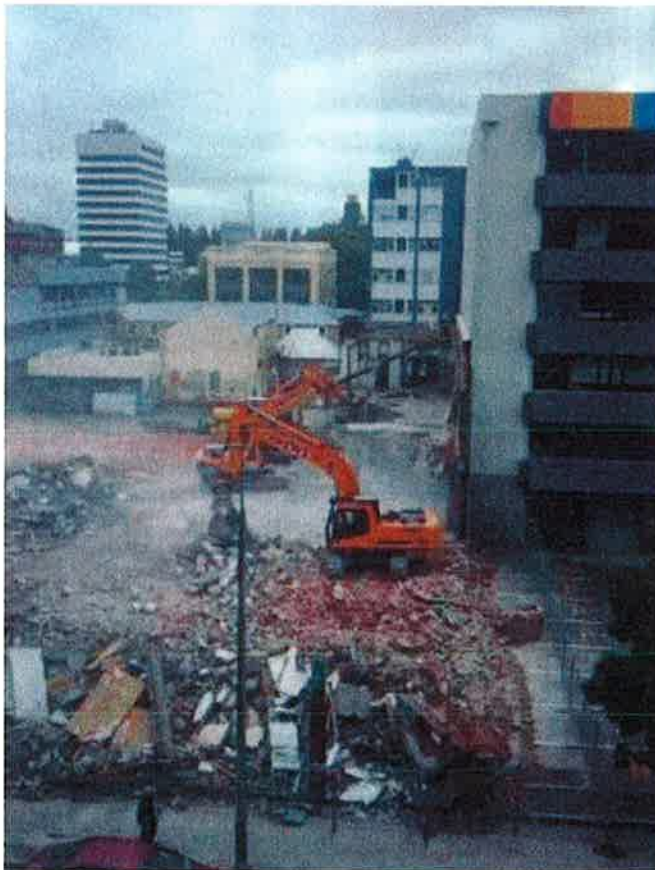
Heavy machinery with pneumatic pokers and pincers, and drop hammers, were used to break it up (Figure 21). This caused ongoing and disturbing vibrations to occupants in the CTV Building.

The authors consider it unlikely that structural damage was caused by the demolition sufficient to affect the earthquake resistance of the CTV Building. This is because it is common practice to use such equipment for demolition work like that seen in Figure 21 and not find it to cause any significant structural damage to adjacent buildings.

Figure 21 - Heavy machinery demolishing the building adjacent to the CTV Building after the 4 September Earthquake. The boundary wall is still in place covering the Line A infill masonry wall of the CTV Building.

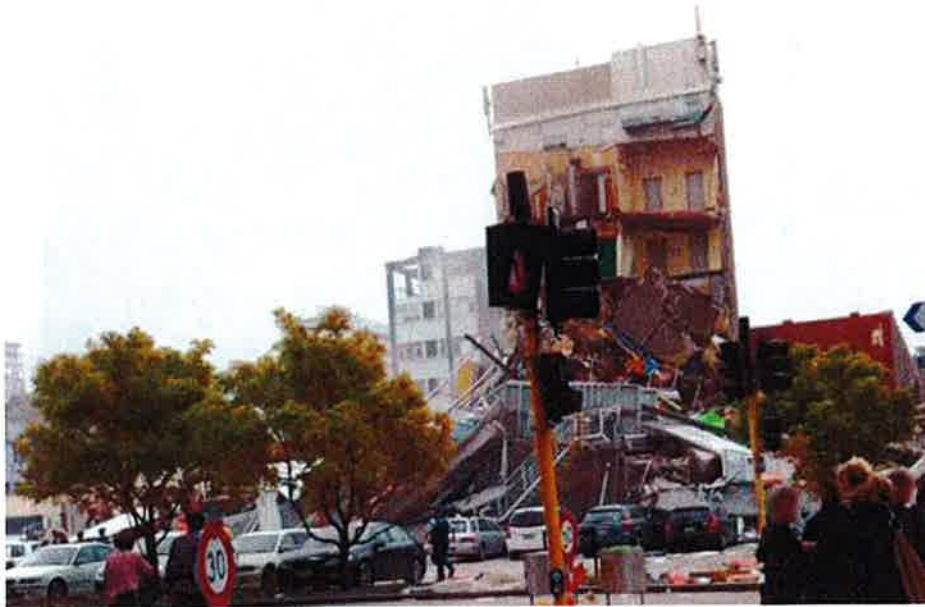
Along the south face on Cashel Street Cashel St (Line I) the North Core tower stood out clearly as seen in Figure 23. The cars in the car park on the south face were largely undamaged. The white escape stair that was attached to the South Wall can be seen still attached to the wall as it lay almost horizontal on top of the collapse building. A portion of the floor slab in front of the lift doors at level 6 remained suspended in mid-air without column support, and a similar portion of slab at level 5 hung down precariously.

Figure 23 - Cashel St. south face with North Core tower in background immediately after collapse and prior to the fire starting. The cars in the car park on the south face were largely undamaged. The white escape stair that was attached to the South Wall can be seen still attached to the wall as it lays almost horizontal on top of the collapse building.

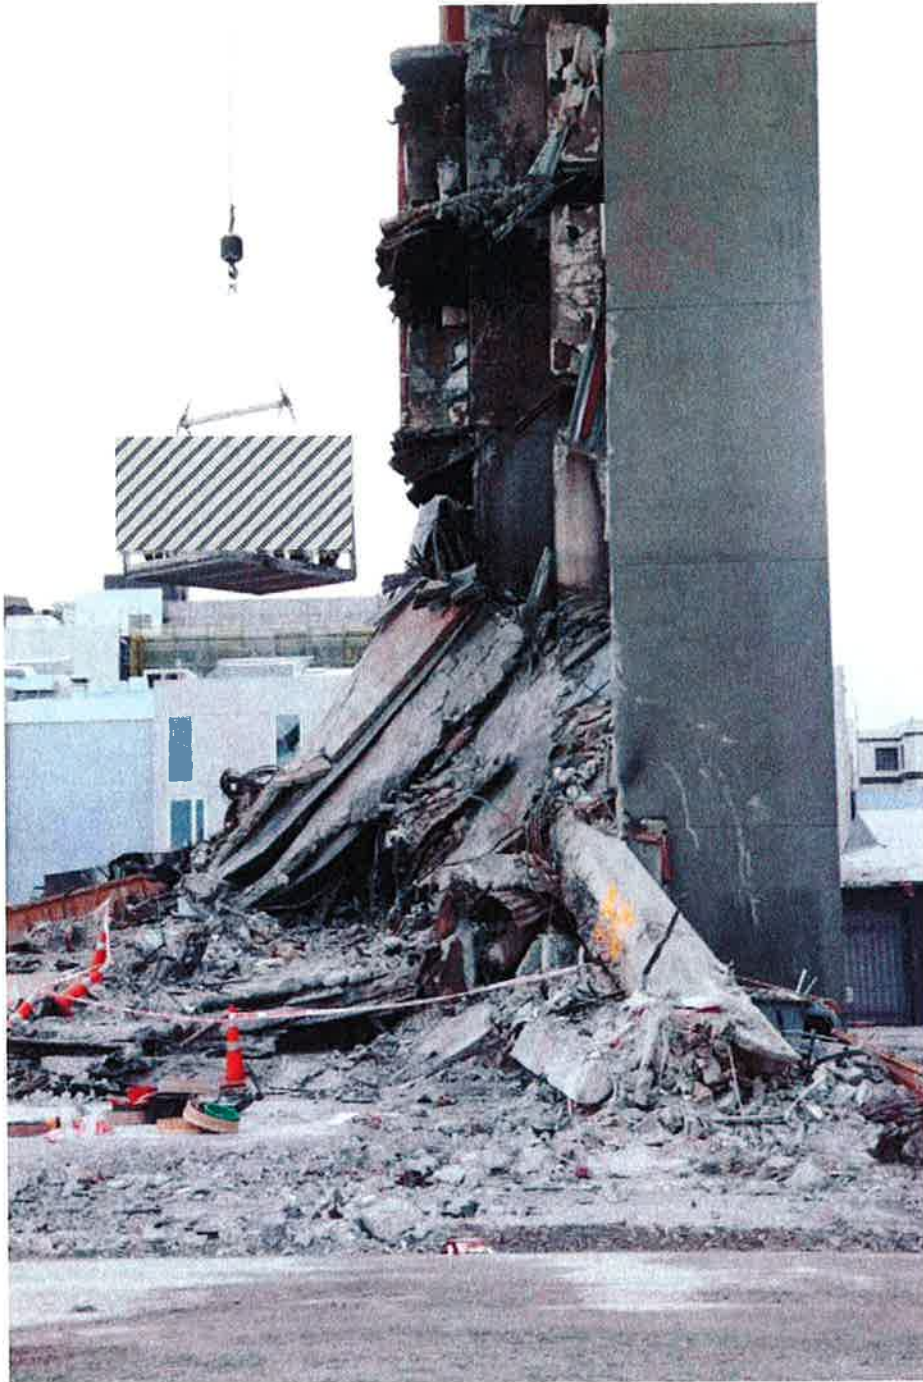
Figure 26 - North Core with Level 4 and 3 slabs laying diagonally against it.

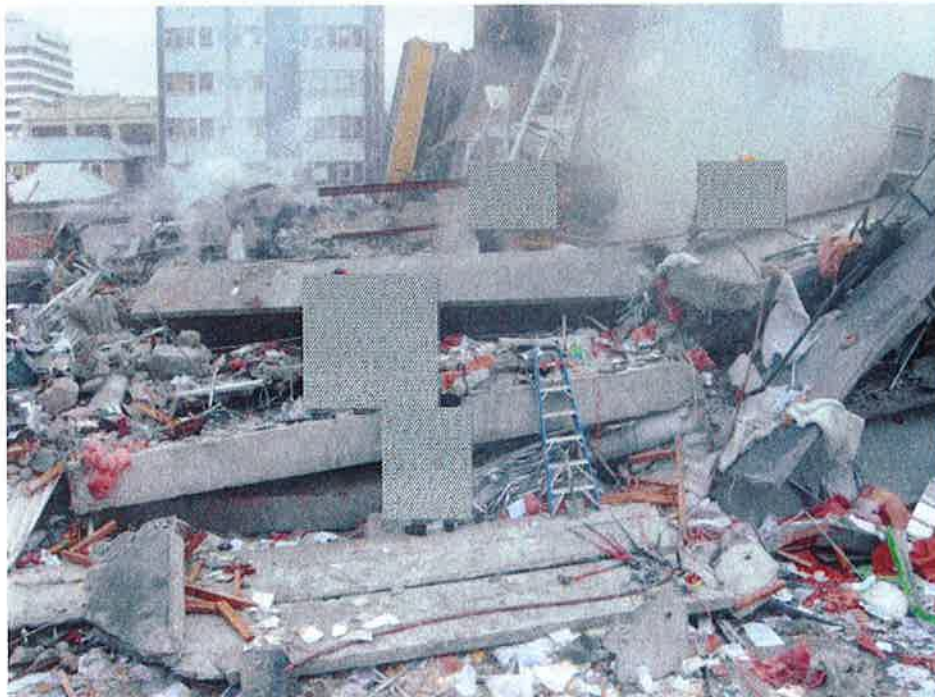
Figure 27 - Concrete Spandrel Panels, perimeter beams and columns on Cashel Street face (Line 1 / B-D).

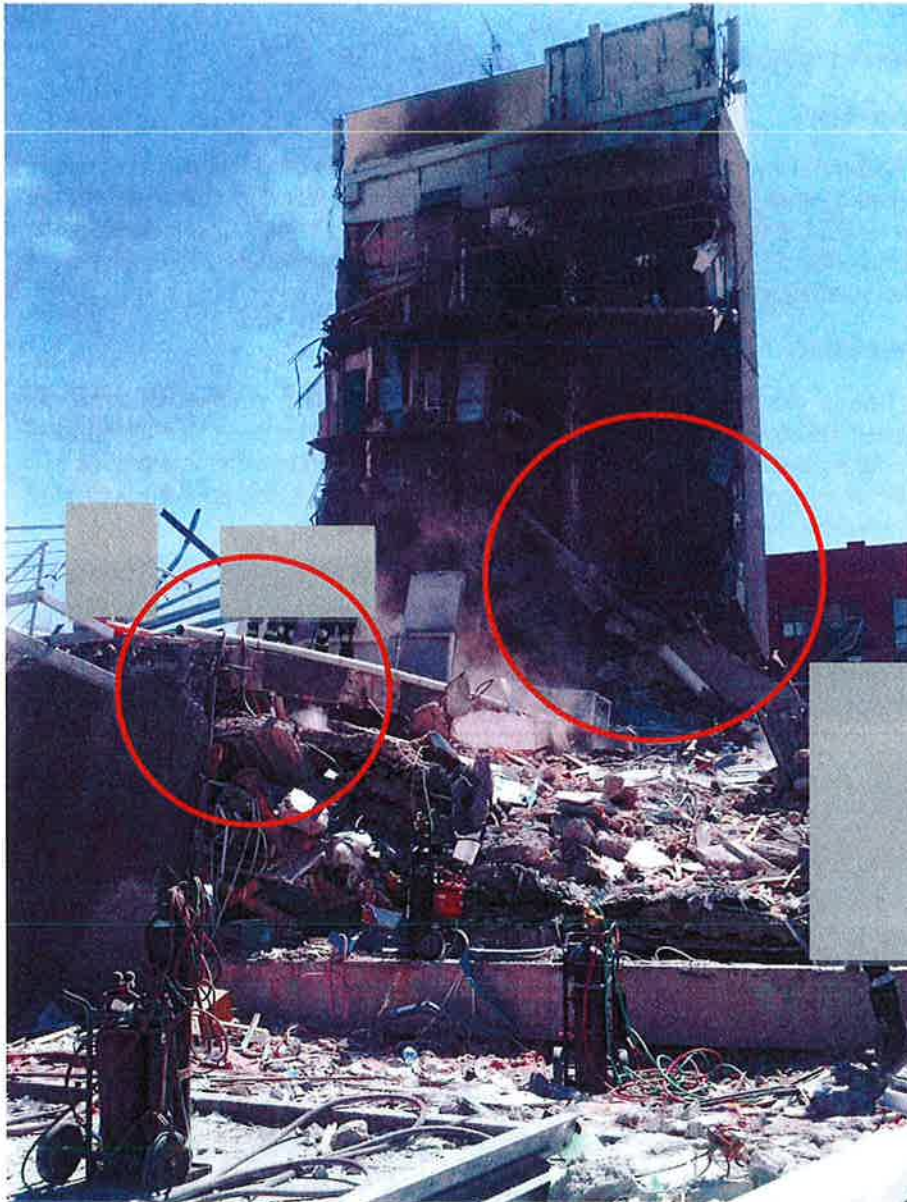
The Line 1 frames attached to the South Wall had fallen northwards onto the collapsed structure (Figure 76). All the floor slabs could be seen laying on top of each other adjacent to the South Wall (Figure 79). A portion of floor slab appeared to still be in contact with the South Wall and may have prevented the South Wall from breaking over at Level 1 (Figure 28 and Figure 80).

This showed that the floors had all broken away from the Line 1 frame and South Wall close to Line 1 and had fallen to the ground prior to the South Wall and Line 1 frames falling onto the collapsed structure. A portion of slab from one of the levels may have held up sufficiently against the South Wall at Level 2 to cause the South Wall to pivot about it as it fell northwards.

Figure 28 - View from Cashel Street east side of Line 1 with Line 1 South Wall lying on debris at left; trapezoidal end profile of floor slabs laying on top of each other in foreground; A portion of floor slab highlighted, appears to be still in contact with the South Wall at Level 2 and may have prevented the South Wall breaking over at ground level. The collapsed column on Line 4-D/E at the North Core in the background is also highlighted.

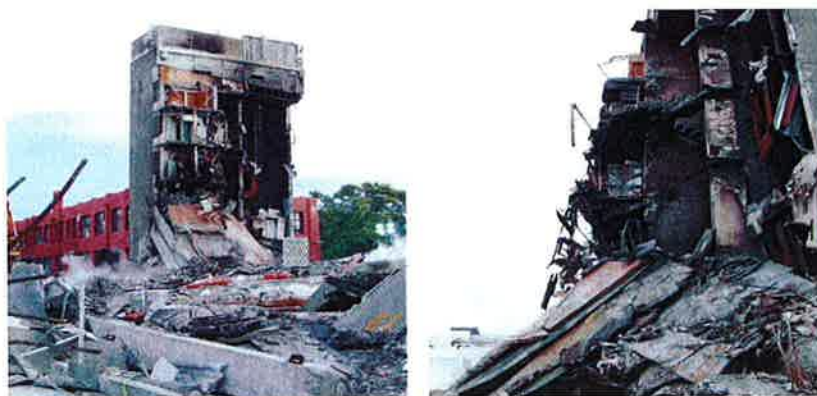
The levels 3 and 4 slabs could be seen to be laying diagonally against the North Core (Figure 30). This indicated that the Level 3 and 4 slabs lost their vertical support on Line 3 prior to them breaking away from the North Core. A portion of the slabs that had been outside the lift well on the North Core appeared to have fallen away as the column connected to the North Core at Line 4-D/E collapsed (Figure 28 and

Figure 30 – View of North Core showing Level 4 slab lying diagonally on top of Level 3 slab. This indicates that the Level 3 and 4 slabs lost their vertical support on Line 3 prior to breaking away from the North Core.

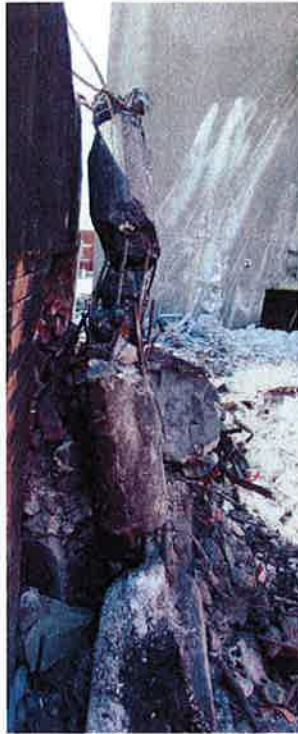
A perimeter column still attached to a Line 4 perimeter shell beam from the northwest face of the building was found showing severe damage indicative of Spandrel Panel interference (Figure 32). Column head damage is visible, though little flexural damage could be seen at the base.

In this case it is thought that the damage may have occurred during the progression of the collapse of the floors rather than in the initiation of the collapse. This is because the analyses showed that the inter-storey east-west drifts along Line 4 were not as high as those along Line 1 and north-south along Line F. the lack of flexural damage at the base may be indicative of the Spandrel Panel having been close to full contact with the column prior to the Aftershock. Based on the displacement compatibility and push-over analyses this may have prevented base hinging occurring in what is likely to have been an upper level column.

Figure 32 - Line 4 / B column with precast log beam in foreground and shell beam at rear. The column appears to have broken its back on a precast concrete Spandrel Panel and sustained head damage during the collapse.

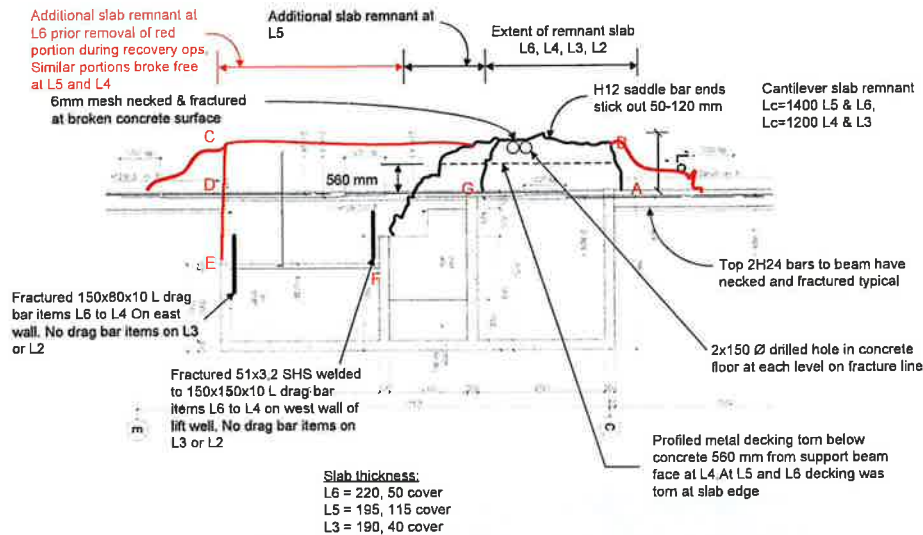
The slab failure surfaces diagram in the Site Examination and Materials Tests report therefore has been modified in this report (Figure 35) to account for observations from the photos of the condition of the structure immediately after the collapse and as found during the debris removal.

This indicated that the slabs at Levels 4 and 5 had not broken away from the North Core walls due to in-plane diaphragm actions as this would have caused all the threaded anchors to have sheared off or bent over. It therefore appeared that the portion of slab immediately outside the lift well (refer Figure 35) had rotated downwards after the slab beyond that had broken away following collapse of Line 3. As it rotated downwards the slab pivoted about the Drag Bar fixing at the tip of the walls, prying itself off the epoxied threaded anchors fitted into the Drag Bar adjacent to the fixings into the walls (Figure 29 and Figure 104).

Figure 35 - North Core slab remnant profile based on the Site Examination and review of collapse photos.

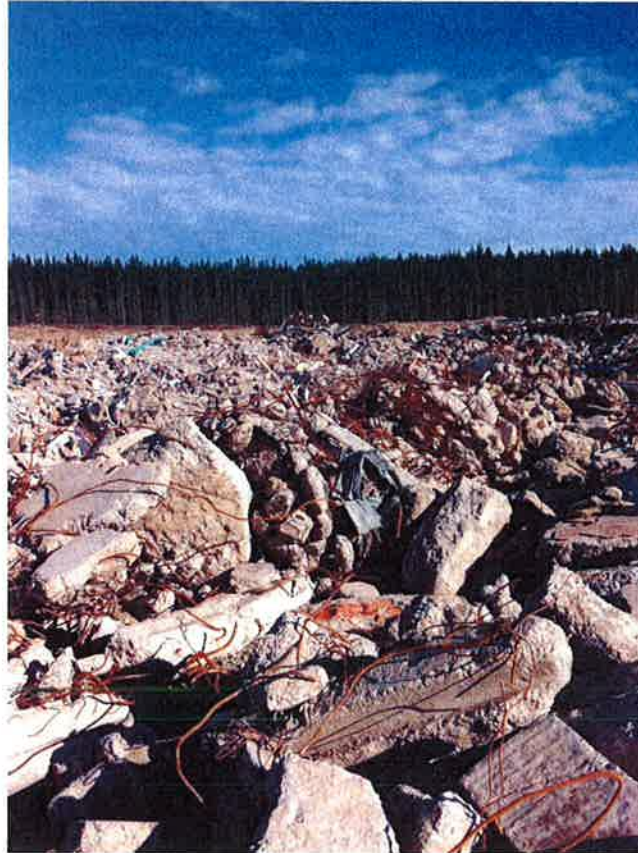
Core testing of two column remnants at Madras Street found lower than expected concrete strengths. As a consequence an additional 24 columns were tested from remnants extracted from the debris at the CTV section of the Burwood Eco Landfill (Figure 37).

A number of circular columns examined showed hinging failures near mid-height as well as hinging at the base or head. Other circular columns were found full height with hinging damage at their heads and bases.

Rectangular columns which had all been located on Line A in the structure, typically exhibited beam-column joint failure as well as other damage.

Figure 37 - A portion of the CTV Building debris field at the Burwood Eco Landfill from which columns were extracted for examination and testing.

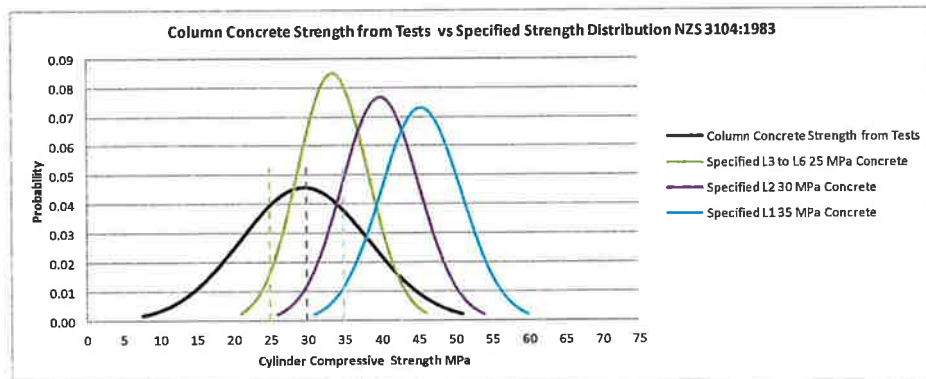
Figure 38 – Column concrete test strengths adjusted for test orientation vs 28-day concrete strength distribution according to NZS3104:1983. This indicates that the concrete in a significant proportion of the columns would have had strengths less than the minimum specified.

Based on the testing undertaken, it appeared that at the time of the collapse the columns in Levels 1 to 6 had mean concrete strength equivalent to that of concrete with 28-day strength of 20 MPa. This was less than the minimum specified concrete 28-day strength of 35 MPa for columns at Level 1; 30 MPa for columns at Level 2; and 25 MPa for columns from Level 3 to Level 6. This is shown graphically in Figure 38.

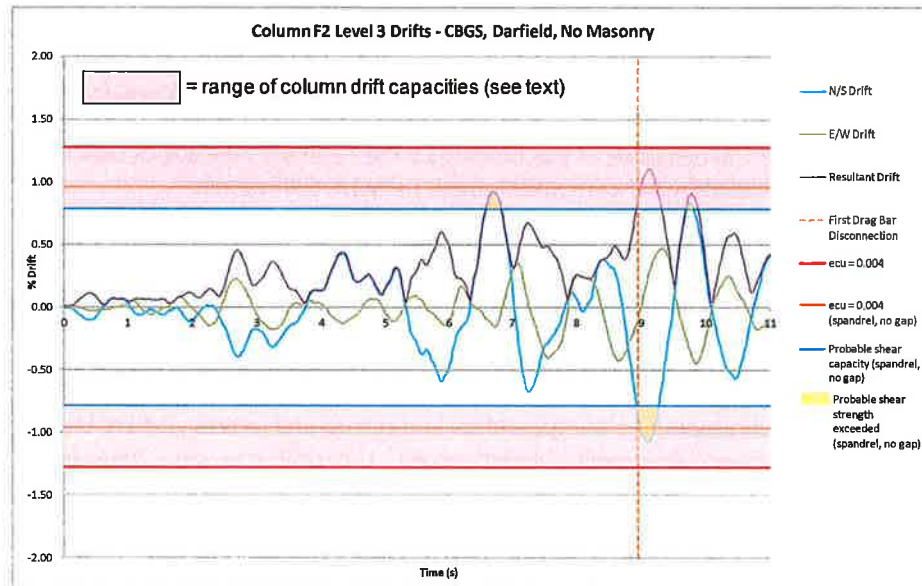
Figure 40 - NTHA drift demands and capacities plotted for column F/2 at Level 3 on Line F for the September Earthquake. This indicates that drift demands were predicted by the model to have exceeded the lower bound drifts at which collapse was found to be able to initiate with interaction from Spandrel Panels. Yielding of the column reinforcing was calculated to have occurred at a drift of around 0.6%. Disconnection of the slab from the North Core was also predicted to have occurred at around 1.0% drift demand.

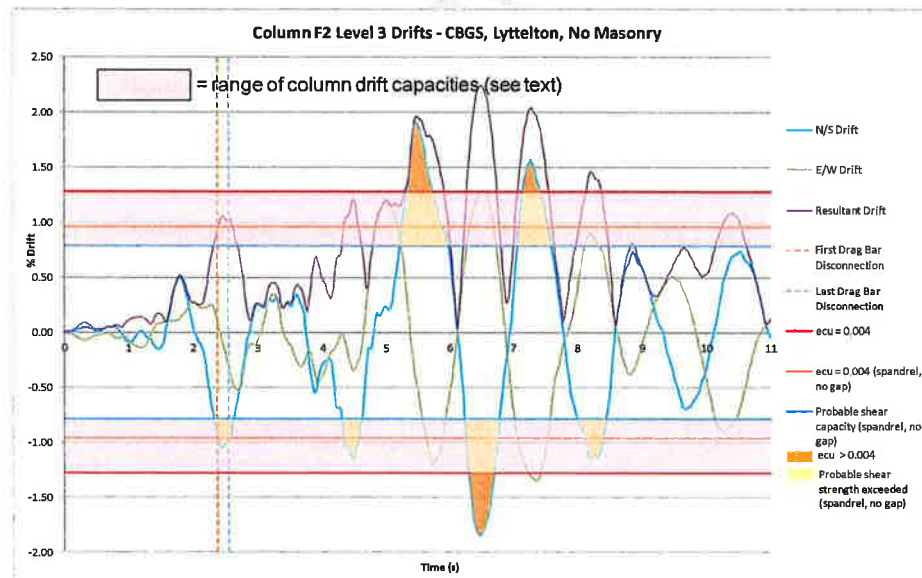
Figure 41 - NTHA drift demands and capacities plotted for column F/2 at Level 3 on Line F for the 22 February Aftershock. This shows that drift demands were predicted by the model to have exceeded many times the lower and upper bound drifts of 0.75% to 1.3%, at which collapse was found to be able to initiate. The lower bound drift being with interaction from Spandrel Panels and the upper bound without Spandrel interaction.. Disconnection of the slab from the North Core was also predicted to have occurred at around 1.0% drift demand early in the record..

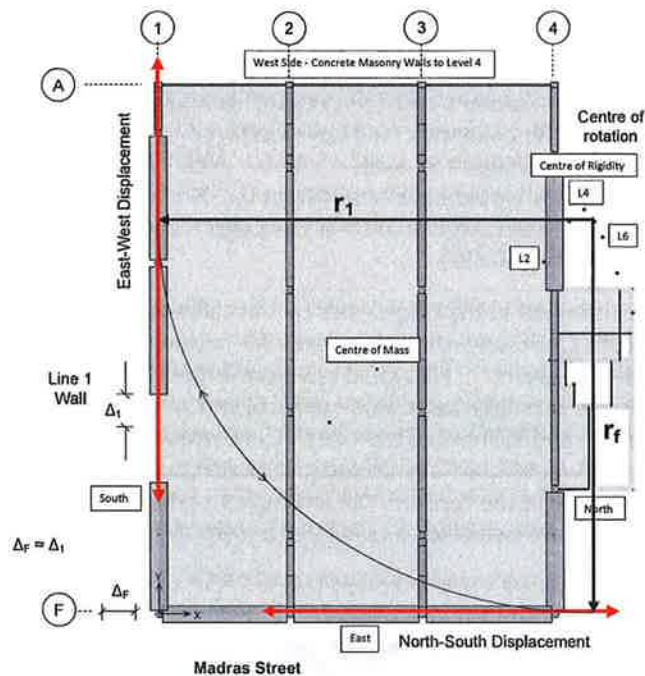
The Line I and F column lines were found to experience similar and the highest inter-storey drifts in the structure due to the effect of the infill masonry wall on Line A shifting westward the centre of rigidity about which the centre of mass of the structure would have rotated (Figure 42).

Figure 42 - Torsional behaviour of the building increased due to the effect of the masonry infill wall on Line A. This shows that the building had a tendency to twist about the centre of rigidity that was moved towards the Line A wall because of its stiffness. The centre of rigidity was furthest west at Level 4. This resulted in the columns along Line I and F experiencing similar and the highest levels of inter-storey drift as the building responded to the Earthquake and Aftershock. This made the columns on these lines the most susceptible to being damaged and initiating collapse during the Aftershock. Line I is thought to have had more protection against progressive collapse occurring due to some of the beams also being supported off the South Wall which was observed to have collapsed after the rest of the building.

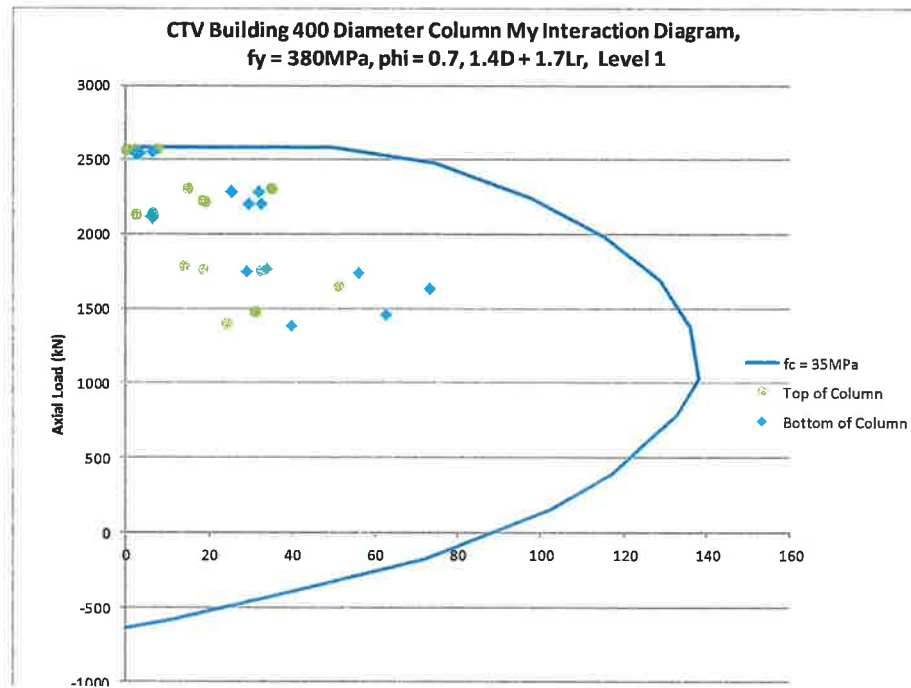
A check of the gravity actions on these columns at Level 1 in accordance with 1986 Codes, and assuming the specified concrete strength of $f_c=35$ MPa, showed they would have been working at the upper Code design limit for axial compression actions. (Refer Figure 43.)

Figure 43 - Column Chart for factored design Gravity Load 1.4D + 1.7 Lr for concrete with specified 28-day strength of 35 MPa. This indicates that a number of the Level 1 columns were getting close to the blue line and nearing the limit to safely hold up the building under general gravity loading conditions within acceptable margins of safety. The phi factor of 0.7 down rates the column strength to 70% of its nominal capacity and the load factors of 1.4 and 1.7 on the dead and live loads respectively factor up the expected loads. For the condition used in the collapse scenarios these safety factors have been reduced to 1.0 to better reflect actual conditions at the time of the collapse.

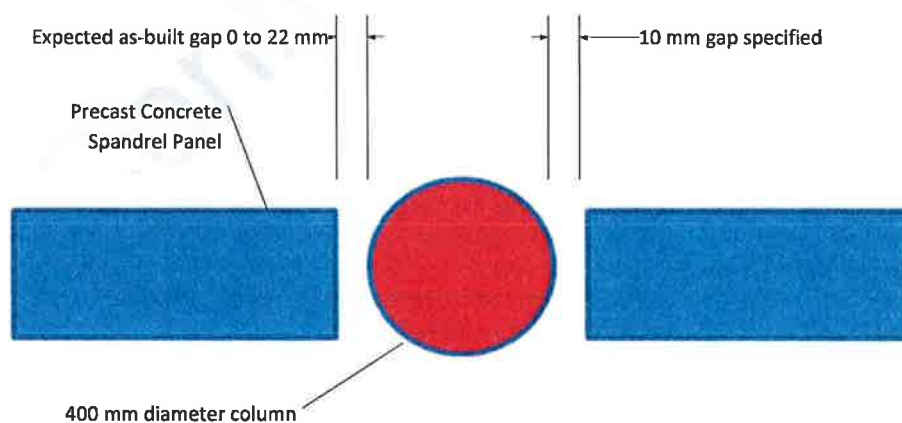
The actual as-built gap to the Spandrel Panels either side of the columns may have ranged between 0 and 22 mm based on the guidelines for assessing combined construction tolerances BS 5606:1990 (Figure 44). This combines the 10 mm off-grid location tolerance of the column; 5 mm oversize allowance on column radius; and half of the 6 mm length tolerance on the precast panels, set in the Specification and the Concrete Construction Standard NZS3109:1987:

Figure 44 - Expected gaps achieved between Spandrel Panels and columns to achieve a specified gap of 10 mm. This based on BS 6505:1990 guidelines on construction tolerances.

Some of the columns may therefore have had little gap between them and the pre-cast panels. It was found from the displacement compatibility and push over analyses that the effect of the Spandrel Panels interfering with the movement of the columns was to accelerate critical column head flexural/compressive damage. It also could have initiate mid-height hinging of upper level columns which had greater displacement ductility due to the lower axial compression actions on them. Column mid-height and base damage was seen in the beam-column remnant seen in Figure 95.

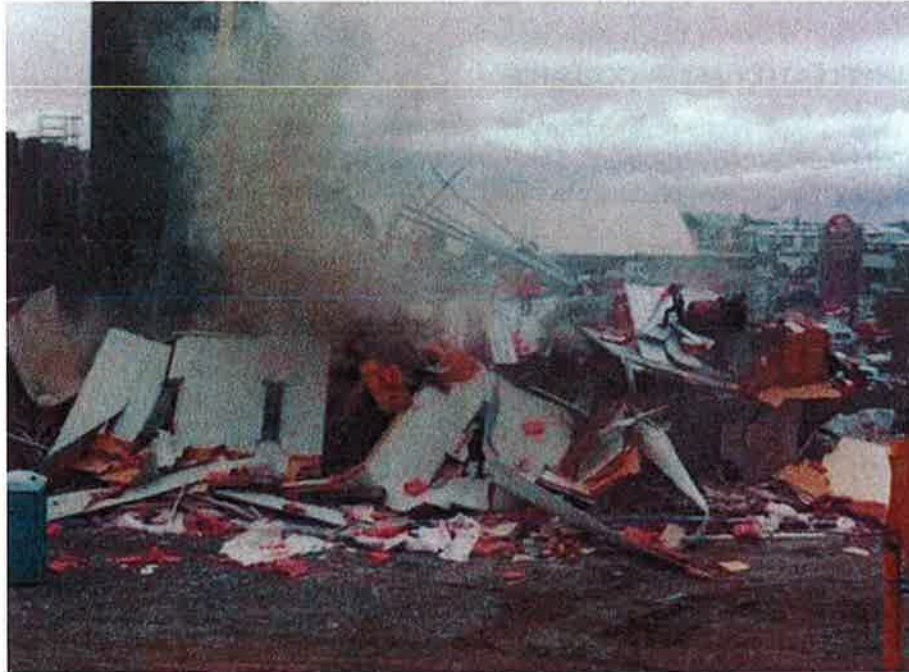
Liquefaction is not considered to have contributed to the collapse. There was a report of liquefaction on the west side of the adjacent empty site. No liquefaction was observed immediately adjacent to the CTV Building itself (Figure 60) or in the streets around the site on the south and east sides.

Figure 60 - West side of building with North Core partially obscured by smoke, prior to heavy machinery removing debris. No liquefaction evident.

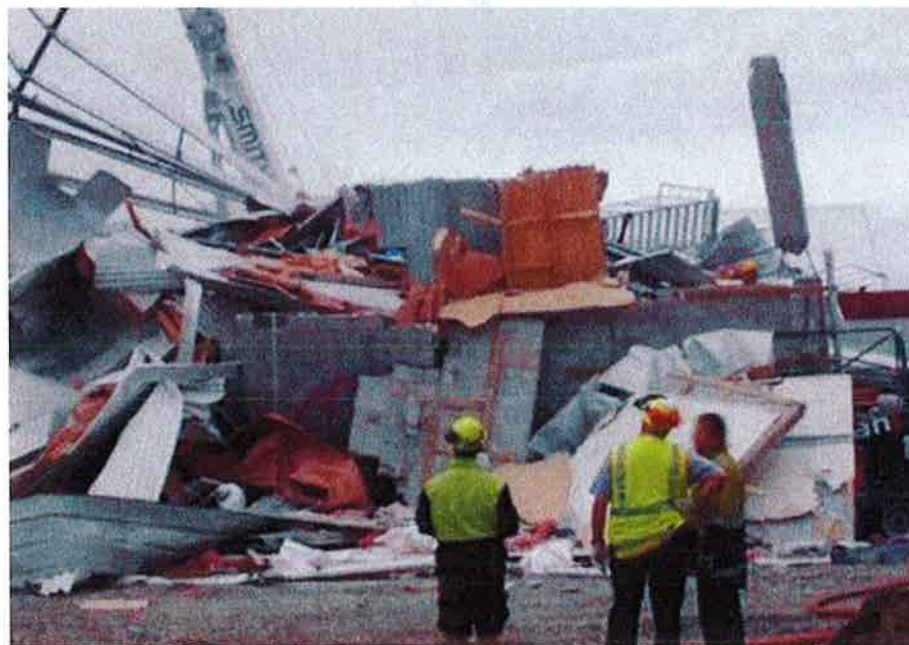
Figure 61 - Southwest corner (Grid A/1) with corner column still standing. Collapsed work platform under wall panels can be seen at the right on which Eyewitness 16 was working.

Severe diagonal fracture of Level 2 wall panels was observed in photos of the debris immediately after the collapse (Figure 61).

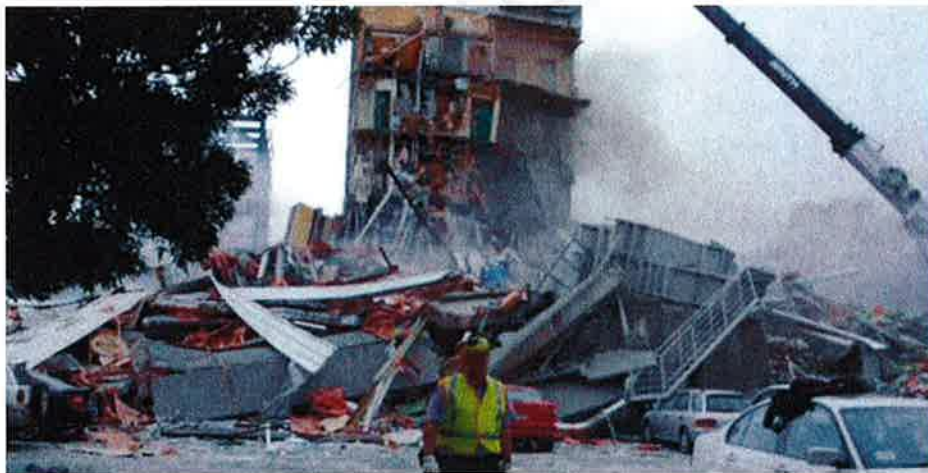
Figure 63 - Western end of south face (Line 1). Collapsed Line shear wall with escape stair to the right.

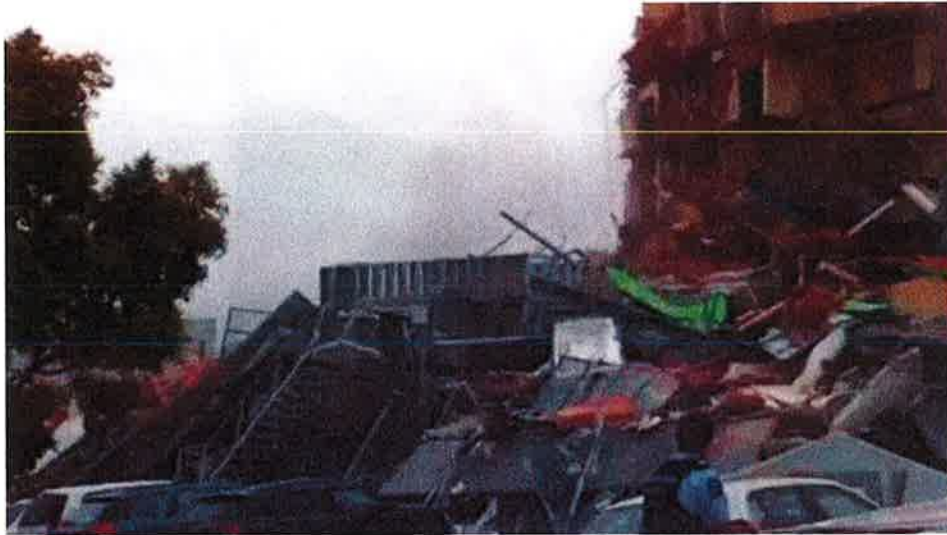
Figure 64 – View southeast corner of the CTV Building looking northwest. The South Wall collapsed onto the top of the debris from Level 2 can be seen, identifiable by the white fire escape stair still attached to it.

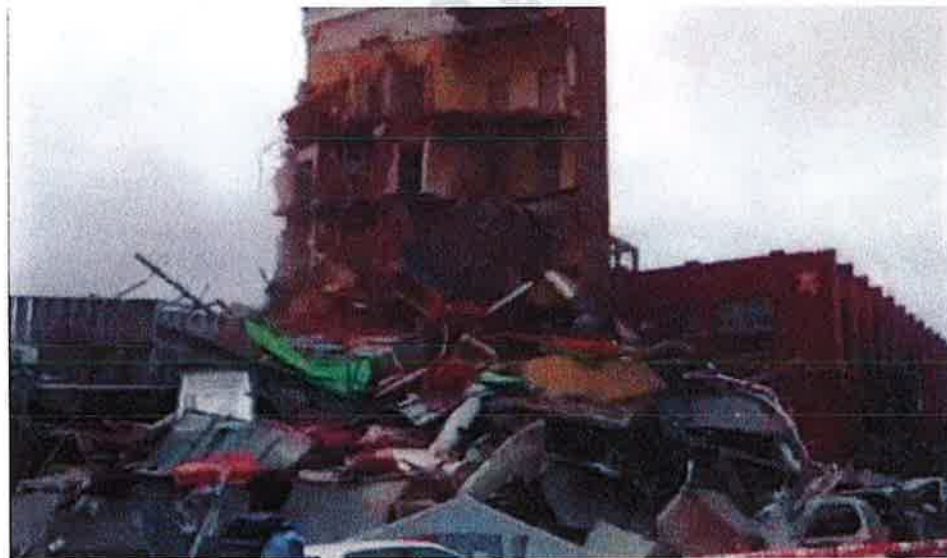
Figure 65 Madras St with precast Spandrel Panels fallen onto cars.

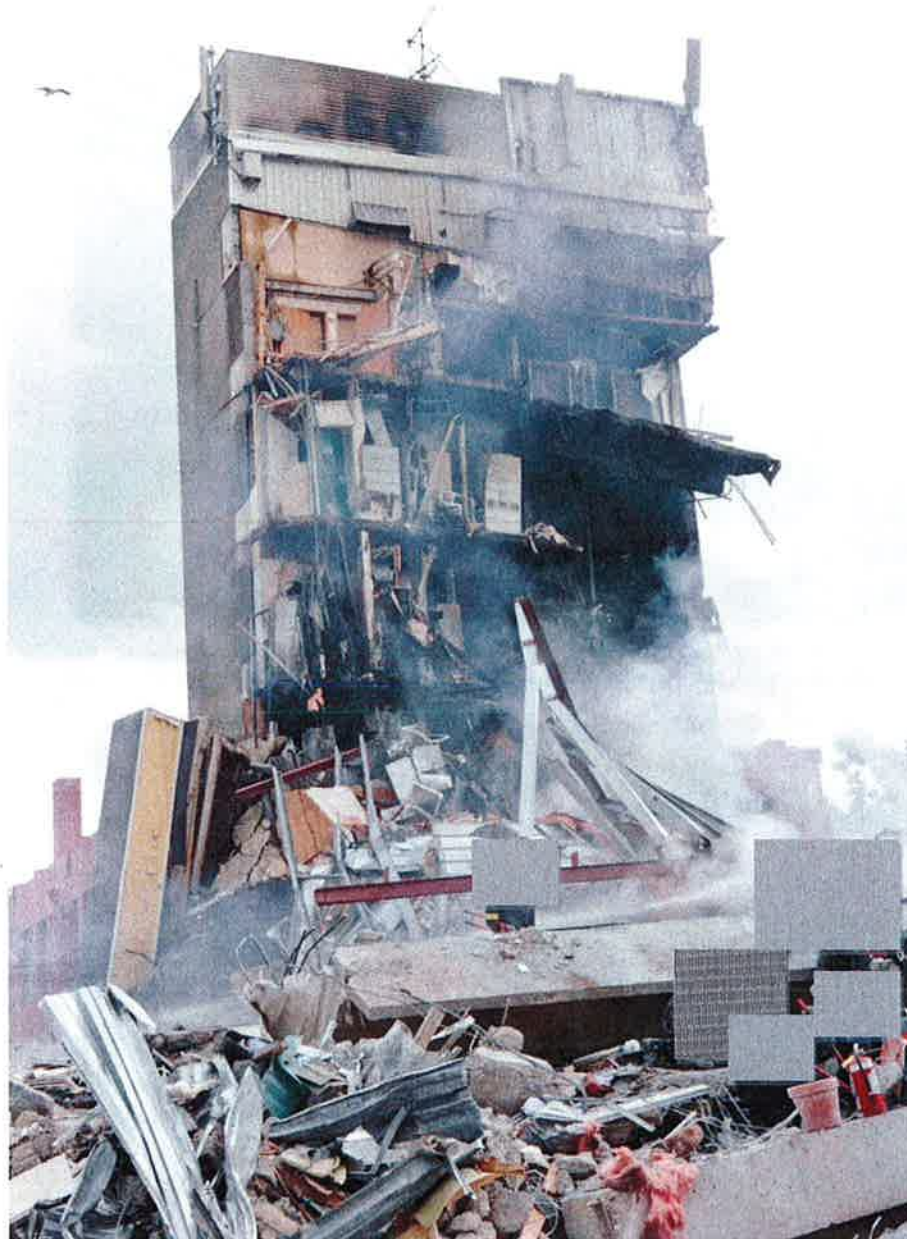
Figure 71 - Spandrel Panels and beams at Cashel Street Line 1 and on Line 4 in background standing vertical. Roof steelwork debris is visible.

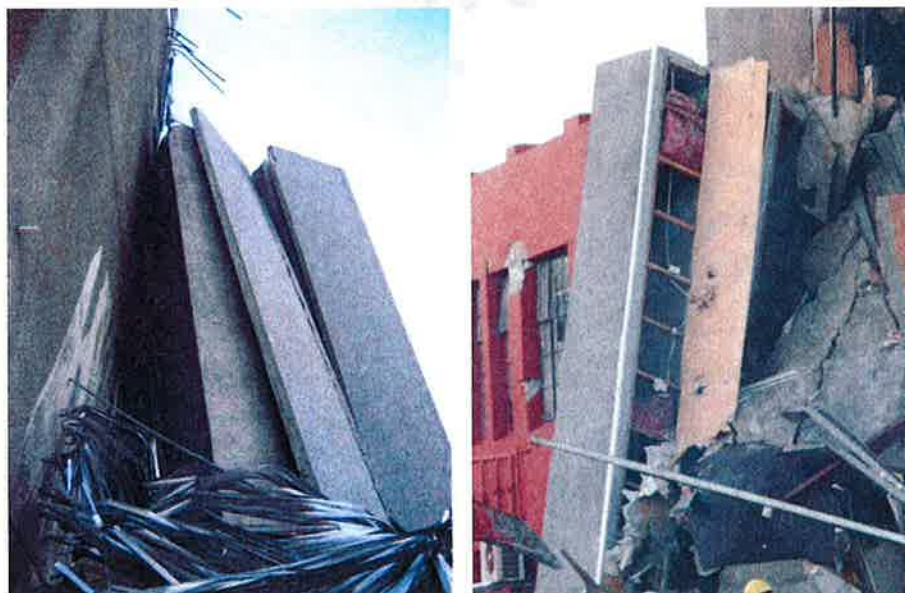
Figure 73 - Line 4 / B-C Spandrel Panels against tower wall, showing (left to right) a) View from north face; b) View from west showing timber framing for wall linings.

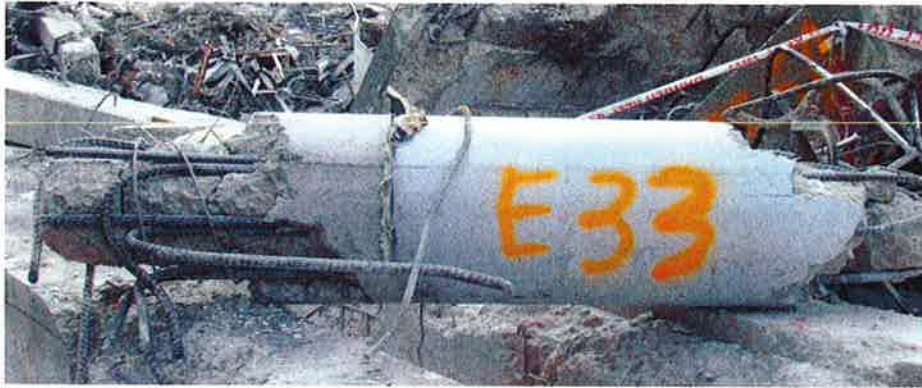
Figure 78 - Perimeter 400 mm diameter column with spalled base and bar lapping zone at left unpainted portion that would have been located at Spandrel Panel infill areas.

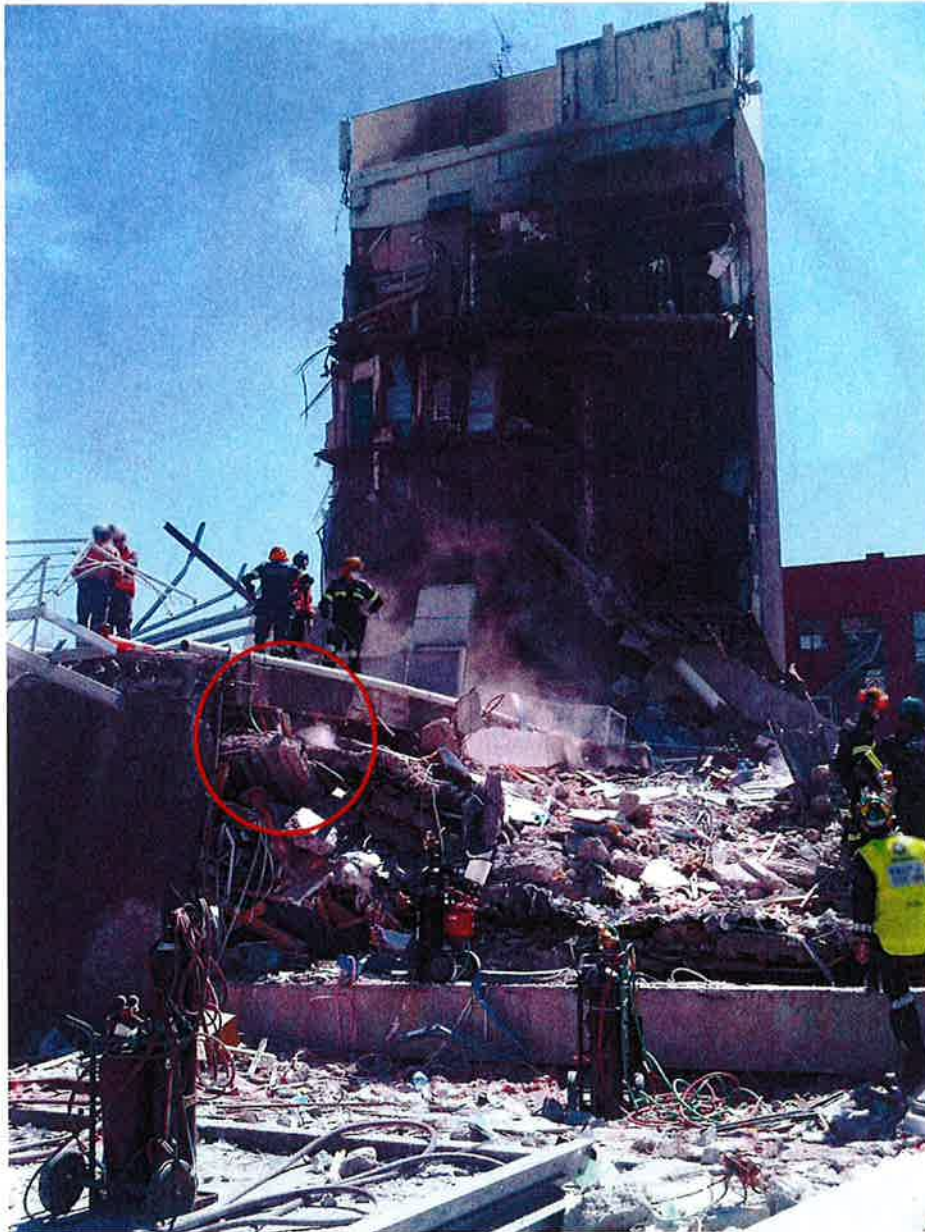
Figure 79 - View from Cashel Street east side of Line 1 with Line 1 South Wall lying on debris at left; trapezoidal end profile of floor slabs laying on top of each other in foreground; A portion of floor slab highlighted, appears to be still in contact with the South Wall at Level 2. Remnants of North Core slabs and the collapsed column on Line 4 D/E can be seen at the rear. The Level 6 slab in front of the lift well can be seen still suspended in mid-air by its Drag Bars connected at Walls D and D/E, even after loss of support from column 4 D/E.

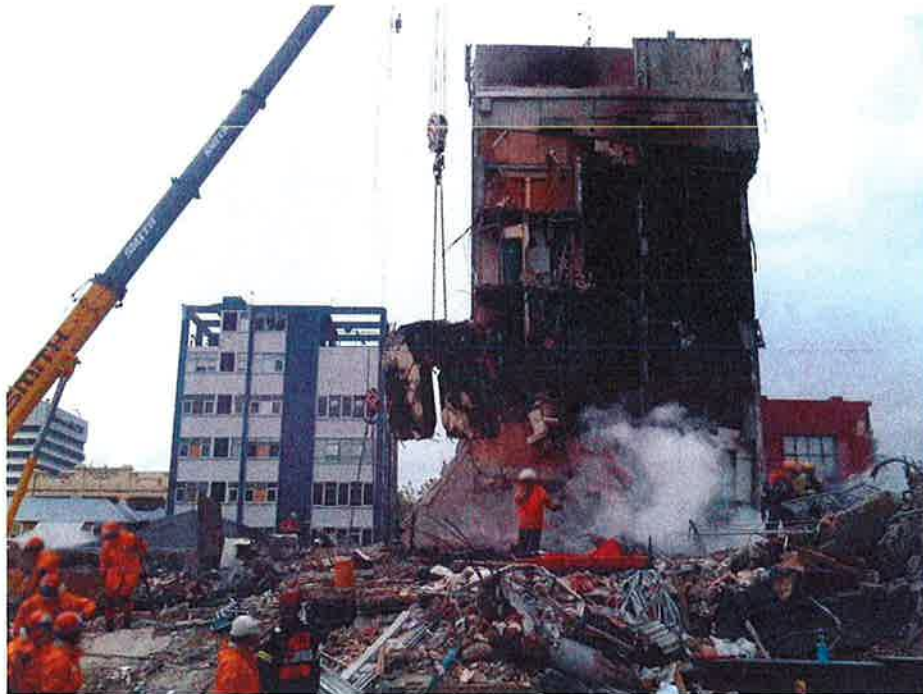
Figure 80 - Portion of Line 1 South Wall being lifted out by crane.. The Level 6 slab in front of North Core has been removed for safety reasons.

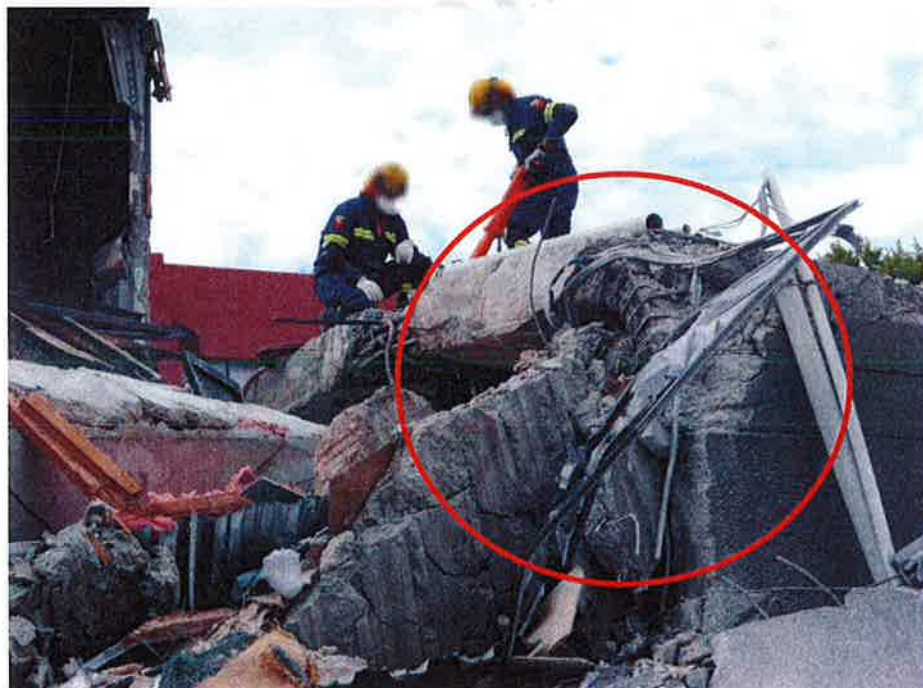
Figure 81 – Upper portion of South Wall being prepared for removal. A portion of slab can be seen highlighted in the foreground in contact with the South Wall on this side at Level 2. It may have forced the wall to pivot against it, preventing it breaking over at its base at Level 1.

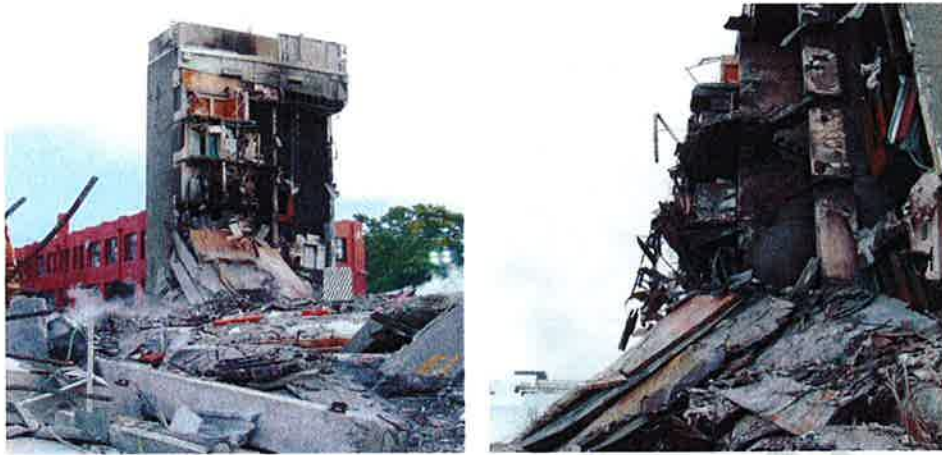
Figure 84 – View of North Core showing Level 4 slab lying diagonally on top of Level 3 slab. This indicates that the Level 3 and 4 slabs lost their vertical support on Line 3 prior to breaking away from the North Core.

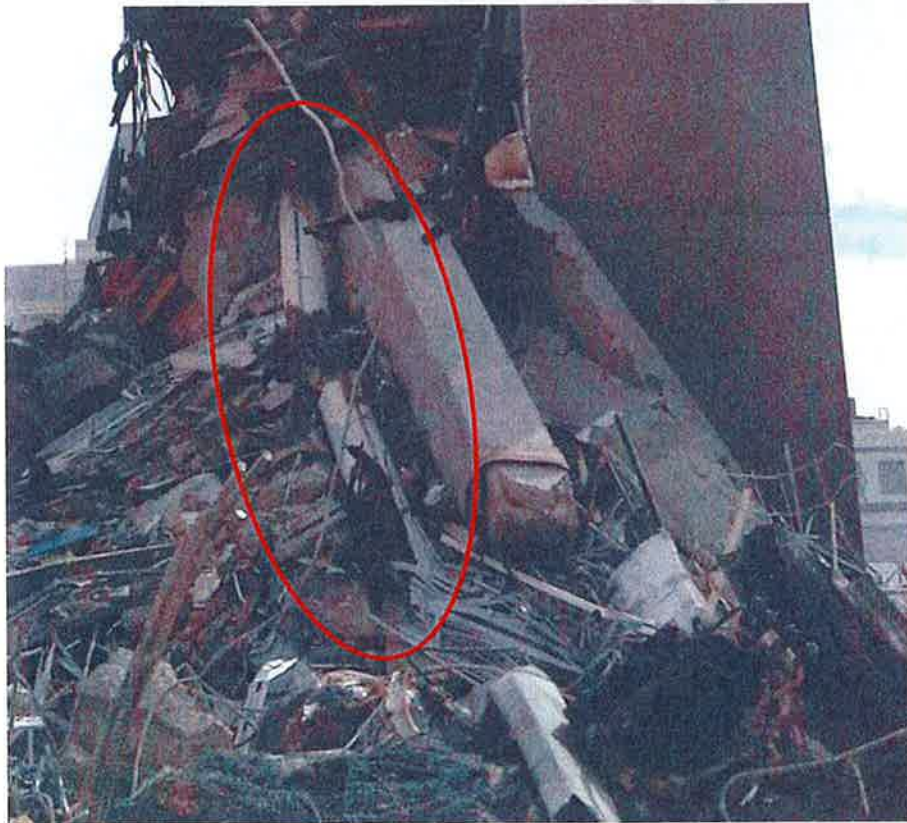
Figure 85 - North Core column 4 D/E highlighted amongst the debris. Hinging can be seen above and below the beam column joint.
