CTV BUILDING

CTV BUILDING COLLAPSE INVESTIGATION FOR DEPARTMENT OF BUILDING AND HOUSING 5TH DECEMBER 2011

CTV BUILDING COLLAPSE REPORT

Report Issue Date: 7 December 2011

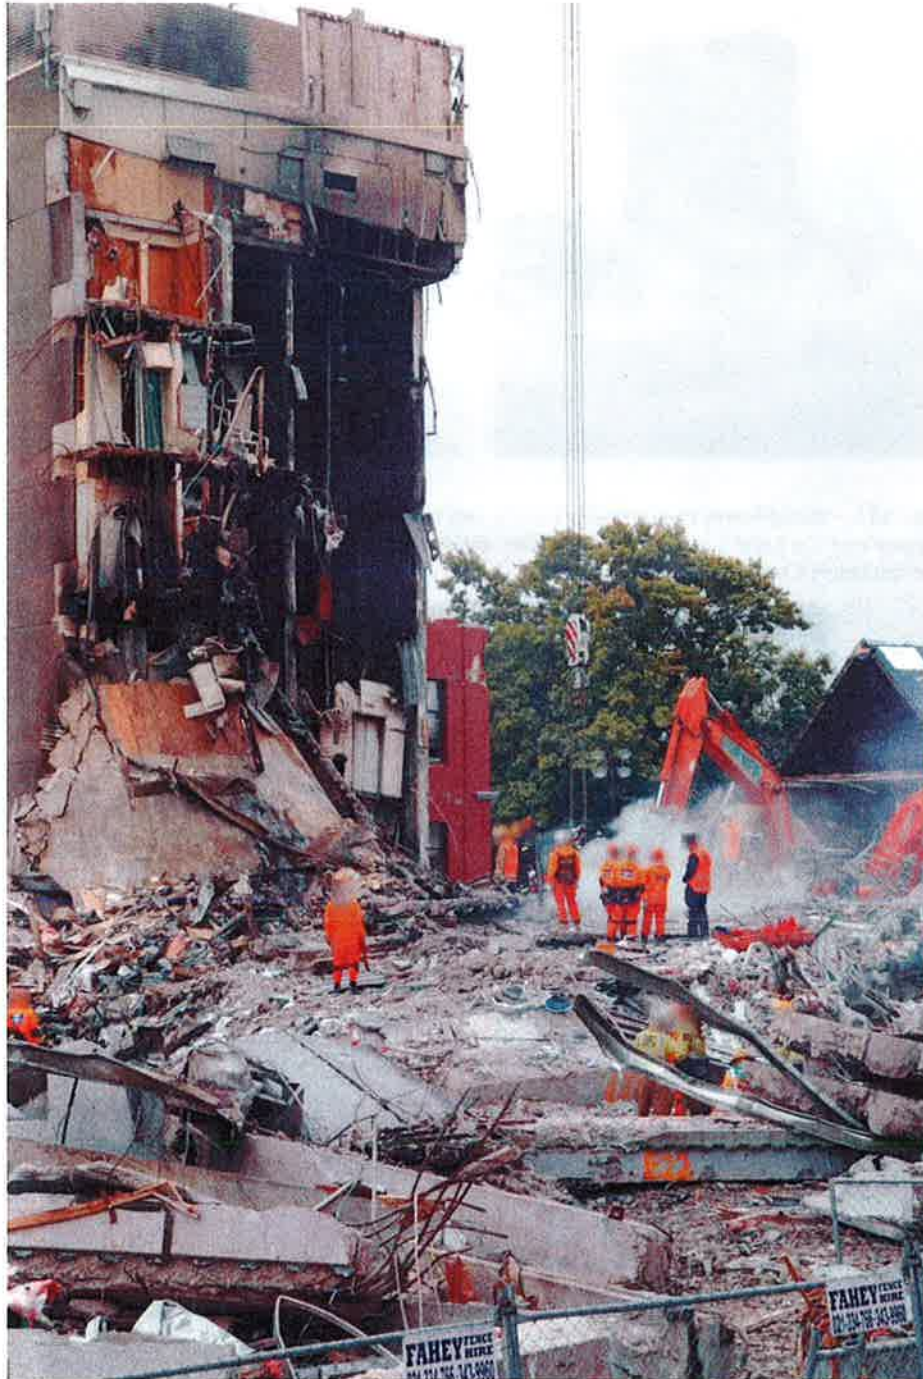
Figure 86 – View from southwest of North Core. The Level 4 slab can be seen lying diagonally against the North Core.

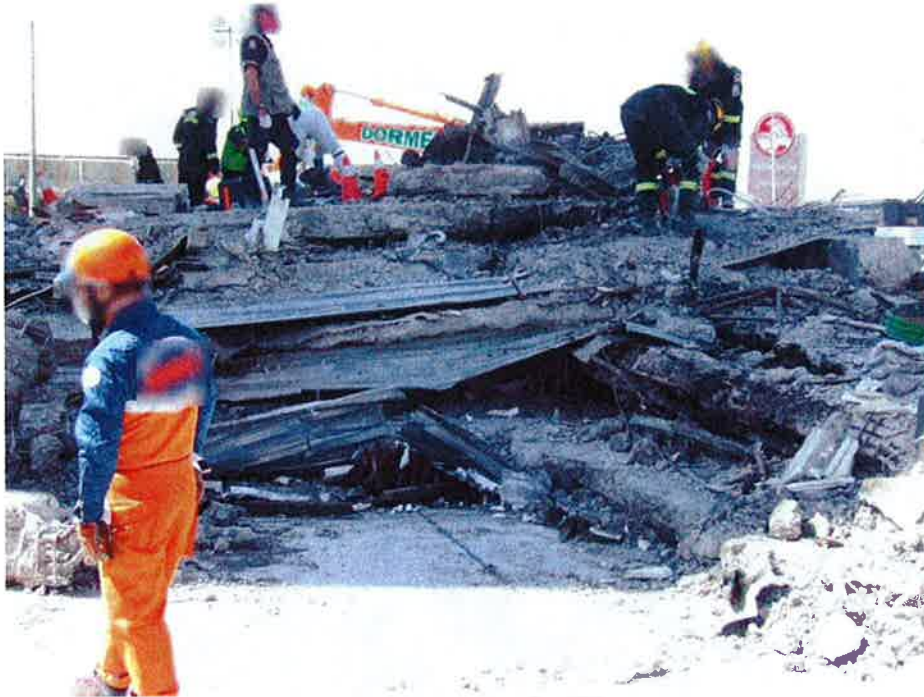
Figure 87 - Line 2 beams lying rotated northwards.

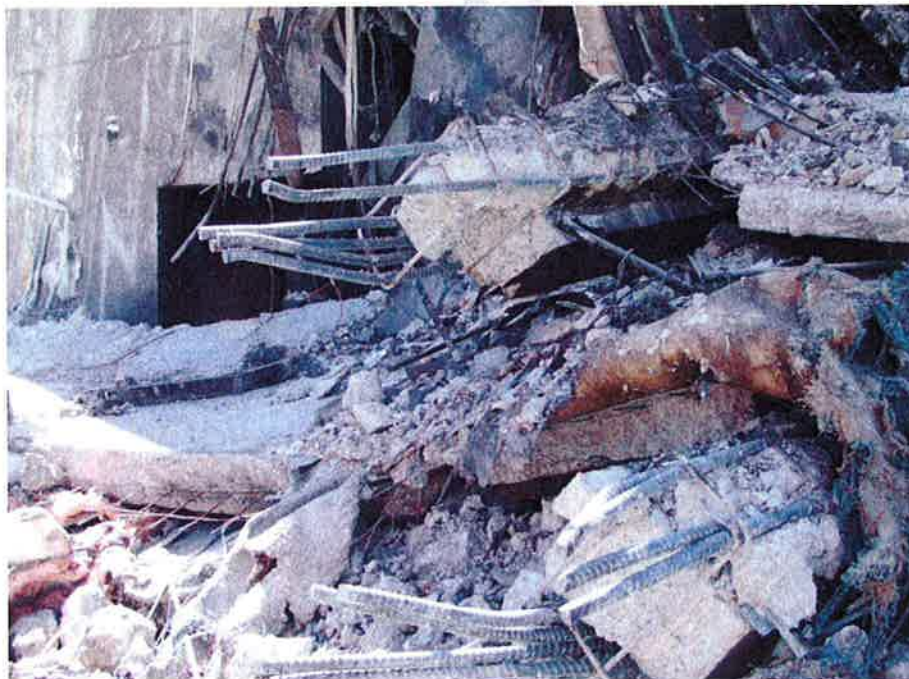
The Line 2 beams were found to be laying northwards (Figure 31) and the Line 3 beams laying southwards (Figure 88). This indicated that collapse of the columns on Lines 2 and 3 had occurred before the slabs detached from the North Core and South Wall.

Figure 88 - Line 3 beams lying rotated southwards

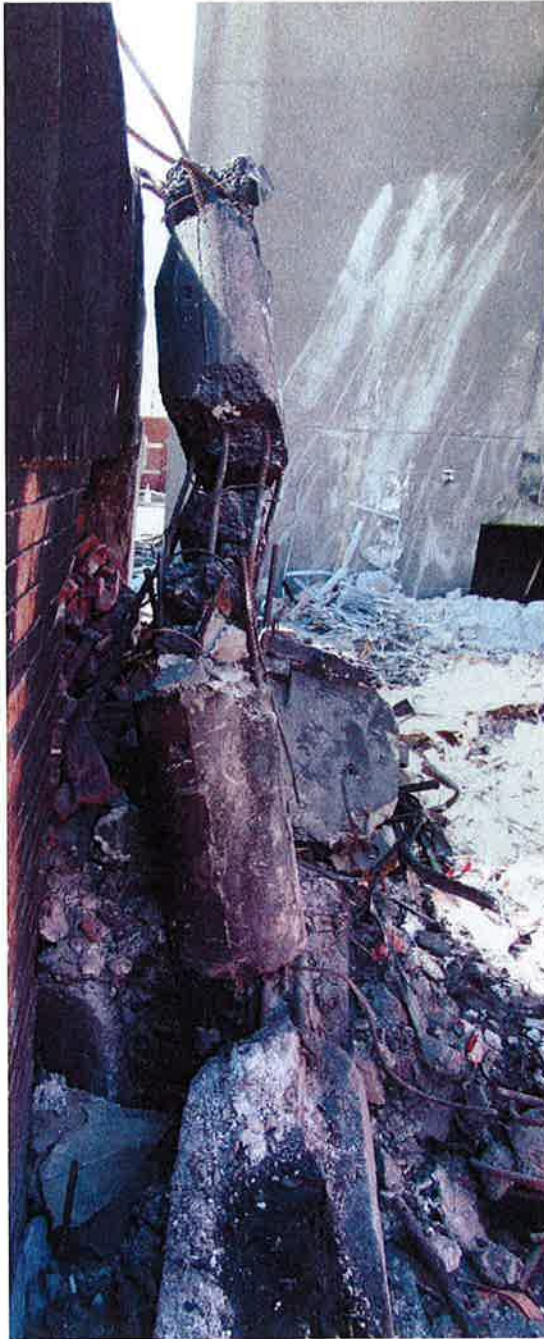
Figure 90 - Line 4 / B column with B22 precast log beam in foreground and B23 shell beam at rear. No hinging is apparent at the base of the column compared to the perimeter column Item E33.

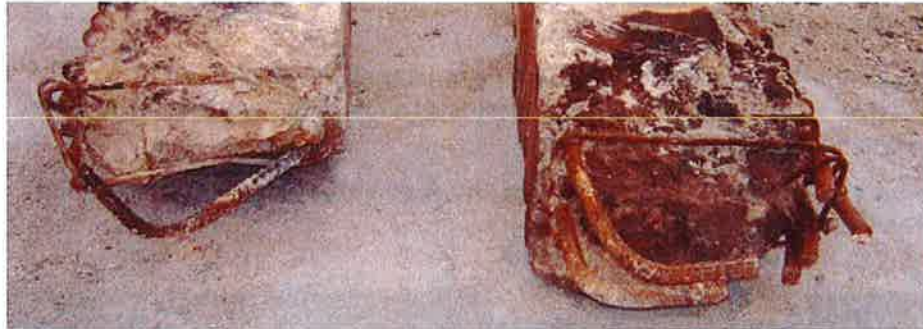
The ends of the pre-cast internal log beams that supported the 200 mm thick profiled metal deck slab, had smooth formed un-roughened ends at the interface with the beam-column joint zone. This would have reduced beam-column joint shear capacity weakening its ability to hold together during earthquakes (Figure 96).

Figure 96 - Interior Pre-cast Log Beams from Line 2 and 3 (DENG Section 3 Dwg S15) showing smooth concrete formed for beam-column joint, and bottom hooked bars that have pulled out of beam-column joints without any obvious straightening;

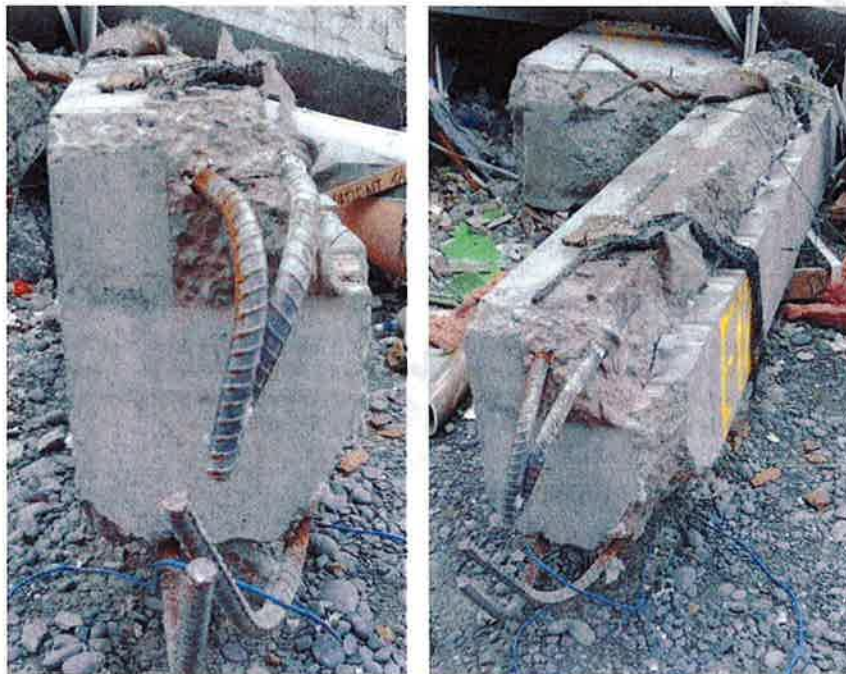
No starter bars connected the log beam into the 200 mm slab that was supported on the shell beams. This is unusual (Figure 97).

Figure 97 - Item E18 Pre-cast edge beam north-west corner (DENG B22 Dwg S18 (from left to right) (a) Smooth form finish at attachment to column 4A (DENG Detail 1 Dwg S19); (b) No starters (reinforcing bars) from pre-cast beam into slab to prevent the profiled metal deck slab pulling away (DENG Section 4 Dwg S15). If roughened these joints may have slowed down development of progressive collapse.

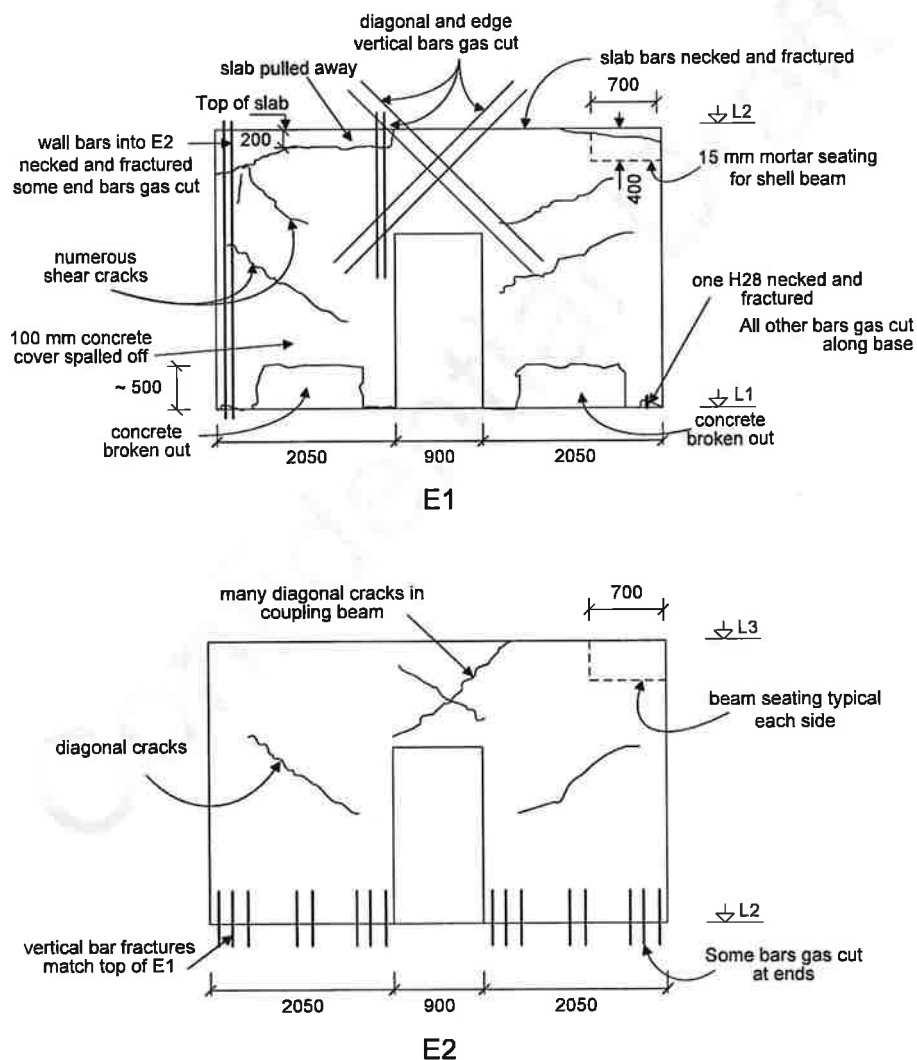
The South Wall had been cut into single storey height portions during the recovery process. The lower portion of the wall at Level 1 had been broken up during removal (Figure 98). There was very little cracking in the door head coupling beam of the level 1 portion of the wall. This may have been due to the influence of the masonry infill to the doorway and the depth of the coupling beam.

This panel showed flexural cracking patterns typical of cantilever shear walls rather than coupled shear walls (Figure 98). This was likely due to the effect of the Level 1 doorway having been infilled with reinforced concrete masonry.

Figure 98 - Line 1 South Wall remnants (top) E1 Level 1 to 2; (Bot) E2 Level 2 to 3.

This panel had diagonal cracking in the piers consistent with cantilever wall behaviour and two way diagonal cracking in the door head coupling beam (Figure 98).

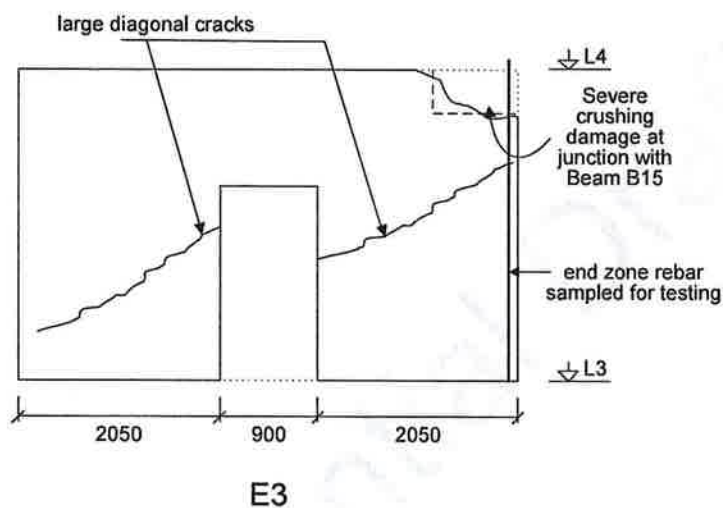
The Level 3 to 4 portion of the wall was significant for one way diagonal cracking and damage at the top eastern corner (Figure 99). This corresponded to severe diagonal two way cracking through the lower portion of the eastern panel of the level 4 to 5 portion of the wall (Figure 100 and Figure 83). It was not clear what had caused this damage. However the structural analyses indicated that the level of shear demand in the east panel consistent with 0.75 to 1.3% drifts along Line F, at which collapse was considered likely to have occurred, was unlikely to have been sufficient to develop that level of cracking prior to the collapse. It was therefore concluded that the damage observed at this location in the wall had been as a result of its fall onto the collapsed building.

This panel had dominant uni-directional diagonal cracking running from the bottom west corner to the top east end (Figure 99).

Figure 99 - Line 1 South Wall remnant E3, Level 3 to 4.

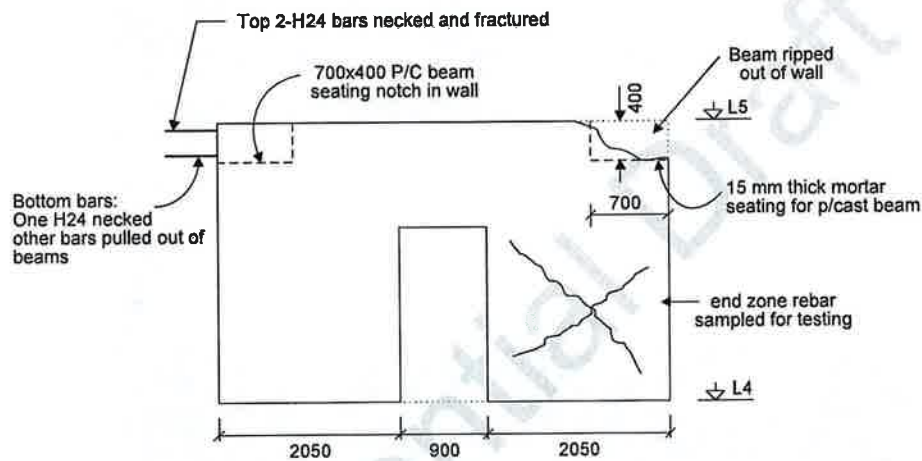
These higher shear demands on the South Wall at this level compared to the one below were identified to occur for east-west earthquake loadings Figure 126. There may have also been slippage on the smooth construction joints found in the wall during the Site Examination and noted in Figure 100 and Figure 101. These factors may have increased the inter-storey drifts between Level 4 and 5 relative to the floors below it, increasing the likelihood of column failure initiating between Level 4 and 5.

Severe two-way diagonal cracking in east pier and loss of cover to vertical reinforcing steel on east edge.

Smooth mortar construction joints rather than roughened at junctions with pre-cast shell beams B15 and B16 (Figure 100).

The cracking may have been caused on impact with the ground during the collapse, as the calculated shear capacity appears to have been adequate for the loadings considered to have occurred at the time of the collapse..

Weak concrete in west pier adjacent to top of doorway that was able to be dislodged by boot (Figure 100).

Figure 100 - Line 1 South Wall remnants E4 Level 4 to 5 and E4 level 5 to 6.

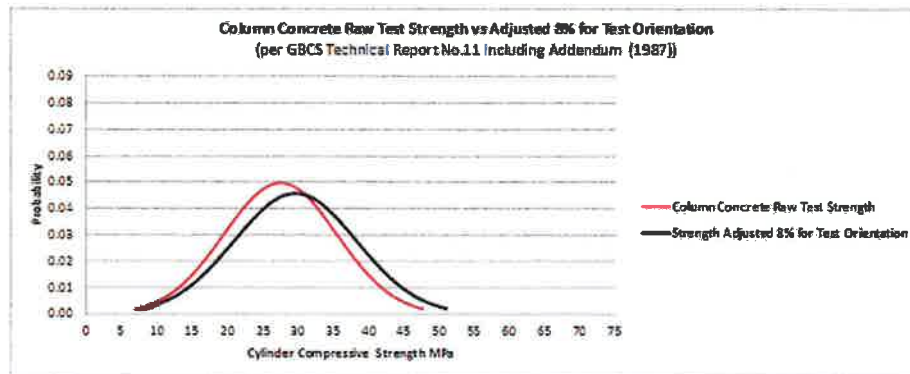
The sample means of the test results for a particular member were adjusted up by a factor of 8% where required, to allow for test orientation effects where testing had been done transverse to the direction of casting (Figure 106). This was in accordance with the recommendations of the Concrete Society Technical Report 11 (GBCS 1987).

Figure 106 - Column concrete test strengths compared to strengths adjusted 8% for test orientation being transverse to direction of concrete casting. This adjustment in test strength was recommended by the Concrete Society Technical Report 11 "Concrete Core Testing for Strength".

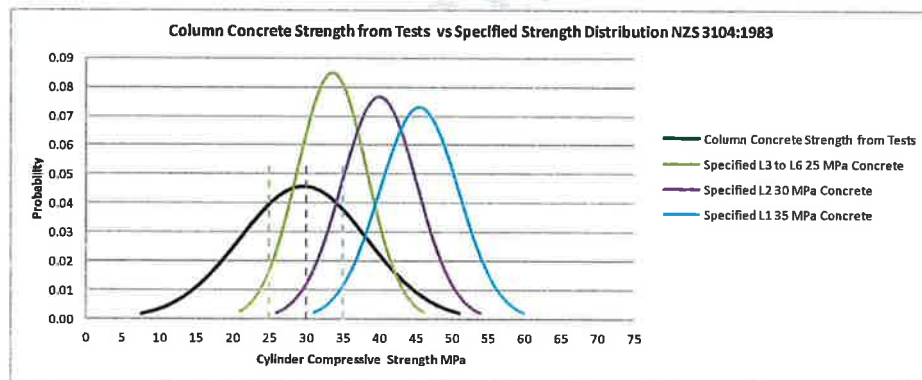
This indicates that at the time of the collapse the columns in Levels 1 to 6 had mean concrete strength equivalent to that of concrete with specified 28-day strength of 20 MPa (Figure 107). This is less than the minimum concrete 28-day strength of 35 MPa for columns at Level 1; 30 MPa for columns at Level 2; and 25 MPa for columns from Level 3 to Level 6.

Figure 107 – Column concrete test strengths adjusted for test orientation vs 28-day concrete strength distribution according to NZS3104:1983. This indicates that the concrete in a significant proportion of the columns would have had strengths less than the minimum specified.

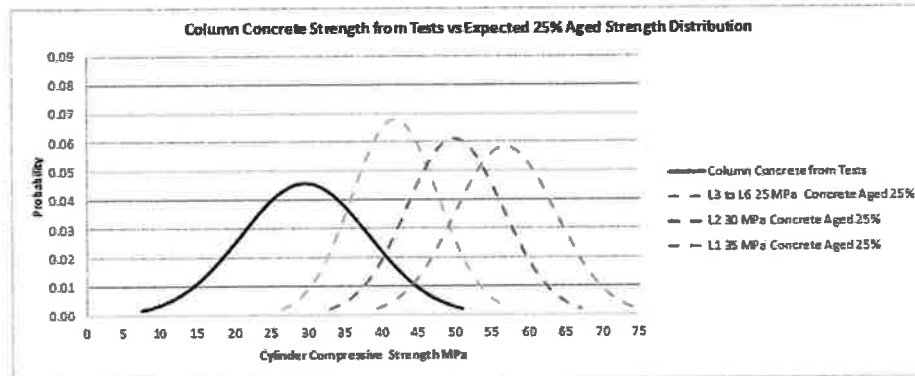
This also indicates that at the columns in Levels 1 to 6 would only have achieved a 28-day strength of 17.5 MPa at the time of construction (Figure 108). This is less than the minimum concrete 28-day strength of 35 MPa for columns at Level 1; 30 MPa for columns at Level 2; and 25 MPa for columns from Level 3 to Level 6.

Figure 108 – Column concrete test strengths adjusted for test orientation vs 28-day concrete strength distribution according to NZS 3014:1983 strength-aged by 25%. This shows that the concrete in the columns had significantly lower strength distribution compared to the lowest concrete strength specified when account is made for the strengthening of concrete with age.

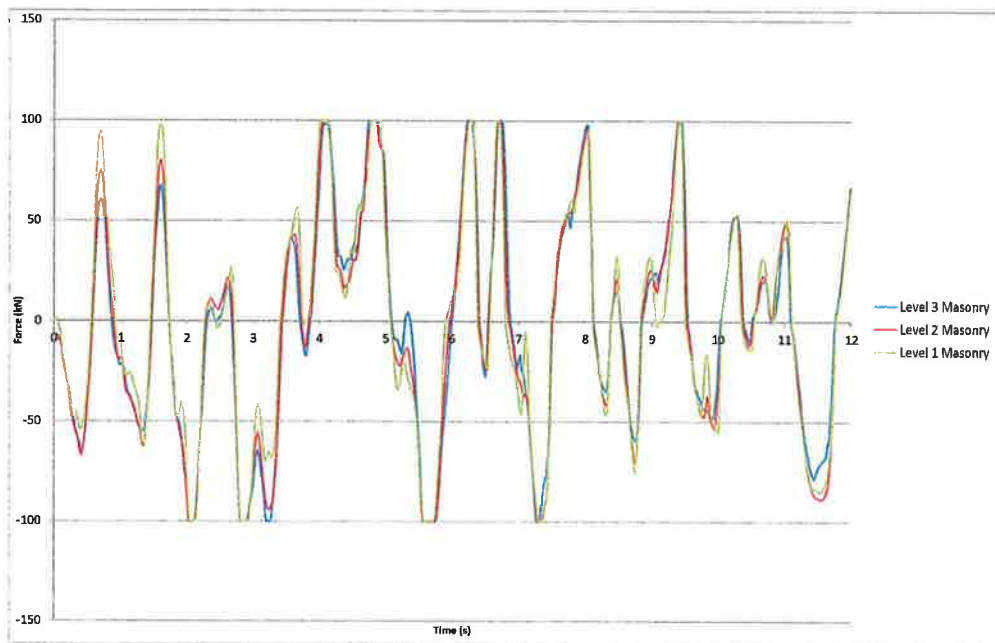
Figure M below is a plot showing the shear force in a typical 2.3m wide masonry infill panel over the duration of the 4 September Darfield Earthquake CBGS record. It shows that the masonry panel, if fully engaged, would have been participating up to near its bending limited shear capacity throughout. There were nine masonry panels on grid A at each floor level, meaning that the total storey shear contribution from the masonry ranged up to 900kN (where limited by cantilever bending capacity).

Figure M - Shear Force in typical 2.3m wide masonry infill panel, 4 September Darfield Earthquake CBGS. This shows that the masonry panels reached their shear resistance as limited by flexural capacity on a number of excursions of loading.

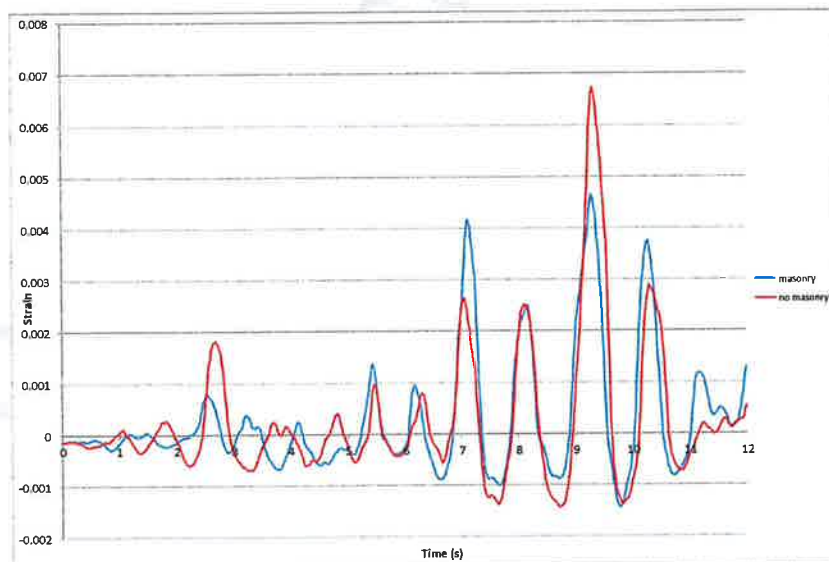
First impressions are that these maximum strains suggest a level of damage somewhat higher than the minor 0.3mm wide cracks that were reported by the OIE after the 4 September Darfield Earthquake. The OIE believed no yielding of reinforcing had occurred in the structure. This may be an indication the NTHA model is over-predicting the response, perhaps due to the input ground motion not accurately representing the shaking experienced at the CTV site or the building response to the ground motion being different to that of the computer model.

Figure N below, is a plot of the strain at the base of the southern coupled shear wall at the eastern face, for Models A (no masonry) and B (with masonry).

Figure N - Strain at base of South Wall at eastern face, 4 September Darfield Earthquake CBGS.

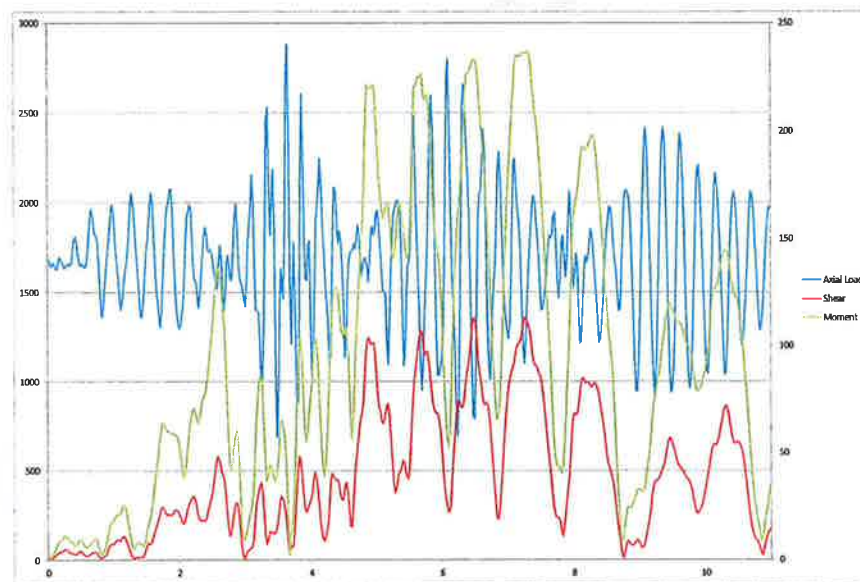
In Figure Q below the variation of axial action, bending moment and shear force is plotted over time for one of the most heavily loaded columns at grid D2 at level 1. This shows the bending moment and the shear force in phase at around one cycle per second, and the vertical component superimposed at a higher frequency. The flat spots on the bending moment and shear force curves represent the times when column hinging is occurring in the model. From this plot it will be appreciated that assessing the demand on, and capacity of the column at any particular instant in time was difficult.

Figure Q - Column Actions D2 Level 1, 22 February Lyttelton Aftershock, CBGS.

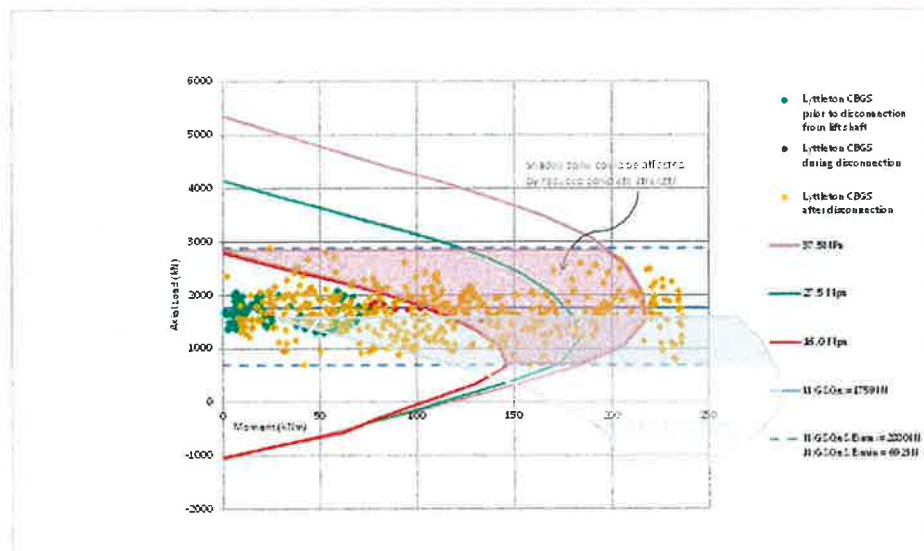
Figure R - Column D2 Level I M-N Interaction diagram. ($F_y=448\text{MPa}$, $\phi=1.0$, no masonry.)

- The M-N interaction curves have been drawn for three different concrete strengths 37.5MPa, 27.5MPa and 16MPa. The specified concrete strength for this column was 35MPa, which is the average strength that was used in the NTHA. The lower bound strength found from material testing of column remnants was 16.0MPa.

Figure R indicates that vertical earthquake effects alone may not have been enough to fail the columns if they had been constructed at the specified strength. However, vertical earthquake effects in combination with column actions resulting from lateral drift are significant and may have contributed to column failures, particularly if in combination with reduced concrete strengths.

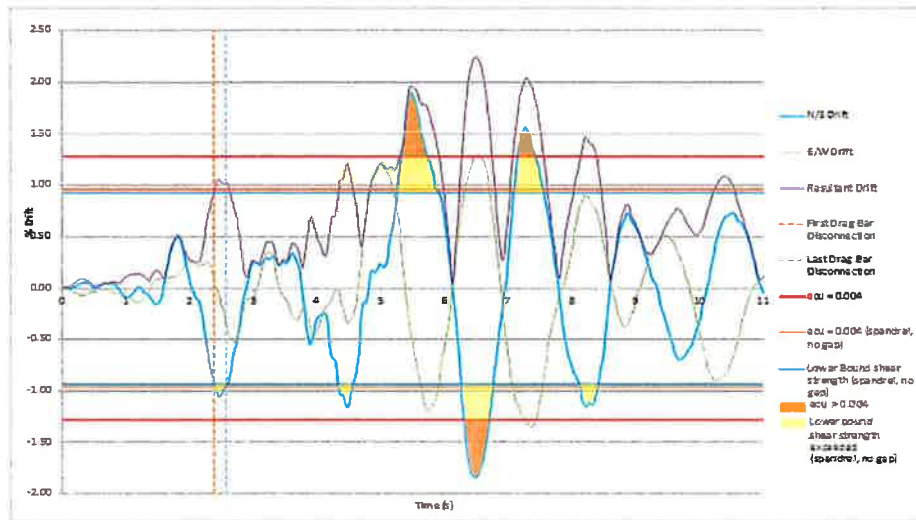
Figure U - Column F2 Level 3 Drifts - CBGS, 22 February Lyttelton Aftershock, no masonry.

Overall the comparisons show that it is more likely that failure initiated in the high level Line F columns (more shaded areas where demand exceeds capacity). In fact line I columns would be similar because they were shown to undergo similar drifts and they also had precast Spandrel Panels between.

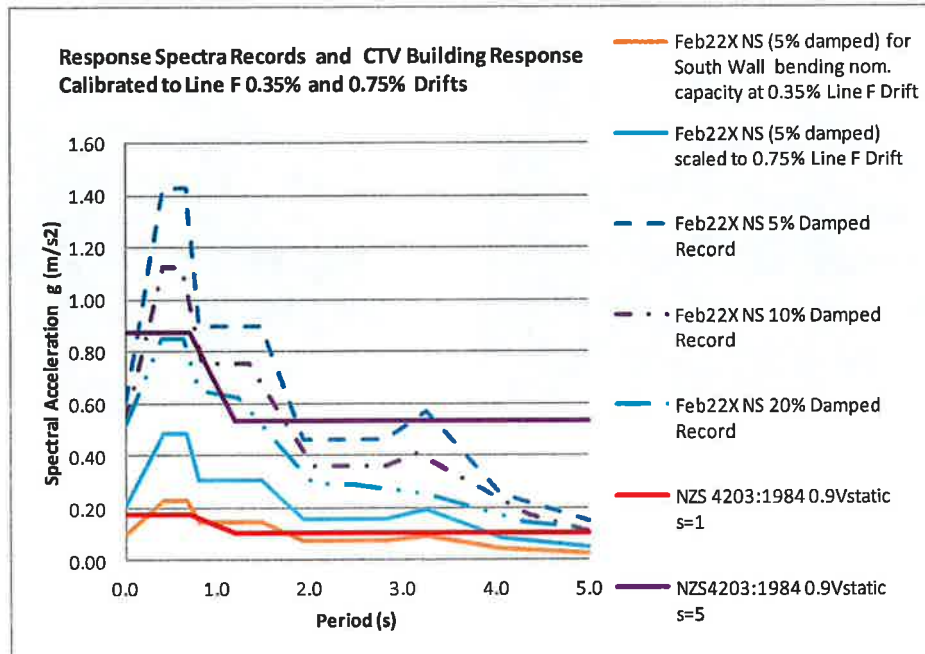
If collapse occurred at drifts along Line F of around 0.75% this indicates that the CTV Building collapsed prior to it achieving its intended fully ductile performance. The intention of NZS 4203:1984 was that a structure designed to be fully ductile ($s=1$) should be able to survive an earthquake response equivalent to that shown by the $s=5$ curve, with a low probability of collapse.

Figure 113 - Response spectra records for various levels of damping are shown alongside those calibrated for building response at development of 0.75% drift on Line F. Also shown is response at development of nominal bending capacity in the base of the South Wall at 0.34% drift on Line F. It appears likely that collapse occurred between 0.75% and 1.3% drifts on Line F. The expectation of NZS 4203:1984 was that drifts of 1.23% should have been attainable with a low probability of collapse.

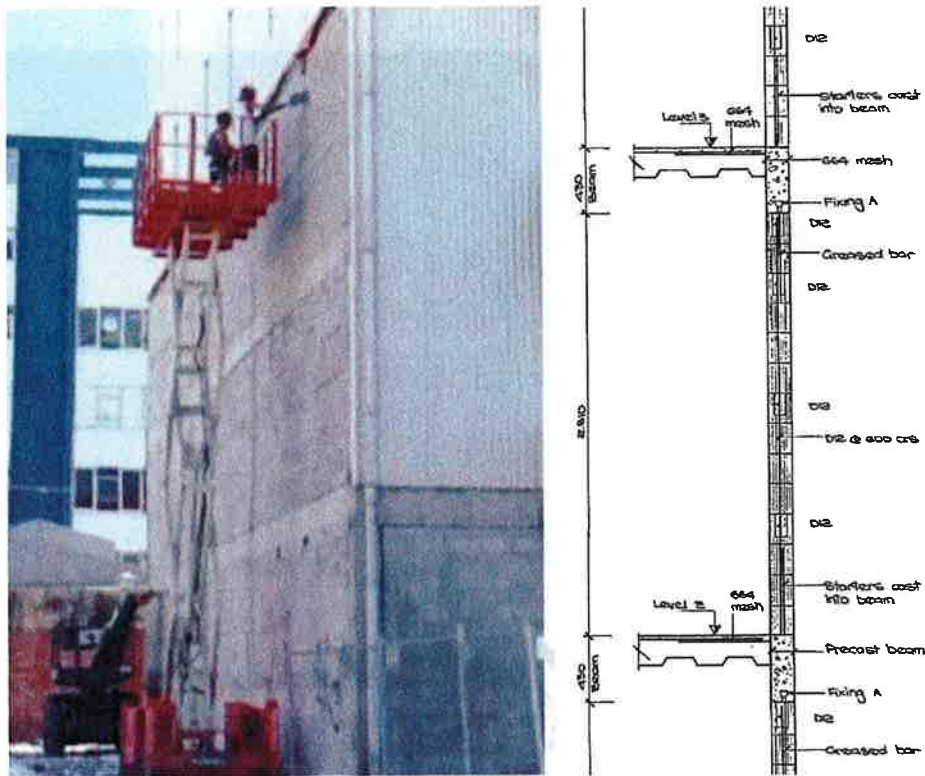
The rectangular columns sat out proud of the wall face by 20 mm or so. Photos showed vertical separation gaps between the corner column (Grid 1/A) and the short Line 1 return wall on the south face of the building. A horizontal separation gap appeared to be evident between the Line 1 wall and the beam above it (Figure 116). However no vertical or horizontal gaps were evident from the photo on the West wall along Grid A.

Figure 116 - West wall on Line A (left to right) : Being prepared for strapping and cladding a day or so before collapse on 22nd February; b) Connection of west wall block work into floor beams top and bottom (portion of DENG Dwg S9 Section 6), showing the fixing of the top of the wall into the structure.

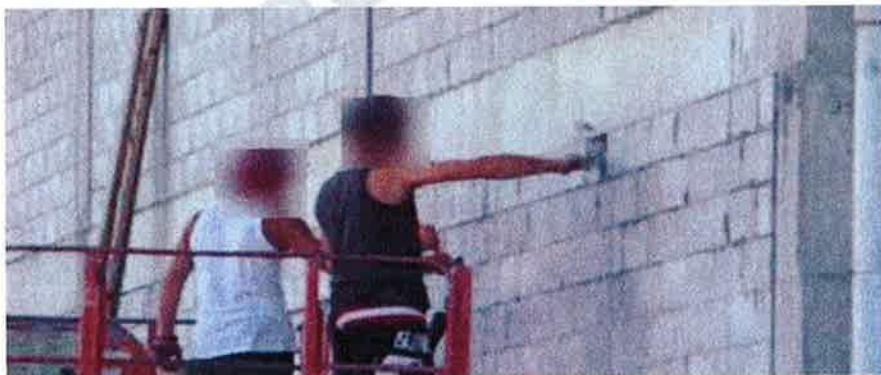
Figure 117 – Workers (including Eyewitness 16) hammering face of top course block away on west wall near Line A / 1 corner column. This indicates hollow blocks occurred in the top course and no separation joints on the outer face of the masonry.

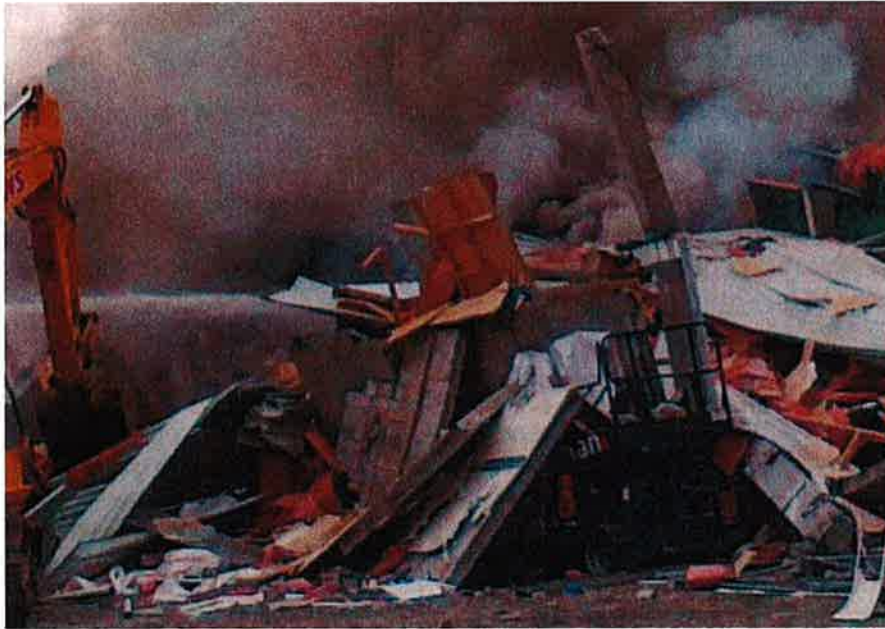
During the collapse (Figure 120) the masonry wall along Grid A broke apart, in some cases as distinct panels, consistent with the design drawings (DENG Dwg S17). Two way diagonal shear fracturing, indicative of severe cyclic demands on the Level 2 masonry was also evident.

Figure 120 - West wall on Line A at southwest corner shortly after the collapse.

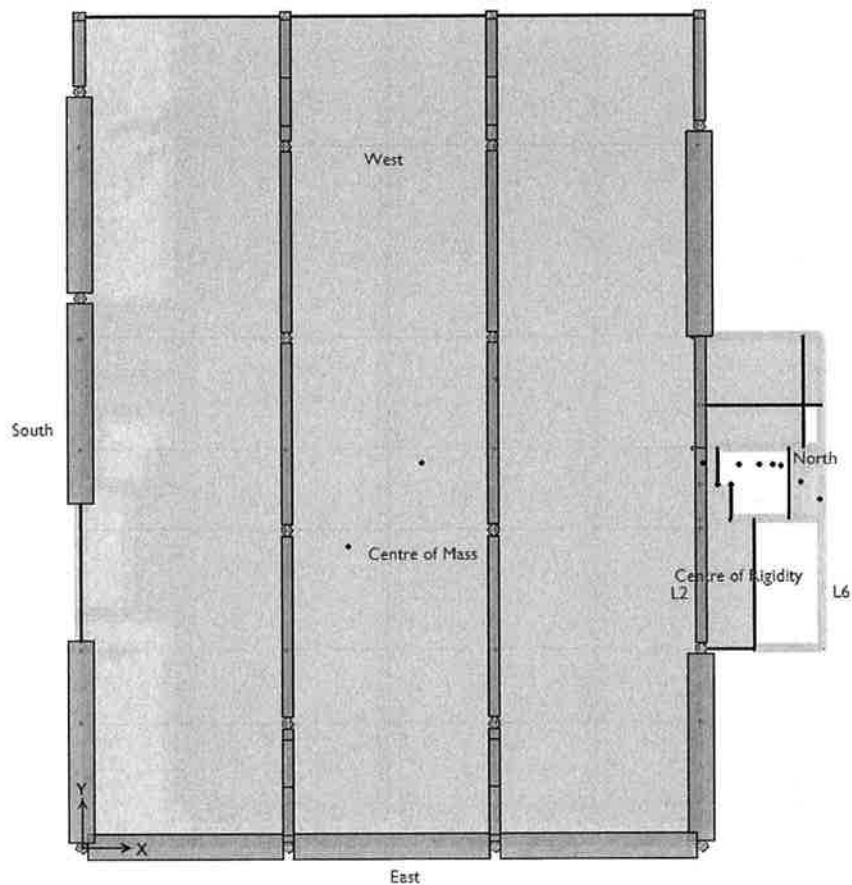
Figure 122 - Centre of Mass and Centres of Rigidity for each Floor (North Core and South Wall only as primary seismic resisting system) The centre of rigidity is close to alignment with the centre of mass for North-South excitation, but highly eccentric from the centre of mass for east-west excitation. This means that the building would have more torsional or twisting response to east-west components of earthquake ground accelerations than to north-south ground accelerations if the Line A masonry infill wall was adequately separated from the structure.

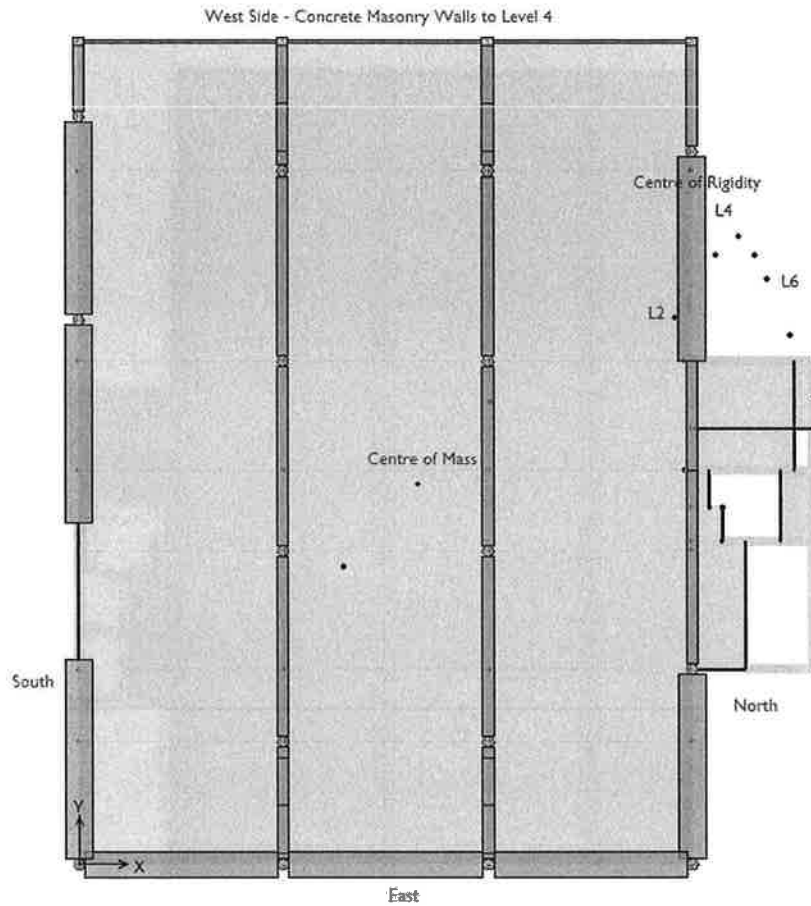
Figure 123 - Centre of Mass and Centres of Rigidity for each Floor (North Core, South Wall and Line A masonry infill wall in contact with structure). The centre of rigidity is highly eccentric from the centre of mass in both directions due to the participation of the west side Line A masonry infill wall below Level 4. The earthquake loads act through the building's centre of mass at each floor level, and the building tries to resist the earthquake actions through its centre of rigidity at each level. The offset between the centre of mass and the centre of rigidity is the eccentricity that determines the level of twist or torsion that results. With Line A masonry wall in full contact with the structure the building will have increased torsional response to north-south earthquake ground motions.

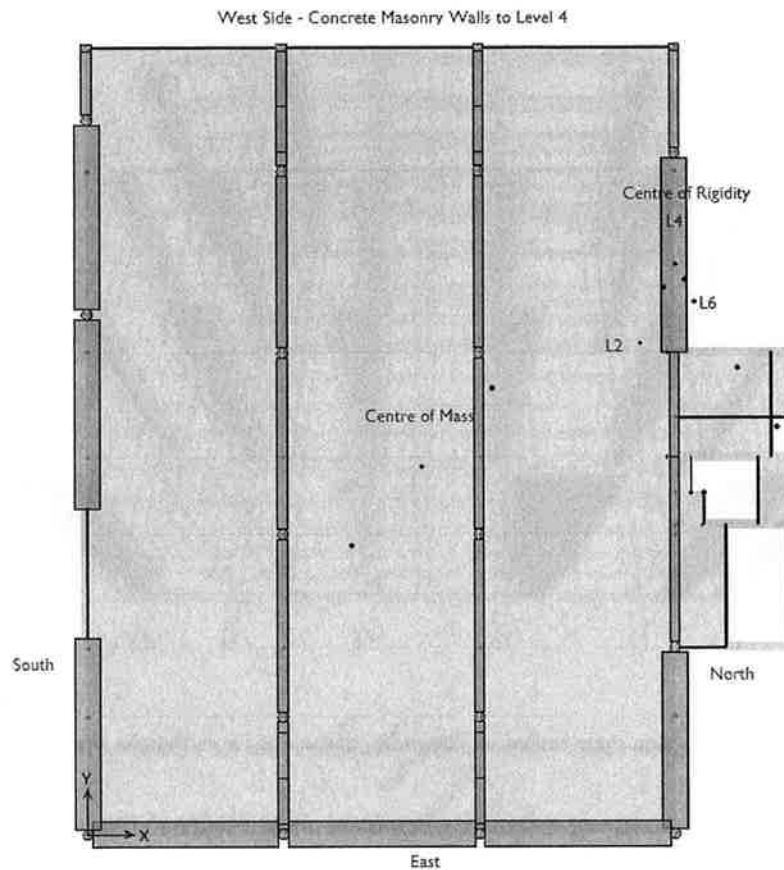
Figure 124 - The changes in the locations of the Centre of Mass and Centres of Rigidity for the building each Floor (North Core, South Wall and Line A masonry infill walls and secondary frames on Lines 1, 2, 3, 4 and F). The centre of stiffness moved south and west, reducing the torsional response of the building, due to the effect of the secondary frames.

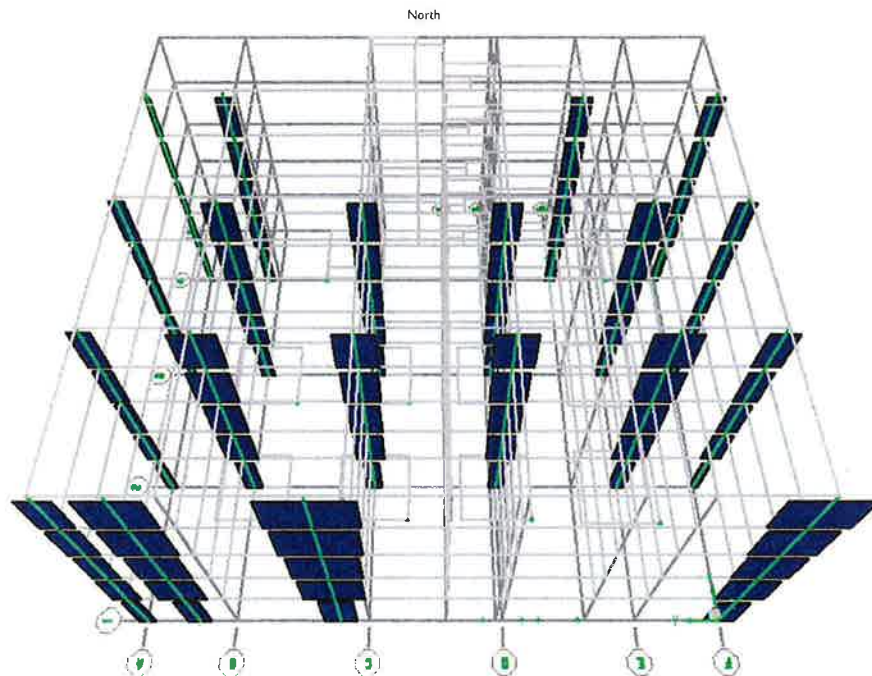
Figure 125 is a plot of shear actions (which are related directly to the level of column drift) on the east-west axis of the columns. The columns nearer to the south side and nearer to the top of the building were subject to higher drifts and shear actions (and corresponding bending moments). This is because they were furthest from the centre of rigidity and so experienced more seismic drift, and because the frame attracted a bigger proportion of the total storey shear compared with the walls nearer the top of the building.

Figure 125 - Plot of column shear actions on east-west column axis for earthquake shaking in east-west direction.

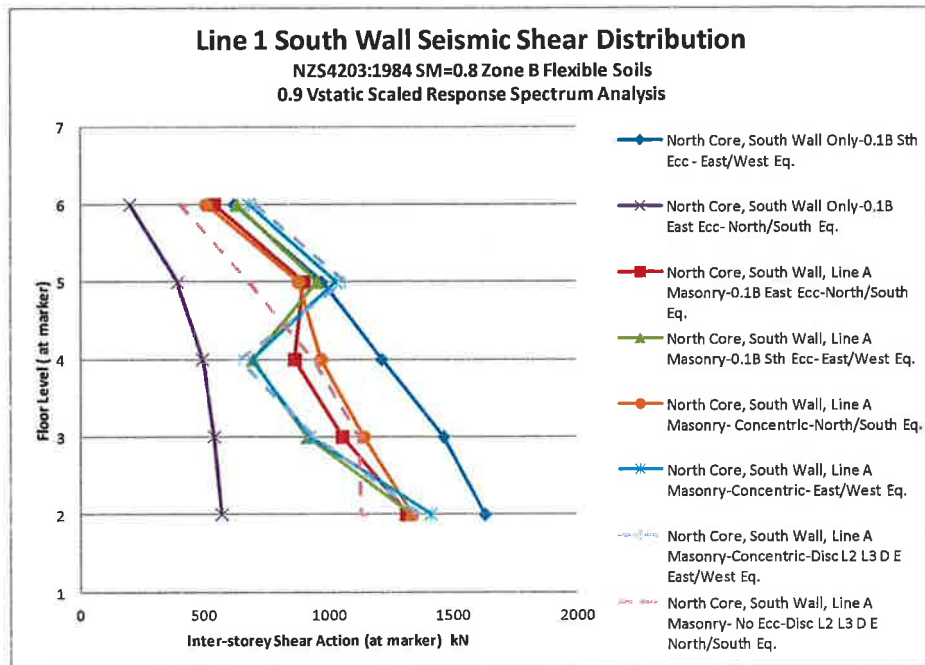
ERSA undertaken neglecting the Line A infill masonry wall, found that inter-storey shear design actions that adequately enveloped the design actions for the worst case East/West and North/South design condition (Figure 126).

Figure 126 – Seismic shear distribution in accordance with NZS 4203:1984 on South Wall with varying conditions of mass eccentricity and with or without the Line A masonry infill wall. This shows that the Line A wall did not affect the design of the South Wall but made it more susceptible to damage under North-South earthquake loading.

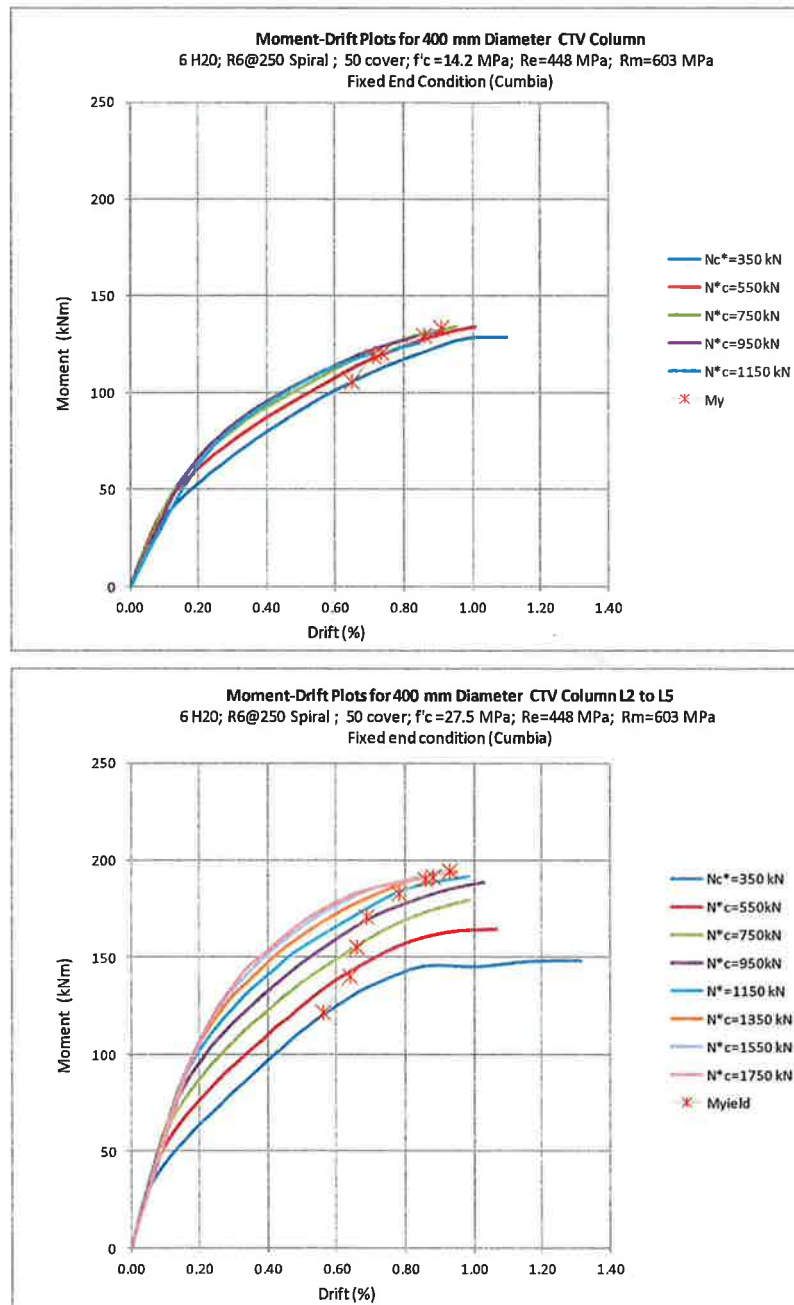
The moment displacement and moment curvature relationships at varying axial actions were developed using Cumbia software (Montejo and Kowalsky 2007). The plot of the moment-drift curves for $f_c = 14.2$ and $f_c = 27.5$ MPa concrete are shown in Figure 127. These show how the moment-drift relationship varies with concrete strength and axial compression.

Figure 127 - Moment-Drift plots for 400 mm diameter CTV columns for $f'_c = 14.2$ and 27.5 MPa concrete, using Cumbia software for fixed end conditions. Concrete limiting strain was set at 0.004. This shows that yielding of the reinforcing steel starts at higher drifts as the axial compression action increases. Similarly the ability of the columns to bend more after starting to yield reduces as the axial compression action increases. Columns in the upper levels had lower axial compression actions compared to the lower level columns, and so were able to sustain more inelastic demand than those at lower levels. The crosses indicate the point at which yield of the extreme reinforcing steel bar occurs designated as the yield moment of the column.

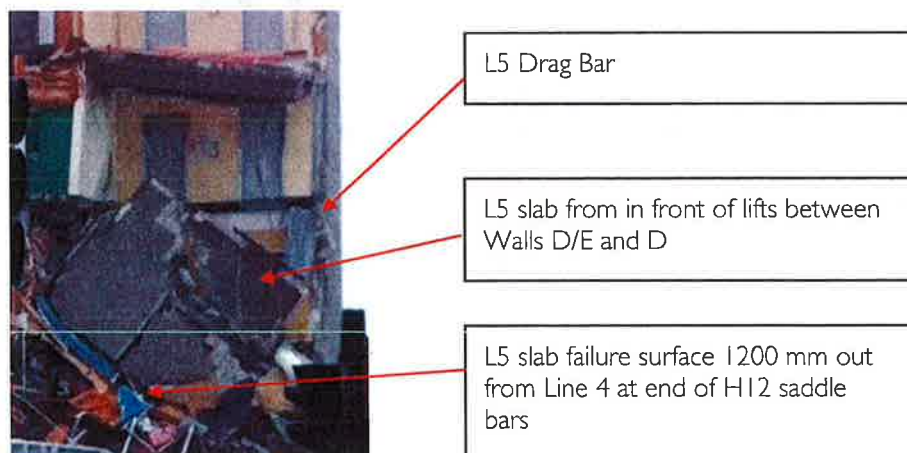
The diaphragm in-plane bending capacity at EFGA at the Drag Bars was the weakest link in terms of diaphragm attachment to the North Core. Failure of the slab was evident along line ABCD (but not through the perimeter beam) at L4 to L6 from a careful look at the photos (Figure 128 and Figure 129).

Figure 129 - Level 5 slab from in front of lifts shortly after the collapse.

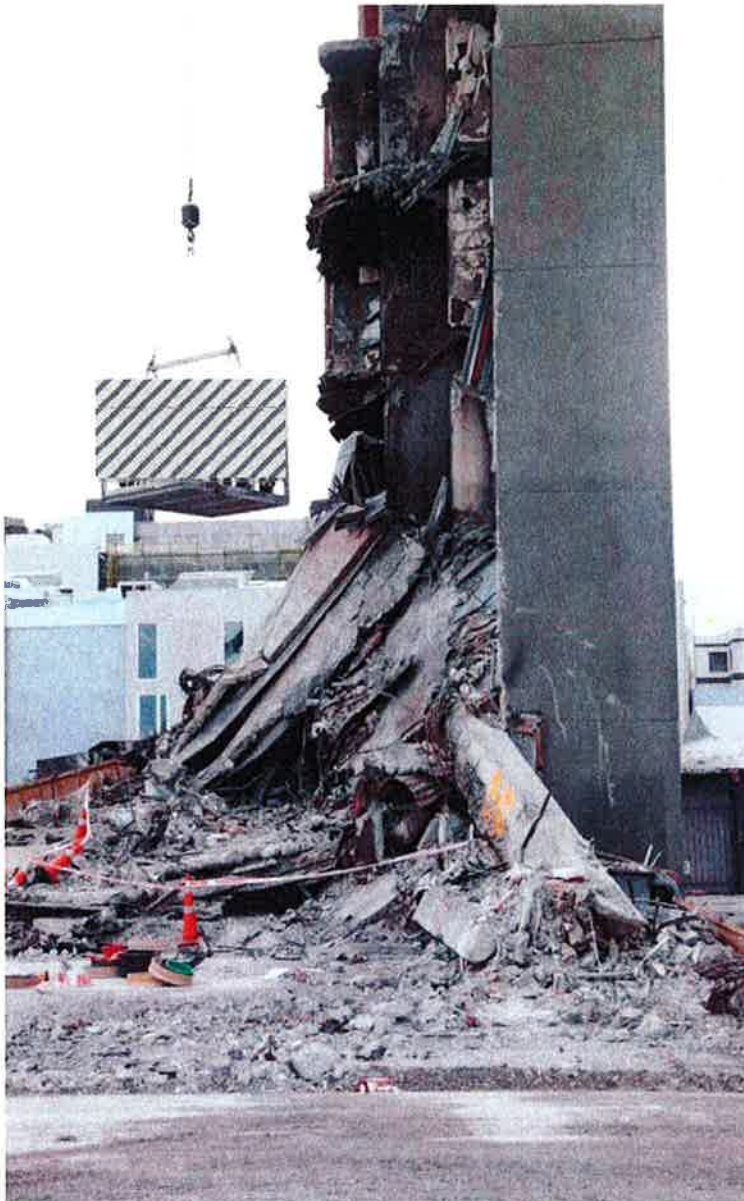
For this to have occurred, column collapse along Line 2 and/or 3 would have occurred pulling the slab at the core downwards so that it failed in flexure and tension at the end of the saddle bars. This was consistent with the way the Level 3 and 4 slabs were found to have fallen, lying diagonally against the North Core after the collapse as shown in Figure 130.

Figure 130 - North Core slabs leaning against the North Core showing that their collapse occurred after collapse of the Line 3 frame
