CTV BUILDING

CTV BUILDING COLLAPSE INVESTIGATION FOR DEPARTMENT OF BUILDING AND HOUSING 5TH DECEMBER 2011

CTV BUILDING COLLAPSE REPORT

Report Issue Date: 7 December 2011

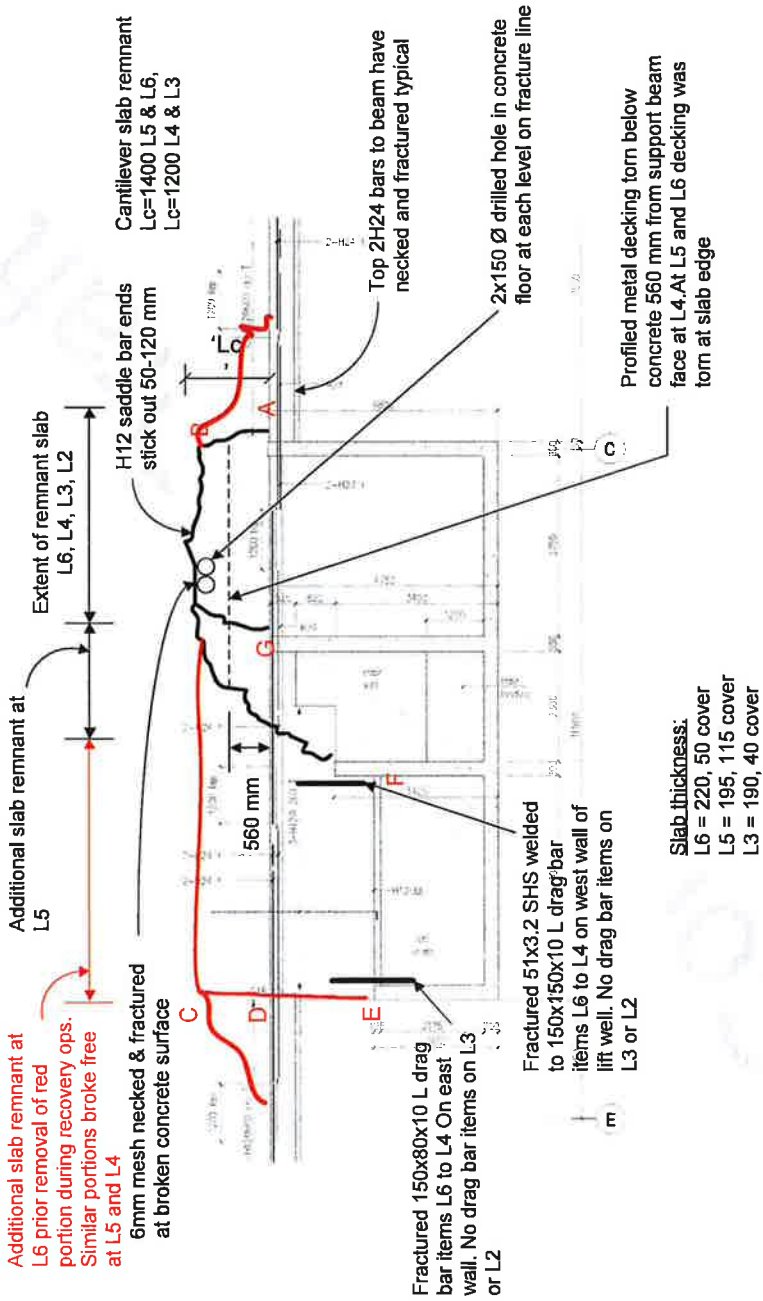
Analysis of the in-plane bending capacity of the diaphragm compared in-plane bending capacity along two critical failure sections shown in Figure 131. The first along the perimeter ABCD running from the edge of the Line C wall out 1200 mm to the ends of the slab saddle bars and along 11.35 m then back 1200 mm the Line D/E wall. The second failure section EFGA ran from the attachment point of the Drag Bars at walls D/E and D and along the slab at Line 4 between Walls C and C/D.

The in-plane bending capacity along ABCD was found to be greater than that along EFGA as shown in Figure 131. The in-plane bending capacity along ABCD included shear contributions of the AB and CD portions and the shear capacity of the with edge beam. The bending capacity along EFGA was limited by the tension capacity of the Drag Bar connections. The contribution of the profiled metal deck in tension was conservatively ignored but would have further increased the differential of strength between the ABCD and EFGA failure sections.

Figure 131 - North Core slab remnants after collapse based on site measurements in black and inferred by collapse photos in red..

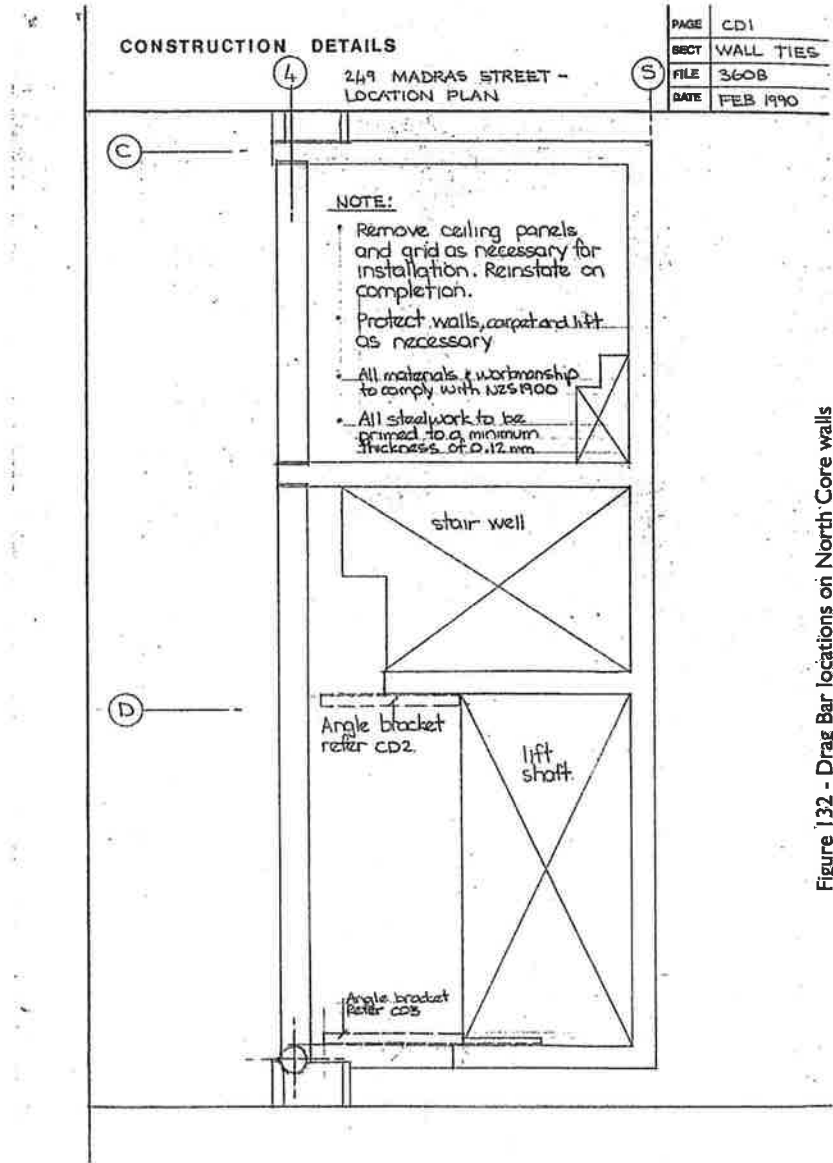
Figure 132 - Drag Bar locations on North Core walls

The Drag Bars had been installed during remedial work to the building in 199. The copies of the sketches issued for their installation are shown in Figure 132 and Figure 133.

The documentation of the connection of the Drag Bar ties into the slab and walls obtained from the Design Engineer (Figure 132 and Figure 133), showed that the Drag Bar actions were calculated following the provisions of NZS 4203:1984. Bars were not designed or installed in Levels 2 and 3. This seems to have been deliberate and appeared to be based on the assumption that adequate shear capacity was
