**Brief of evidence of Richard George Seville relating to 593 Colombo
Street for hearing week commencing 12 December 2011**

Project Name 593 Colombo St

Project Name 593 Colombo Street
 Project No: 105380.71
 S.R. No: I
 Date: 4 October 2010
 Reviewed By: Paul Roberts

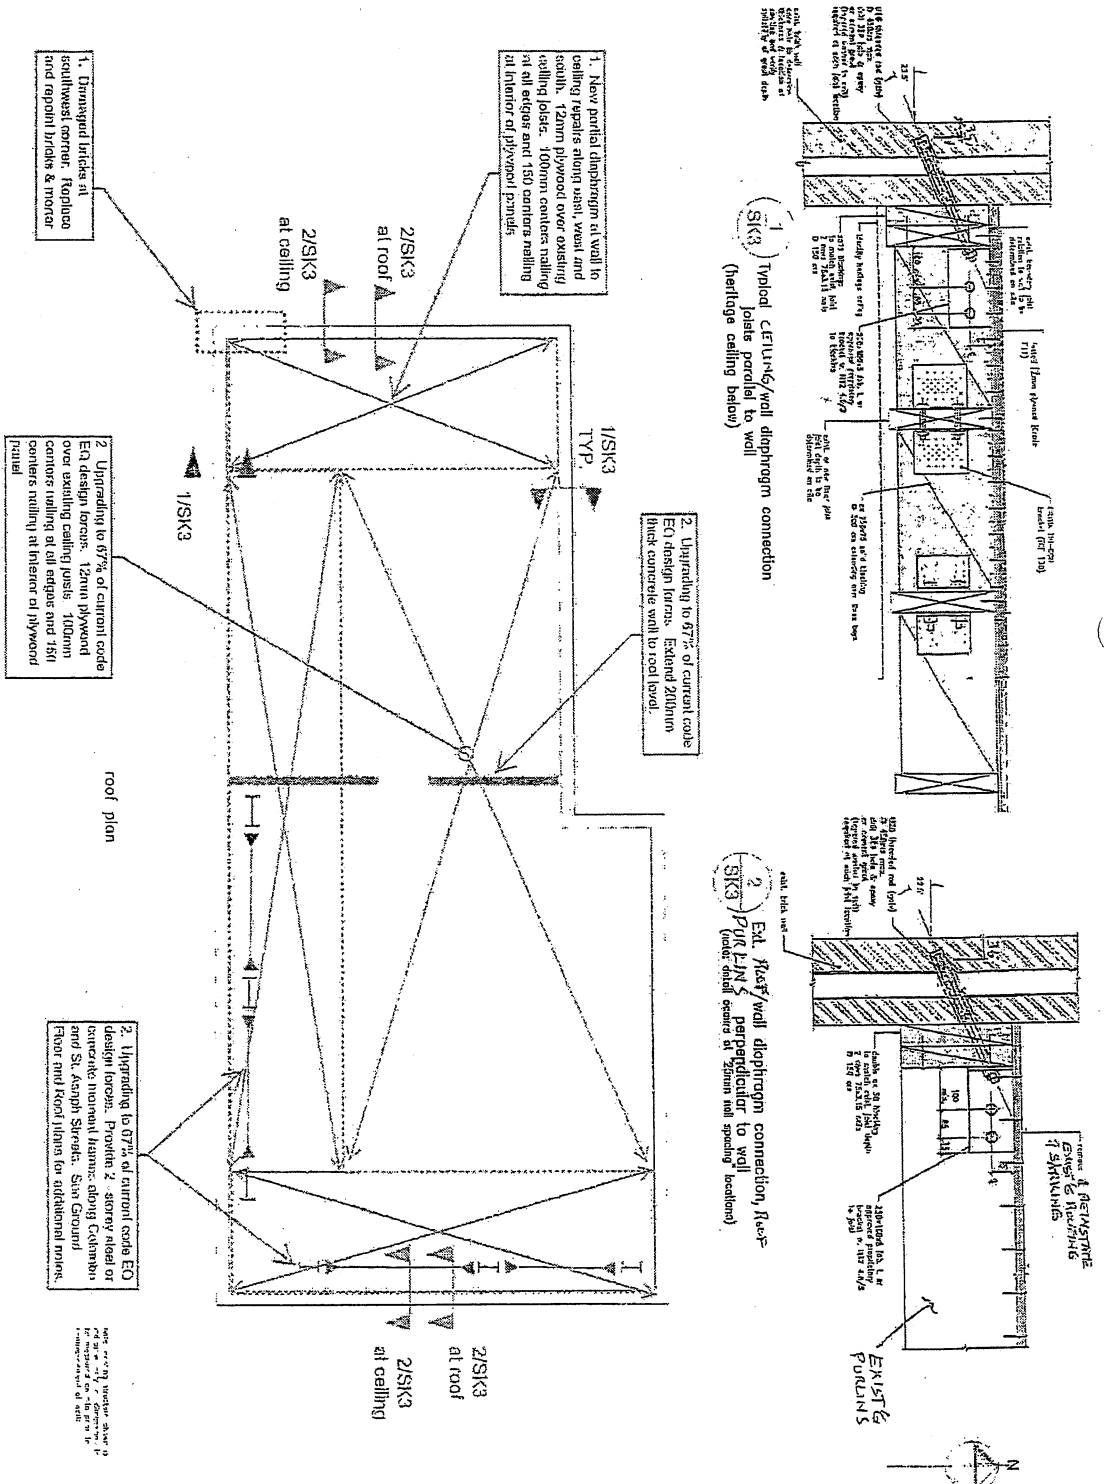
ground floor plan

<p>Concept Design for E.O. repairs and required structural work</p> <ol style="list-style-type: none"> 1. Required repair: prior to reconstruction of deck/wall. Damaged structure must be returned to its original strength. Damaged non-structural portions shall be removed or replaced. 2. Required repairs are marked in RED. 3. Alternate options for these items are marked in GREEN. 4. Required seismic upgrade to 67% of the existing jurisdictional code, by September 2013. These items are marked as BLUE on the plans. 	
<p>693 COLUMBO ST CHRISTCHURCH</p>	
<p>22/211 PAR Council for Planning 105380.71 SK3</p>
