re MAURICE KENNEDY LTD, 593A Colombo Street

SEISMIC RISK BUILDINGS - SURVEY

Project Name 593 Colombo St
 Project No: 105380.71
 S.R. No: 001
 Date: 24 September 2010
 Reviewed By: Alistair Boys

SITE REPORT

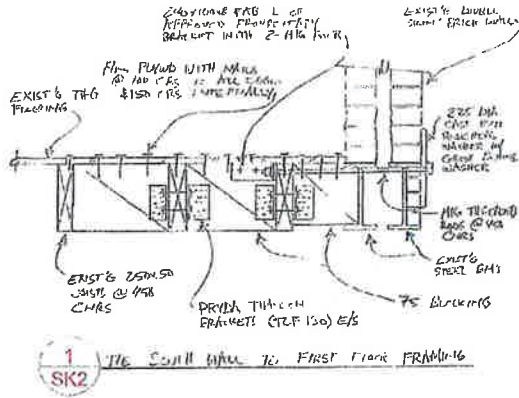
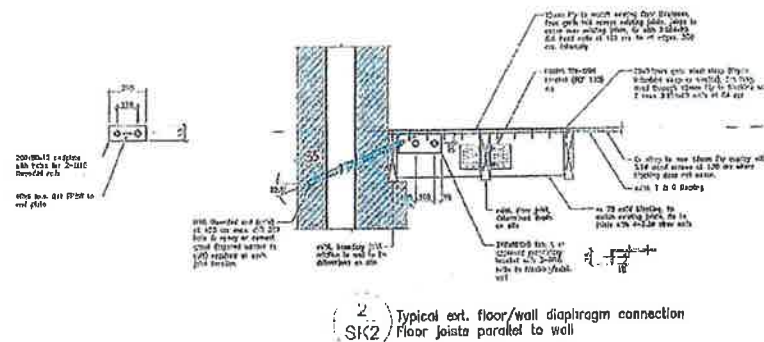
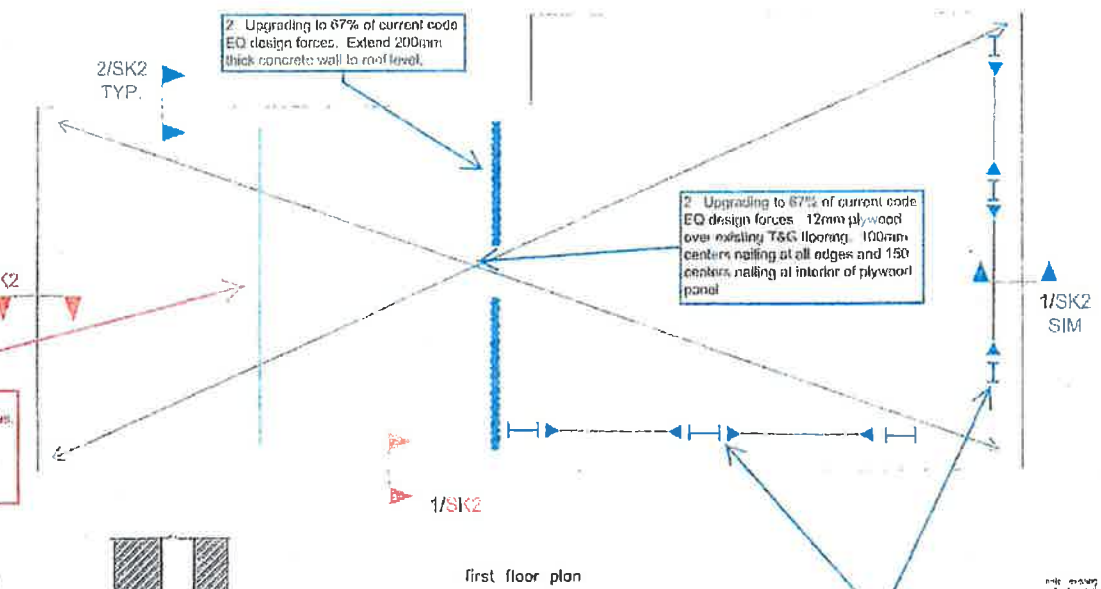
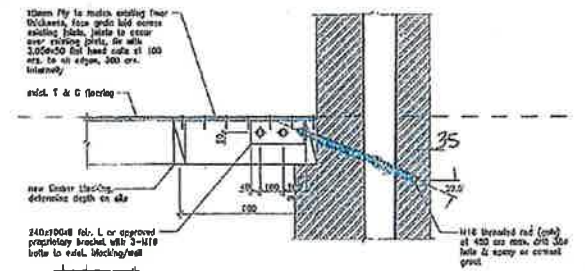
3 SK2

Concept Design for EQ repair and required strengthening
