Canterbury Earthquakes Royal Commission
Te Komihana Rūwhenua a te Karauna

593 Colombo Street

The Royal Commission of Inquiry is currently inquiring into the failure of a number of buildings in the Christchurch CBD, including the building at 593 Colombo Street (the Building).

**Canterbury Earthquakes Royal Commission - Requirement for
Information dated 28 October 2011
Re: 593 Colombo Street**

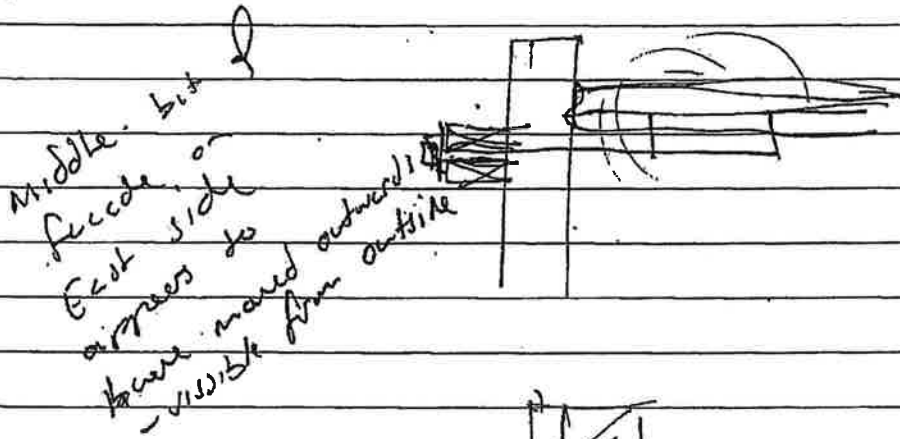
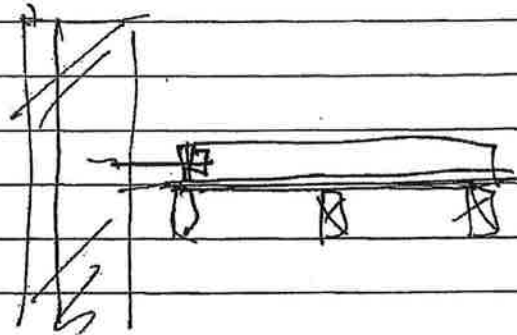
South & East facade appear to have
moved away. Over 1st floor a roof
displacement $\approx 10-20m$ in some places,

visible from 1st floor inside

→ Western end wall - top appears to have
moved out

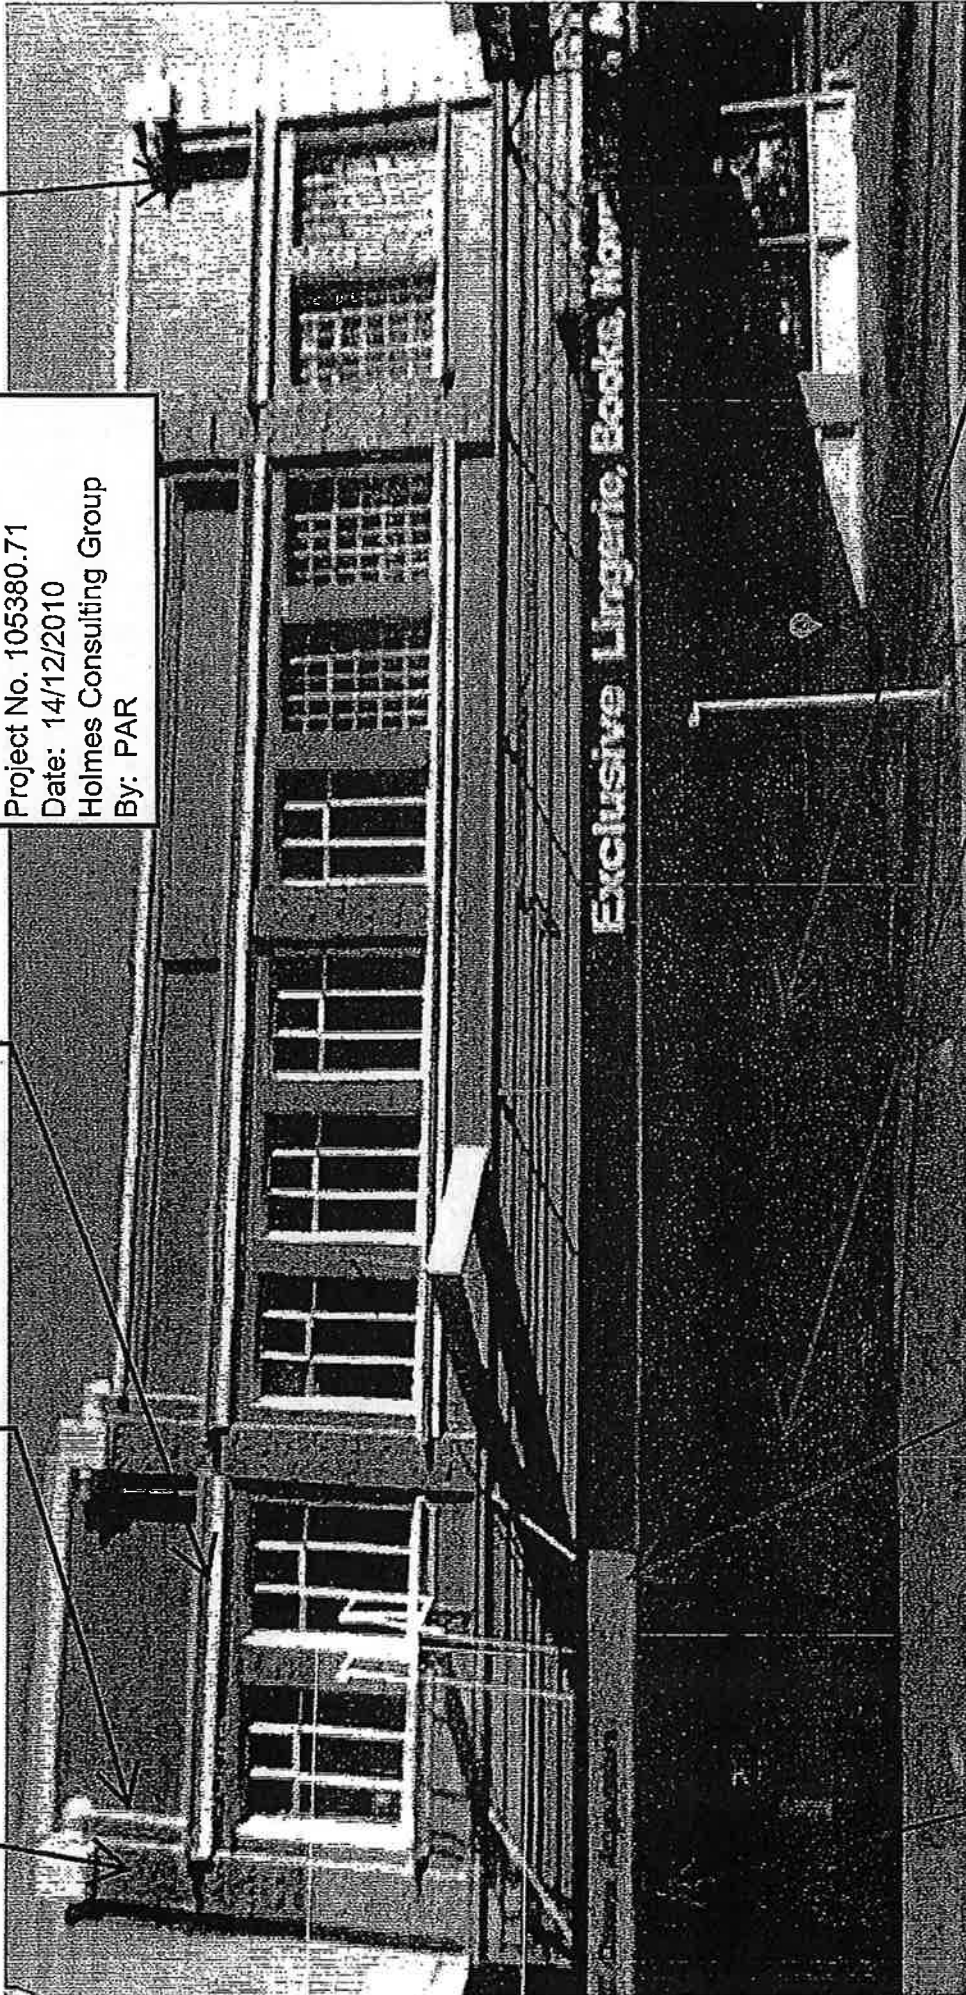
South Elevation with description of damage and picture locations
Project: 593 Colombo Street
Project No. 105380.71
Date: 14/12/2010
Holmes Consulting Group
By: PAR

West wall has shifted outward from 1st floor ceiling by 30mm. See pictures #8 & 9

South wall has shifted outward from 1st floor ceiling by 25mm. See pictures #6 & 7

cracks seen from inside face of east side of south parapet. See picture #1

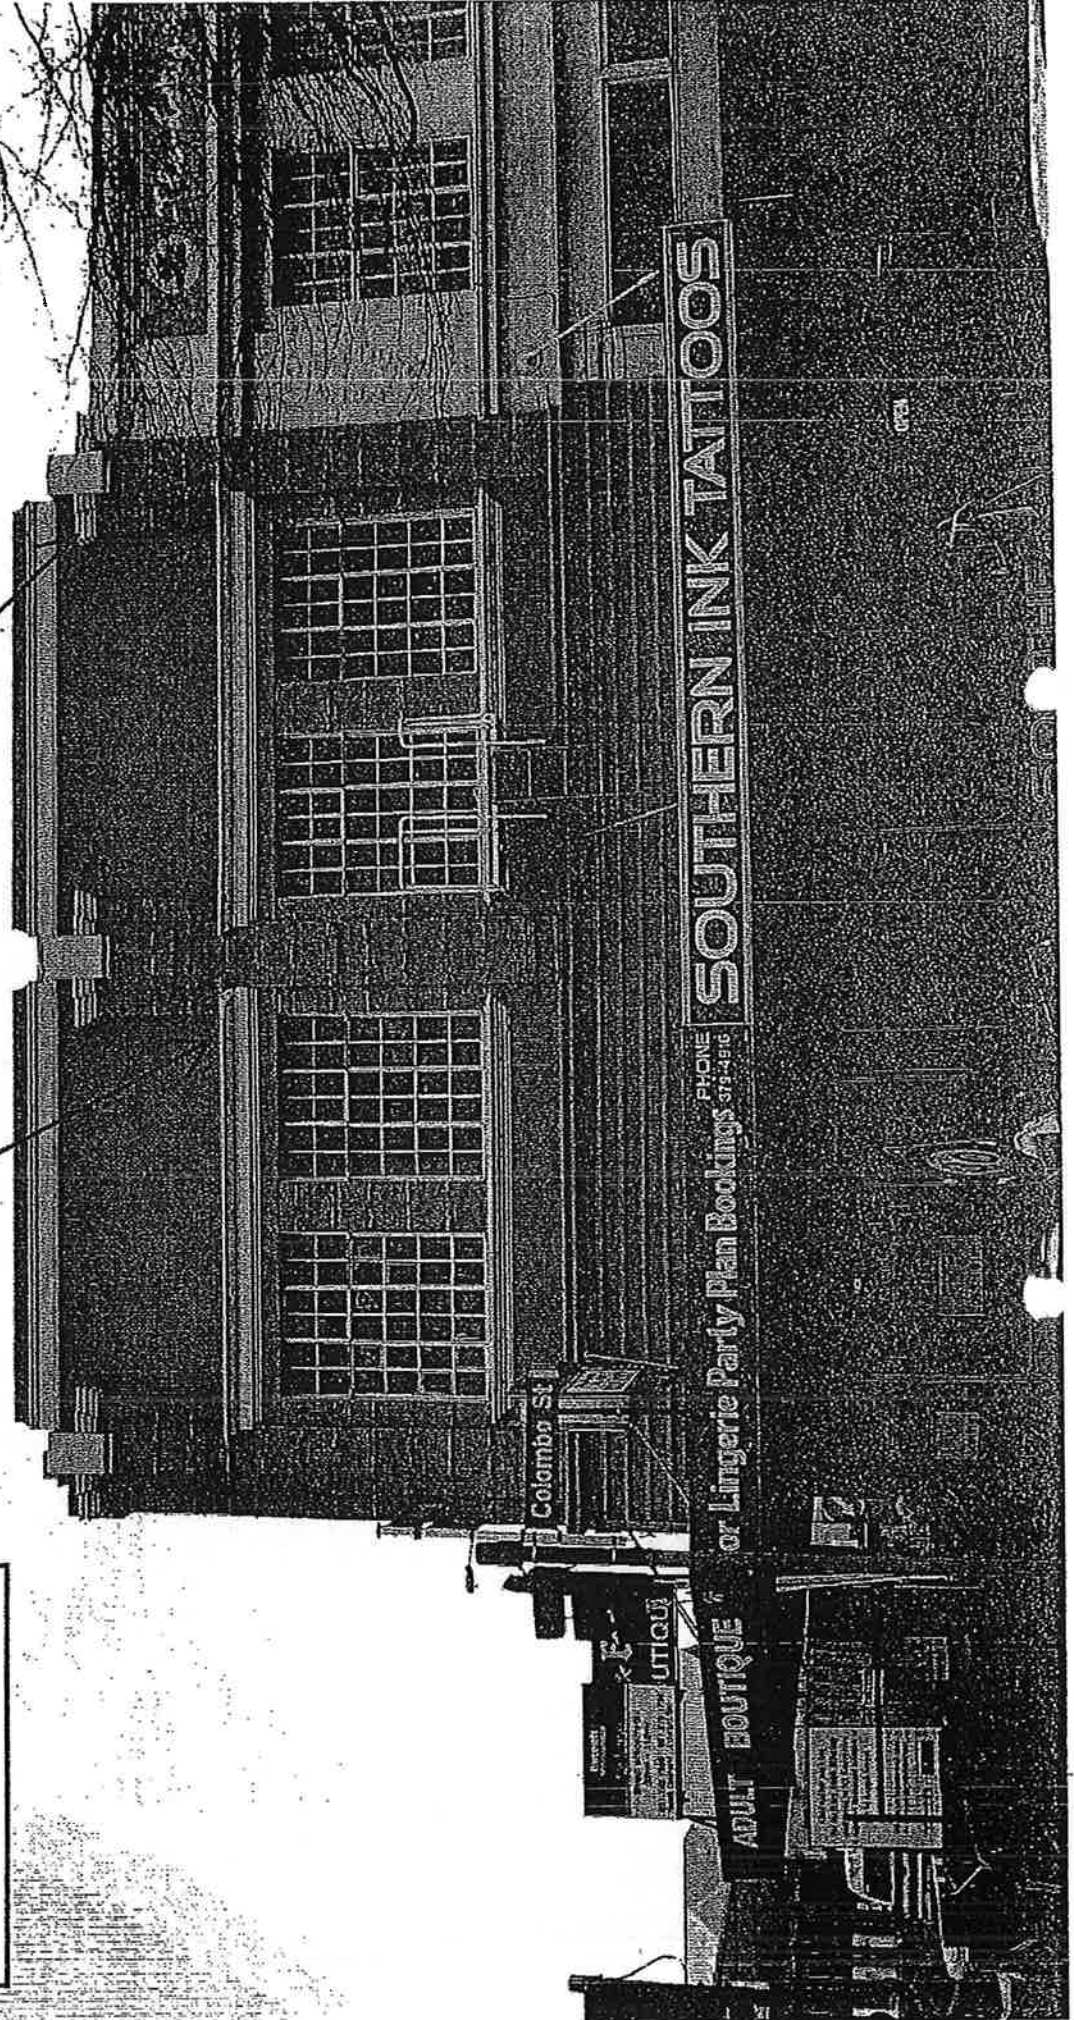
West wall has shifted outward to the west from the 1st floor framing by 30mm. See picture #16

South wall has shifted outward by 25mm - 30mm from 1st floor.

Parapet deflecting outward from corner. See pictures #2 & 3

East wall has shifted outward from 1st floor ceiling.
