**ROYAL COMMISSION OF INQUIRY INTO BUILDING  
FAILURE CAUSED BY CANTERBURY EARTHQUAKES**

**STATEMENT OF EVIDENCE OF STEPHEN JAMES MCCARTHY IN RELATION TO  
601/601A COLOMBO STREET**

**DATE OF HEARING: WEEK BEGINNING 12 DECEMBER 2011**

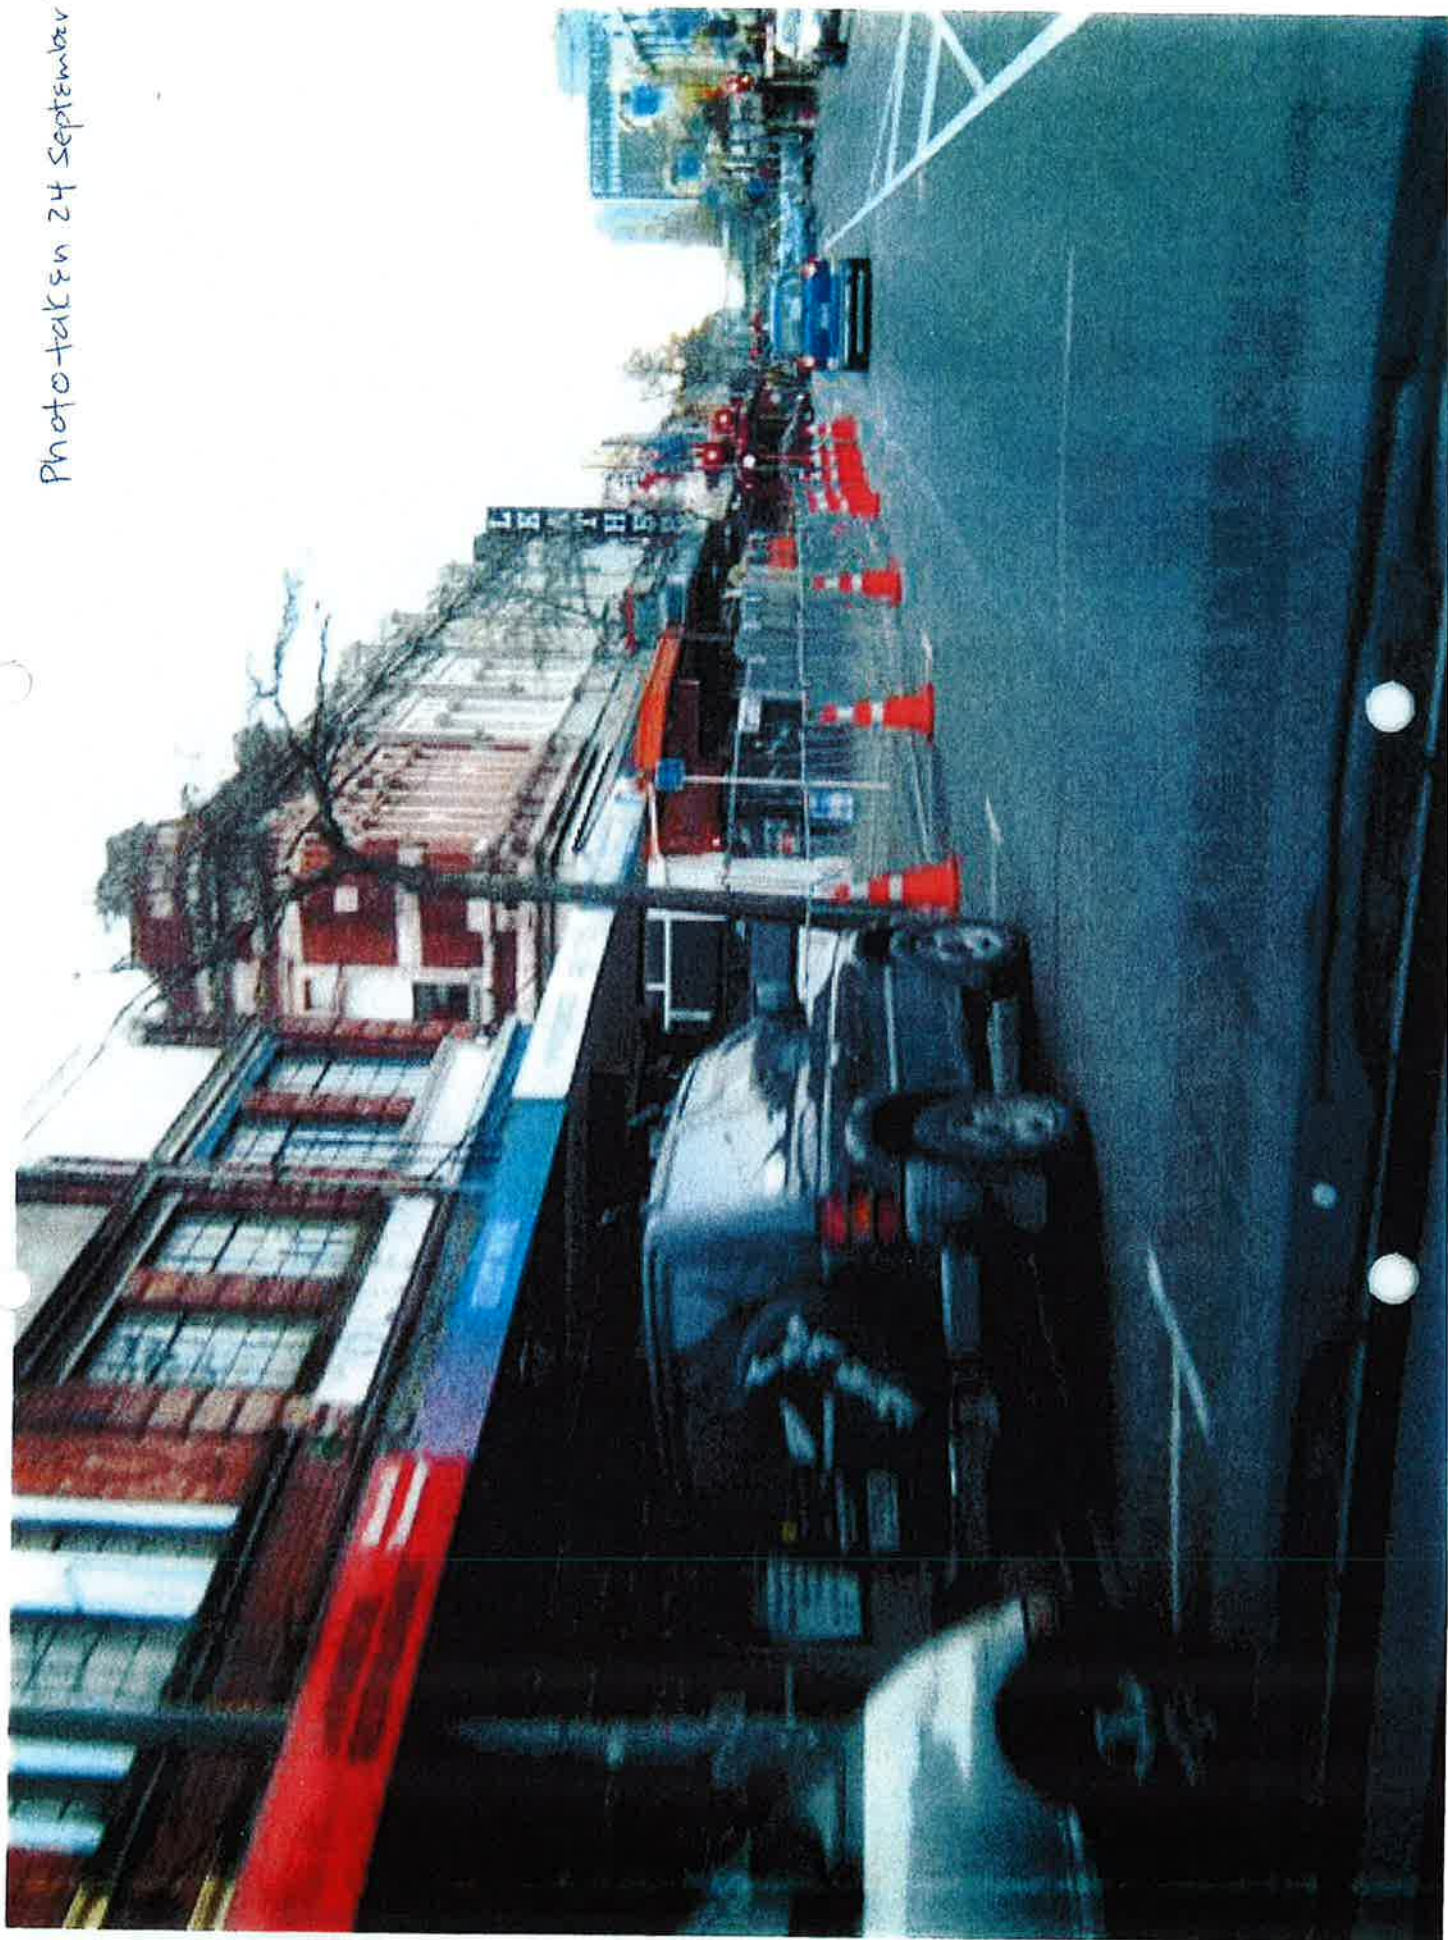
BUI.COL601.0002.1

As already noted, the photograph shows the barricades as at 24 September 2010, and indicates that barricades were placed in front of the Building and across the entrance to Mollett Street to prevent access along that street.

Photo taken 24 September 2000
