Review of Expert Panel and Beca Report on PGC Building

William T. Holmes
Structural Engineer
San Francisco

Pyne Gould Corporation Building

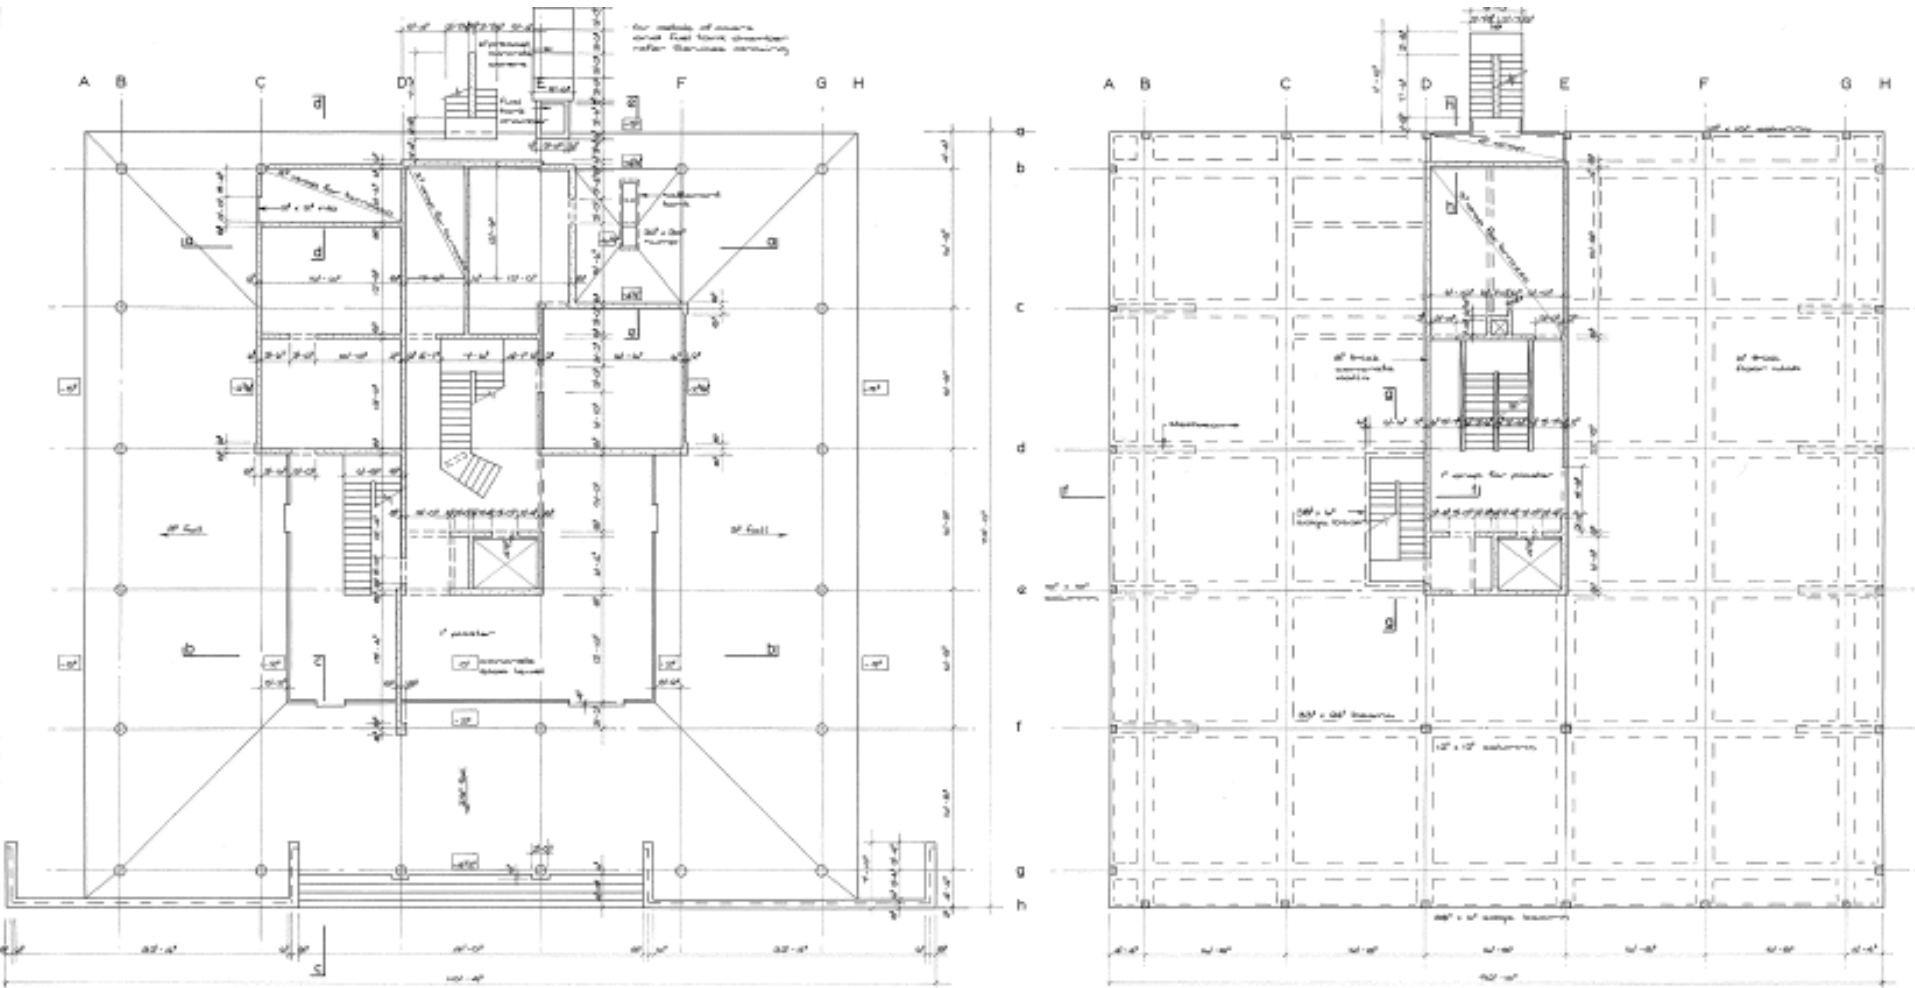
Structural plan of Ground and Level 1

- All agree that building collapsed due to failure of the central tower at floor 1-2
 - Failure caused large movement of Level 2 downward and to the east (about 3 m)
