Canterbury Earthquakes Royal Commission Te Komihana Rūwhenua a te Karauna

242-246 High Street

The Royal Commission is inquiring into the failure of the building that was located at 242-246 High Street (the Building).

SITE REPORT

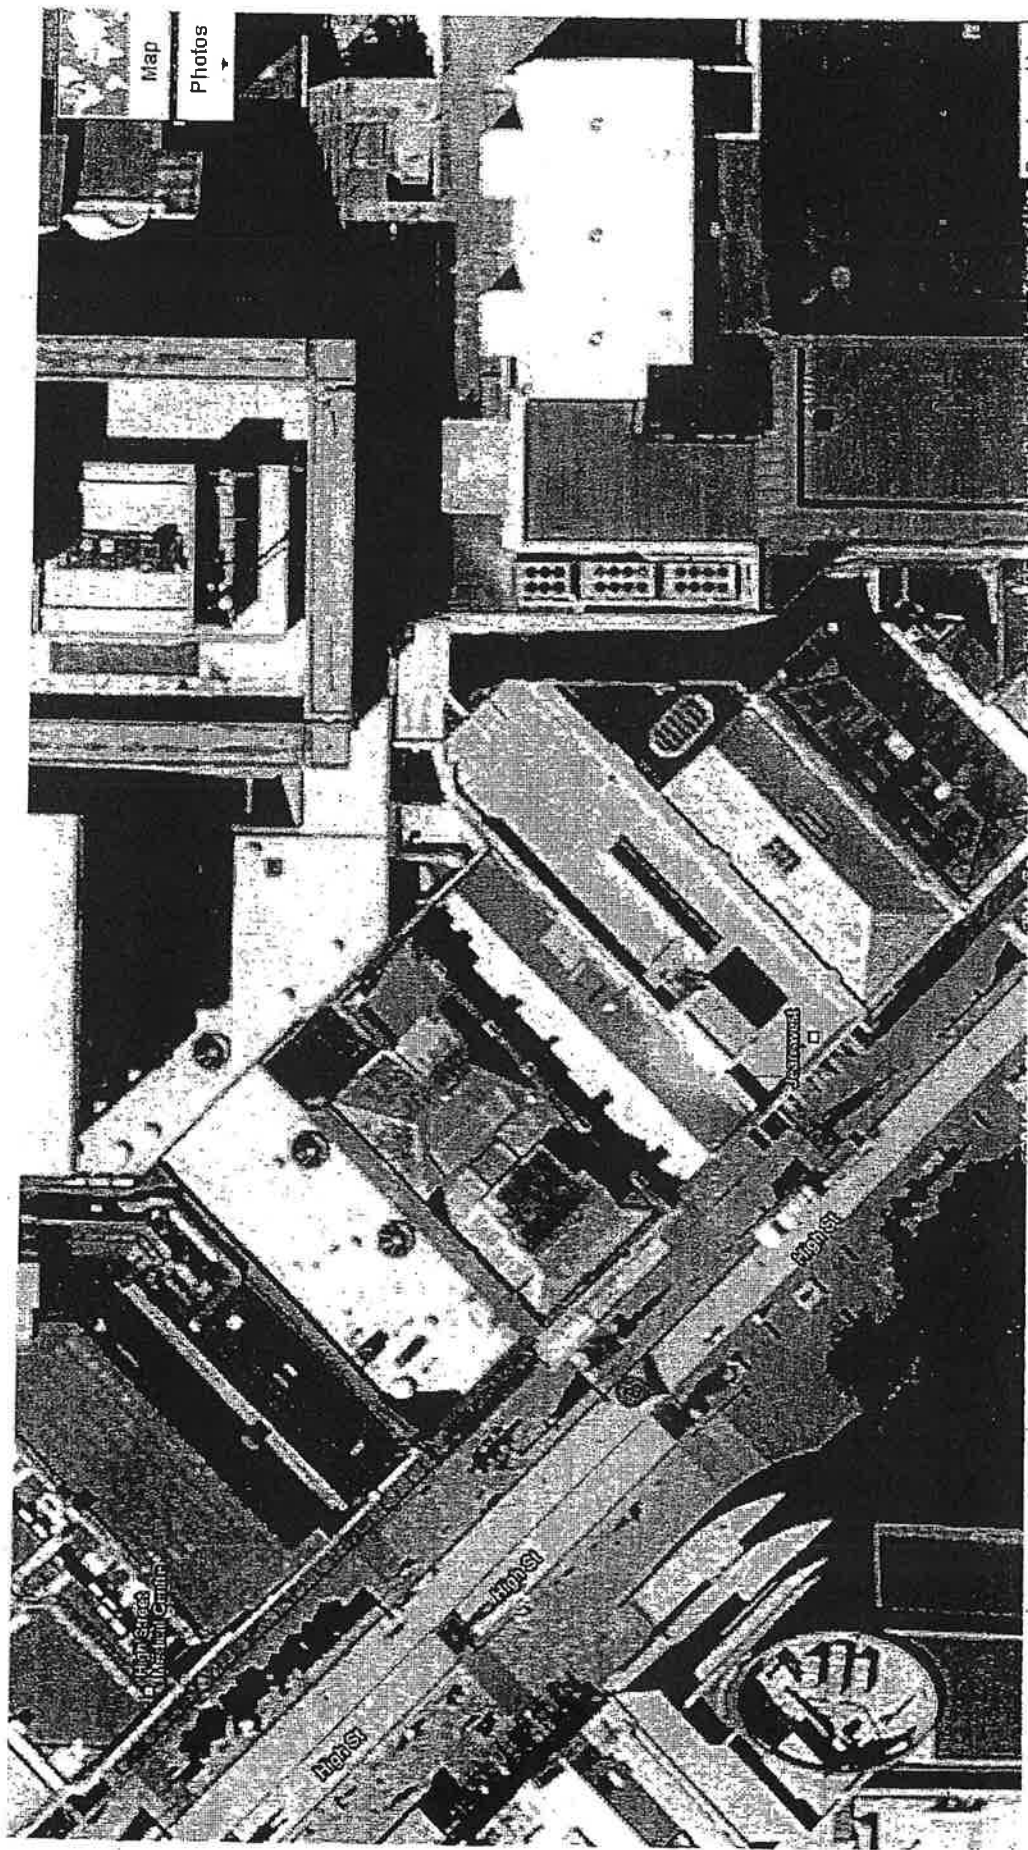
Structural Hazards/ Damage	Minor/None	Moderate	Severe	Comments
Foundations	<input checked="" type="checkbox"/>	<input type="checkbox"/>	<input type="checkbox"/>	
Roofs, floors (vertical load)	<input checked="" type="checkbox"/>	<input type="checkbox"/>	<input type="checkbox"/>	
Columns, pilasters, corbels	<input checked="" type="checkbox"/>	<input type="checkbox"/>	<input type="checkbox"/>	
Diaphragms, horizontal bracing	<input checked="" type="checkbox"/>	<input type="checkbox"/>	<input type="checkbox"/>	
Pre-cast connections	<input checked="" type="checkbox"/>	<input type="checkbox"/>	<input type="checkbox"/>	
Beam	<input checked="" type="checkbox"/>	<input type="checkbox"/>	<input type="checkbox"/>	
Non-structural Hazards / Damage				
Parapets, ornamentation	<input checked="" type="checkbox"/>	<input type="checkbox"/>	<input type="checkbox"/>	<i>Minor Cracking on remaining parapets will require remedial work - not life threatening</i>
