**IN THE MATTER OF
THE CANTERBURY EARTHQUAKES ROYAL COMMISSION**

BRIEF OF EVIDENCE OF RHYS COLLIN SMITH

Dated 16 December 2011

194 Hereford Street (Joe's Garage) ("the building")

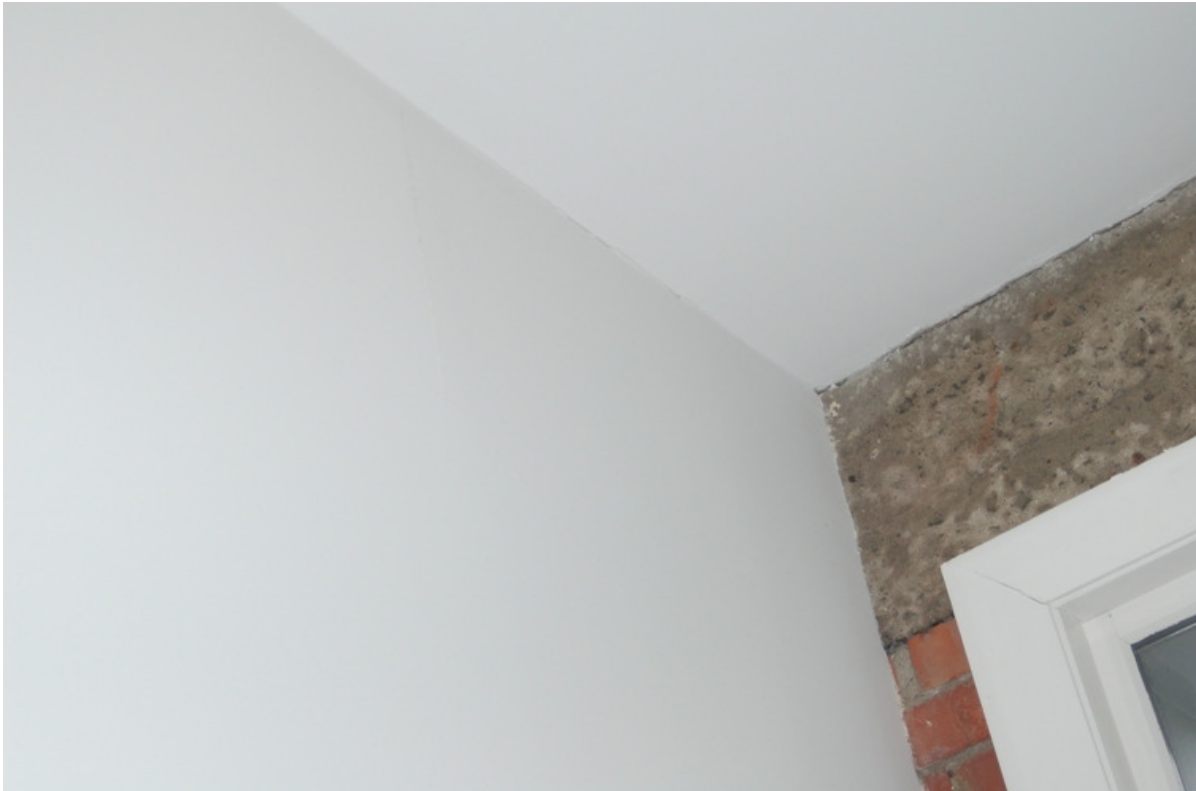
Photo 13

- Photo 13: View of back of front upper bond beam showing minor movement between beam and ceiling.

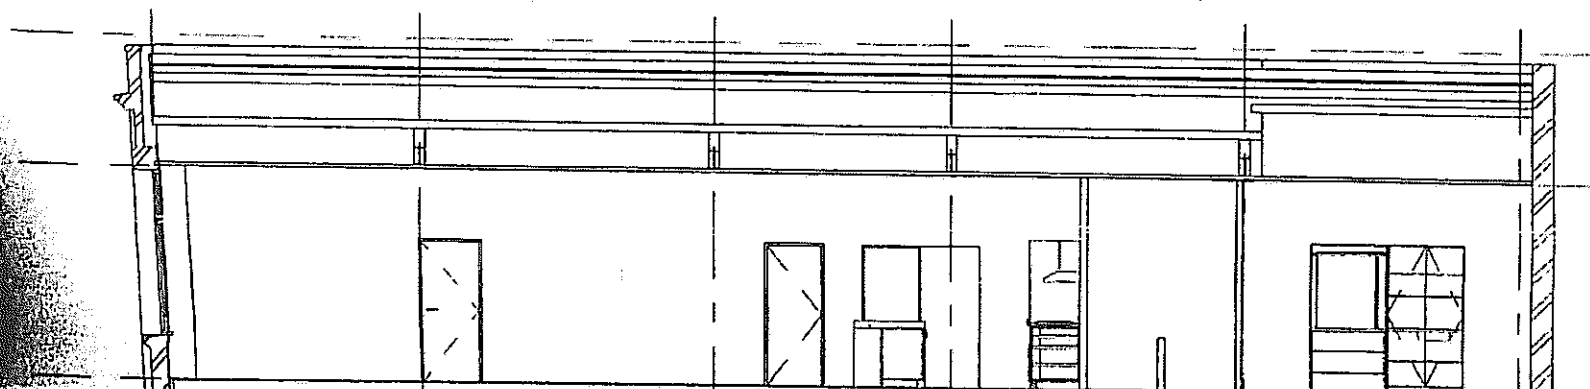
FIGURE 3.

- Minor flexural cracks to URM columns and panels in west façade as shown on Figure 3.
- A flashing between the north facades of 194 and 196 Hereford Street has been dislodged in the Boxing Day Earthquake. This flashing was fitted after the September earthquake presumably by the builders of the new premises at no. 196. There is an approximately 50mm gap between the buildings and this is to allow for the independent movement of each building however the flashing had not been designed to allow for any movement.

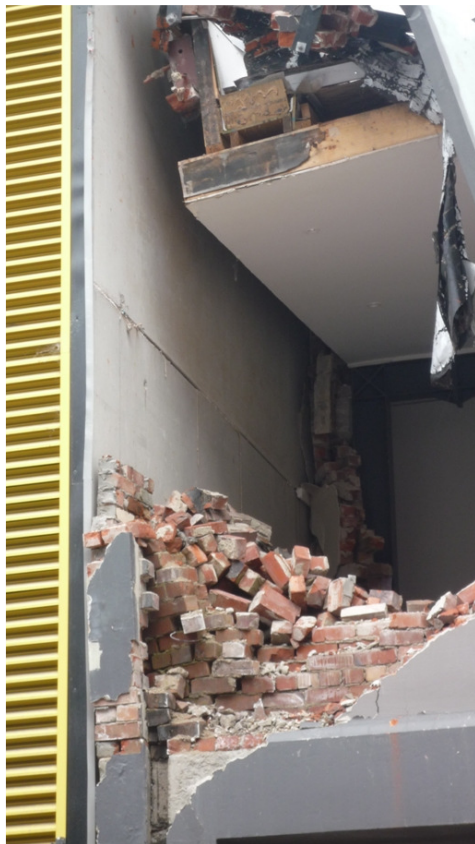
47. Photo 11 shows the standard detailing from the Earthquake Society recommendations. The damage shows that the standard solution to parapet restraint simply failed in the force of this earthquake.
48. Photo 5 illustrates the failure of the upper east wall in the north bay. This wall supported the bond beam.
