SEISMIC RISK BUILDINGS - SURVEY

Address: 309 Durham St (Methodist Mission Church)  
Legal Desc.:  
Owner:  
Date: 17/12/92 Date Building Built:   
BU/40/

**Re: Earthquake Damage Inspection for Durham Street Methodist Church**

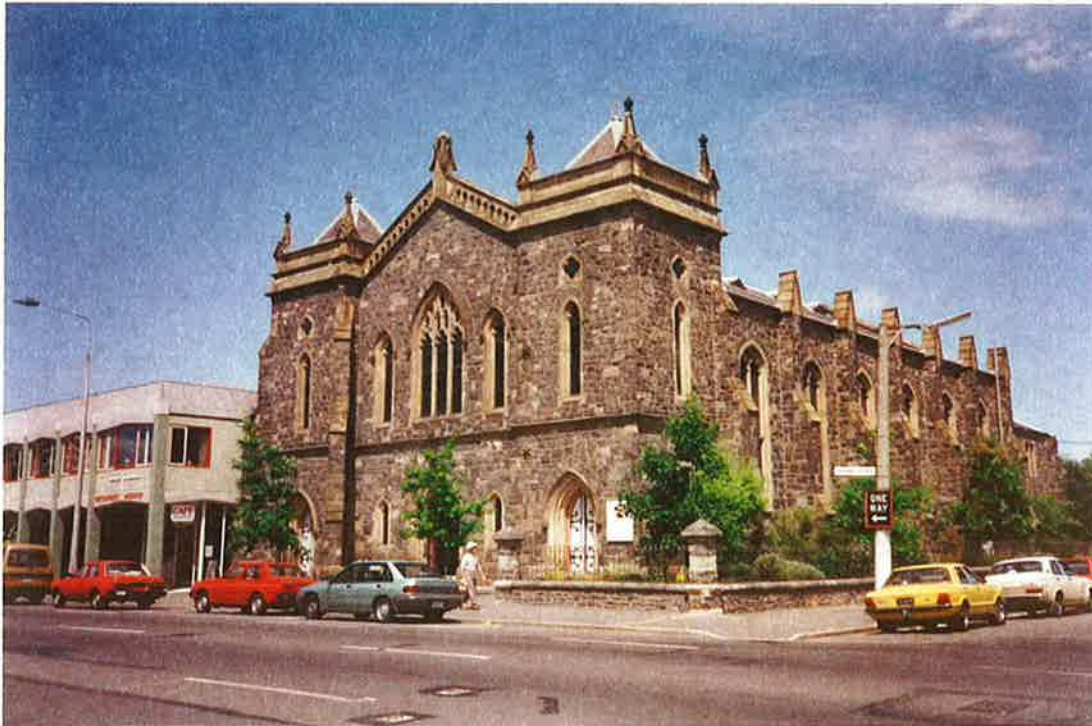
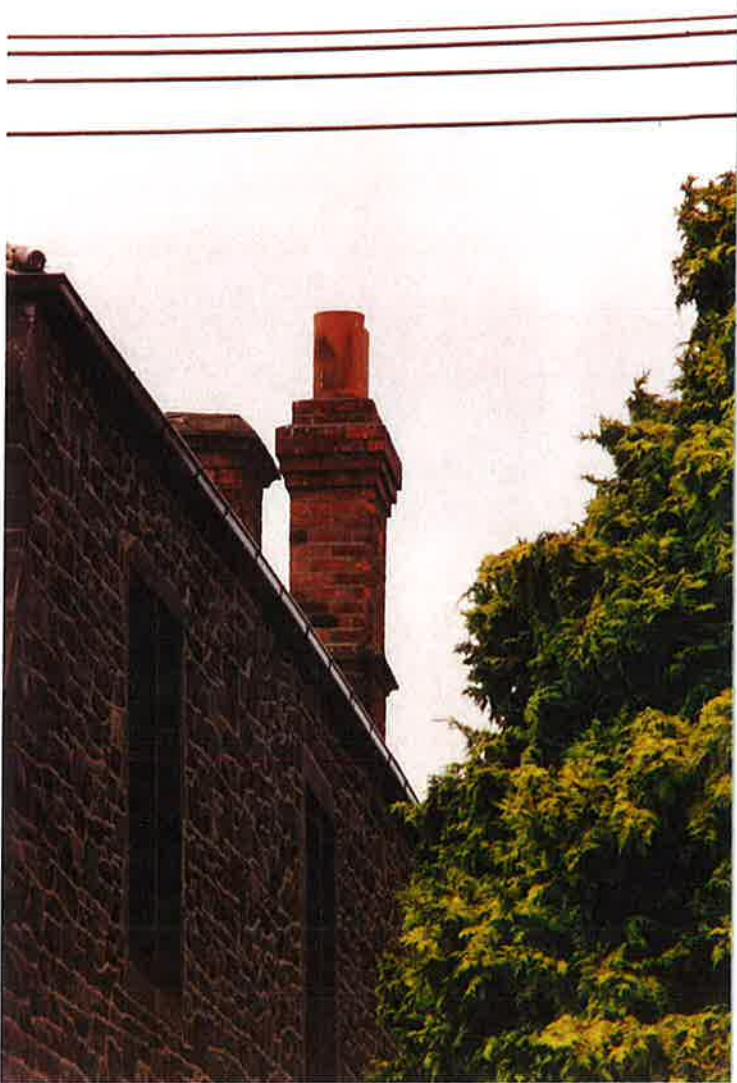
Comments: 2 storey. There are lots of "spikes" (see photo below).

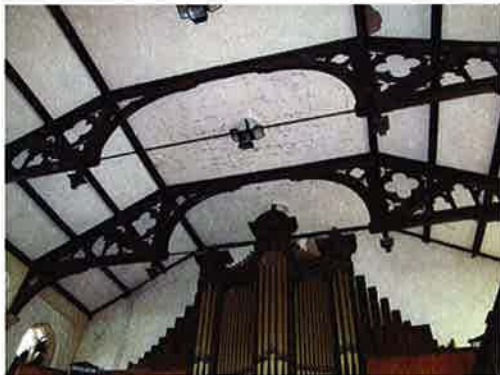
Inside Church

The Church has undergone very extensive cracking at the east end and exposed construction in the cracks and plaster which has fallen off. The North wall also has extensive cracking and the support corbels for the mezzanine have come away and in some cases fallen off the walls.

Remove the inside of the first floor and stairs. Pour new foundations and build structural concrete walls on the inside to provide support for the stone walls.

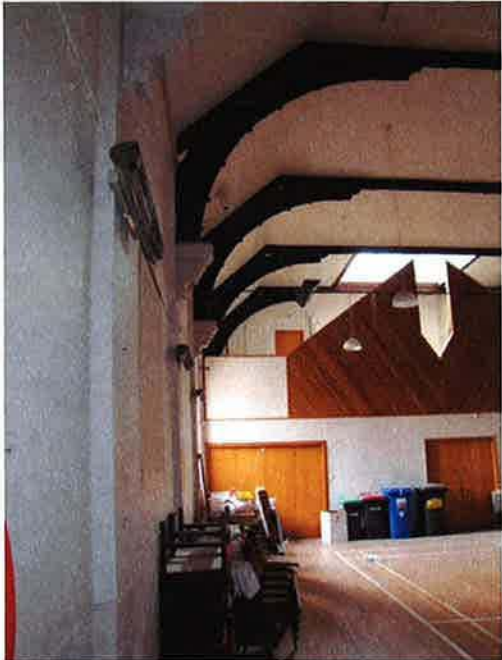
The hall construction has a slate roof supported on tied timber arches at 3m centres. The building has moved transversely and leans to the west by approximately 200mm. This movement has dislodged masonry and the east side has cracked stonework on the west side.

West wall of hall

If the hall is to be retained then the walls will require strengthening with internal concrete piers which cantilever from a foundation beam under the floor.

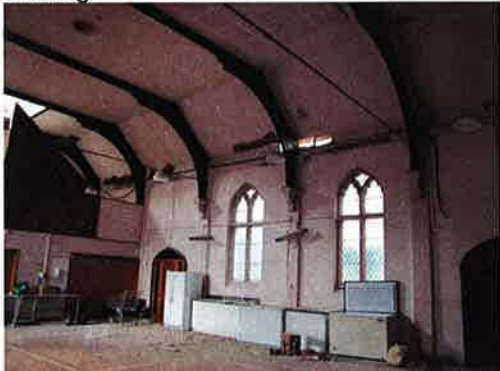
East wall of hall

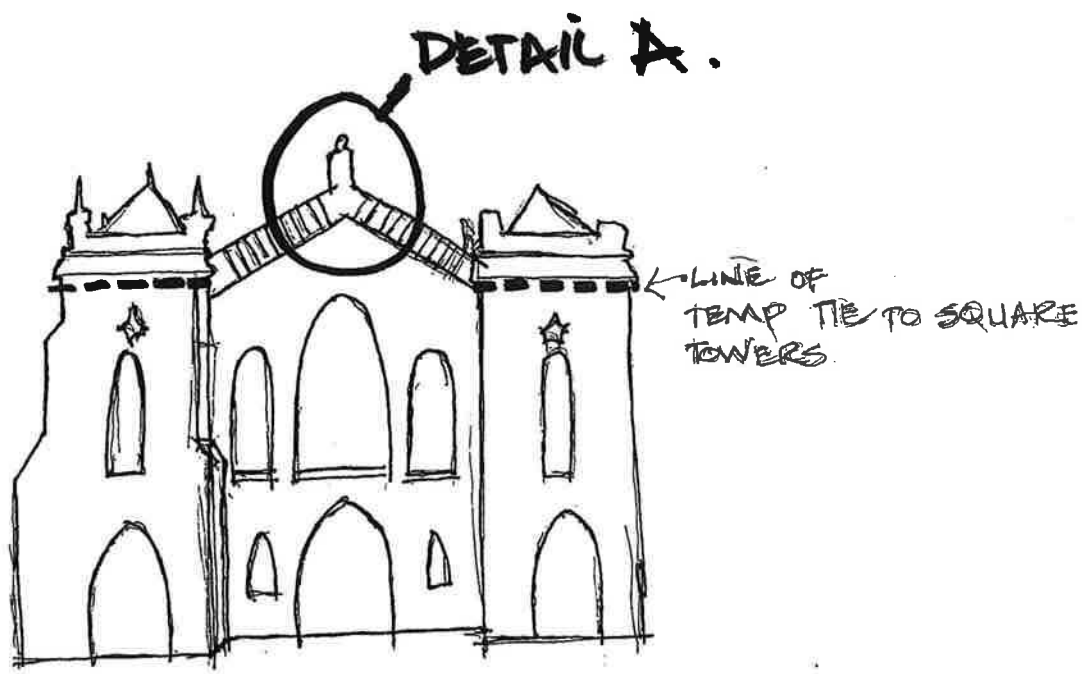
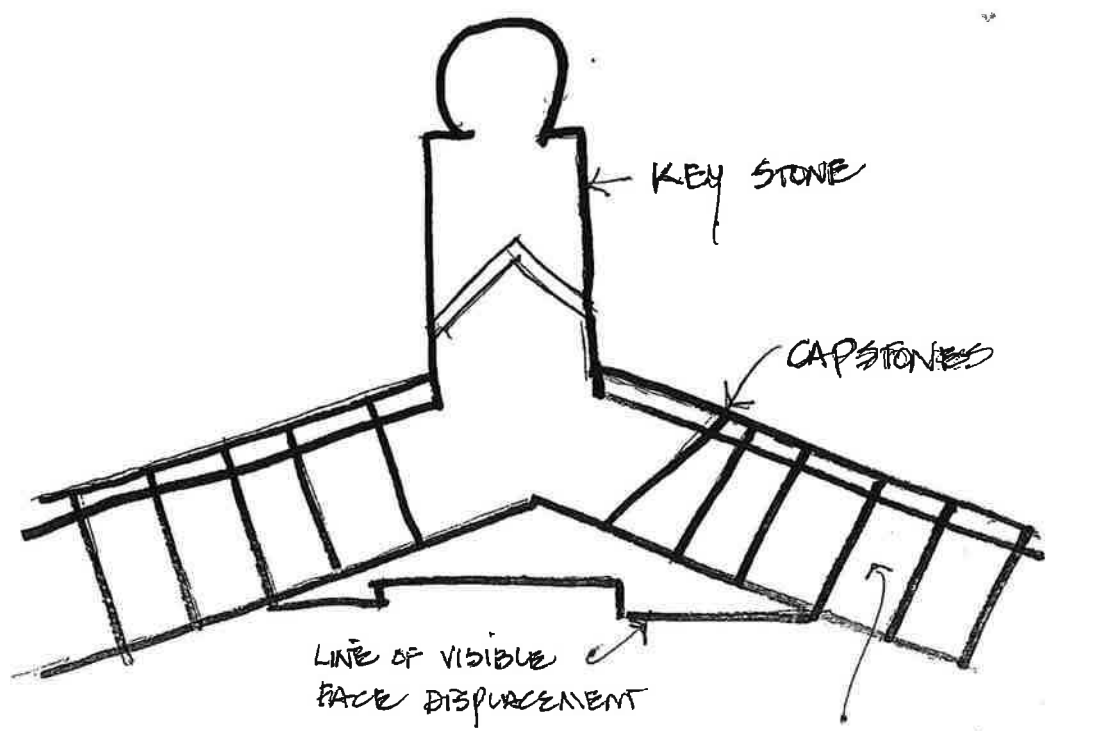
DURHAM ST ELEVATION

Here are the notes and my quick sketch from our discussions this morning (to save you time) relating to the scope of removal of loose/dislodged portion of the East Gable Durham St.

2 The ties to pass thru existing holes in the decorative gable blocks as discussed.

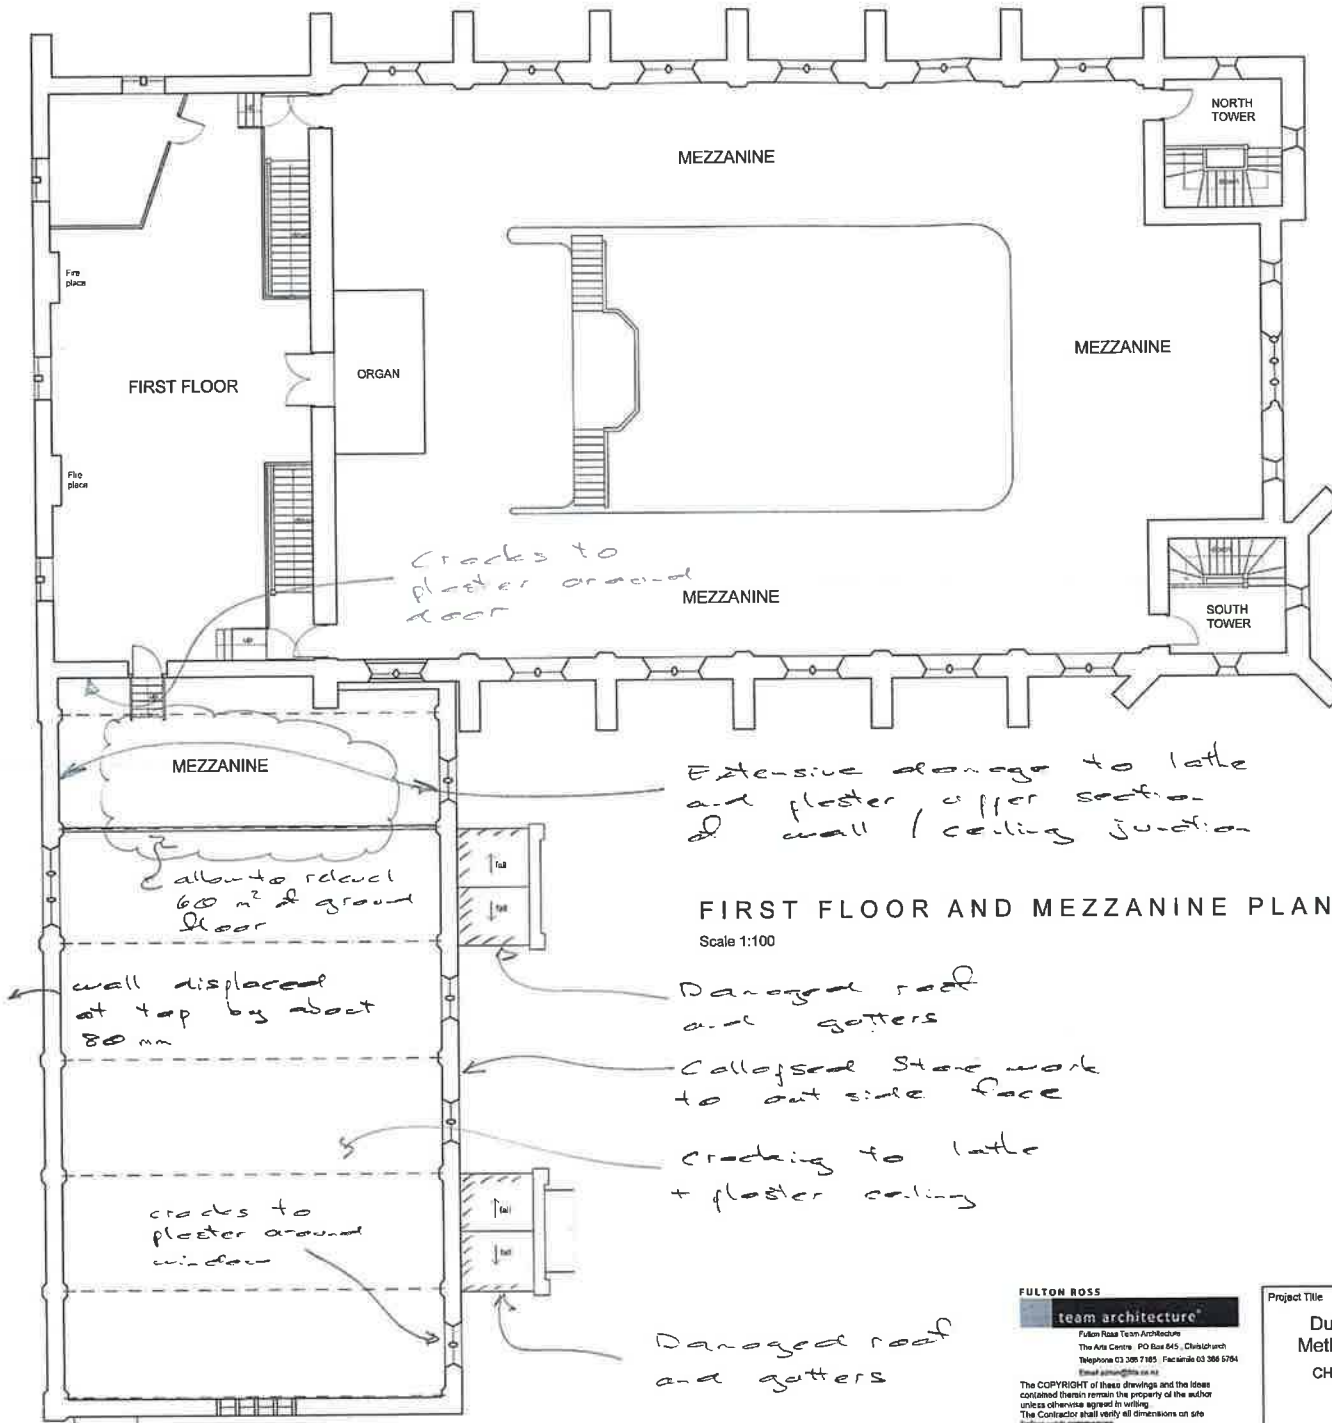
**FIRST FLOOR AND MEZZANINE PLAN**  
 Scale 1:100

Damage  
Summary  
Hall

Crack to  
inside face  
of wall to  
both sides  
of building

raft tie connections  
dislodged.

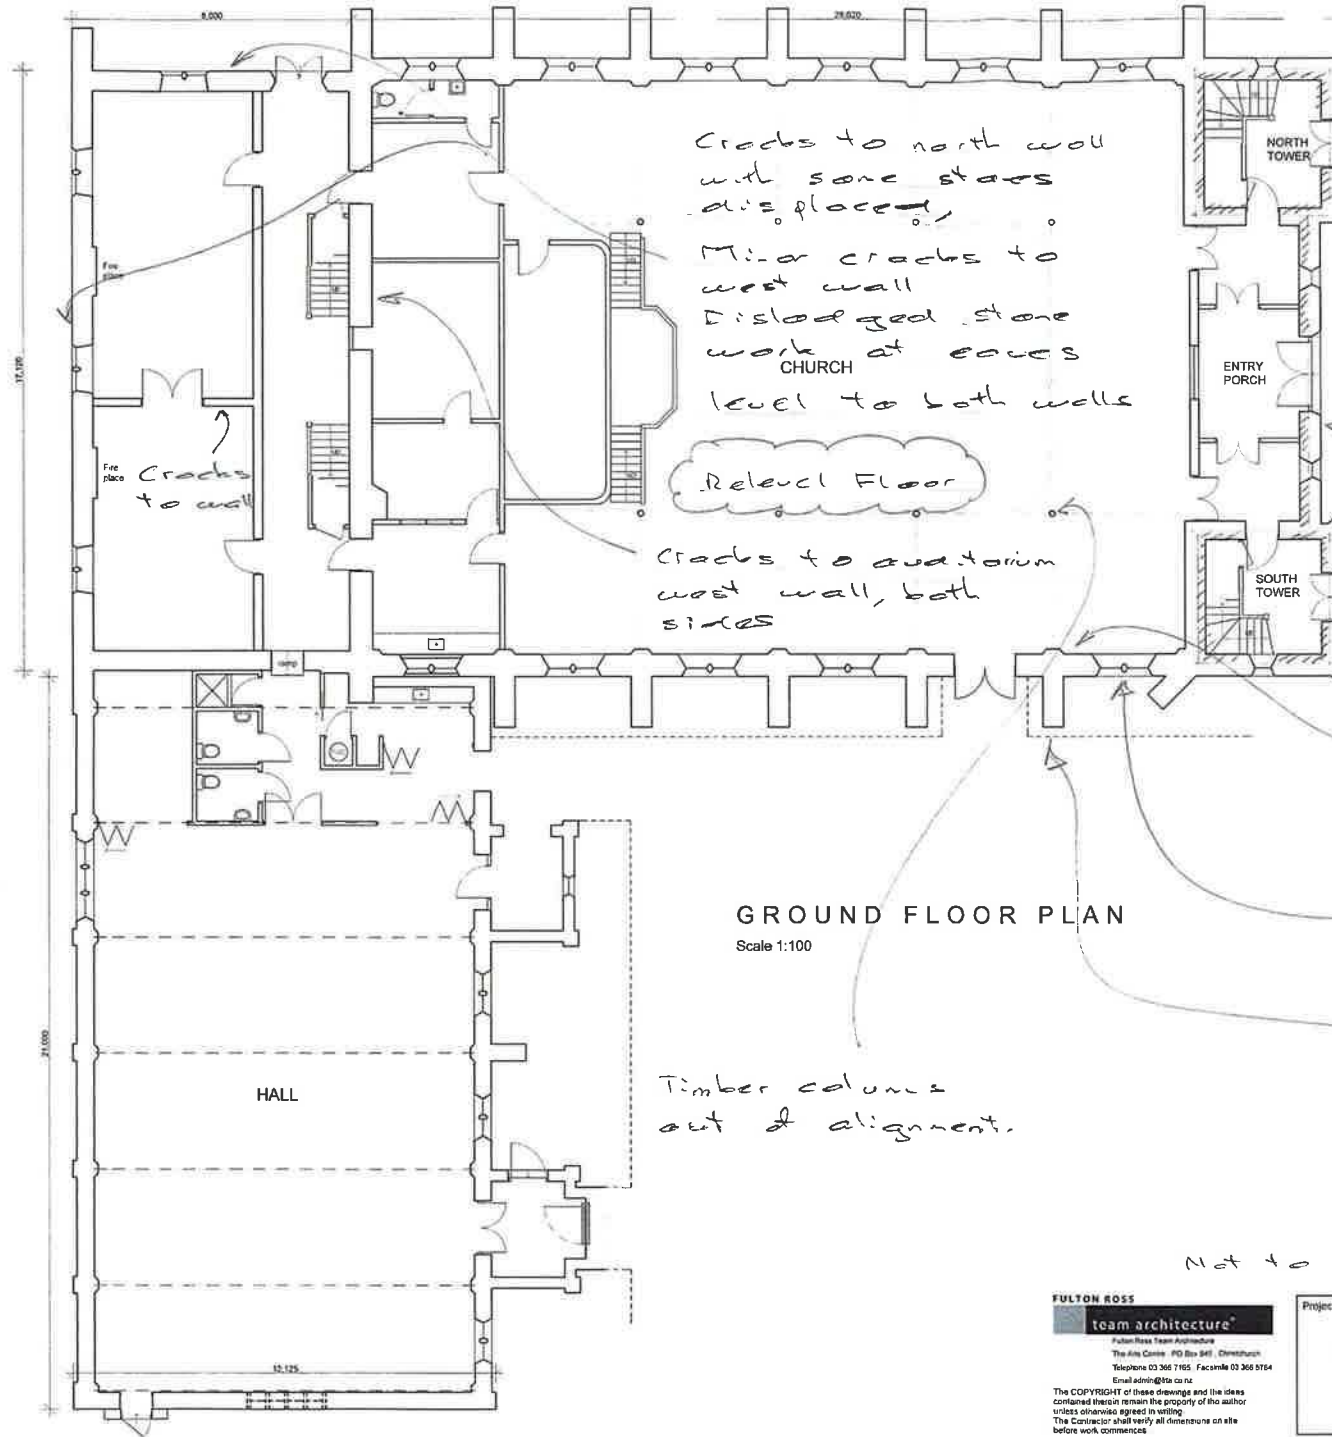
Some stone work to windows dislodged.

Side wall buttresses have cracks and some dislodged stones, 4 buttresses on the north side have significant cracks.

Cracks to north wall with some stone displacement,  
Minor cracks to west wall  
Dislodged stone work at eaves level to both walls  
CHURCH

Relevel Floor

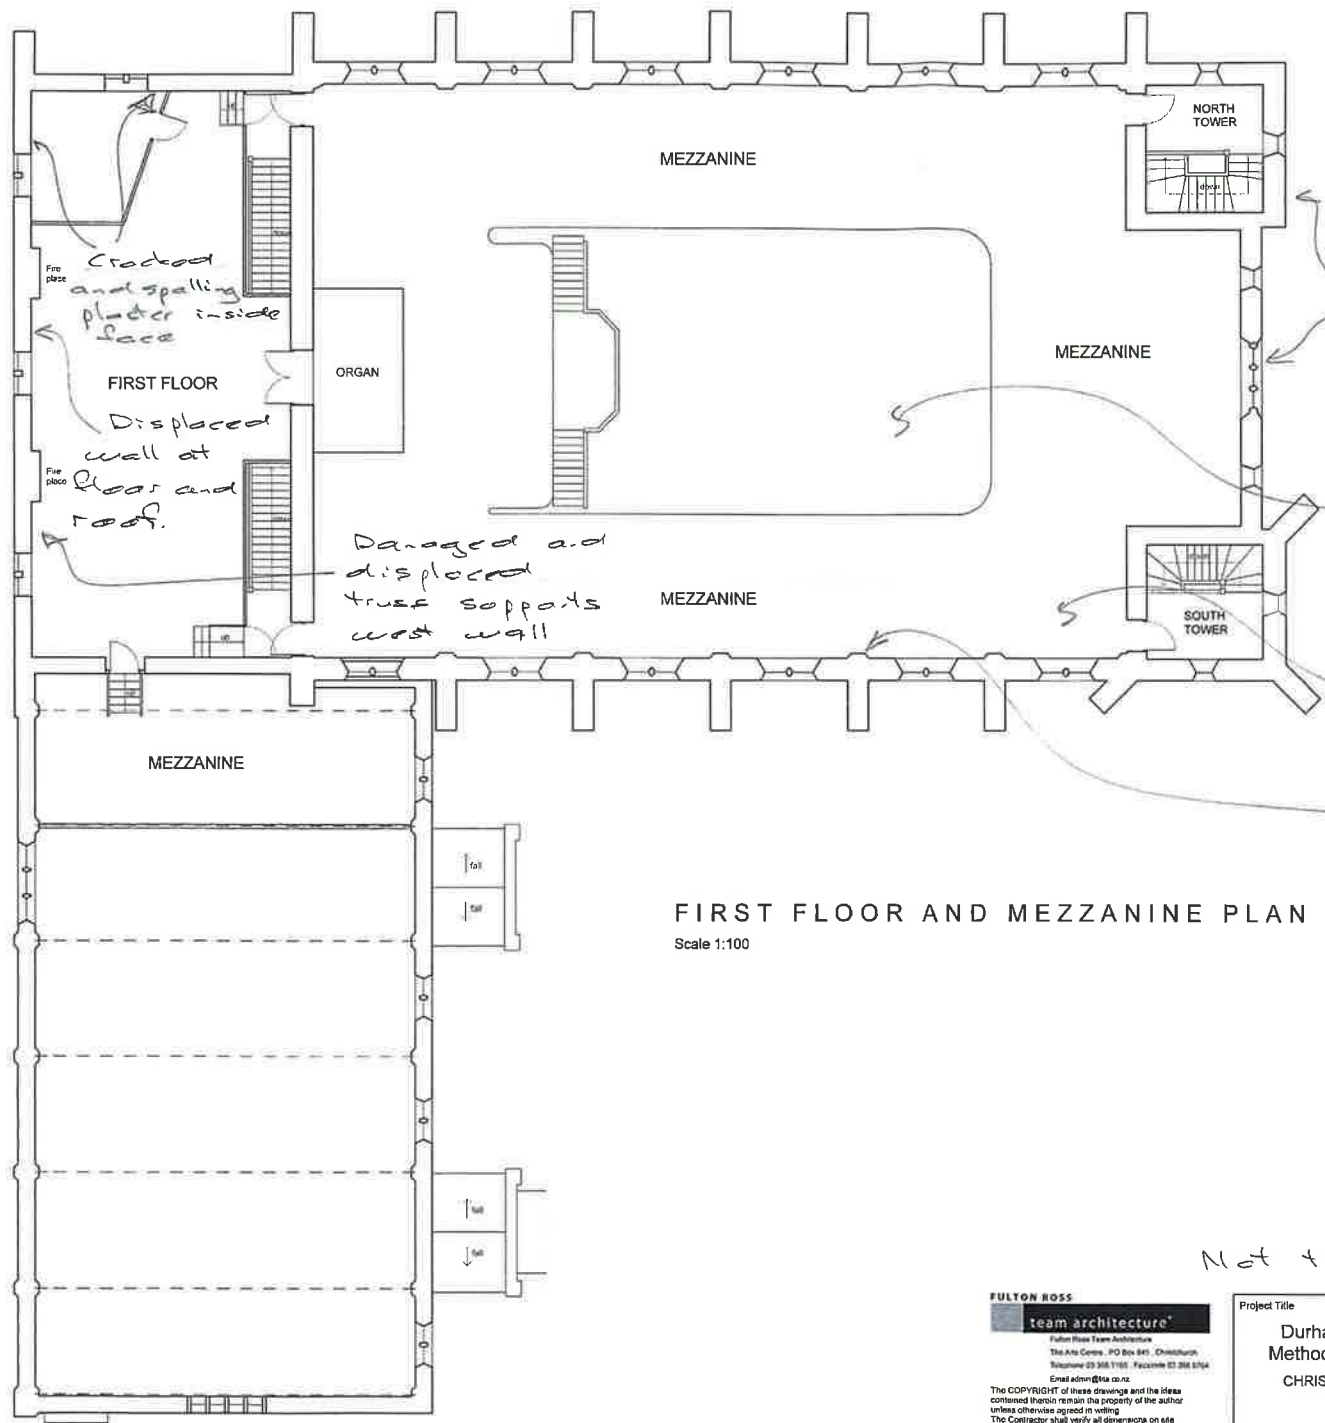
FIRST FLOOR AND MEZZANINE PLAN  
 Scale 1:100

Damage Summary Church

Stone finish damaged or collapsed.

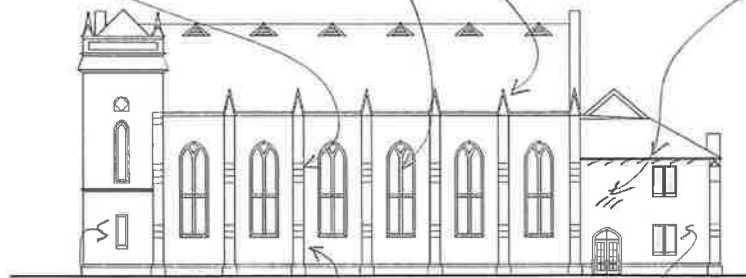
NORTH ELEVATION

Extensive cracking to exterior north tower and east gable

Extensive cracking

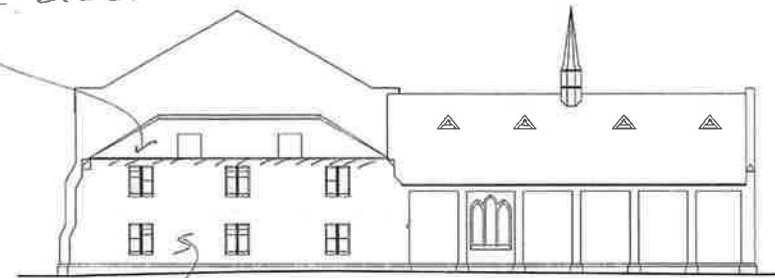
WEST ELEVATION

Large cracks to N north wall battresses  
Cracks to remaining battresses

Displaced stone at eaves and above door

Minor cracking to stone
