Christchurch City Council

BUILDING CONDITION REPORT SEPTEMBER 2009

32 Cathedral Square –
URGENT REMEDIAL WORKS

DAMAGE SURVEY - 16-09-10

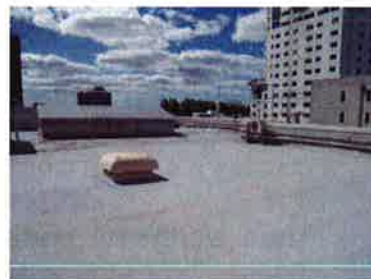
The main roof membrane is in good condition. The membrane replaced a former surface about a decade ago. It has been well maintained and patched where required.

Roof looking North

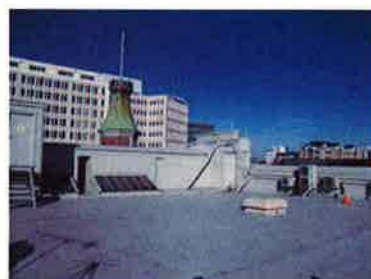
The steel cladding has been painted with a metallic based paint. The Pigeon house spaces are original fabric and in fair condition.

Southern Stair & Pigeon House

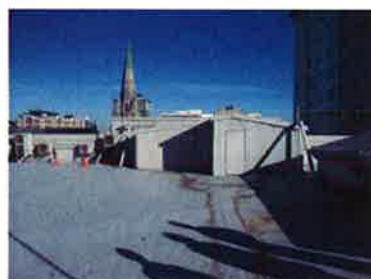
The Northern stair and lift are housed in another shed form. This time with a split gabled roof. This is also clad in corrugated steel and sits behind the second remaining section of original full height parapet. The cladding has been painted, well maintained and in good condition.

Northern Stair and Service Lift

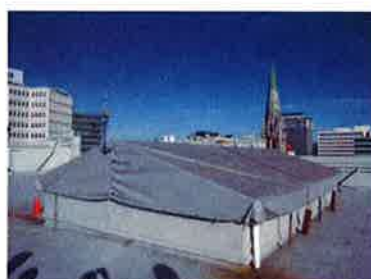
There is a large gabled skylight running East/West over the Northern portion of the building. It originally provided daylight to the Etching room, a space now used as a staff cafeteria. The skylight is now covered in a tarpaulin because there were overheating issues in the cafeteria below.

Skylight to Cafeteria

- *Repaint the flagpole and check structural support and flashing to tower roof*
- *Rustproof and repaint the crows nest fence fixings to copper roof*
- *Repair sections of copper roof where rust marks may have damaged the base copper*
- *Continue ongoing maintenance on roof structures*
- *Check cafeteria skylight*
- *Continue ongoing maintenance on membrane roofing*

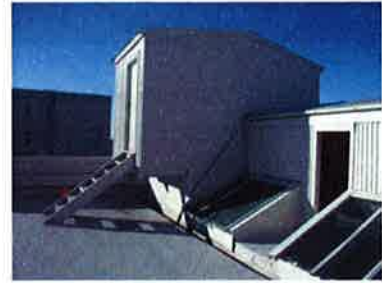
There are also smaller skylights around the former Pigeon house. These provide daylight to the 3rd floor reception and circulation spaces around the Southern stairwell. These skylights have been well maintained and are in good condition.

Skylights to Southern Stairwell

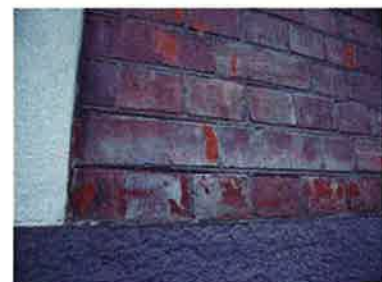
Detail showing milky coating on brickwork

The brick panels also have the milky appearance of a seal coat. There is minor damage to parts of the brickwork in part due to the sealant trapping moisture in the brick causing surface delamination. This seal coat should be carefully removed and any damage to the brickwork repaired.

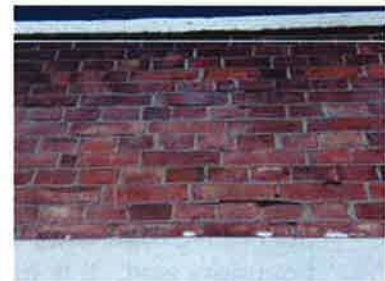
Sections of the brick work to the parapet are deteriorating and are also in need of some minor repointing and the occasional brick replacement.

North Elevation detail of weathered brickwork

- *Investigate the 'best case scenario' of removing the paint work, reinstating and repairing the original stone façade*
- *In the meantime, ensure the ongoing repainting programme is maintained*
- *Investigate and repair the cause of visible rust staining by removing and plugging the offending metal fixings*
- *Remove any redundant surface fixings and seal the original fabric*
- *Repair damaged brick work with repointing and brick replacement as necessary*

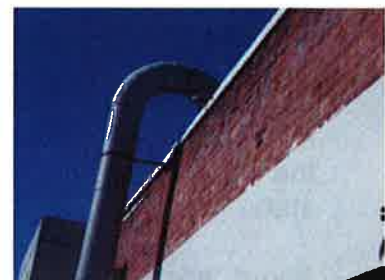
North Elevation detail of fixing for ventilation cowl

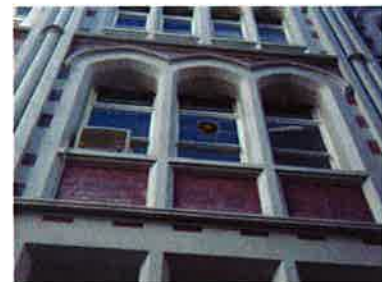
Extract fan cut into glazing

- *Continue the routine painting of timber frames and sashes*
- *Remove any modern incisions to the glazing where they are no longer necessary*

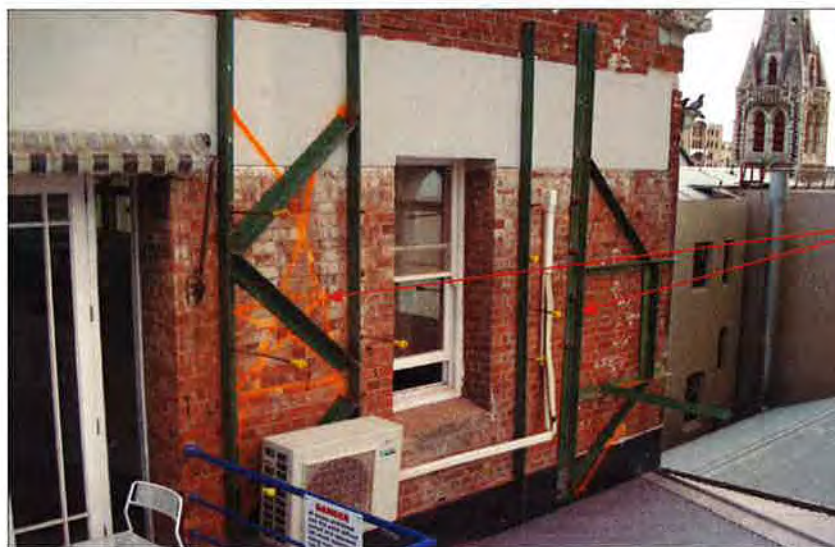
Clamping of wall with threaded rods and steel angles.

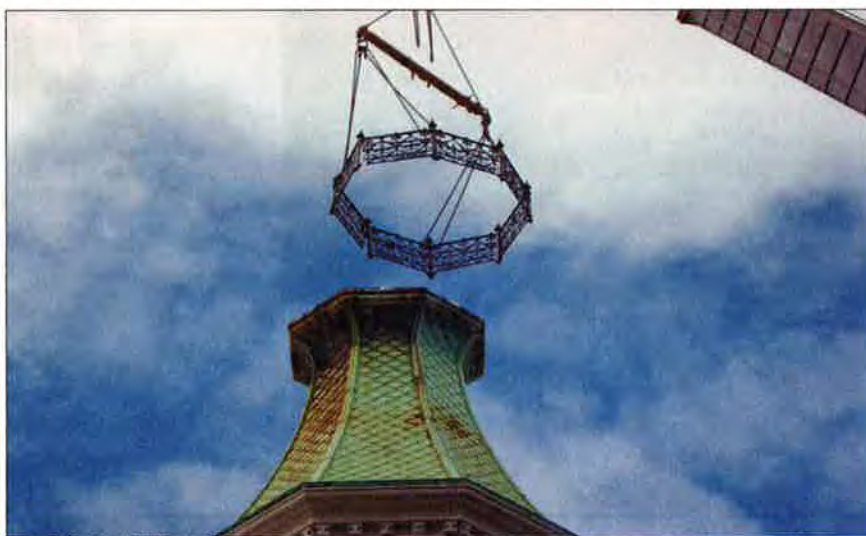
Removal of iron railing from Turret.

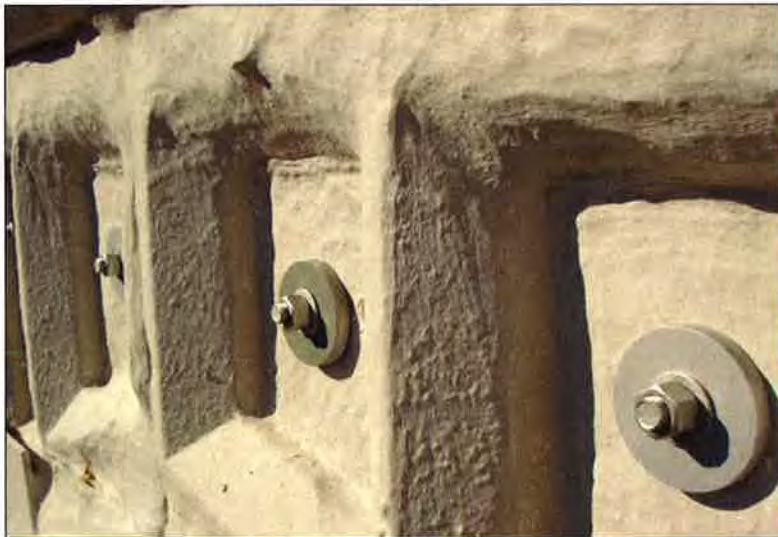
Circular washers were used on the face of the parapet wall.

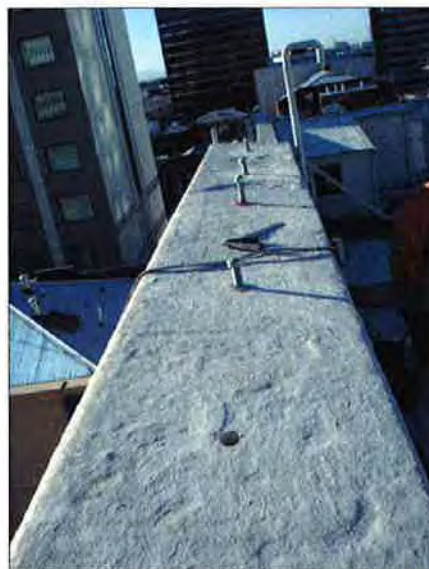
Threaded rods were chemset vertically into the parapet wall into retain the crown stones.

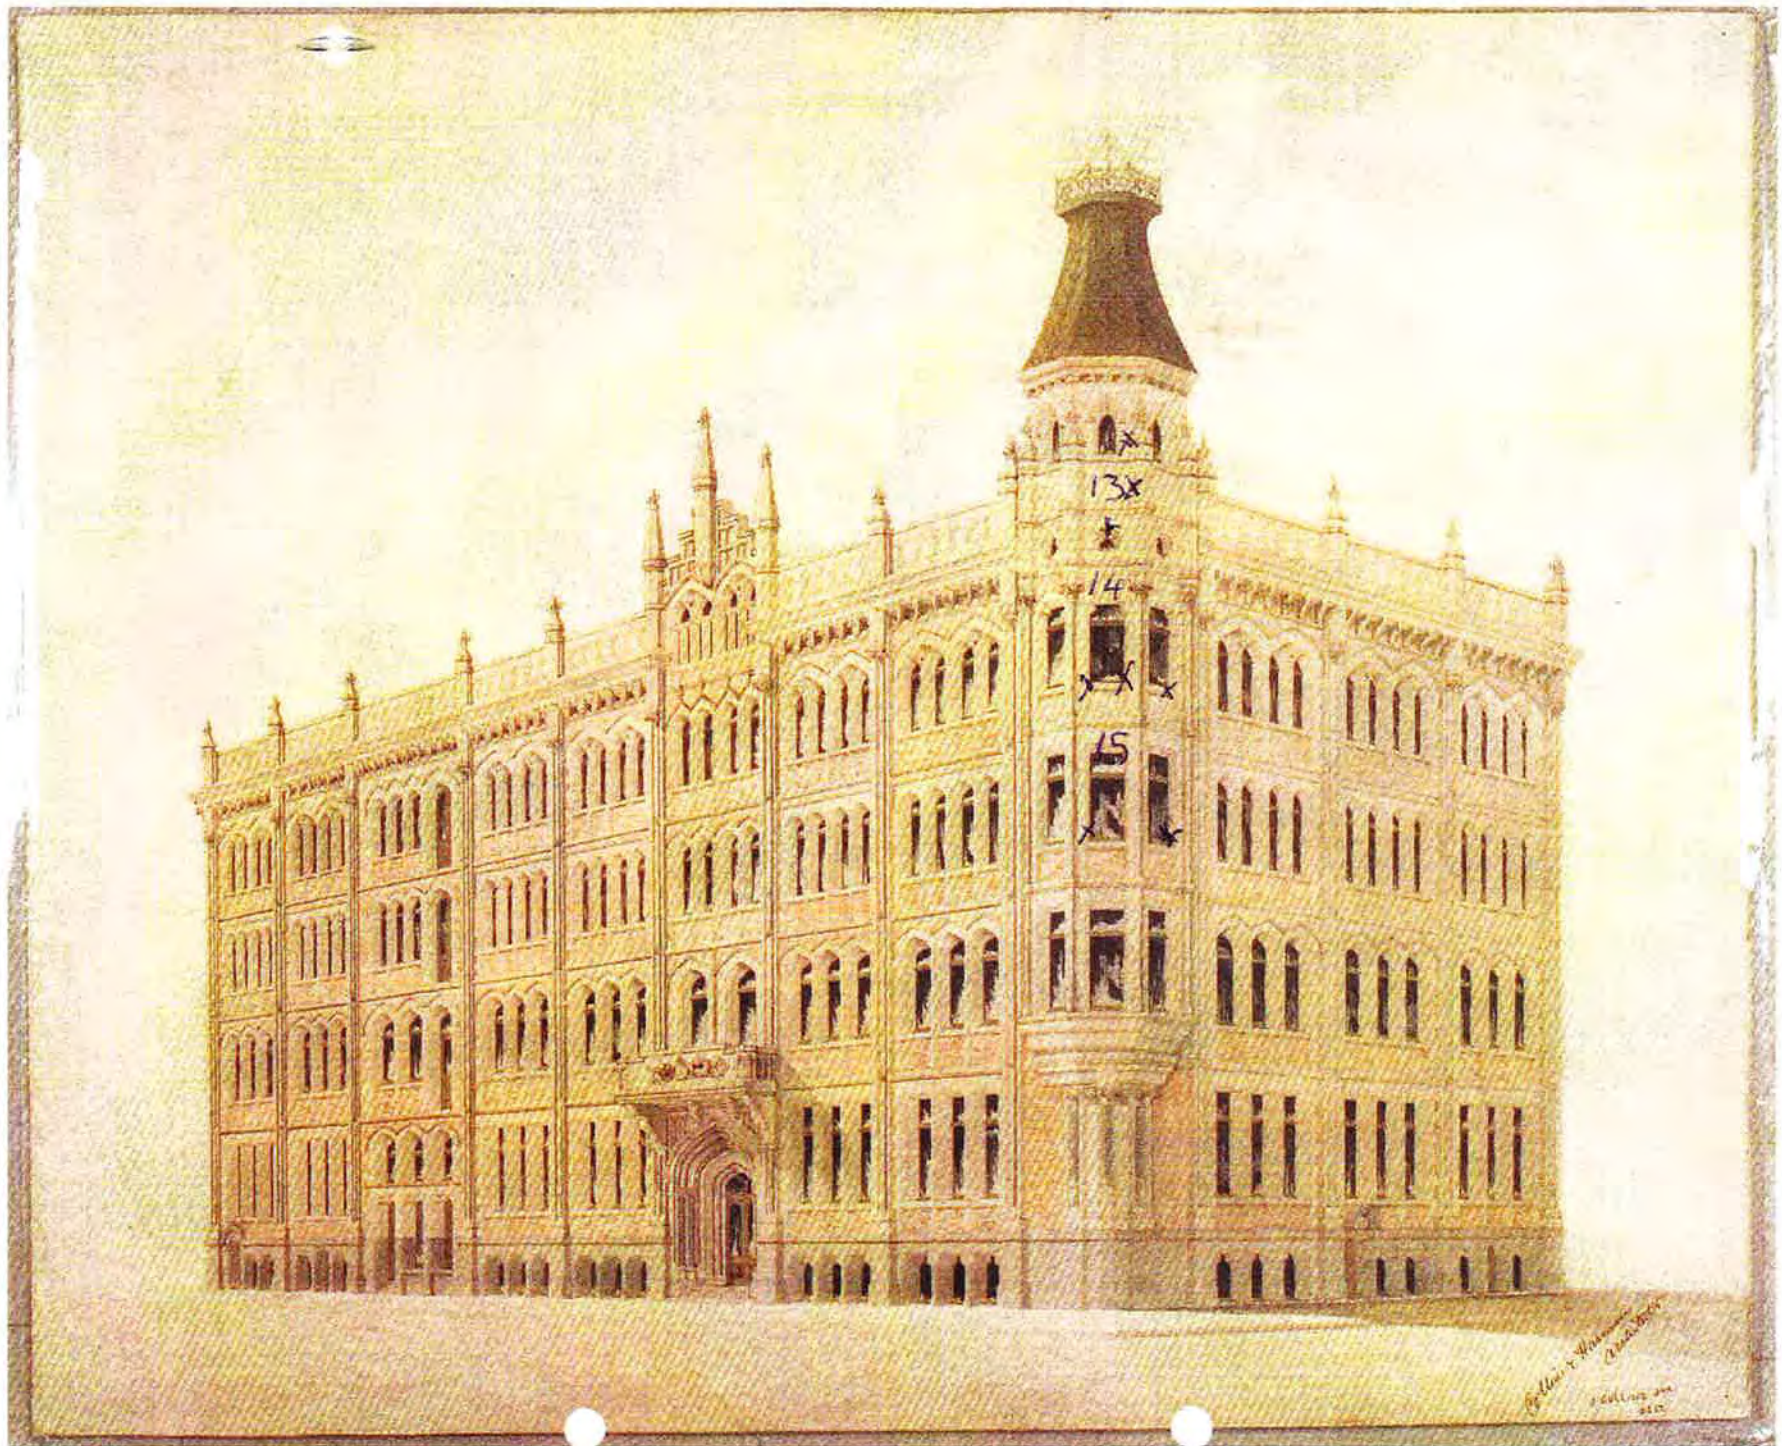
- 1 - car park side gap between sand stone & brick Top corner
- 2 - sand stone joints in columns movement - chipped
crack Top & Btm of column
- 3 - cracks sand stone ~~in~~ window columns both outer sides at base
- 4 - columns moved still solid 3 stones high right side
of centre column
cracks sandstone window columns both outer sides at base
Flaking paint around columns

Flaking paint around window

2 cracked window panes

5- Crack window column btm left side
 Crack window column Lower Right side
 centre column crack/chips right side
 cracks in stone joints window columns

6- Crack window column btm left side

7- Centre column moved 10mm gap solid - 1 stone
 cracks window columns btm both outside

8- Crack btm centre left window column

1 cracked window

9- crack/chip left column
 old gaps/new cracks base flower corbel
 Loose pointing left window arch
 3 window columns/arch cracked
 cracks btm outer side window columns both
 1 Broken window 1 cracked window

10- crack window arch left side - Flaking Paint right side
 cracks outside window columns btm both sides.
 Crack ^{top} right side column under window
 Broken window

11- cracks top 2 outside archs
 cracks/chips 3 column/arch joints
 chipped/cracked window column right side btm

12- crack pointing top window left side

14 - cracks window column bTms x3

15 - cracks window column bTm x2

⊗ cracked window

16 - Crack in column

18 - crack window column btm left

19 - crack window column btm left

cracked window

20 Crack window columns outside both sides btm

21 gap between stone column & brick 2 shots no dust
crack window columns outside both sides btm

- 22- Crack top corner
 Crack left outside column
 Crack ledge below rectangle window
 Crack left side window column btm
- 23- Crack window columns btm outside both
 Crack left side ledge at column
 Crack left side window arch at top
- 24- Cracks Top window arch both outside window
 Left side large right side small
 Cracks btm outside window columns
 Crack left side window ledge at column
- 25 - Crack/chip Btm right window column
- 26 - Crack Btm right window column
- 27 - Crack btm right window column
- 28 - Crack ~~left~~ Centre left side window column
 From window sill to Top of lower window

- 29- window arch left side crack / ~~mount~~ ^{or} Painting missing
cracks both sides of door intill
- 30- window arch left side crack / mortar missing
- 31- centre window arch crack / painting missing
crack in window sill left window right side
crack left side old door sill to window arch below
- 32 - crack window arch left side ^{window} centre
crack window arch Right side window left side
from above.

1 broken window

- 33 - crack ~~centre~~ column between windows at flower
crack Right window sill down to ledge & window below
- 34 - cracks window arch 2 left ~~side~~ side windows
crack window right side around sill
- 35 - crack centre window column right side Top
- 36 - crack window right ~~side~~ side head to Top of ledge above

~~3~~ 4 cracked windows

37. End column 15mm at arch height crack
 through to window
 Crack Top centre window column &
 Crack Top Right window arch.
 crack end column through to window
 Crack right side window btm column.
 Flaking Paint end column at ledge height
- 38 - Left window arch Flaking paint
