THE PRESS HERITAGE BUILDING

STRUCTURAL DAMAGE REPORT FOLLOWING 4/9/10 EARTHQUAKE

October 2010

Project N°: 110117

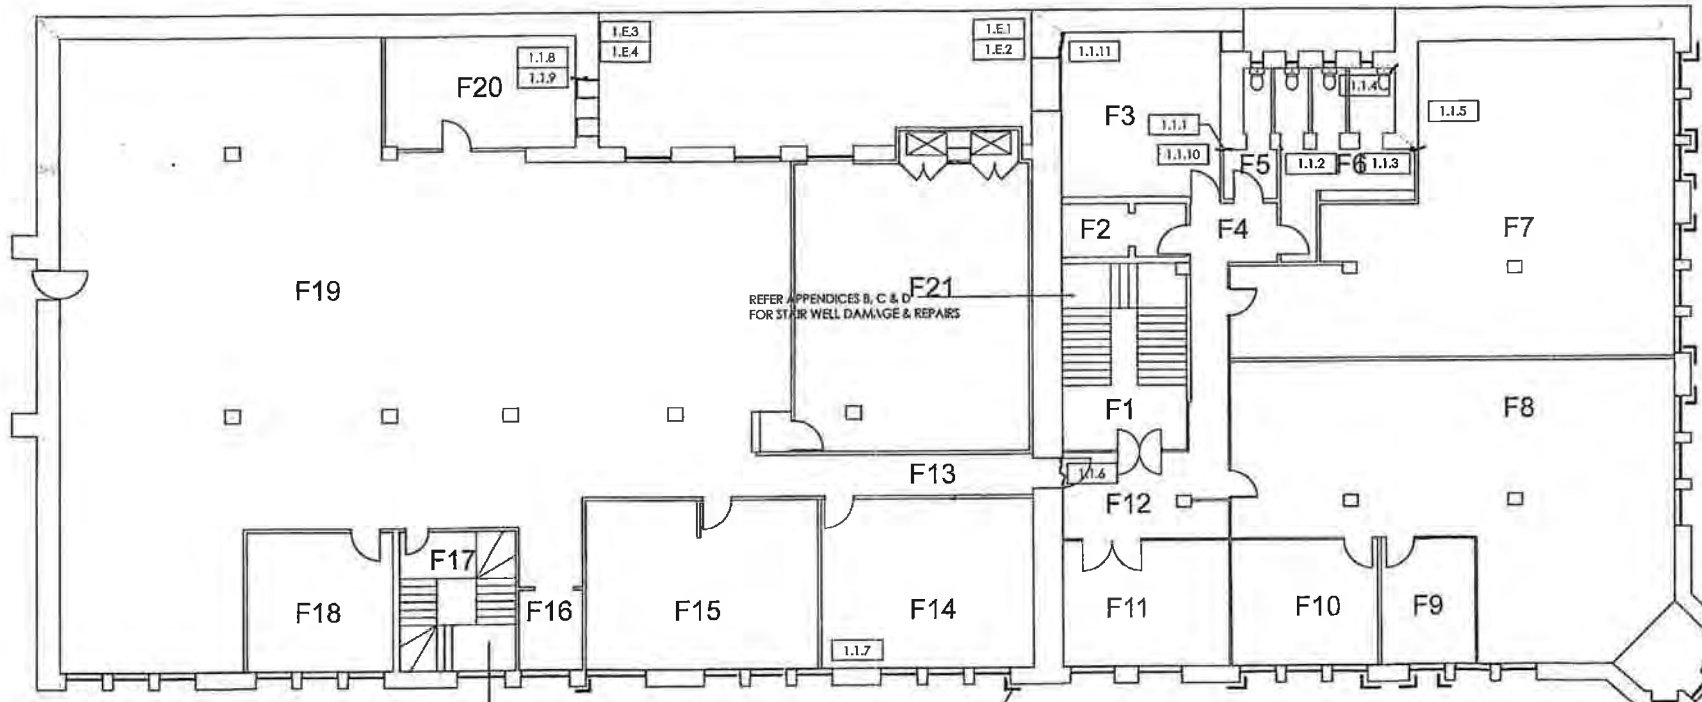
APPROXIMATE EXTENT OF CRACKING SHOWN INDICATIVE.
REFER APPENDICES FOR DETAILS AND REPAIRS, CONFIRM EXTENT ON SITE

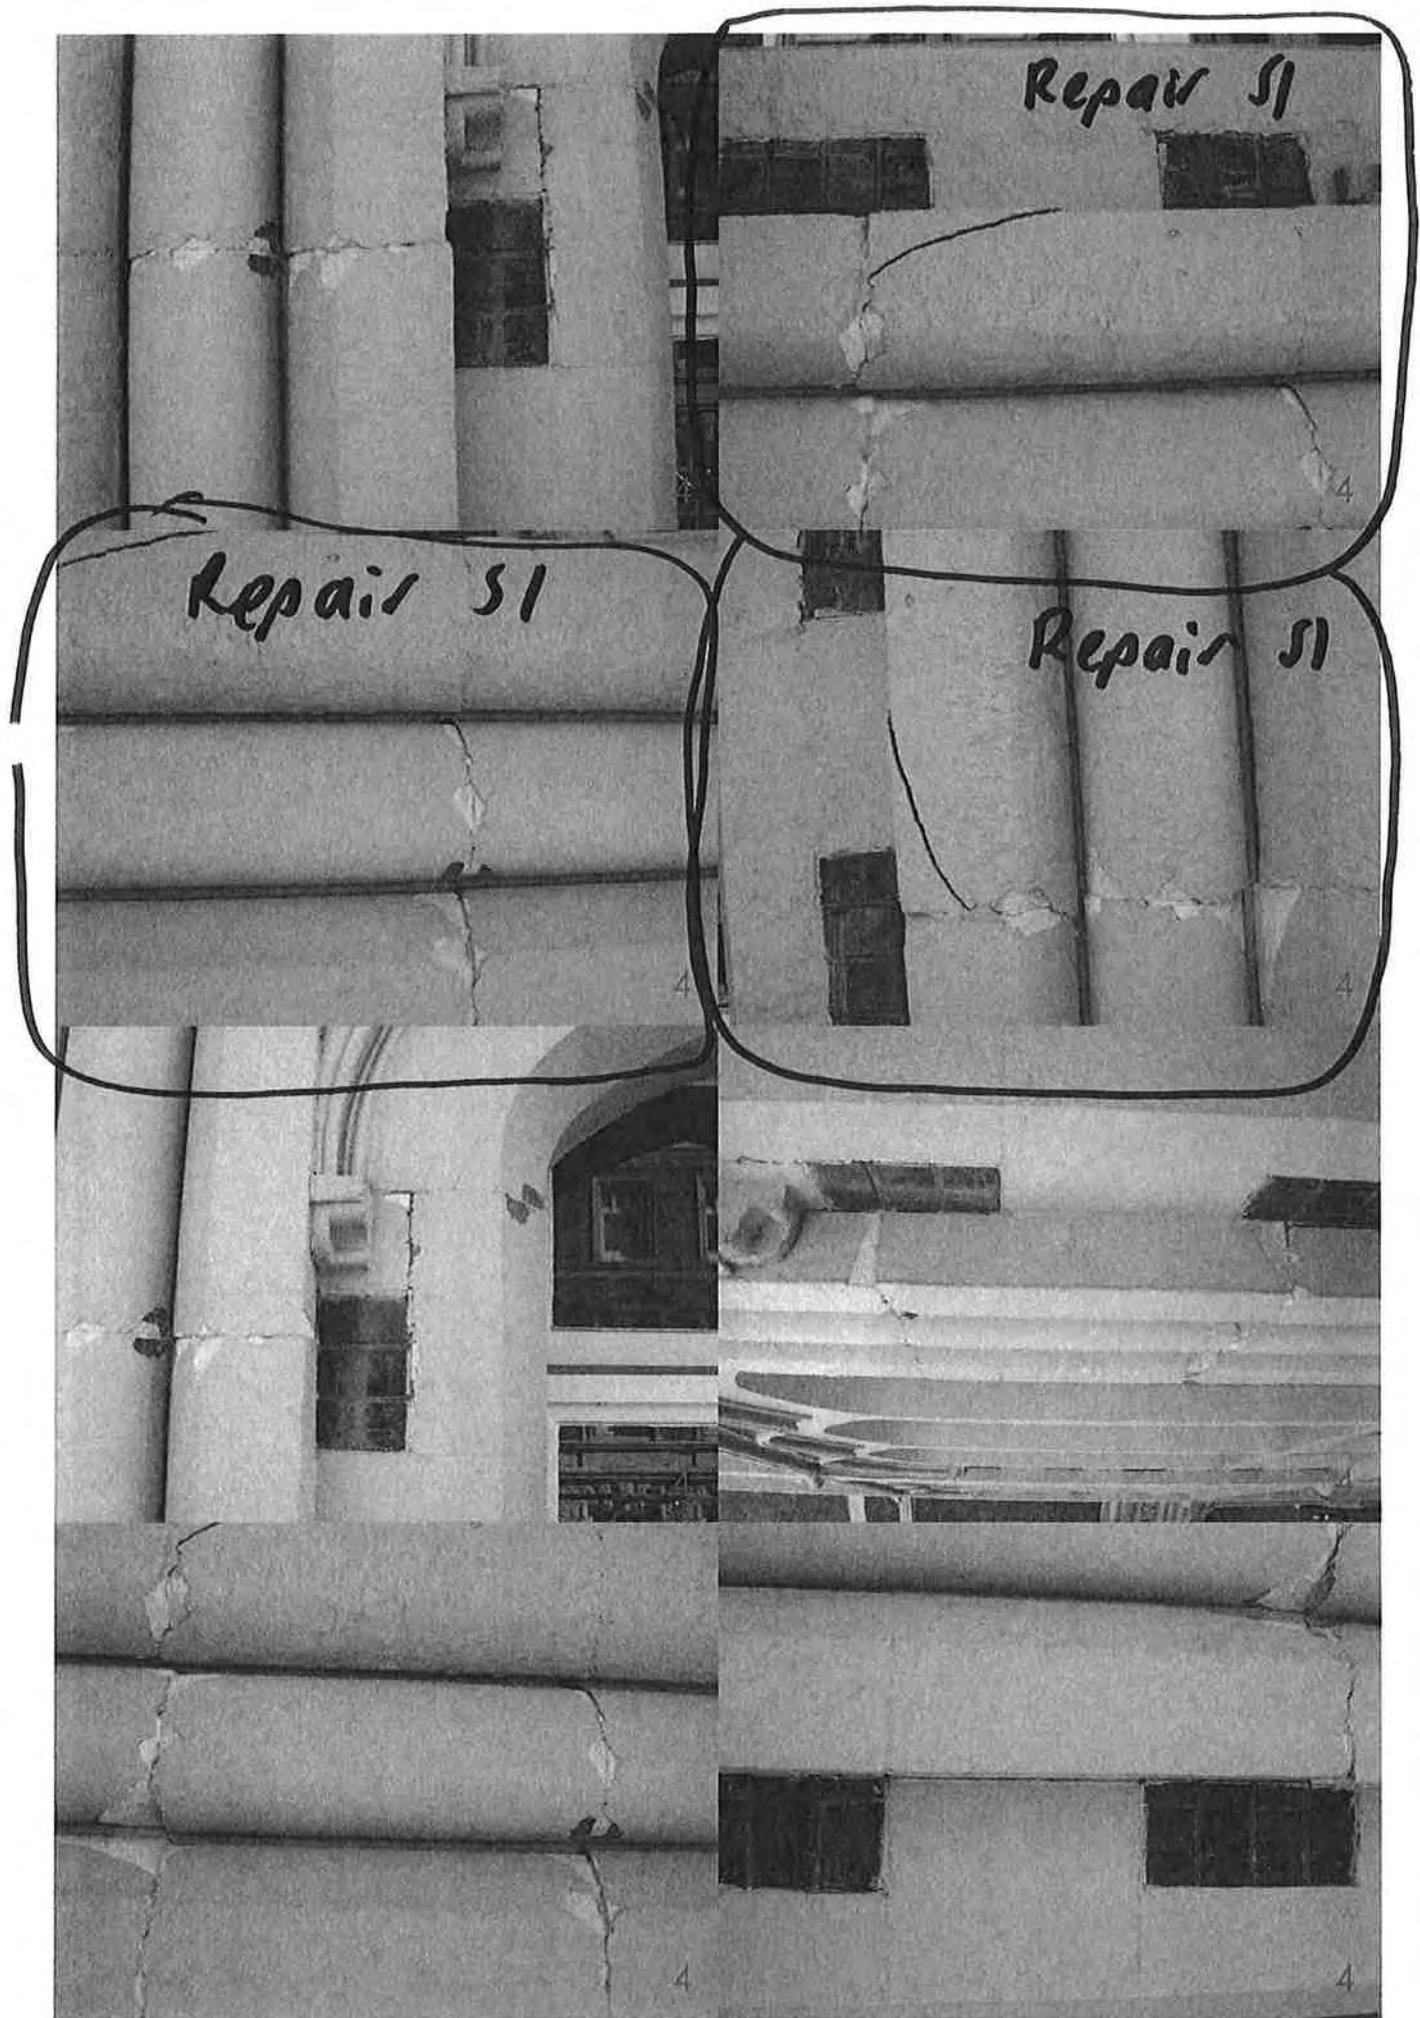
Repair 51

The repair work required for the damage to the stonework is typically (Repair S2). However due to cracks through existing stone blocks (Repair S1) is required in a number of locations which are marked up on the photographs. Refer to Appendix B for repair schedule.

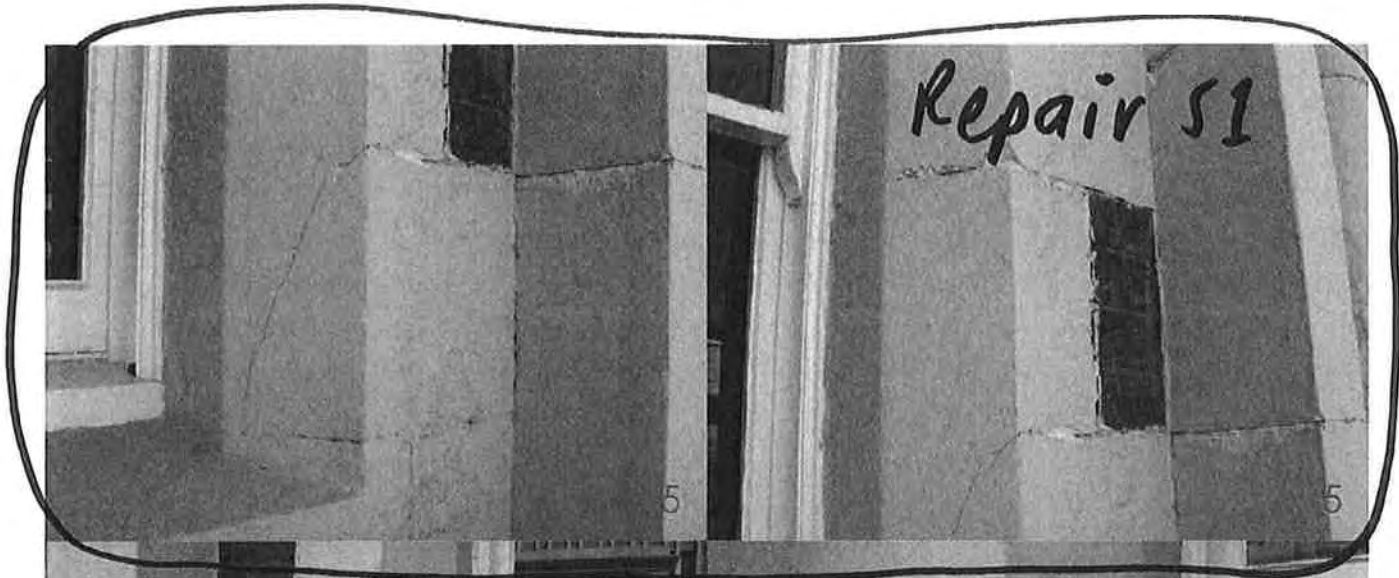
5

Repair 51

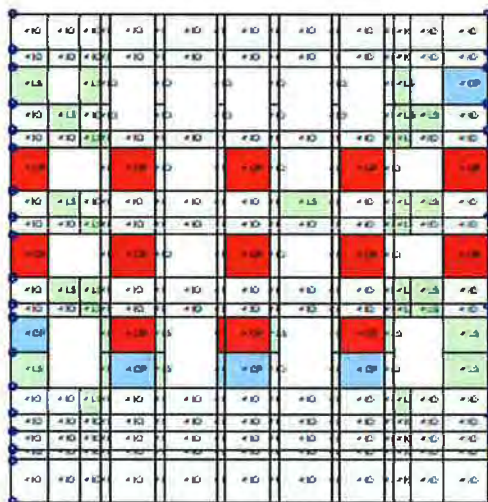
NORTH WALL
(proposed configuration)
33% NBS

windows from the ground floor to the second floor sustain significant damage (shown in red) at an earthquake level corresponding to 33% of current National Building Standard (NBS). The right figure below illustrates the damage sustained by the north wall in the current configuration at an earthquake corresponding to 50% of current NBS.

Associated with the damage to the northern wall under the proposed configuration is an increase in damage to the remainder of the structure. However if the integrity of the wall is maintained via an appropriate retrofit solution the performance of the Press Building in the current configuration is such that collapse is unlikely during a seismic event corresponding to 50% current NBS.

Remedial strengthening of the north wall will be necessary and are also likely to be required in other locations in order to bring the building up to the target strength of 67% NBS. These will be more readily identified when the actual material strengths are known and will depend on the redistribution of loads associated with the integrated remedial solution. A summary of the required and likely proposed remedial details is provided in the following section.

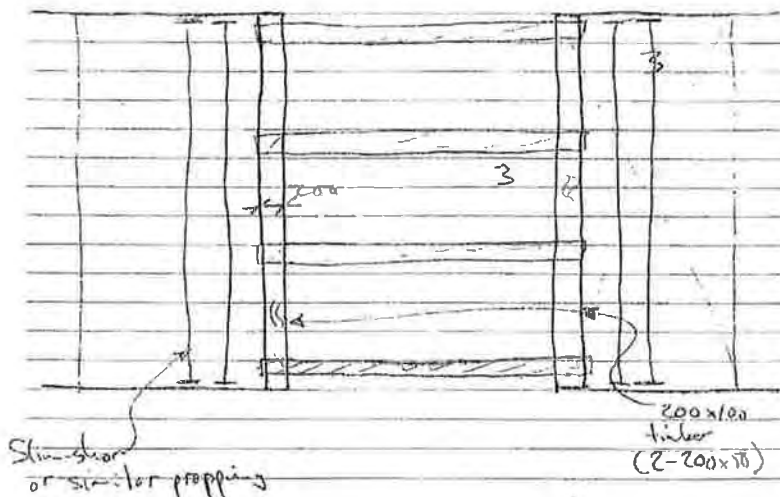
1. Major damage at:-
 - South wall, mostly at levels 2 and 3. Diagonal shear failures in brick piers.
 - Central stairwell at level 3. Diagonal shear failure, compressing fire escape door running across to sliding shear at approximately 400mm below level 3.
 - North wall, piers cracked at east end and piers at west end have moved another 10mm on previous cracks.
 2. Moderate cracking to tower above roof level and in walls below.
 3. Propping and shoring required to south wall. Remove windows adjacent to piers and profile cut timber packing to shape of stone. Tie around piers with 4-2.5 t straps. Prop adjacent from spandrel below to spandrel above. (Refer below detail).
- For two central piers of south wall and east end pier of the north wall.
