THE PRESS BUILDING  
32 CATHEDRAL SQUARE  
CHRISTCHURCH

## Damage Report, JANUARY 2011

Project Title The Christchurch Press Complex  BUILDING ONE  Cathedral Square Christchurch	Drawing Title EXISTING BASEMENT FLOOR PLAN  Scale Scale 1:200 @ A3	Issue <b>SKETCH</b> Date C.A.D file Project No.	Sheet No. <b>SK 1.0</b> Rev
---	--	---	-----------------------------------

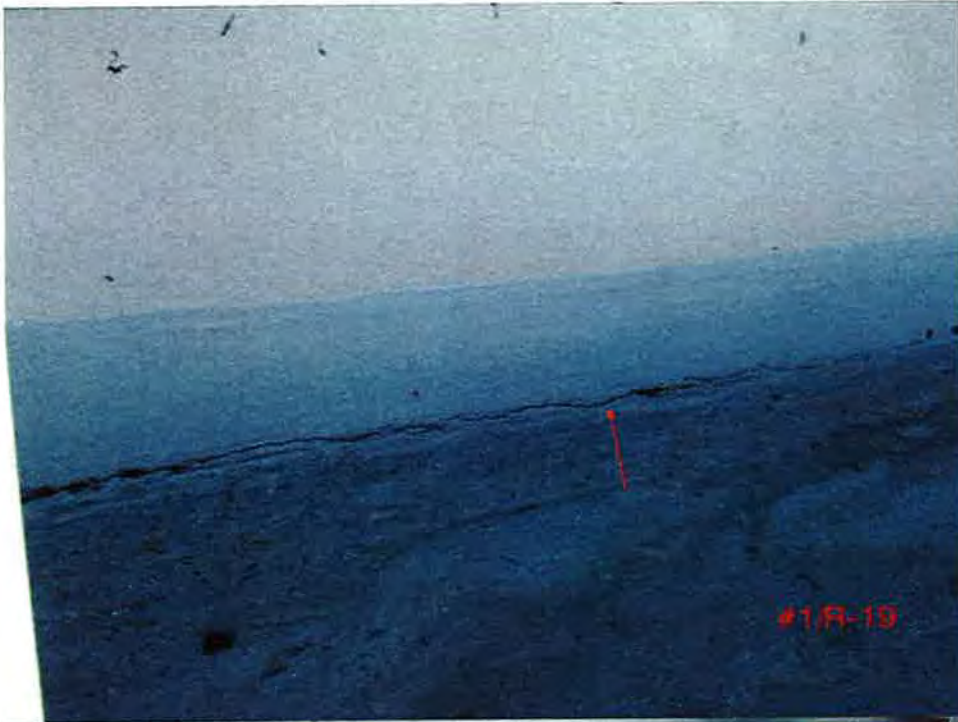
#1/R-17	Brickwork cracked
#1/R-18	Membrane faulty
#1/R-19	Membrane faulty
#1/R-20	Membrane faulty
#1/R-21	Parapet brickwork cracked
#1/R-22	Parapet brickwork cracked

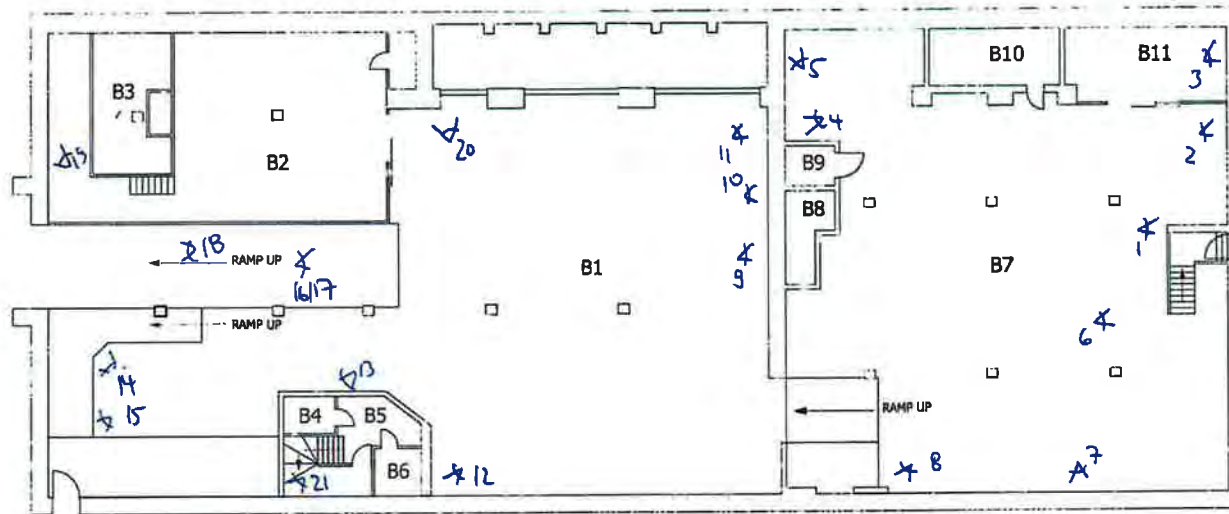
VIEWS X22 to X25  
 • ADDITIONAL DAMAGE APPEARS STAIN NORTH

DAMAGE SURVEY  
 20TH JANUARY 2011  
 C. TOWNIUS PAGE 1 OF 6

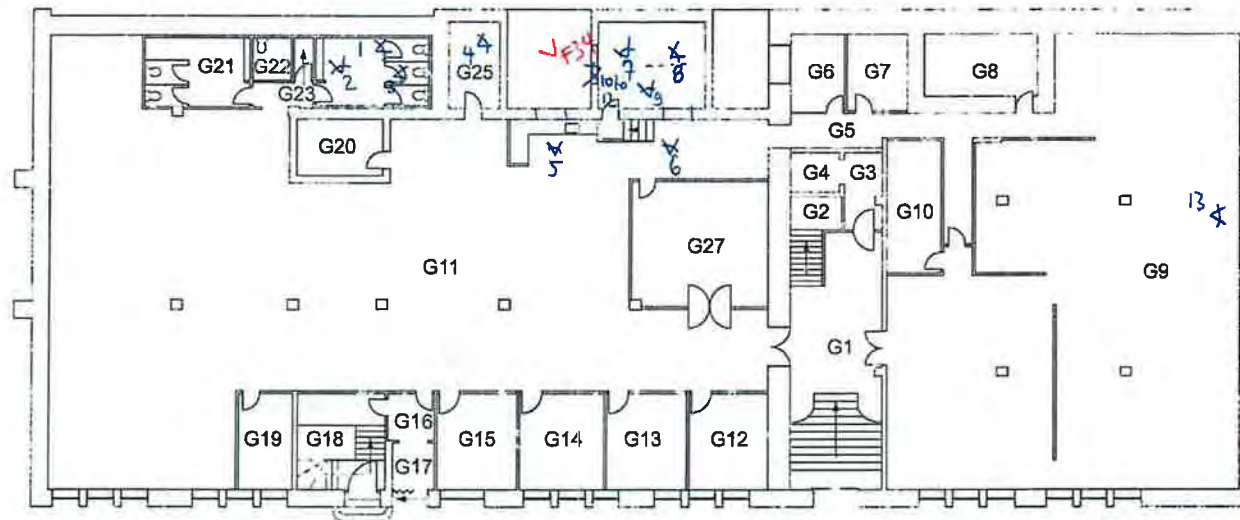
Project Title <b>The Christchurch Press Complex</b>		Drawing Title <b>EXISTING GROUND FLOOR PLAN</b>		Scale Scale 1:200 @ A3		Issue <b>SKETCH</b>	
BUILDING ONE		Cathedral Square Christchurch		Date		Sheet No. <b>SK 1.1</b>	
Drawn by Date		Checked Date		C.A.D file		Rev	
Project No.

\* F21 to 32  
 DETAILS SOUTH  
 FACADE  
 DAMAGE

DAMAGE SURVEY  
 20 TH JANUARY 2011  
 C. TONNIUS PAGE 2076

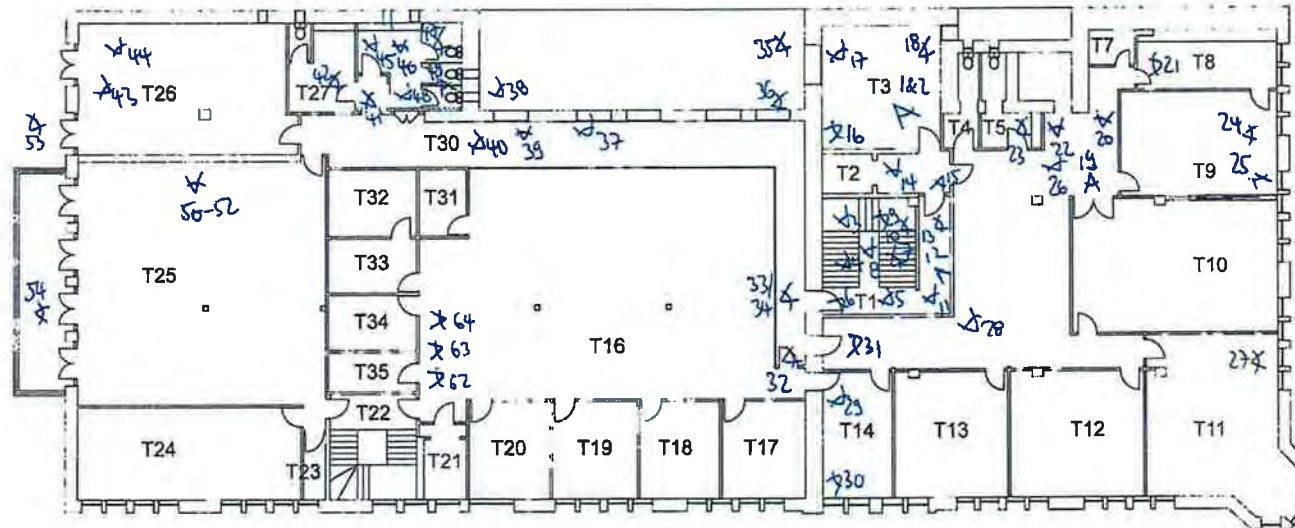
✕ 55 to ✕ 61  
 ADDITIONAL DAMAGE  
 IN NORTH STAIR  
 LEVEL 3

DAMAGE SURVEY  
 20TH JANUARY 2011  
 C-TOWNIUS PAGE 50F6

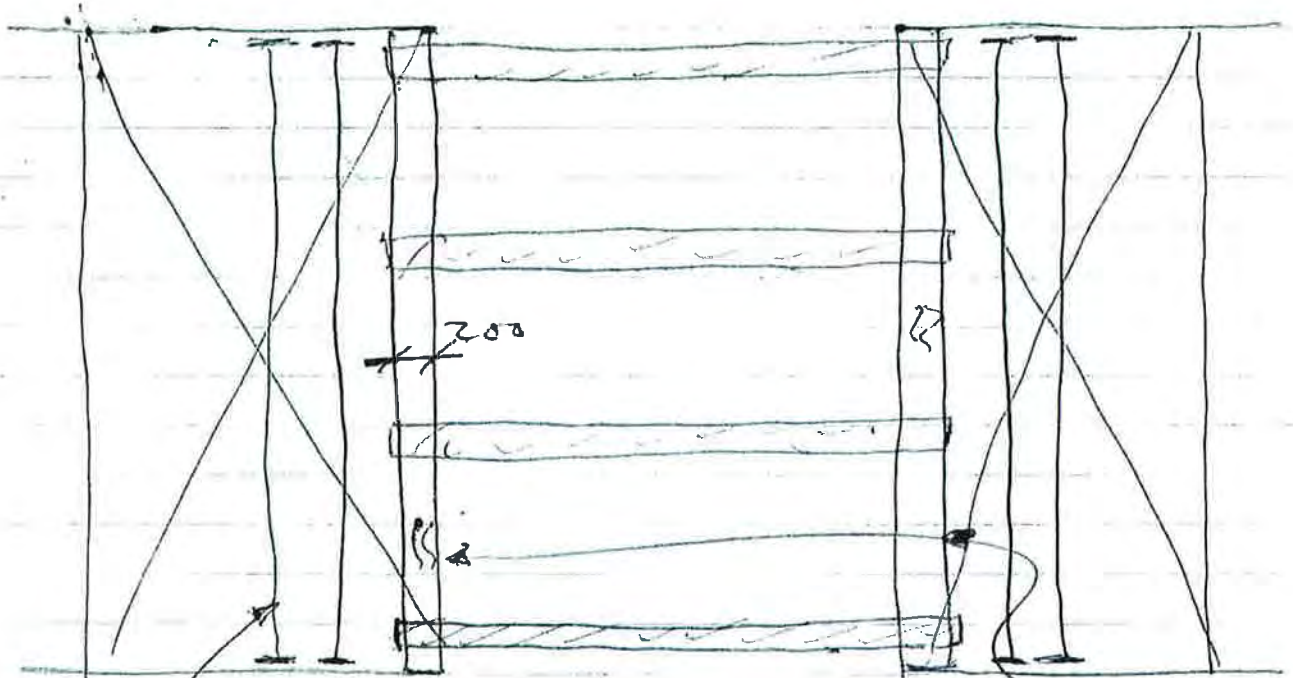
from above  
spandrel below to spandrel above  
↓  
For 2 central piers  
at 3/4 & 1 only at 1

Slender pier  
or similar propping  
or 3 200x50's

200x100  
timber  
(2-200x50)

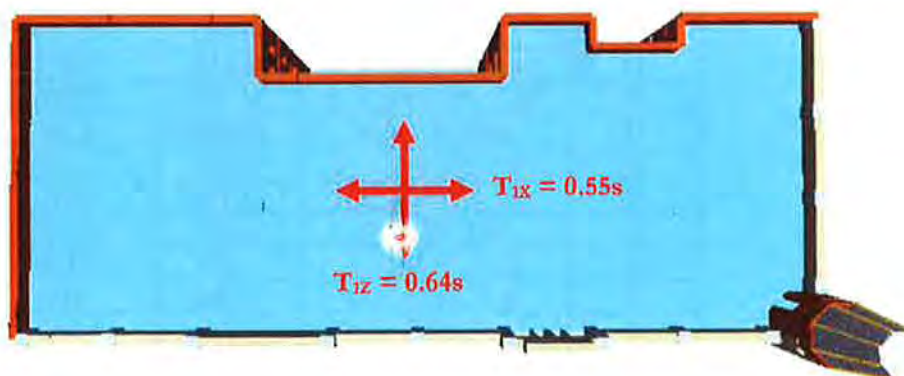
Figure 5-1 First and Second translational Modes

The dynamic characteristics of the structure are dominated by the eccentricity of the centre of rigidity from the centre of mass. The eastern wall of the building is considerably stiffer and stronger than the walls on the north, south and west faces of the building. This can be seen from the mass participation results shown in Table 5-1. The first translational mode (0.644s) is in the E-W direction and contributes over 60% of the participating mass in the Z direction. In the N-S direction however the torsional response of the building means that the second and third modes are both required to activate more than 50% of the participating mass of the building. Figure 5-1 below illustrates the first two translational modes of the building.

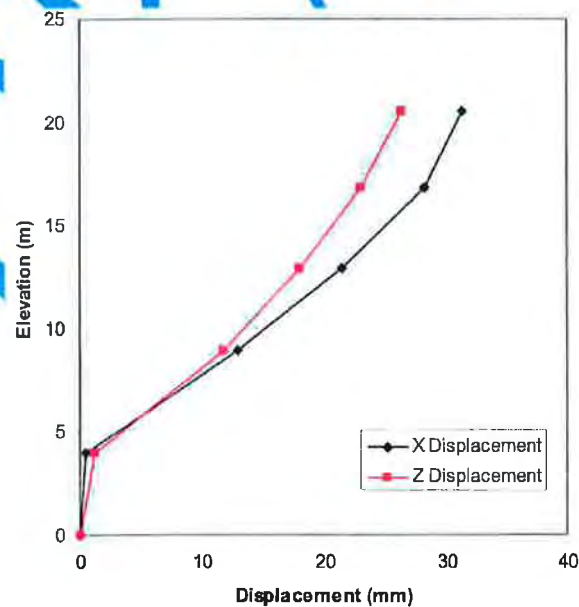
Figure 6-3 Peak Floor Level Displacements

From Figure 6-5 it can be seen that in the x-direction and z-direction the maximum floor displacements were all 30 mm or less.
