**Christchurch Earthquake
CBD Building Performance Technical Investigation**

**Report on the Structural Performance
of the
Hotel Grand Chancellor
in the
Earthquake of 22 February 2011**

Prepared By:
Dunning Thornton Consultants Ltd

Final: 26 September 2011

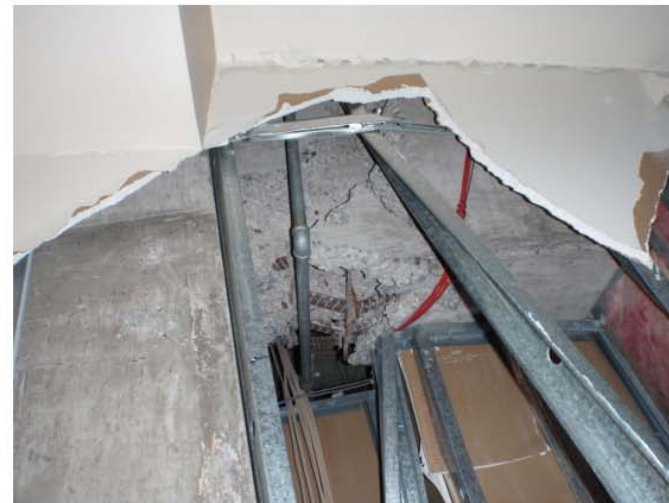
Photo 18 - Hinging in grid D tower beams

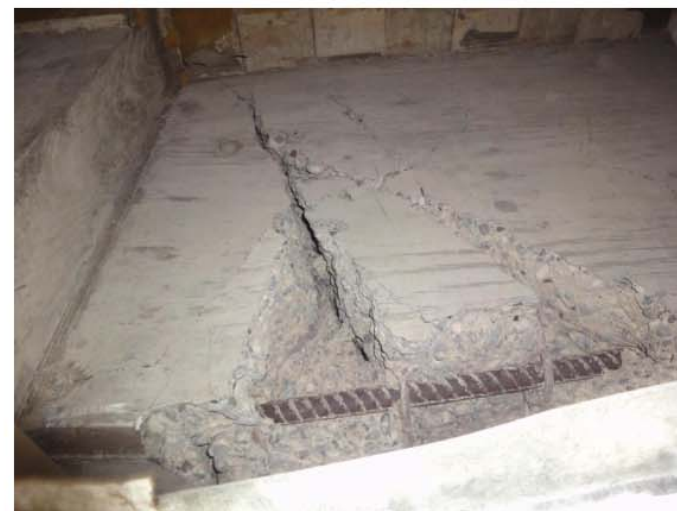
Photo 19 - Hinging in grid D tower beams

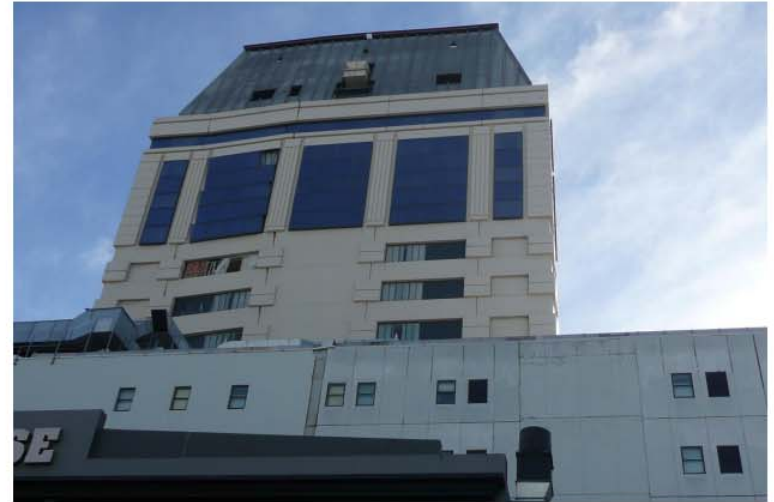
Photo 4 - Eastern
Elevation - Post
February

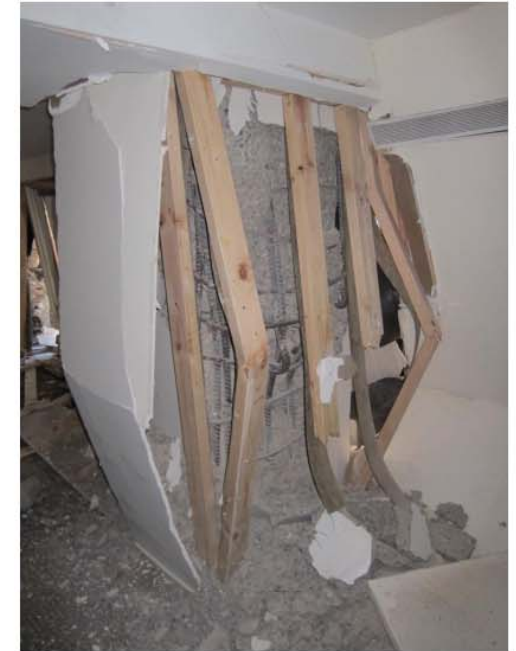
Photo 21 -
Crushed
columns at level
10, lines 5 & 6

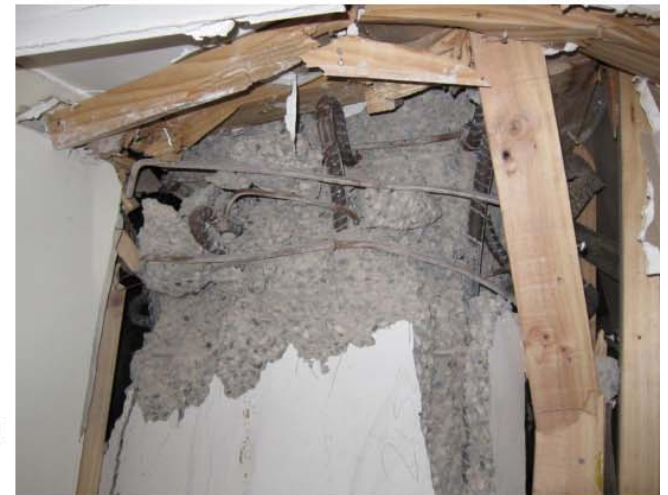
Photo 22 -
Crushed
columns at level
10, lines 5 & 6

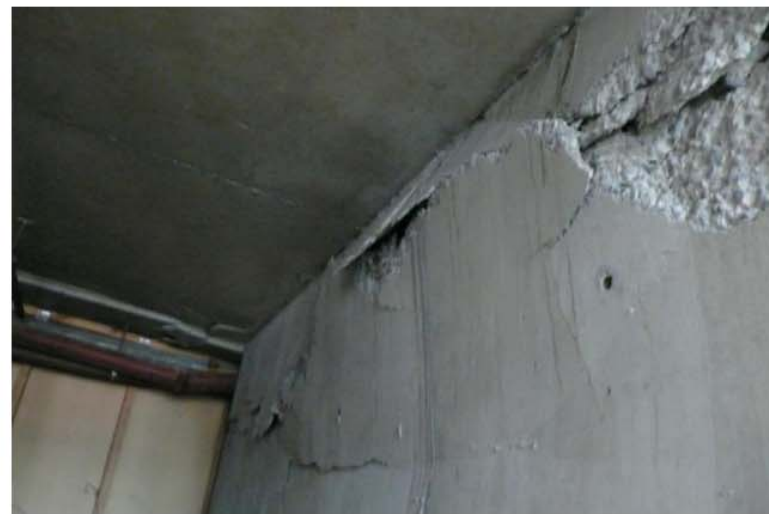
Photo 8 - Shearwall D5-6 - Hingeing at top of ground floor
