**From:** Glen McConnell [ | ]  
**Sent:** Wednesday, 18 January 2012 12:04 a.m.  
**To:** Mark Zarifeh  
**Subject:** Report for Commission

Hi Mark, the following is a summation of my involvement in the events leading to the collapse of 116 Lichfield st (Reuben Blades)

## engineer's instruction

project 116 Lichfield St.

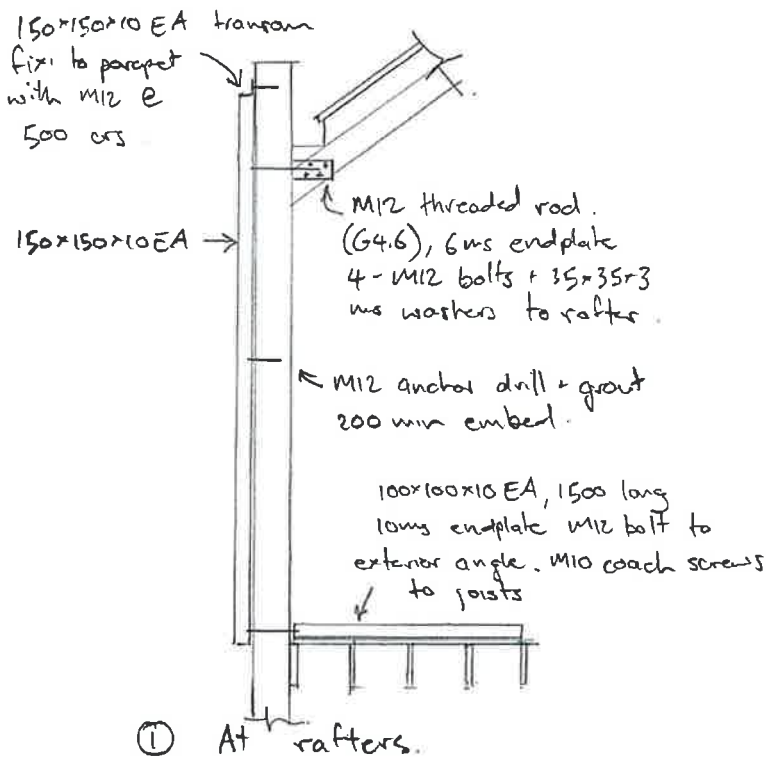
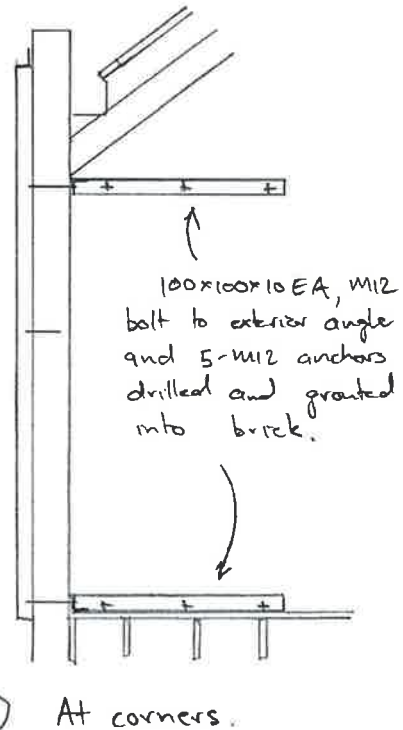
These high level bricks and stone blocks are potential fall hazards to the areas directly adjacent and should be secured as soon as possible, (or the fall areas cordoned off).

150x150x10 EA transom  
fix to parapet with M12 e 500 CRS

150x150x10 EA

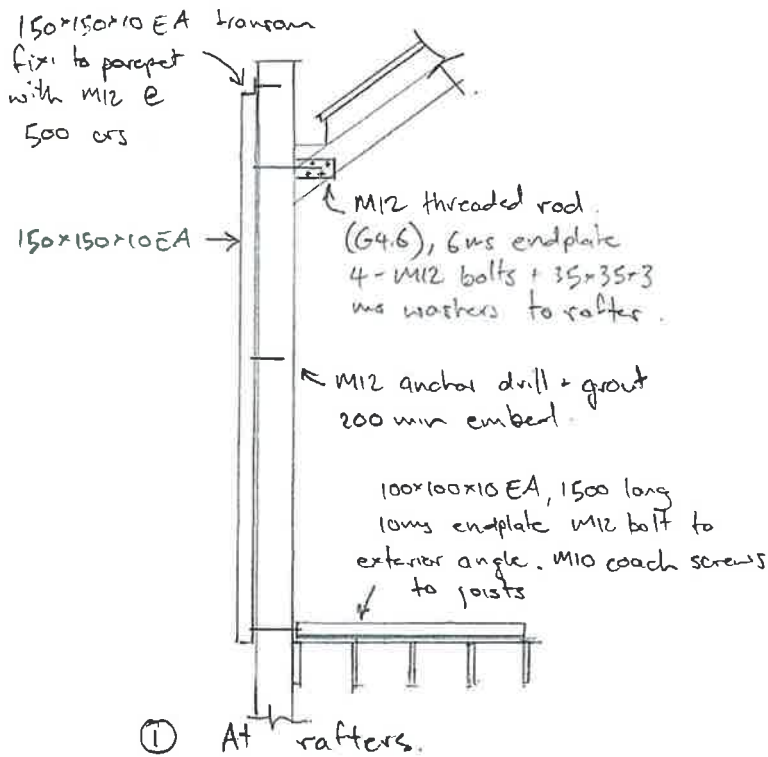
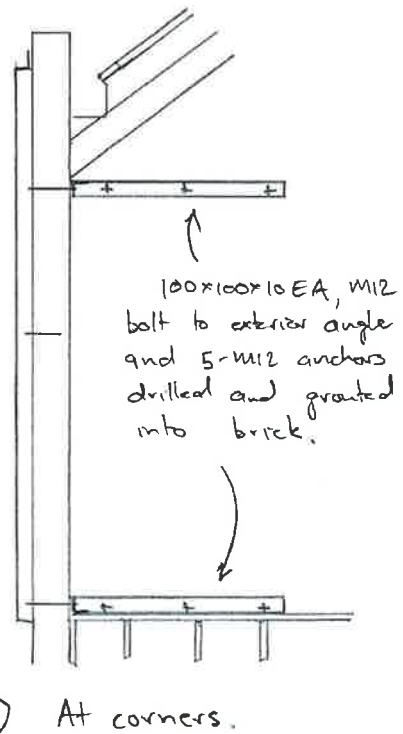
These high level bricks and stone blocks are potential fall hazards to the areas directly adjacent and should be secured as soon as possible, (or the fall areas cordoned off).

150x150x10 EA transom fix to parapet with M12 @ 500 c/s

150x150x10 EA
