**INDEPENDENT ASSESSMENT ON EARTHQUAKE PERFORMANCE
OF
595A Colombo Street**

**FOR
Royal Commission of Inquiry into building failure
caused by the Canterbury Earthquakes**

**Report prepared by Peter C Smith and Jonathan W Devine
OF
Spencer Holmes Ltd**

December 2011

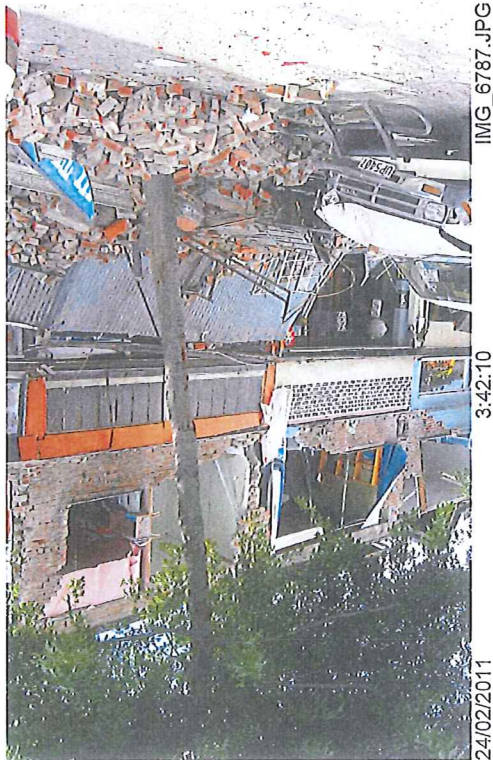
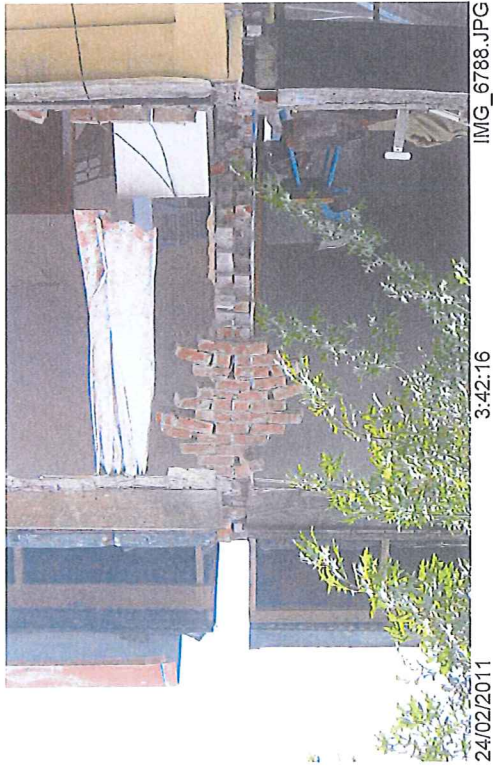
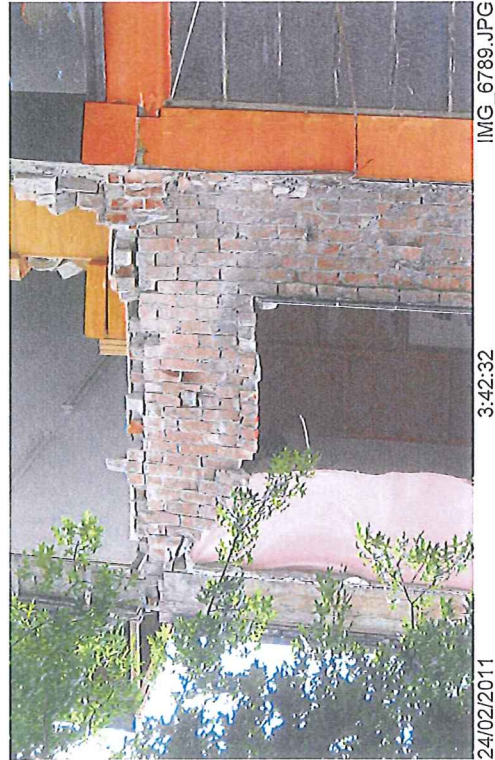
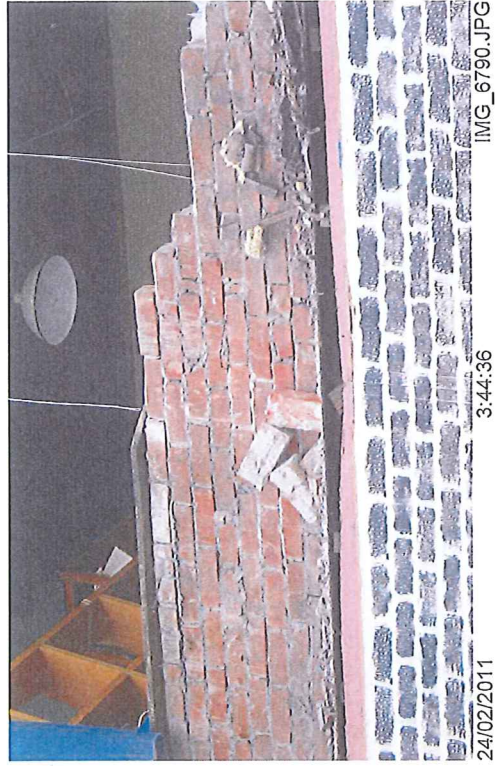
10_595 Colombo Street PHOTOS

Significant portions of the first floor façade (primarily the parapet) of the building failed outwardly in the severe shaking during the 22nd February, 2011 earthquake.

**Photos taken after 22nd February, 2011 earthquake.
- (Note Date on photos assessed 1 year out)**
