**INDEPENDENT ASSESSMENT ON EARTHQUAKE PERFORMANCE
OF**

173 Gloucester Street(255-271 Manchester Street)

**Royal Commission of Inquiry into building failure
caused by the Canterbury Earthquakes**

January 2012

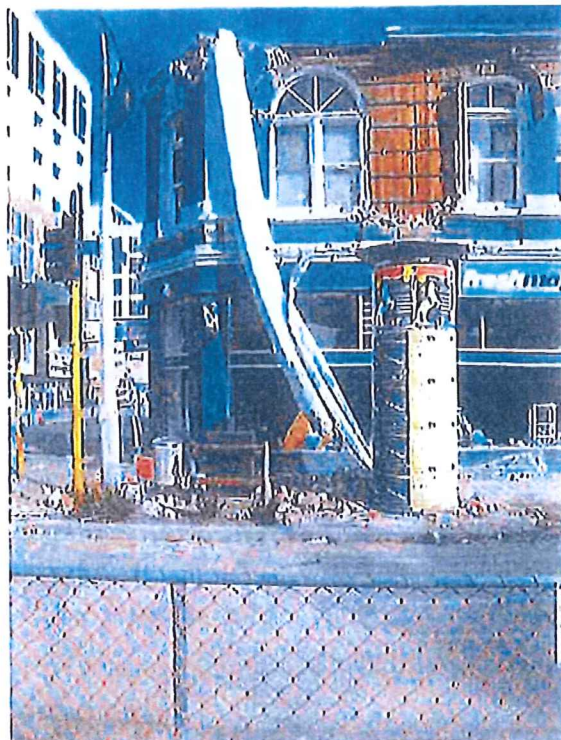
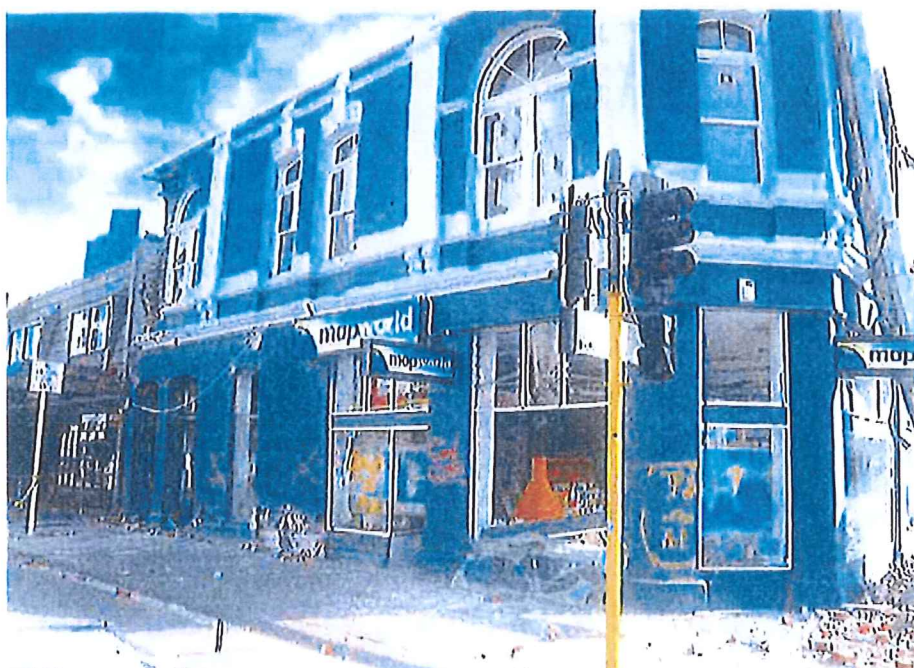
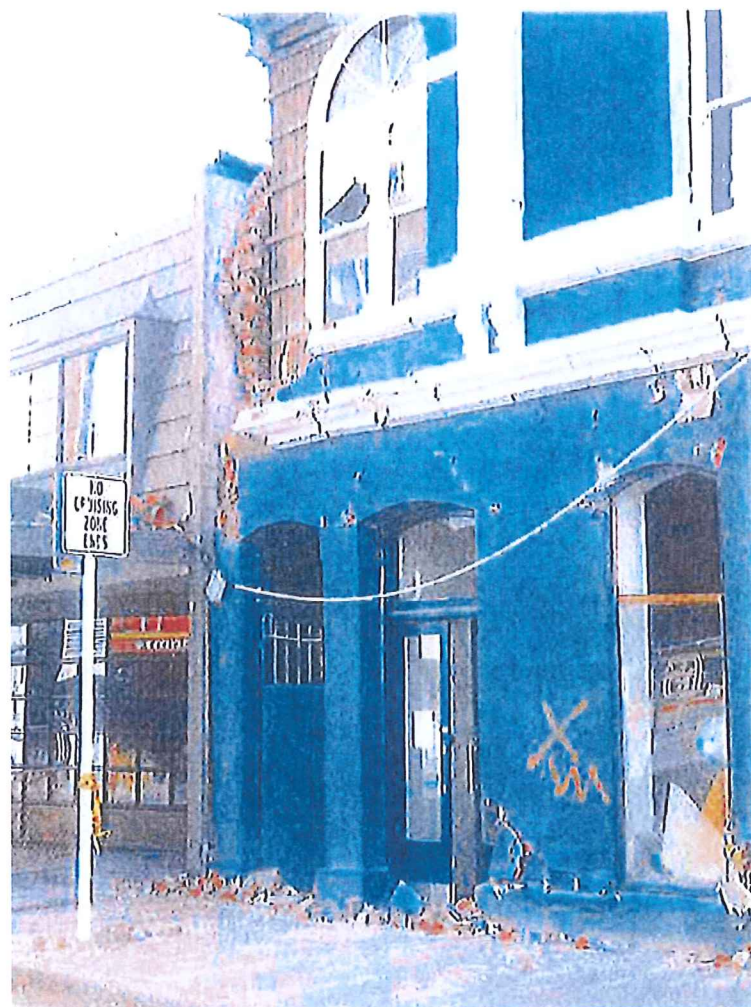
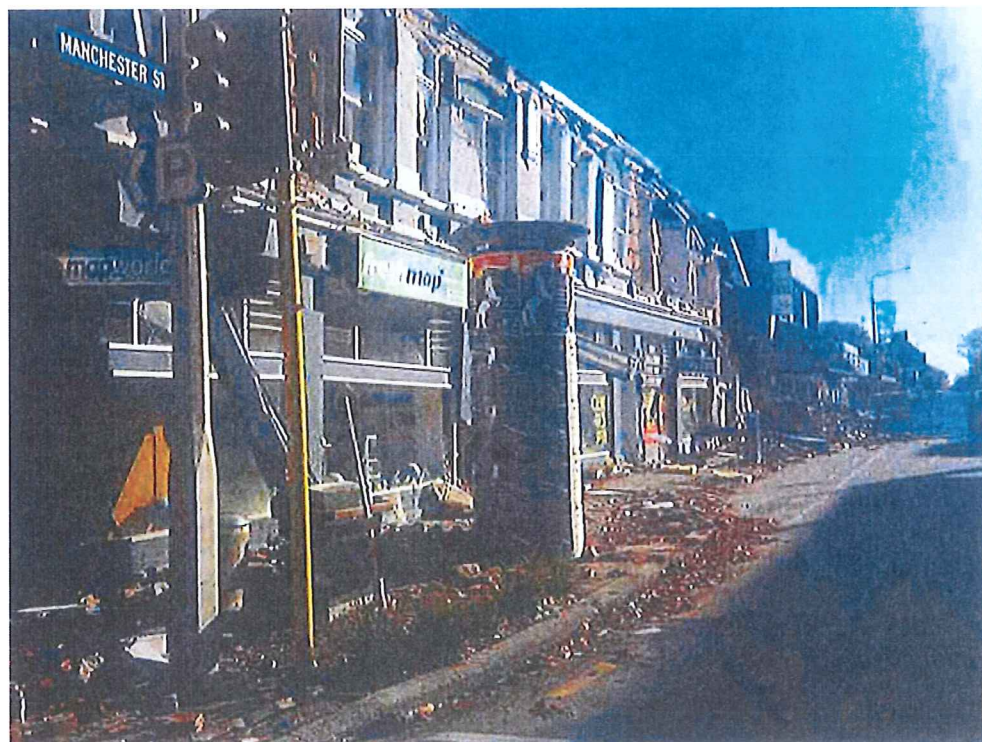
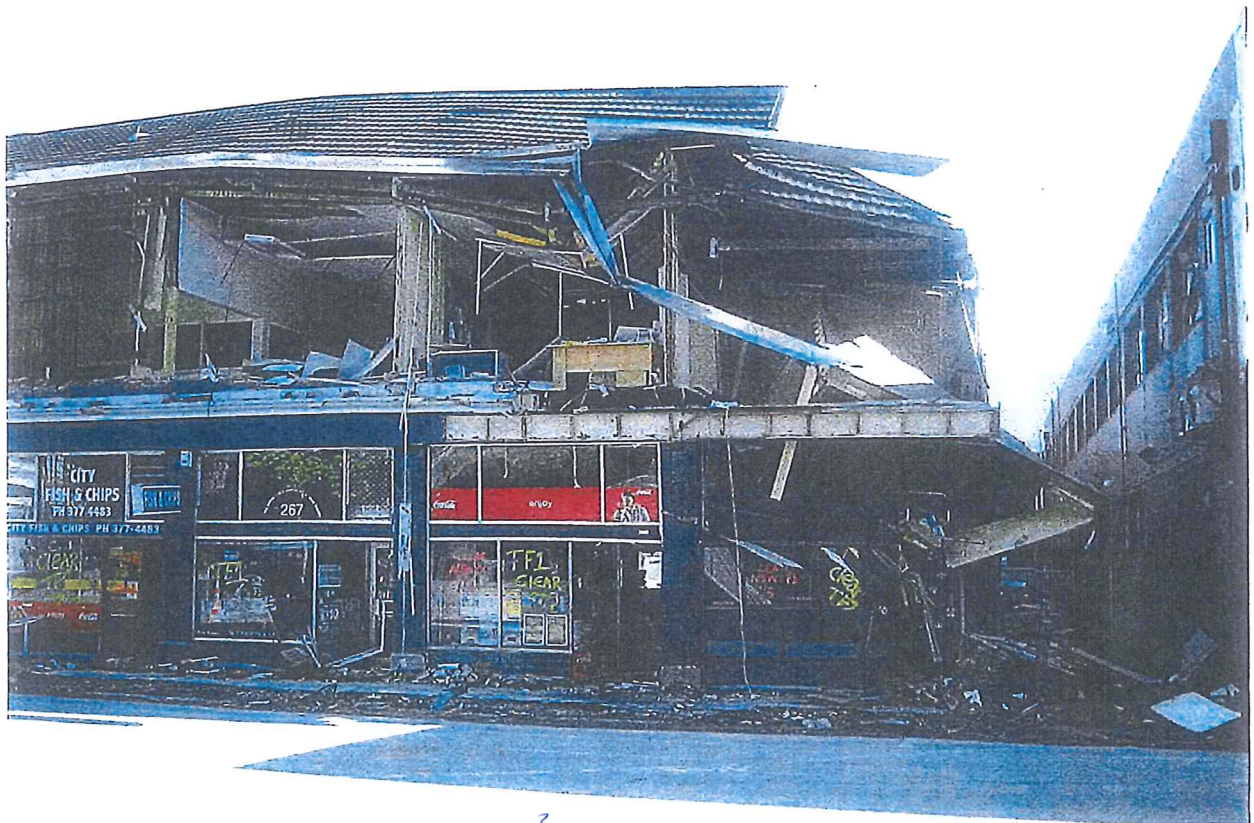
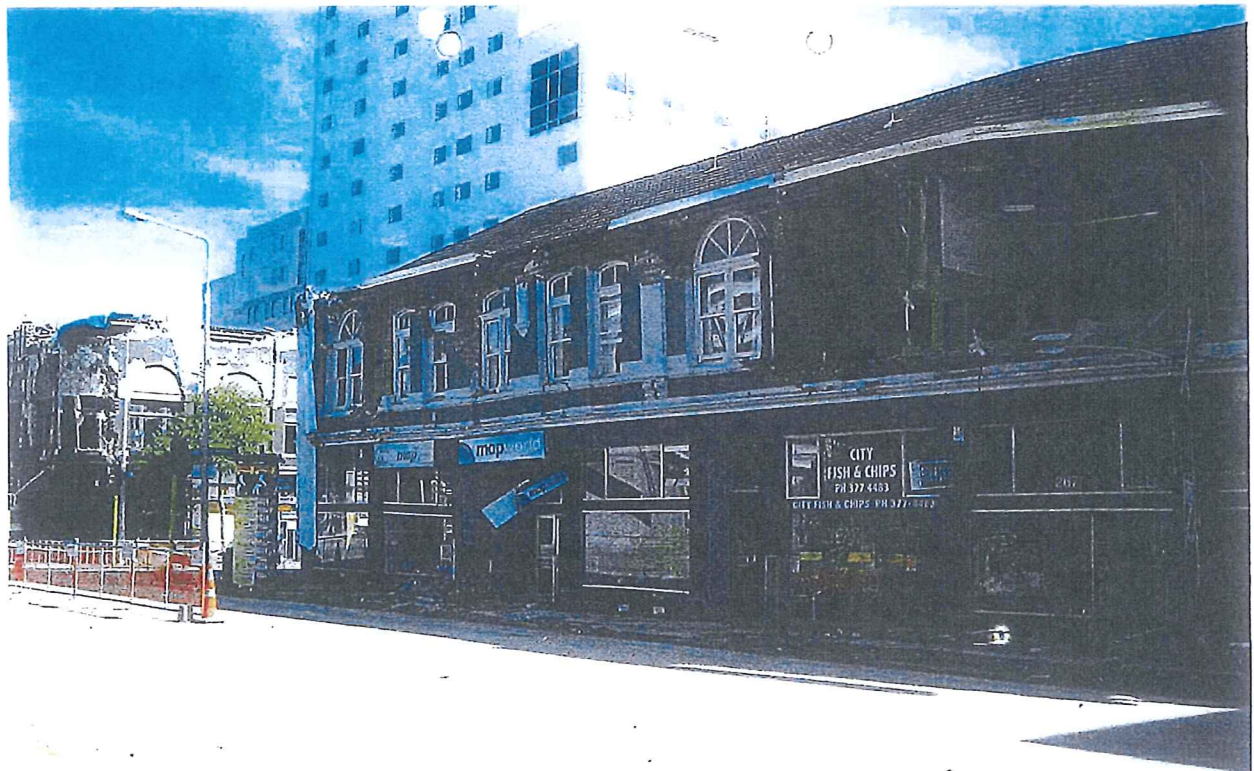
The Rapid Assessment form noted *some cracking to foundations. South wall brick parapet cracking and cracks to façade. Slight movement to internal lining of 10mm to back wall. Ceiling to NE parapet and + cracks to glass.*

A series of photographs were provided with the Rapid Assessment-Level 2 recording the extent and location of cracking.

The Rapid Assessment-Level 2 assigned a green placard and commented *fill cracks in parapet + bricks with epoxy resin once scaffold erected. Refix windows to brick work.*
