**Brief of evidence of Jeffrey Gavin Matthews relating to 242 - 246 High
Street for hearing week commencing 13 February 2011**

Date: 8 February 2012

SITE REPORT

Christchurch Eq RAPID Assessment Form - LEVEL 2

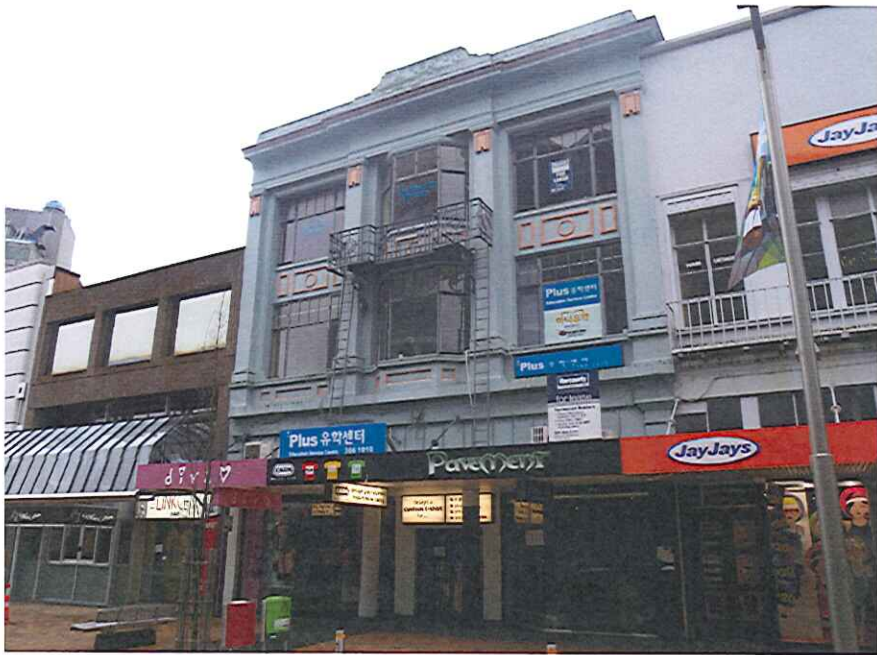
P9105509

On the top of the building there is damage to the parapet/chimneys. One had fallen through a sky light and landed on the floor inside the building. Others are cracked and couple topple given an aftershock.

- parapet on right hand side of the bldg needs to be secured or removed prior to bldg being occupied.
