EXPERT PANEL REPORT

Structural Performance of Christchurch CBD Buildings in the 22 February 2011 Aftershock

February 2012

Report of an Expert Panel
appointed by the New Zealand Department of Building and Housing

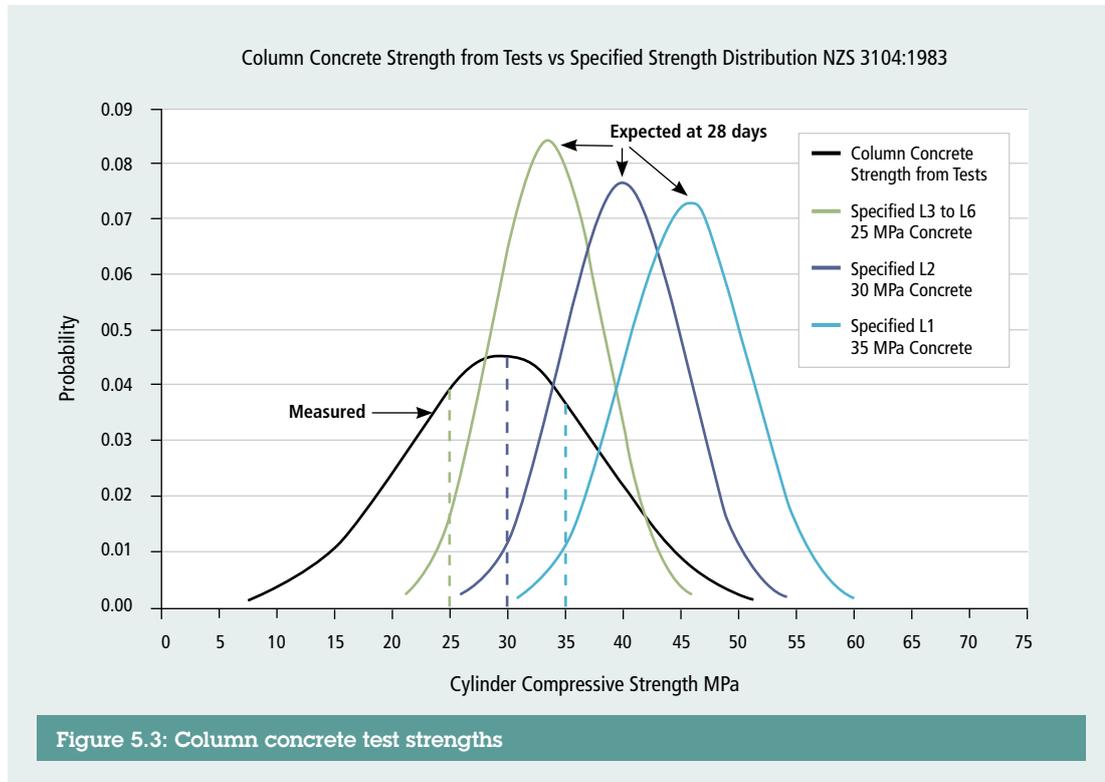
The position in relation to the column samples is summarised in Figure 5.3. The black line indicates the inferred distribution of concrete strengths from the tests. The other three distributions are the expected strength distributions at 28 days from pouring of concrete based on the specified concrete strengths (after 28 days) which were 35 MPa for Level 1 columns, 30 MPa for Level 2, and 25 MPa for Levels 3 to 6. Even though it is not known which of the measurements applies to which expected strength distribution, it can be seen that a higher than expected proportion of the results is below the specified level in all cases.

While it is recognised that the tests were conducted on members that had been involved in the collapse, the results indicate that column concrete strengths were significantly less than the expected strength considering the specified strengths, the conservative approach to achieving specified strengths, and the expected strength gain with age.

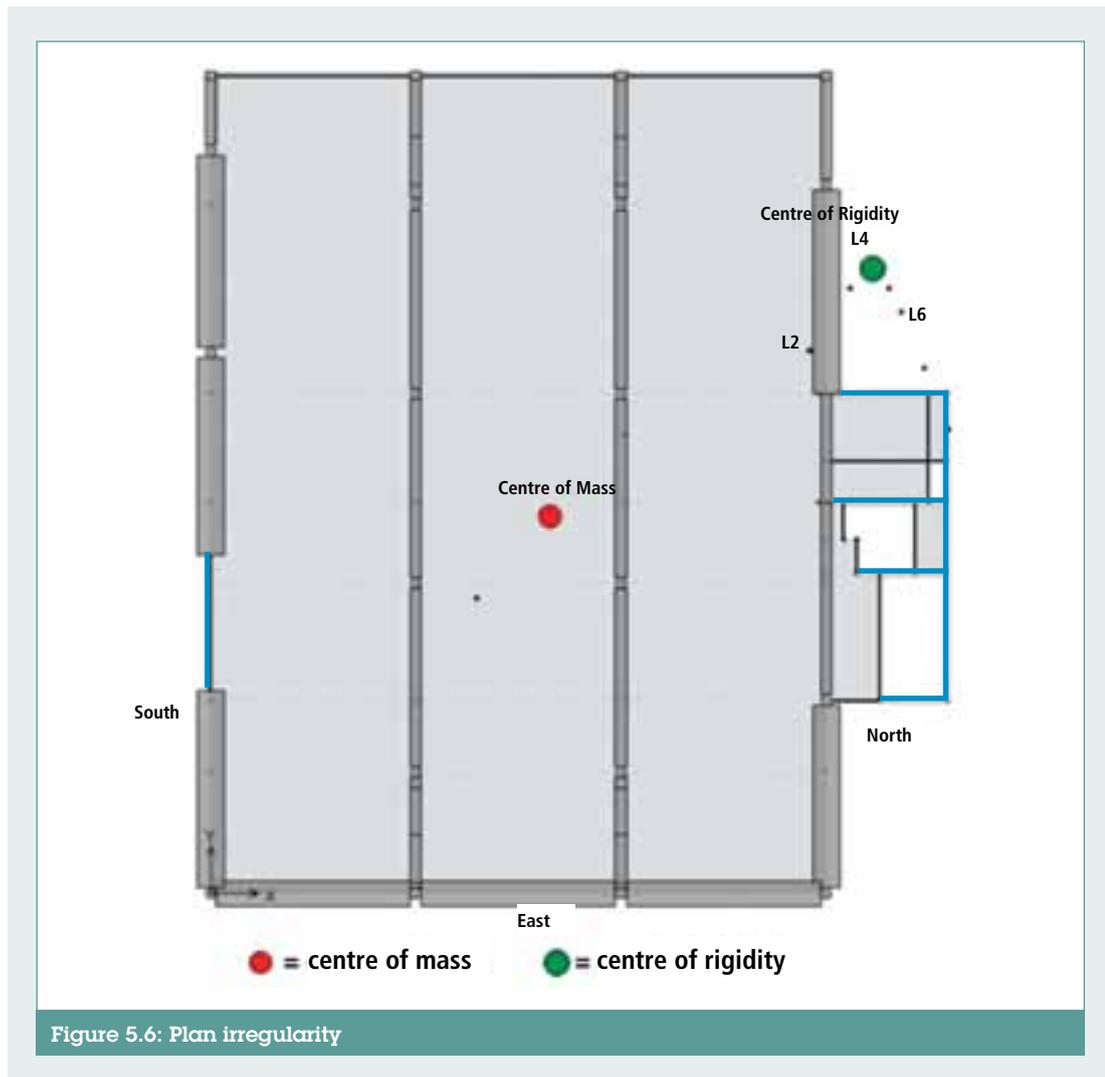
It was considered that the lack of symmetry in plan could cause displacements on the south and east faces to increase as the building rotated in plan. Figure 5.6 illustrates the results of one examination of this effect. The centre of mass indicates where the lateral forces would act. The centre of rigidity indicates where lateral forces, at Level 4, would be resisted. The horizontal distance between these points is a measure of the tendency of the building to twist when subject to horizontal ground motions.

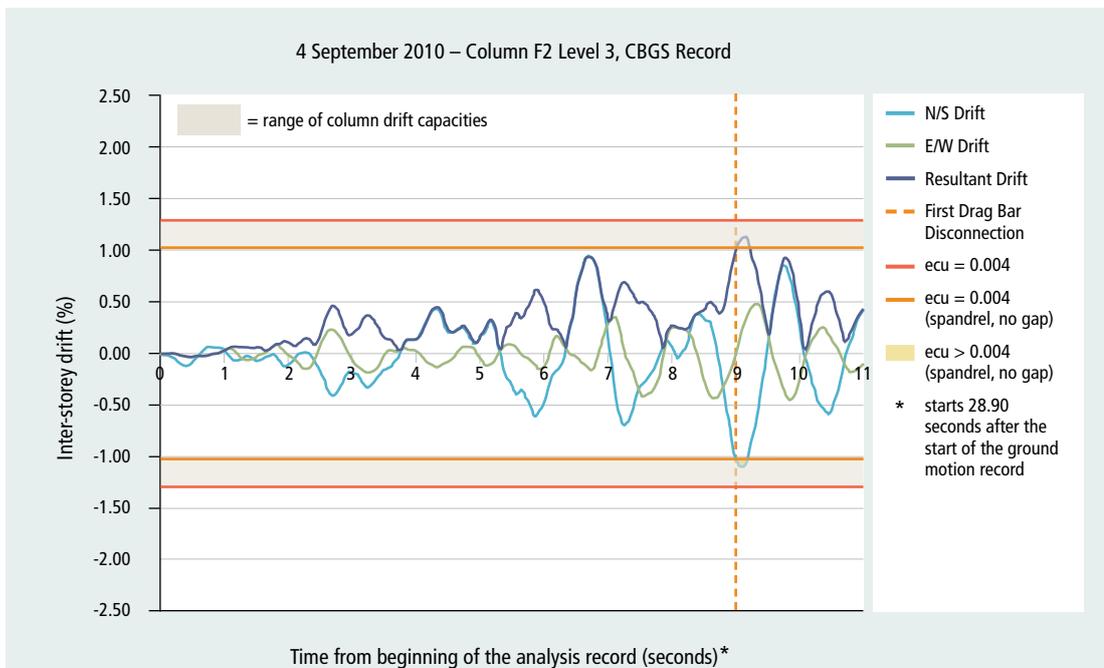
Figure 5.10: Comparison of drift demand and capacity – column F2 Level 3

Figure 5.10 and Figure 5.11 show output from the non-linear time history analyses for column F2. Figure 5.12 shows output from the analyses for column D2. The vertical axis shows the amount of inter-storey displacement (drift) at this column location. The horizontal axis is the time from start of shaking (as input into the analysis). The wavy lines plot the drift level over time and are based on application of the full ground shaking record in the analyses. This drift is a key measure of demand on the column. The light blue line shows the north-south drift which is critical for the grid F columns, taking into account the stiff façade beams and the potential interaction with spandrel panels. The dark blue line indicates the resultant drift of the north-south and east-west drifts.

The horizontal lines represent the estimated capacity of this column to sustain the drift without failing according to various criteria (assuming average concrete strength and without vertical earthquake effects). The band between the horizontal lines in Figures 5.10 and 5.11 reflects the difference between “no interaction with the spandrels” (higher value) and “full interaction with the spandrels”. The areas where the drift has exceeded the estimated capacity are shown shaded dark orange. The band showing the range of capacities would be wider if allowance was made for the effect of variable concrete strength and vertical earthquake forces in the column.

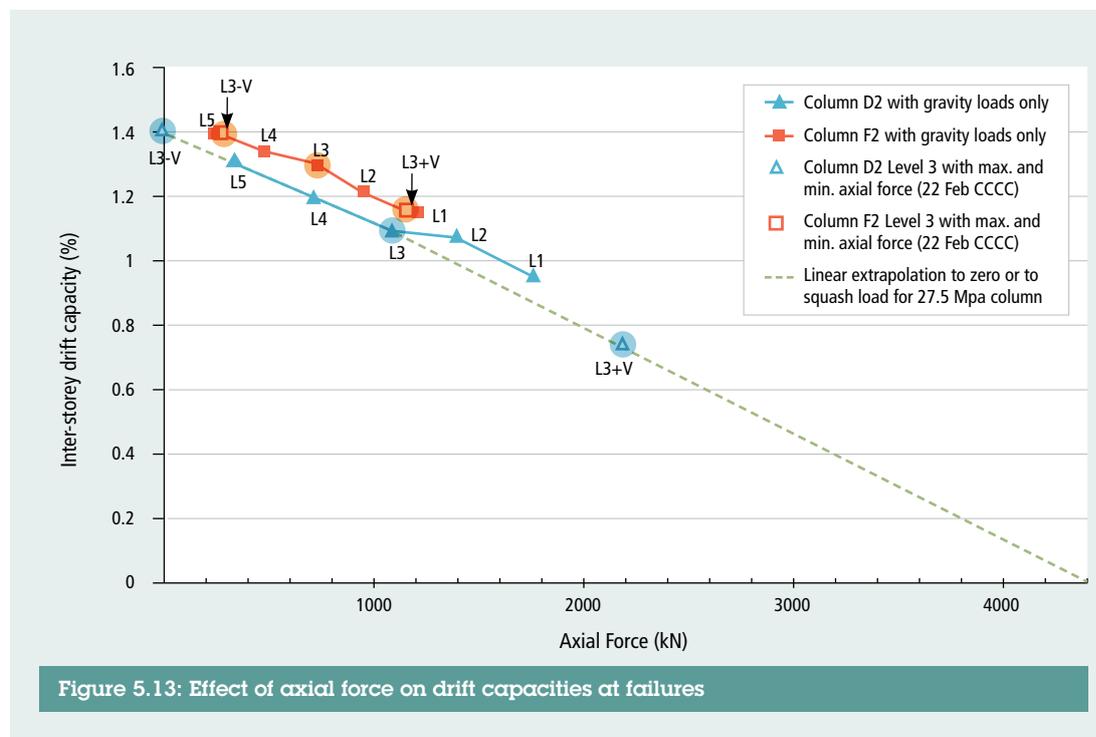
The vertical accelerations measured in the 22 February 2011 aftershock were exceptionally high and may have contributed significantly to vertical forces and columns and walls. The extent of this contribution is generally difficult to quantify, but analyses of the CTV Building indicated that vertical accelerations could have doubled the vertical forces in some critical, heavily loaded columns and this may have reduced the capacity of those columns to sustain lateral displacements by up to 40%, depending on concrete strength. If concrete strength in those critical columns had been less than the values that the analyses were based on, the displacement capacity would have been further reduced.

The highlighted markers on each plot in Figure 5.13 show the situation for two columns at Level 3. The middle highlighted marker shows the axial force and drift capacity without earthquake effects. The highlighted markers to the right and left show the effects of vertical earthquakes, reducing (left mark), or increasing (right mark) the column axial force (compression). It can be seen that in these examples, the effect on drift capacity is significant, ranging up to more than 30%.

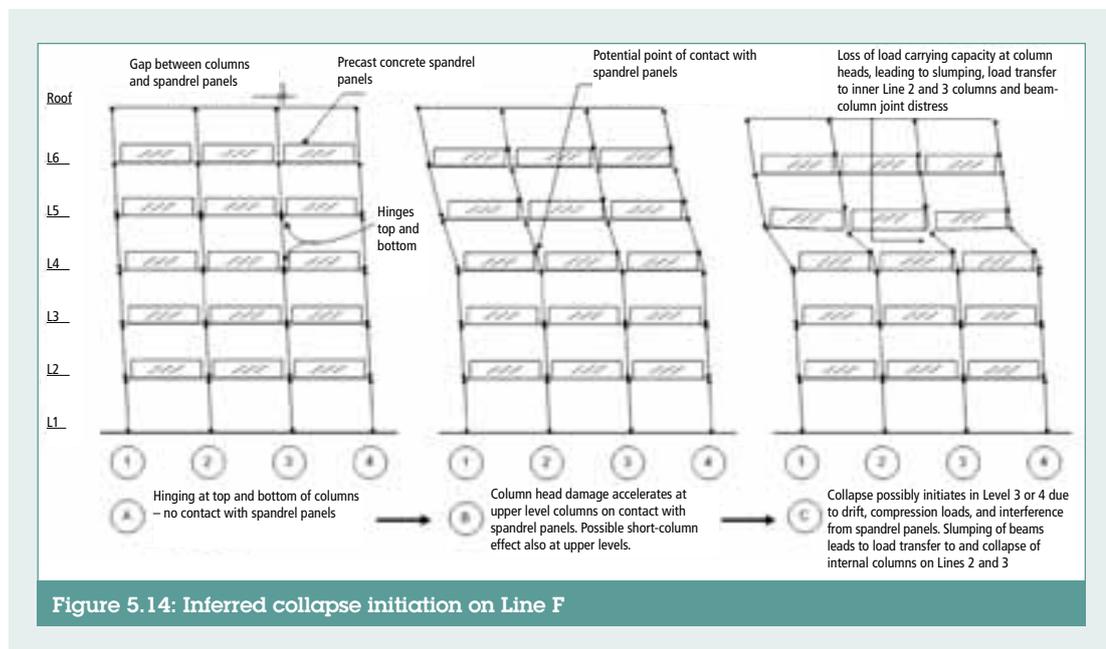
Figure 5.14 shows the situation for this scenario with no spandrel interaction (A) and with spandrel interaction (B and C). Figure 5.16 illustrates the case of failure of ground floor columns on Line D for this scenario and the subsequent collapse of the floor slabs and frames for this inferred collapse sequence. Figure 5.15 shows the case along Line 2 of the scenario involving initiation on Line F.

Concrete strengths that were lower than the average used in the analyses would have reduced the load capacities of critical columns. Vertical accelerations from the ground motions may have added to the demands on columns and reduced their capacities to tolerate lateral displacement. The lack of symmetry of the lateral load-resisting elements is likely to have placed further demands on the critical columns by causing the building to twist and displacements to be larger than expected. Failure of diaphragm connections between floors and the north core walls, if it occurred prior to collapse initiating elsewhere, may have resulted in additional displacement demands on the critical columns.

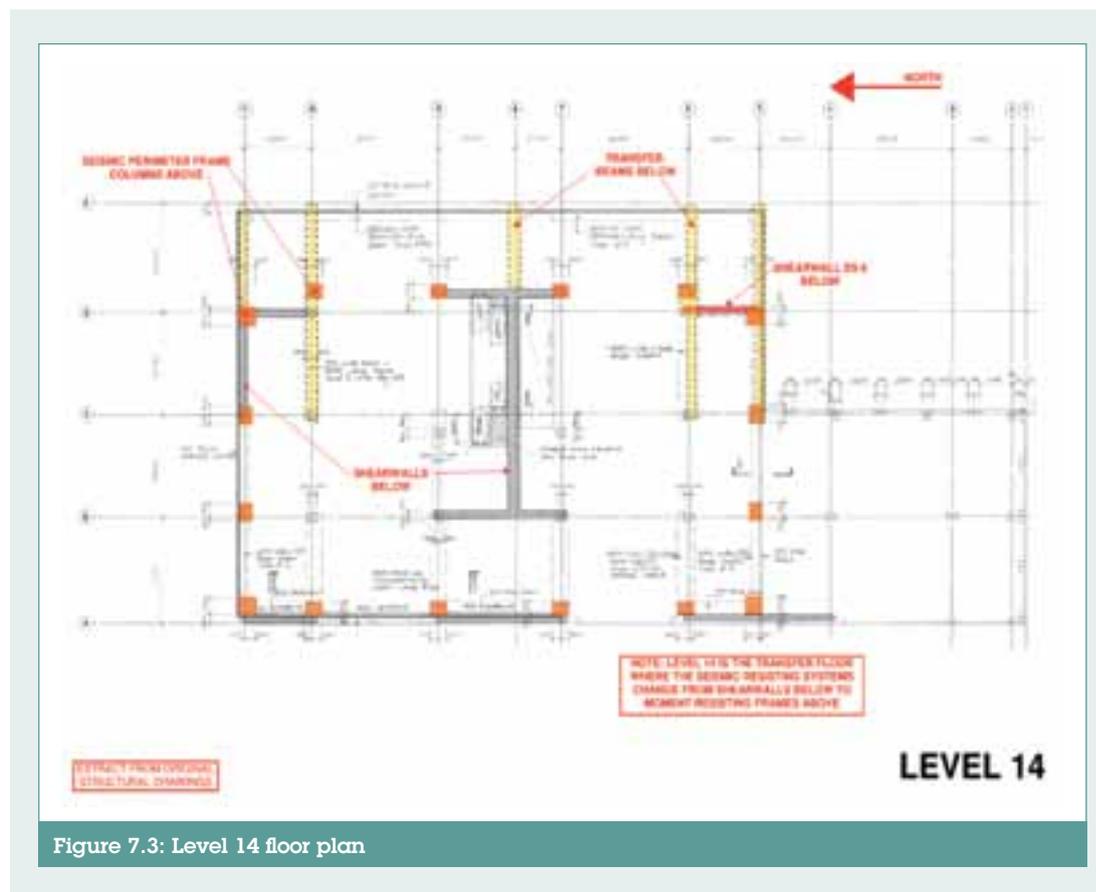
Figure 7.3: Level 14 floor plan

During the approximate 12 seconds of intense shaking that occurred in the 22 February 2011 aftershock, the Hotel Grand Chancellor Building suffered a major structural failure with the brittle rupture of a shear wall (D5-6, refer to Figure 7.3) in the south-east corner of the building. This shear wall provided vertical support for approximately one-eighth of the building's mass and was also expected to carry a portion of lateral earthquake loads. Damage to the base of the shear wall is shown in the photograph in Figure 7.4.

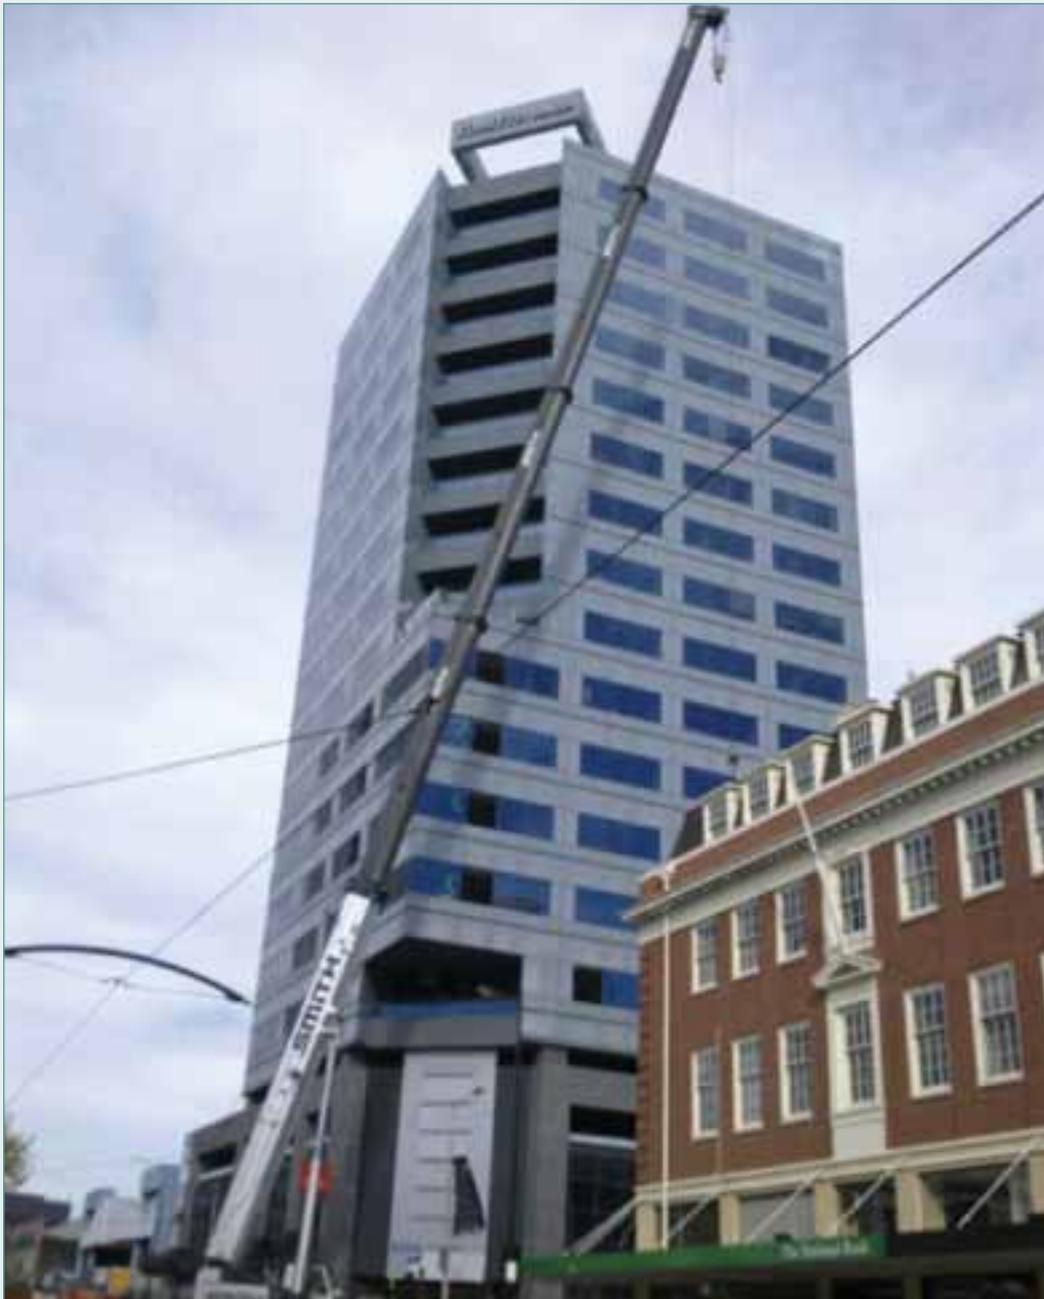
Figure 8.1: The Forsyth Barr Building from Armagh Street (looking south-east)

In the 22 February 2011 aftershock, the Forsyth Barr Building suffered a collapse of the main stairs from the Ground Level to Level 15 (one flight) and from the Ground Level to Level 14 (the other flight). The upper part of a column supporting the south-east corner of the podium roof was also significantly damaged.

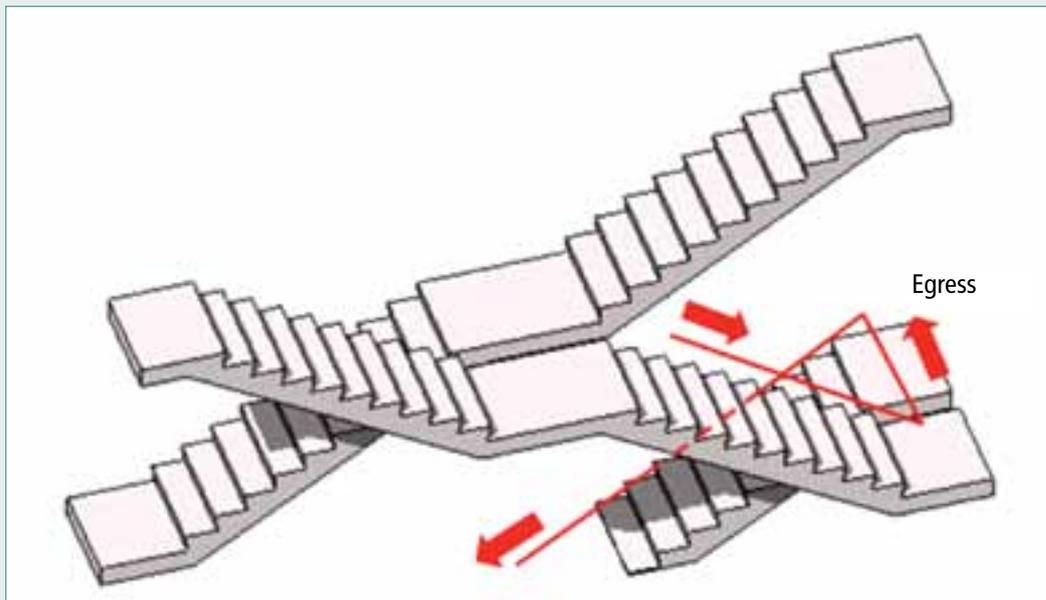
Figure 8.3: 3D view of typical scissor stair system between two adjacent levels

The stairs are orientated diagonally within the tower in a north-east/south-west direction. The majority of the stair flights were pre-cast units cast into the landing at their upper ends, and seated on a steel channel at their lower ends which, in an earthquake, allowed the lower end to slide within limits. This provided a horizontal gap specified at 30mm wide for the closing cycle and 72mm for opening (refer to Figure 8.4).

Evidence was found of modification to the lower end of at least four stair units (two units inspected after removal and two still in place) that may indicate the prescribed seismic gap at that end was not achieved in all cases during construction.
