# Investigation into the collapse of the stairs in the Forsyth Barr building

Mr Rob Jury and Dr Richard Sharpe

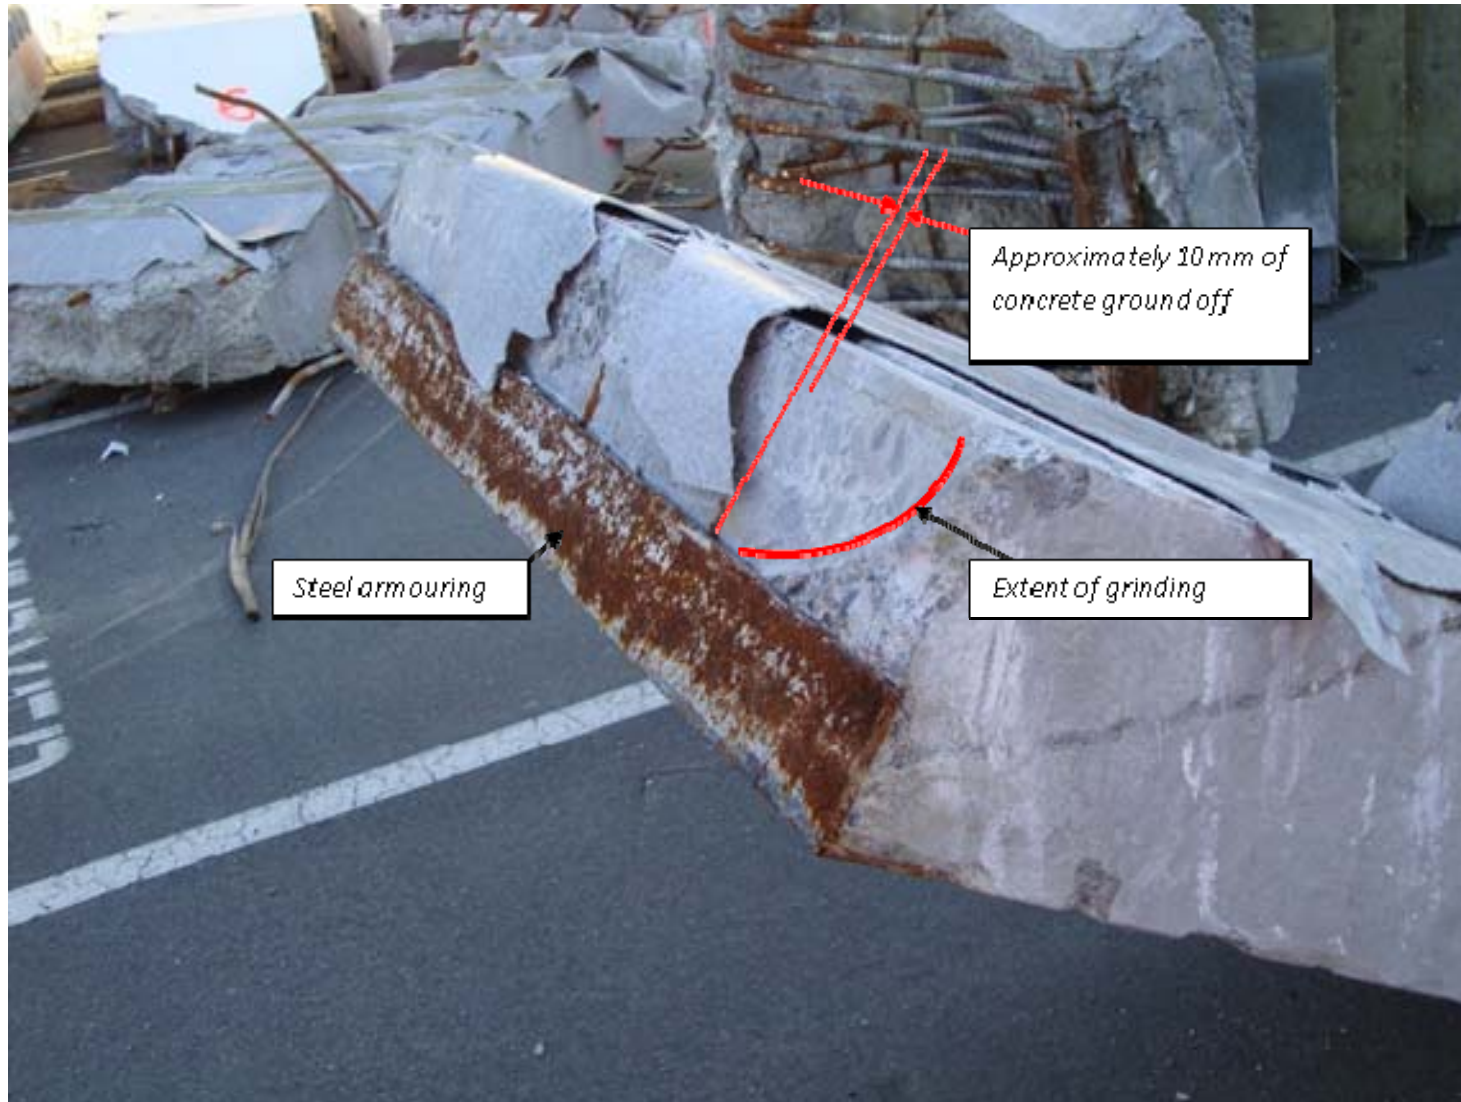
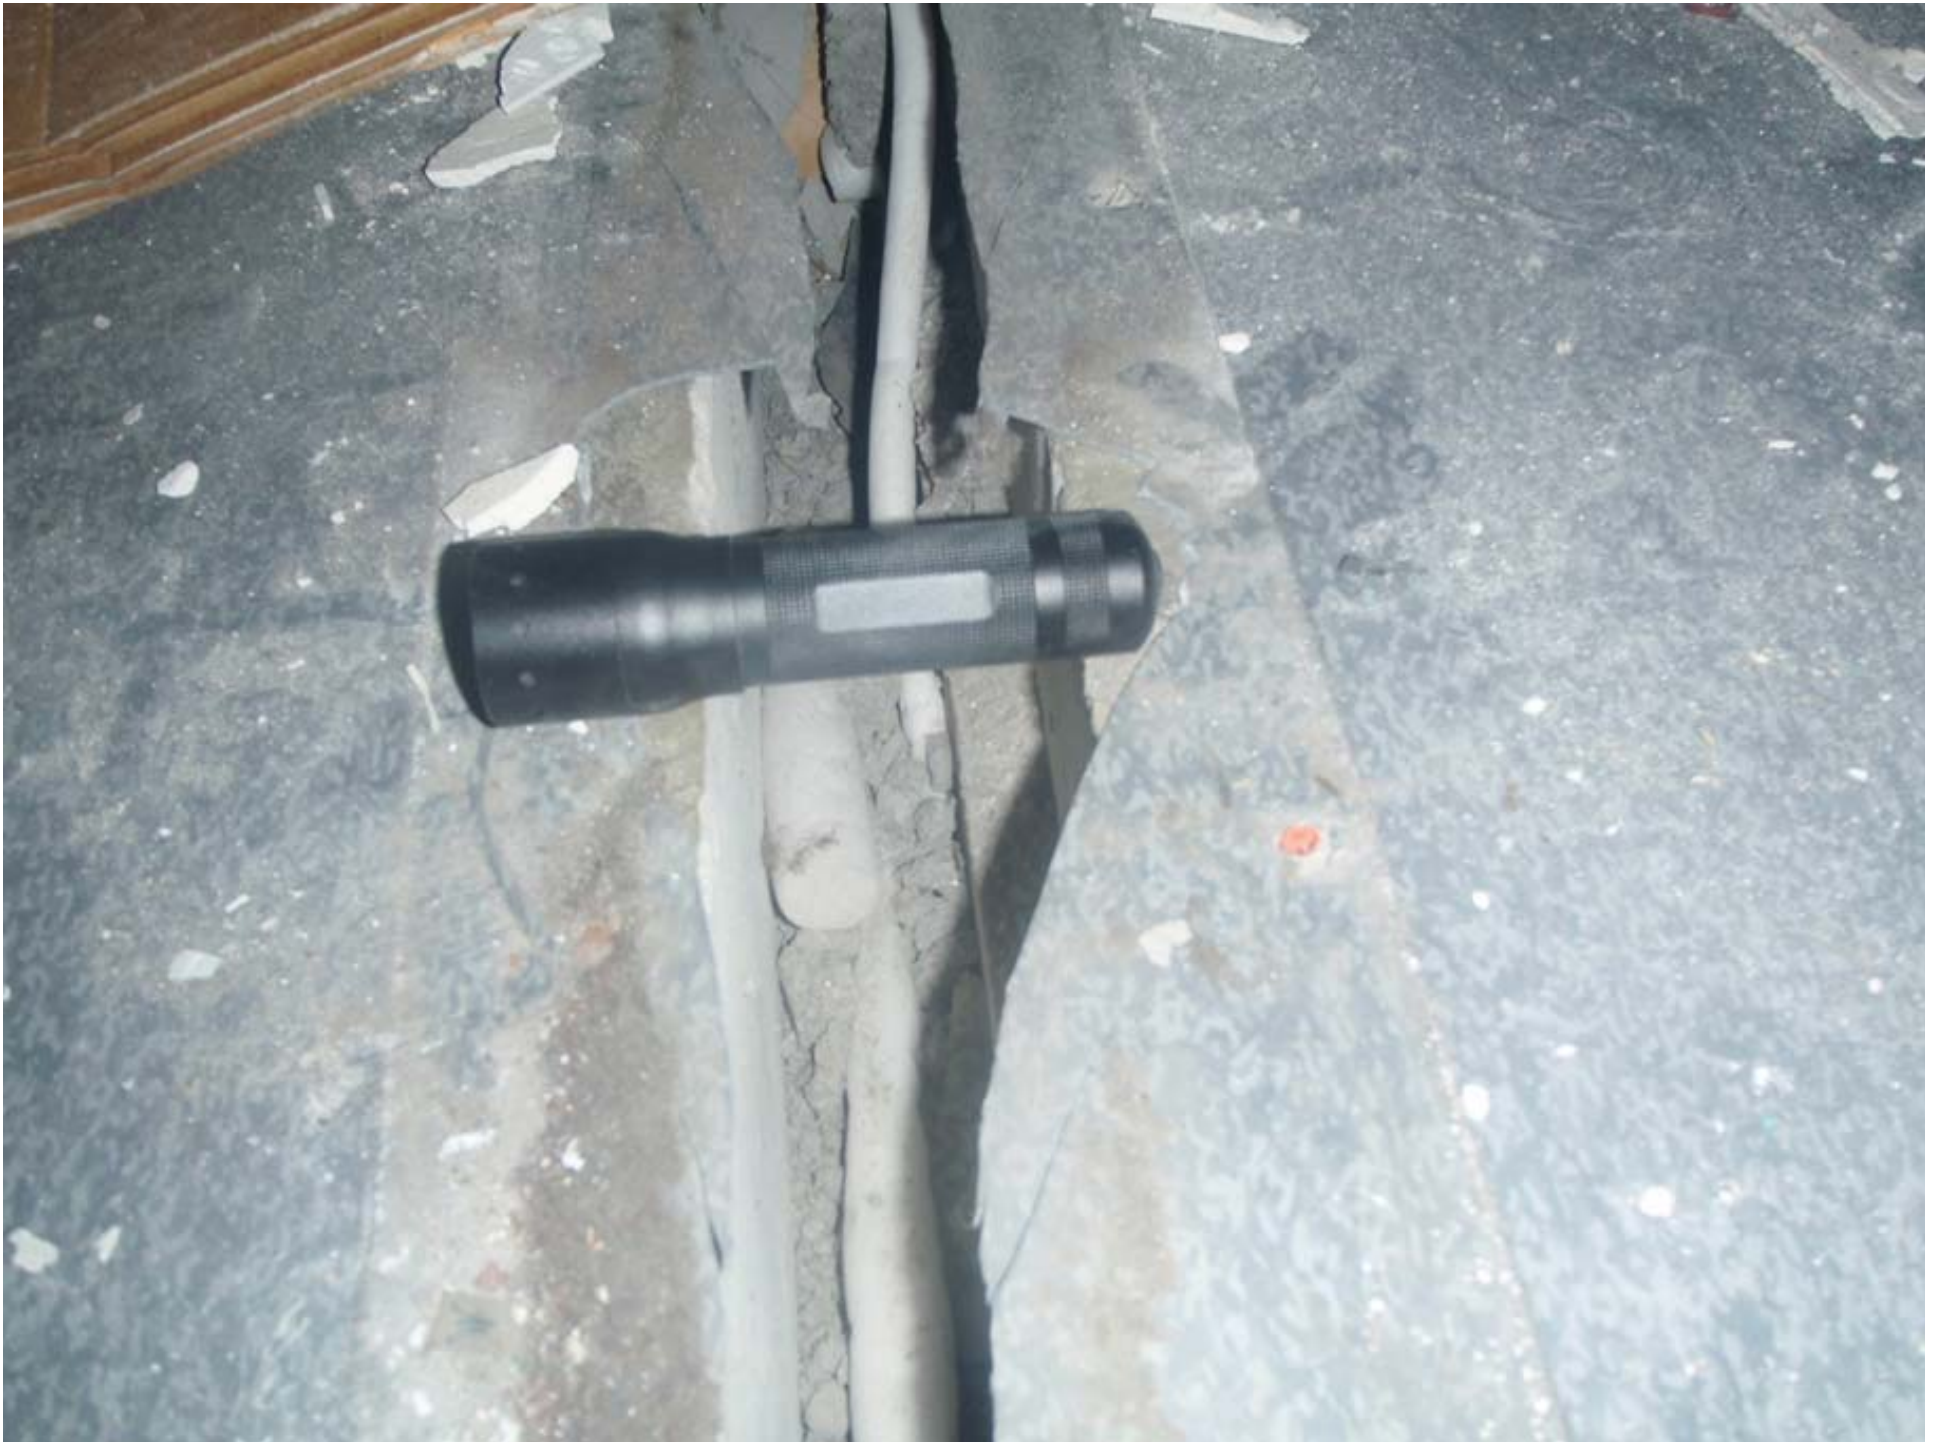
# Design & Construction Issues

- The building appears to have been designed in accordance with the standards of the time (1988).
- The construction of the stairs appears to have been in general accordance with the design, but with some exceptions.
