Seismic Performance Investigation
Draft Report

Clarendon Tower
78 Worcester Street
Christchurch, New Zealand

Clarendon Tower

February 2012

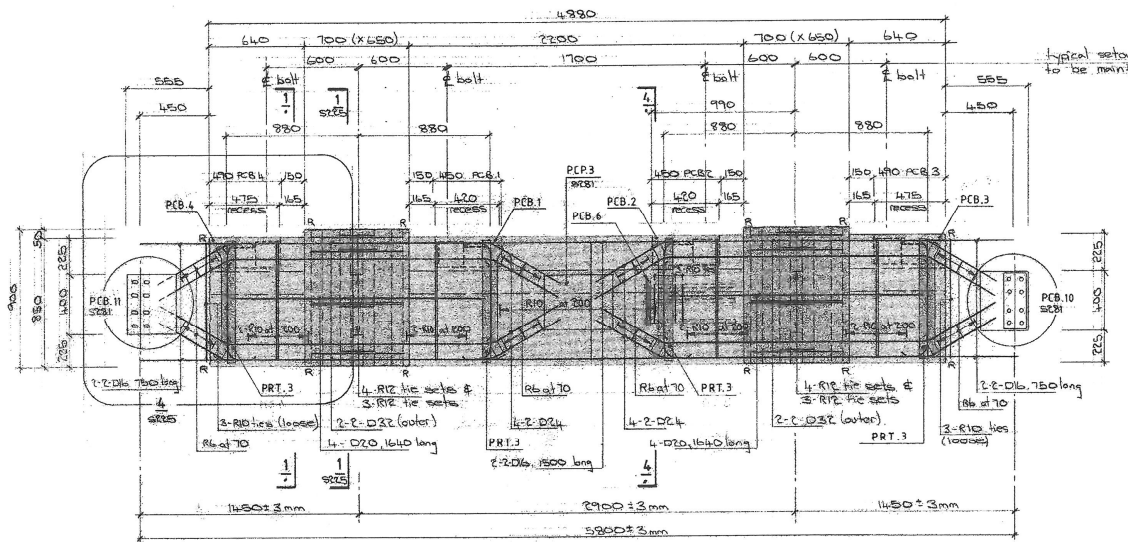
Figure 4: North and South Frame Shear Link Connection Detail

Instead of allowing hinging to occur at the ends of beams on the north and south frames, as for typical moment frames, the midspan was detailed to yield similar to a coupling beam of a coupled shear wall as shown in Figure 4. A University of Canterbury test conducted after the structure was built showed an inherent flaw in the connection design that produced non-ductile behavior outside of the designed hinge zone [45]. The load-displacement relationship and image of the connection at the end of testing is shown in Figure 5.

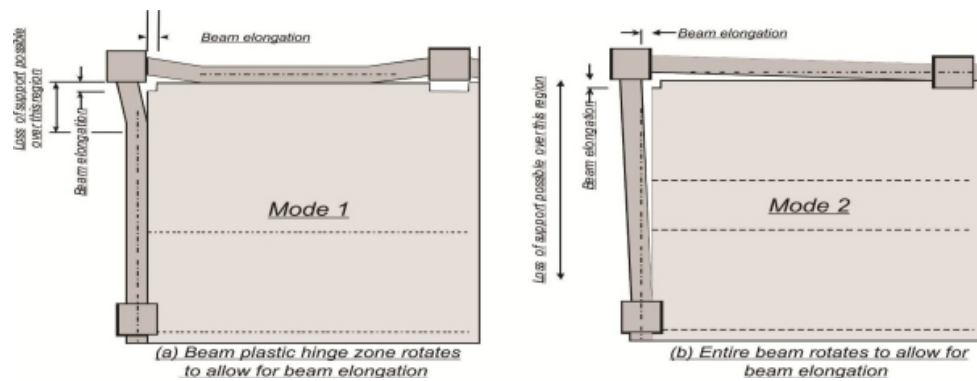
Figure 7: Frame Elongation Modes [31]

Investigation after the Darfield earthquake noted flexural cracking within the span and vertical cracking at the column faces of the south frame beams which are assumed also to occur at the north frame [2]. These cracks were in the process of being epoxy injected, which may have been completed, when the Lyttelton event occurred. Immediately after the Lyttelton event, 2mm shear cracks were observed in the north and south frame beams and it was noted that the connection did not appear to have activated properly [26]. Later 10-15mm diagonal shear cracks were discovered appearing around levels seven and eight in addition to a vertical offset, referred to as vertical stepping, at the beam midspan connection as shown in Figure 6 [28, 29]. Frame elongation was noted as more severe for the north frame, somewhere between 20 and 50mm, although it was documented for the south frame as well [28, 34]. See Figure 7.

Diaphragm cracking is thought to be caused by elongation of the exterior frames as sketched in Figures 7 and 8 [31]. Since these diaphragm cracks indicate reduced seating for the flange hung double-Ts, steel ties were installed across the building to restrain the floor against further expansion. Partial floor collapse was thought to be the most likely collapse scenario for this structure [27]. A sketch of the implemented scheme is provided on the left of Figure 14. There was also concern that the nearly full-

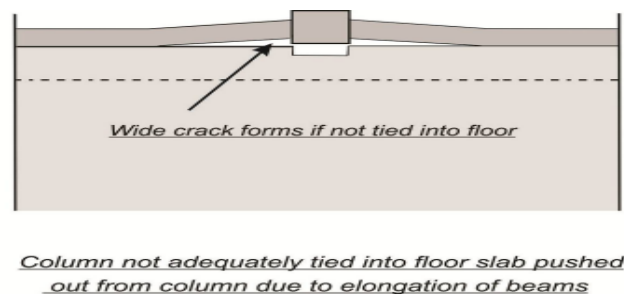
Figure 8: Outward Column Movement Mode [31]

Flexural cracks in addition to a vertical crack between the precast beam and the cast-in-place column were observed on the west frame after the Darfield event [2]. These types of cracks in beams were subsequently repaired through penetration injection [13]. After the Lyttelton earthquake, new 2mm flexural cracks at the column face were observed and extensive rebar yielding was assumed to have occurred [26, 32]. Frame elongation is thought to have caused movement of the north and south frame approximately 100mm farther apart at levels five to nine in addition to resulting in bulging at levels five to eleven as shown on the left and right of Figure 9, respectively [31, 34]. The bulging that appears in Figure 9 is said to result from an outward movement of the east and west frame columns as sketched in Figure 8. The yielding of the rebar has also brought up the issue of low cycle fatigue and it is unclear, without further analysis, how much remaining capacity exists in the east and west frame beams after undergoing repeated earthquake excitation [31].

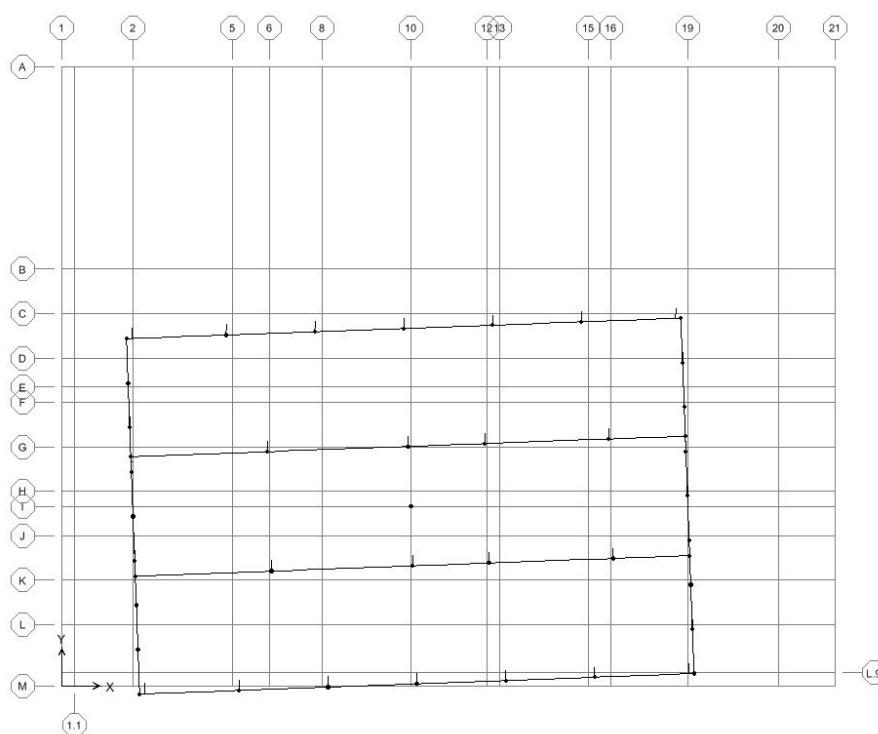
Figure 19: Coupling of Translation and Torsional Response

The first several modes for the longitudinal, transverse and torsional directions are shown in Table 1. Longitudinal signifies movement in the North-South direction. The transverse mode shape is not purely translation but instead includes some amount of torsion that eventually explains the north frame experiencing greater interstory drift ratios. See Figure 19. Approximately 65% and 10% of the mass participates in the first and second modes, respectively, for the longitudinal and transverse directions with very little mass participation in the torsional mode. The three columns of periods correspond to the beam stiffness parametric study discussed later in this report.

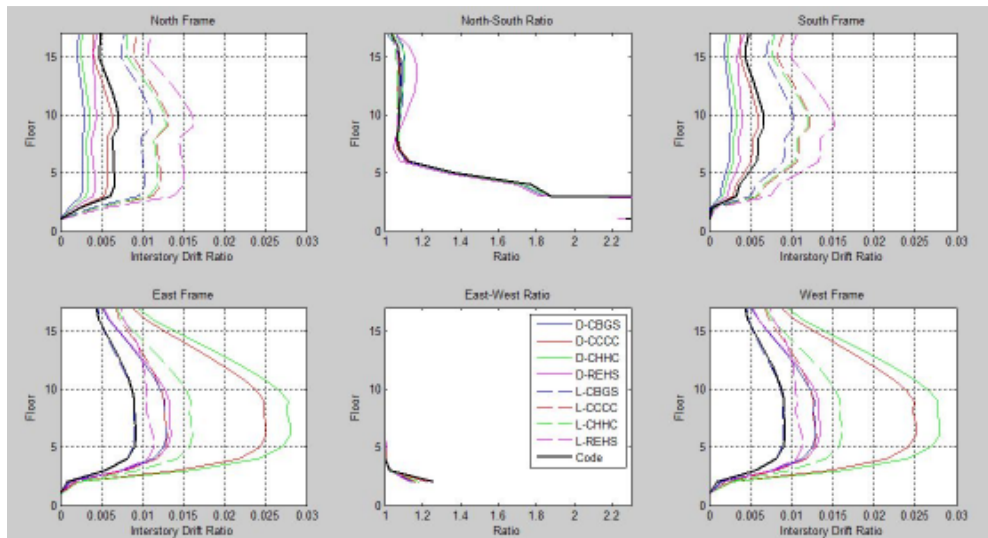
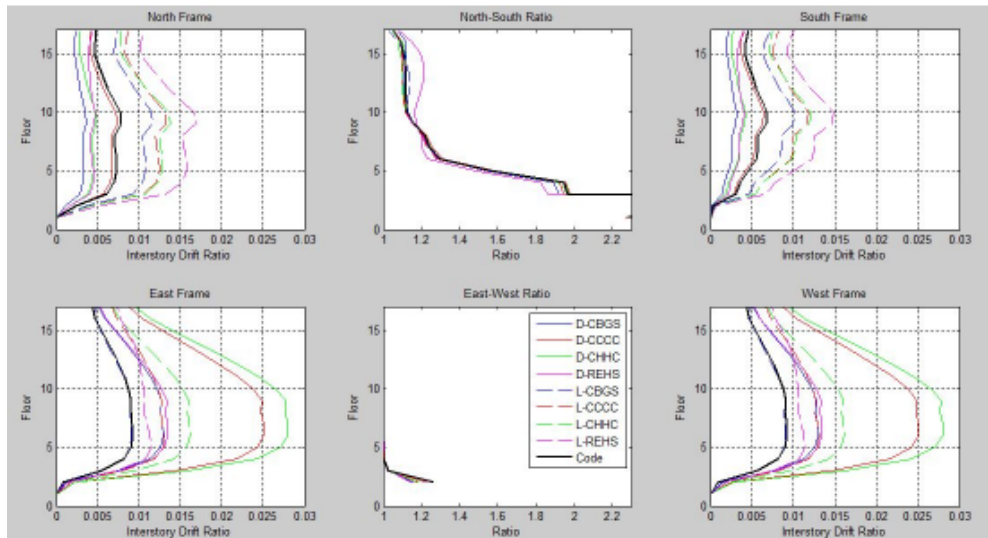
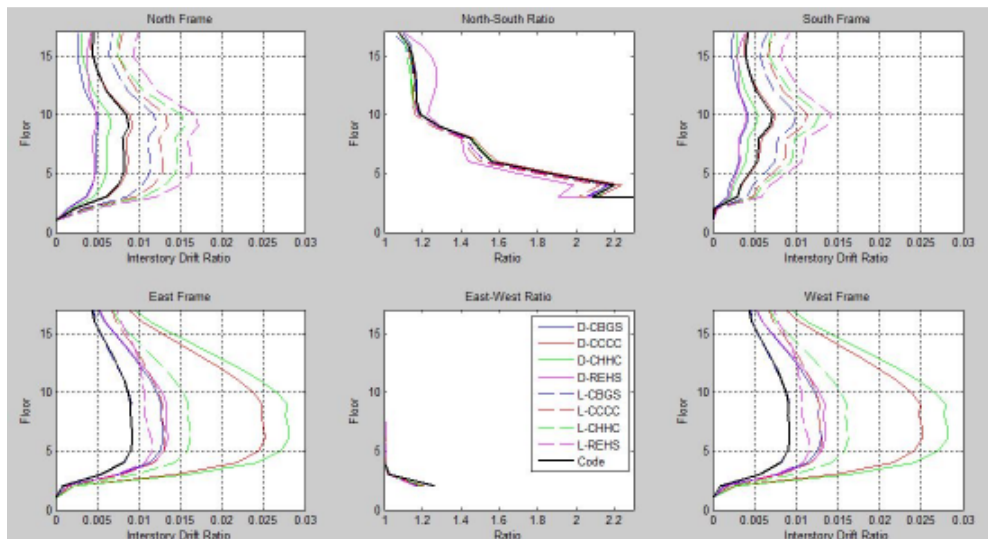
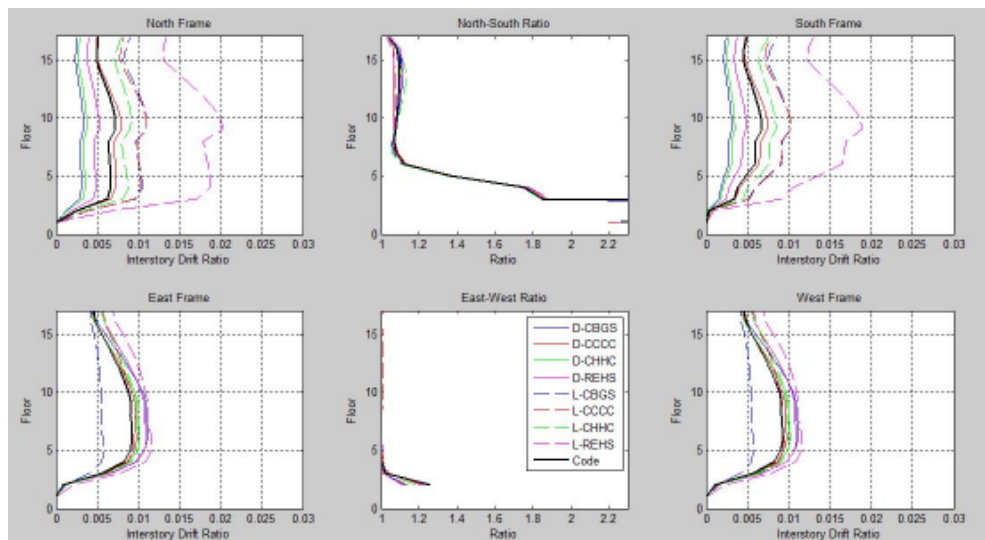
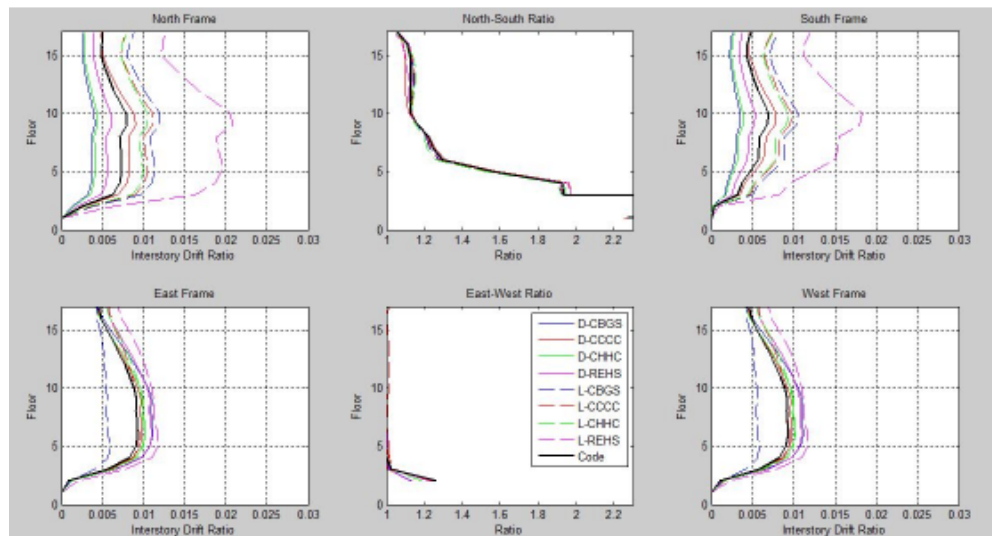
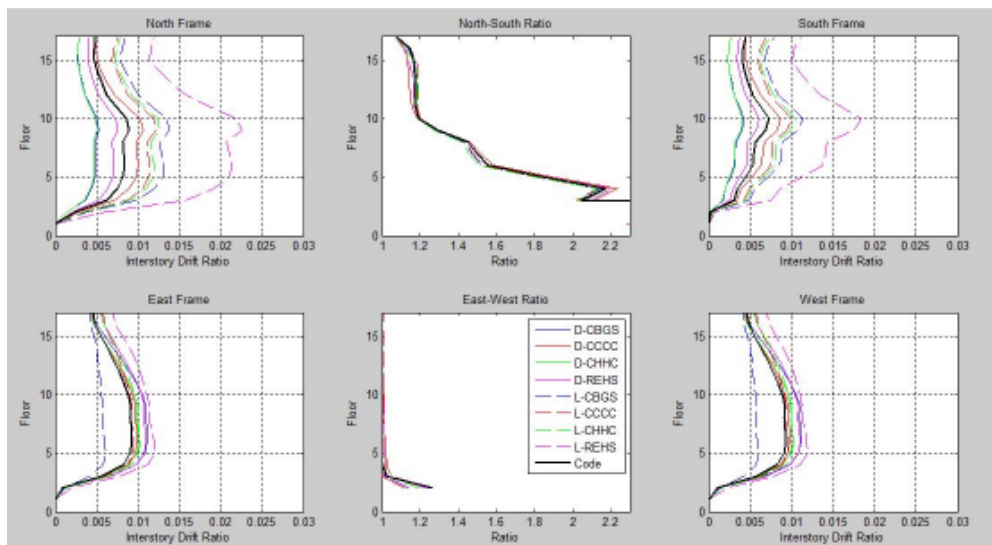
Using the response spectra in linear response spectrum analysis produces predictions of maximum interstory drift ratios for each of the four frames for eighteen different cases (2 earthquakes x 4 recording stations x 2 ductilities + 2 code spectra). It is observed that the north frame drift ratios exceed those of the south by approximately 5-10%, as can be seen in the following figures, and that they are more uniform over the central stories whereas those of the south tend to concentrate at stories nine and ten. The east and west frames have nearly identical interstory drift ratios except at the lowest several floors. This information, combined with the damage assessments described in earlier sections of this report, motivated a further parametric study where the stiffness of beams at levels four through ten and nine through ten on the north and south frames, respectively, was reduced. Two levels of stiffness reduction are considered. The first reduces the frame beams' shear areas and effective cracked second moment of areas to 80% of their original values. The second reduces them to 60%. In the end, this produced fifty four different combinations (18 cases x 3 stiffness ratios) that are plotted in Figures 24 through 29.
