Earthquake strengthening targets

Building condition

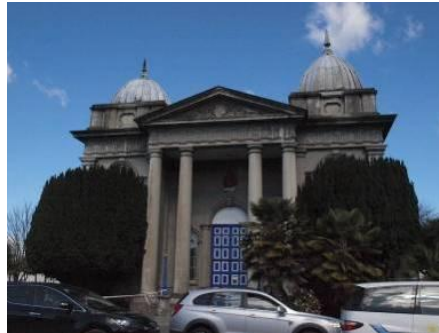
St Paul's-Trinity-Pacific Church

EQP assessment prior to September 2010 (CCC, 2009): Potentially Earthquake Prone
Condition prior to September 2010: Poor with fire damage (but repairs and conservation work under action)

Level of Damage: September-December 2010: Moderate-severe damage.

January-June 2011: Major damage (dome, roof and wall collapse).

NZHPT post-earthquake response: The NZHPT did not oppose the demolition of the building following the 22 February 2011 earthquake due to severity of damage.

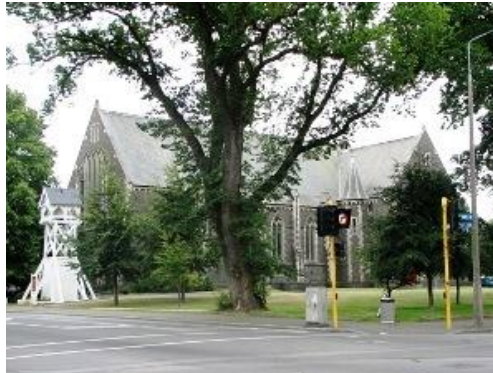
Church of St Luke the Evangelist

Powell Fenwick Consultants Ltd prepared a seismic assessment report in January 2003. The consultant's considered that the church had a 'resistance of about 25% of the current loading code's elastic response. But it would still suffer significant damage in a major earthquake. The risk to life would be mitigated because of the short time that the church is occupied. It would be a major undertaking and cost to strengthen this building to resist a major earthquake.'⁴⁵ The consultant recommended:

Level of Damage: September-December 2010: Moderate damage.

January-June 2011: Major damage (partial collapse, cracking and liquefaction).

NZHPT post-earthquake response: On 5 May 2011, the NZHPT did not oppose demolition following an assessment by the NZHPT's engineer and due to severity of damage.

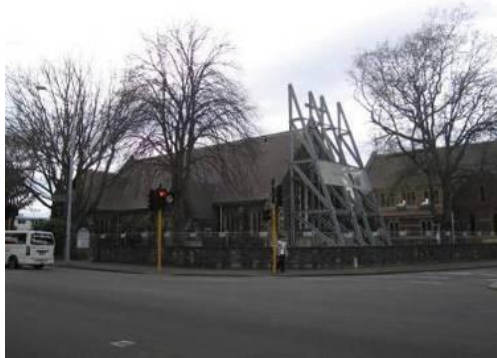
Church of St John the Baptist

Level of Damage: September-December 2010: Moderate-severe damage.

January-June 2011: Major damage (collapse of bell tower, partial wall collapse, cracking).

NZHPT post-earthquake response: Following September-December 2010 earthquakes, the NZHPT recommended the site be made safe to allow time for a comprehensive engineering review to be undertaken and future options for the building to be considered. Later in April 2011, the NZHPT did not oppose demolition on engineering advice.

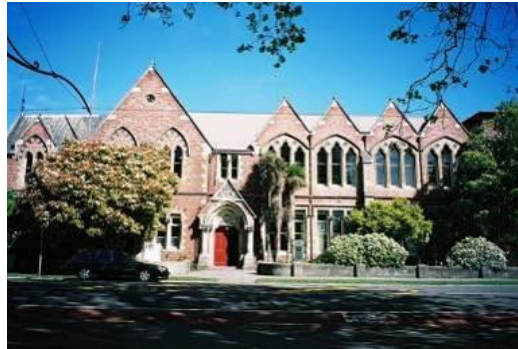
Cranmer Centre (Former Christchurch Girls' High School)

The building was damaged in the September 2010 earthquake. Repairs and strengthening were proposed in November 2010 to improve structural performance to 67%NBS. Severe damage occurred following the February 2011 earthquake while earthquake strengthening work was underway.

Level of Damage: September-December 2010: Moderate damage.

January-June 2011: Severe damage (partial collapse, major cracking).

NZHPT post-earthquake response: In April 2011, the NZHPT did not oppose demolition of the building after an assessment by NZHPT's engineer due to severity of damage. Architectural and historical features retrieved.

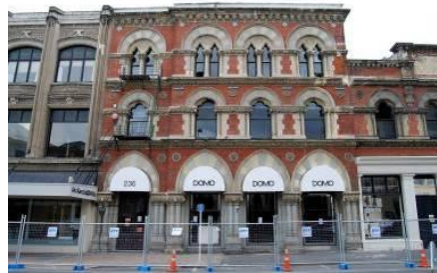
A. J. White's Department Store, McKenzie and Willis Ltd (Former)

The building was damaged in September 2010, but was considered to be repairable (staff were still operating within the building after the September 2010 earthquake). Severe damage occurred following February 2011 earthquakes.

Level of Damage: September-December 2010: Moderate damage.

January-June 2011: Major damage (partial collapse).

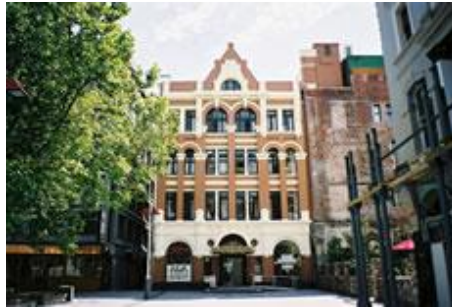
Lyttelton Times Building

Level of Damage: September-December 2010: Moderate damage involved loss of parapet and chimneys. Following the September 2010 earthquake, repair work was undertaken and the backpacker accommodation reopened in October 2010.

January-June 2011: Severe damage (parapet collapse and cracking).

NZHPT post-earthquake response: While initial NZHPT comment promoted repair and making safe, by June 2011, damage had become severe and the NZHPT did not oppose demolition.

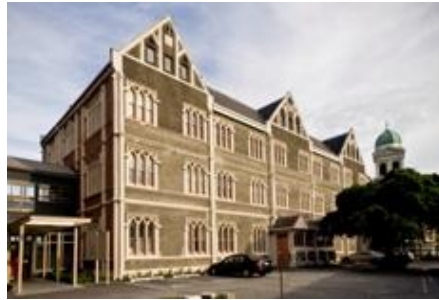
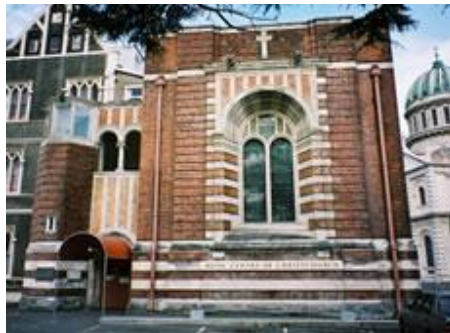
Level of Damage: September-December 2010: Moderate damage.

January-June 2011: Severe damage (collapse of gables and parapets with major cracking).

July 2011-January 2012: Severe damage (further partial collapse).

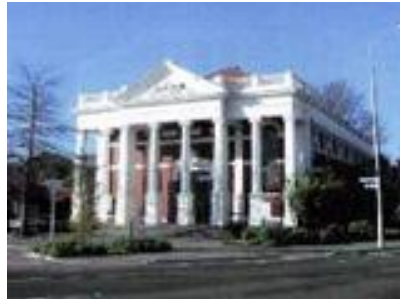
Oxford Terrace Baptist Church

Level of Damage: September-December 2010: Moderate damage.

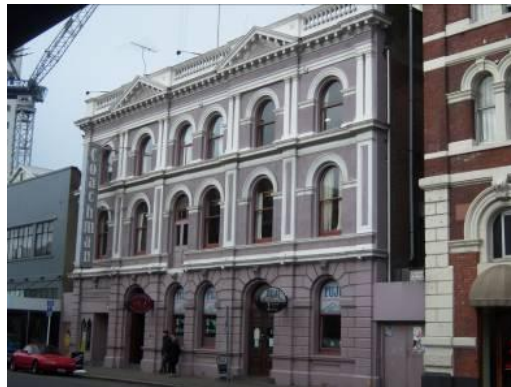
Coachman Inn

The building experienced damaged parapets in the September-December 2010 earthquakes and repairs were being planned. Further damage followed the February 2011 earthquake and the building was demolished in July 2011.

Level of Damage: September-December 2010: Moderate damage (parapet damage).

January-June 2011: Moderate damage (rear wall partial collapse, damage to parapets, cracking).

NZHPT post-earthquake response: In June 2011, the NZHPT recommended that the building be secured and a strengthening scheme developed.

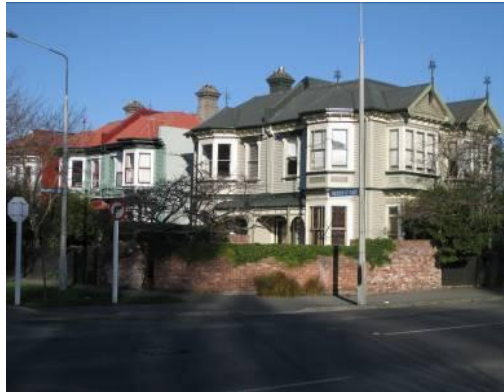
Houses (semi-detached)

Level of Damage: September-December 2010: Moderate damage.

January-June 2011: Severe damage.

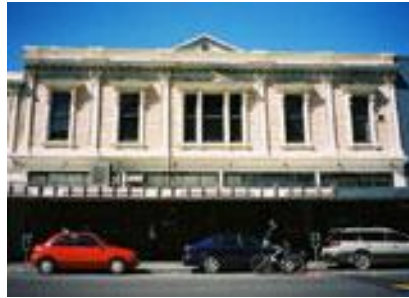
Old Theatre Royal

Condition prior to September 2010: Poor

Level of Damage: September-December 2010: Moderate damage.

January-June 2011: Severe damage (damage behind the façade).

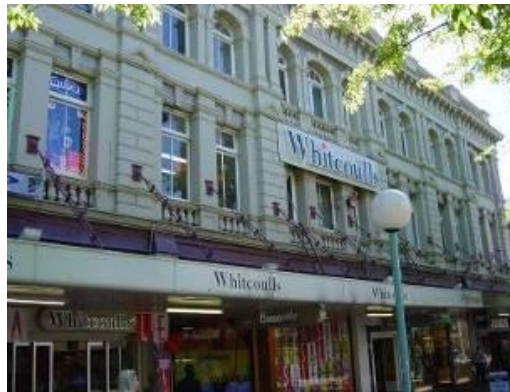
Whitcoulls Building

Level of Damage: September-December 2010: Moderate damage.
 January-June 2011: Severe damage.

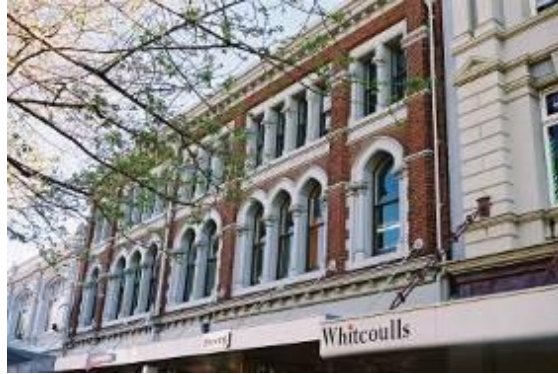
Former Press and Weekly Press Building

Level of Damage: September-December 2010: Moderate damage.

January-June 2011: Severe damage (partial collapse of upper levels and partial demolition by USAR).

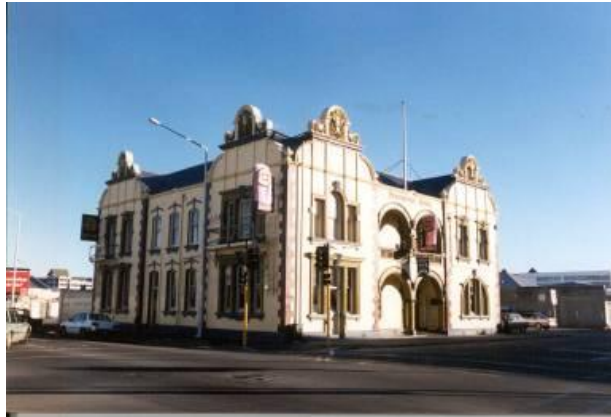
Provincial Hotel

Historical bracing and ties of walls, floor and roofs was observed following earthquake damage.⁶³

Level of Damage: September-December 2010: Moderate damage.

January-June 2011: Major damage.

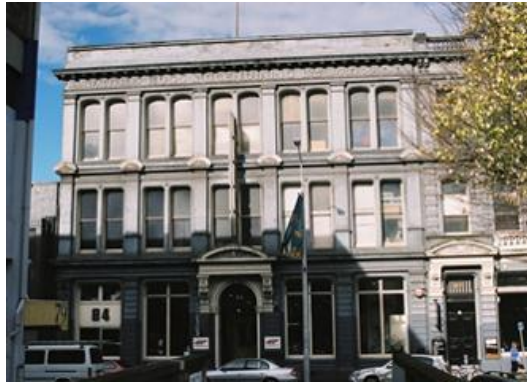
Bain's Building

Historical bracing and ties of walls, floor and roofs was observed following earthquake damage.⁶⁴

Level of Damage: September-December 2010: Moderate damage.

January-June 2011: Major damage (top floors collapse).

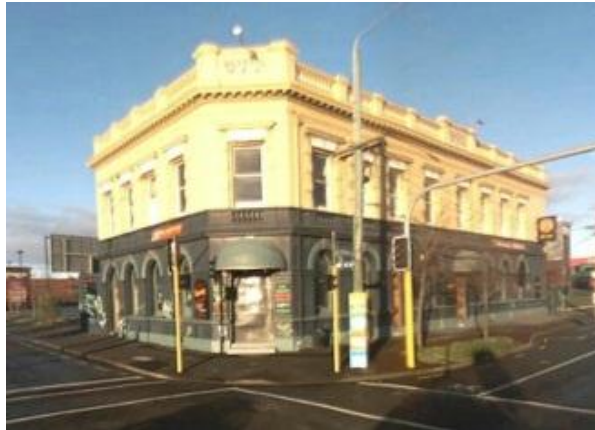
Crown Hotel

Level of Damage: September-December 2010: Moderate damage.
January-June 2011: Moderate damage (cracking of brickwork and damage to parapets)

NZHPT post-earthquake response: In May 2011, the NZHPT supported making safe, stabilisation and an engineering assessment to guide repairs. The building, however, was demolished without further input from the NZHPT.

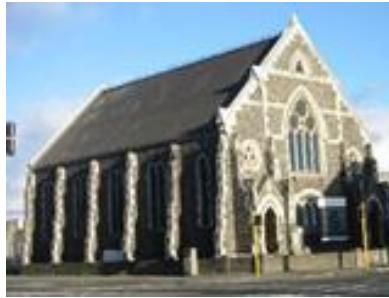
Colombo Road Wesleyan Church (Sydenham Methodist Church)

Level of Damage: September-December 2010: Minimal damage (dislodged capping stones and steel cross).

January-June 2011: Severe damage.

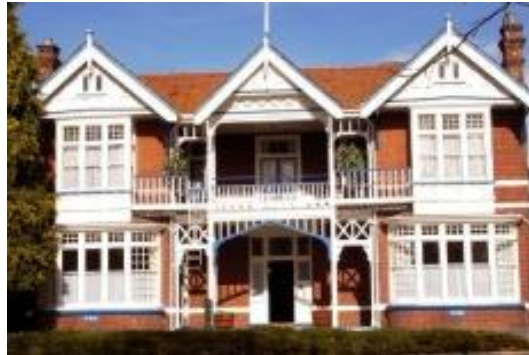
Windsor Private Hotel

Strengthening history: While there is no record of earthquake strengthening to the knowledge of the NZHPT, historical bracing and ties of walls, floor and roofs was observed following earthquake damage.⁶⁷

Level of Damage: September-December 2010: Minimal damage (chimneys down, hotel continued to operate).

January-June 2011: Severe damage.

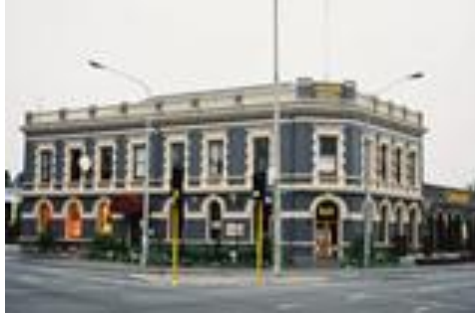
Carlton Hotel

Level of Damage: September-December 2010: Moderate damage (parapet damage, external walls separated from roof).

January-June 2011: Severe damage (south-west corner collapse, north parapet collapsed).

NZHPT post-earthquake response: The NZHPT recommended make safe and a further engineering assessment to guide repair works.

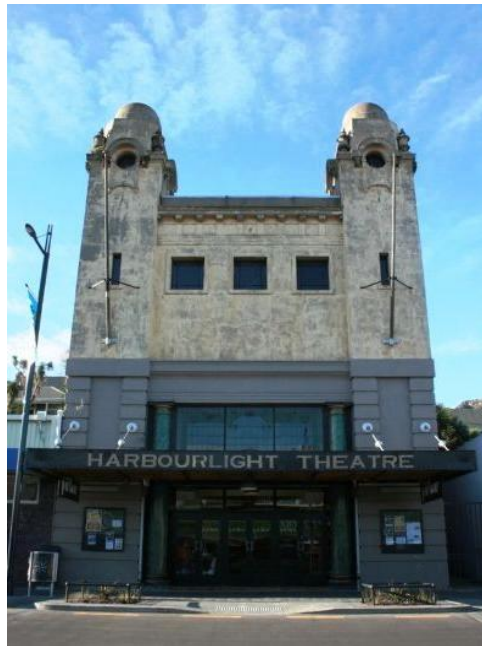
Level of Damage: September-December 2010: Moderate damage.

January-June 2011: Severe damage (rear wall collapse, parapet collapse, extensive cracking, towers damaged and unstable).

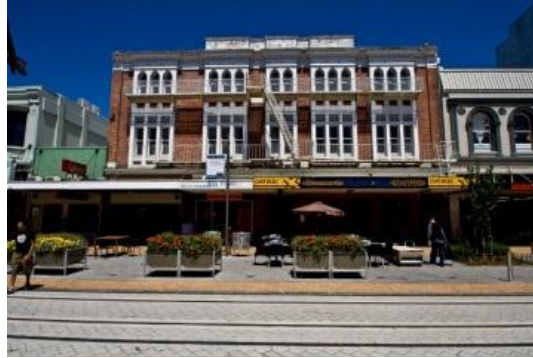
Zetland Hotel

Level of Damage: September-December 2010: Minimal damage (chimney damage from adjoining building).

January-June 2011: Moderate damage (parapet collapse, partial stair collapse, wall cracking, water ingress).

NZHPT post-earthquake response: The NZHPT recommended that the building could be made safe, repaired and strengthened based on engineering report.

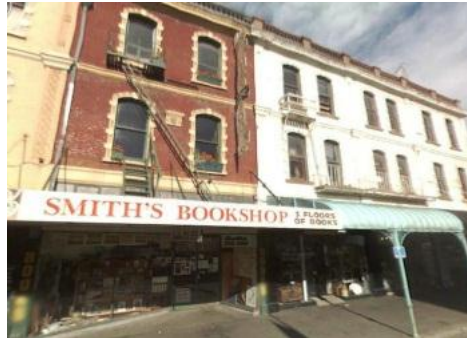
Level of Damage: September-December 2010: Moderate damage.

January-June 2011: Severe damage.

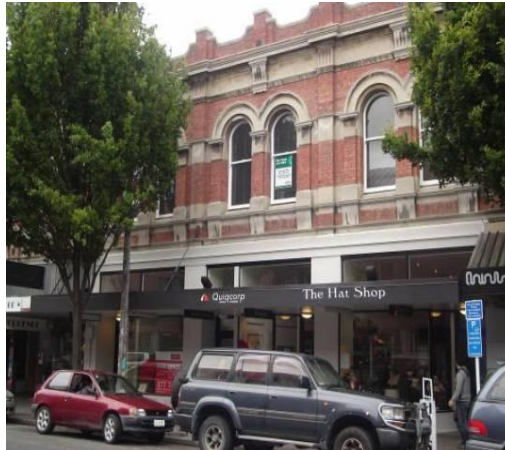
Level of Damage: September-December 2010: Moderate damage.

January-June 2011: Severe damage: The façade of No.135 High Street was partially demolished by USAR to enable access to the McKenzie Willis building.

July 2011-January 2012: Severe damage: The façade of No.165 High Street collapsed and the rest of the façade is unstable.

NZHPT post-earthquake response: The NZHPT advocated retention of the building and an engineering assessment to guide make safe and repair works.

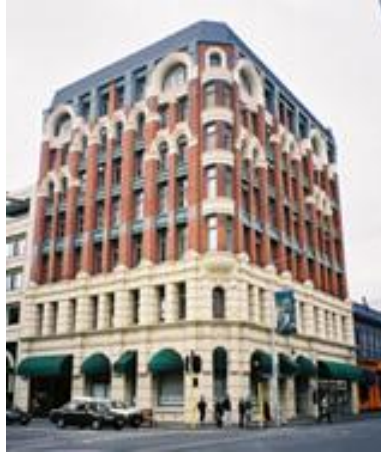
NZ Express Co Building (MLC Building or Manchester Courts)

Manchester Courts was moderately damaged in the September 2010 earthquake and the proposed demolition of the building sparked a major public debate. On 6 October, the Council voted 10-2 to demolish the building. Despite some media reporting at the time (*The Press*, 6 October 2010), the NZHPT did not oppose the demolition of the building in the interests of public safety on the basis of professional engineering advice.

Level of Damage: September-December 2010: Severe damage.

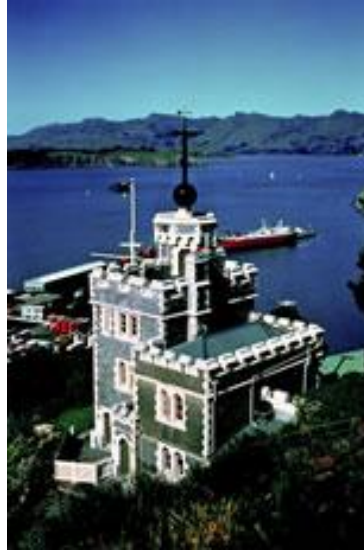
Level of Damage: September-December 2010: Moderate damage.

January-June 2011: Major damage.

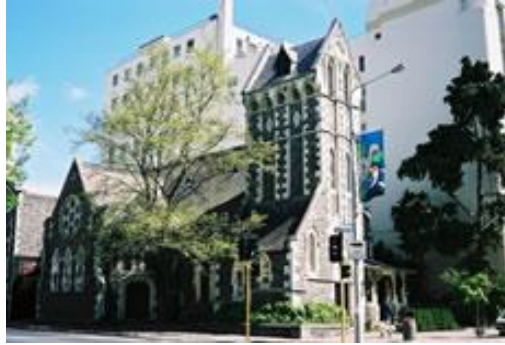
Former Trinity Congregational Church

Level of Damage: September-December 2010: Moderate damage.

January-June 2011: Severely damaged and partial collapse - tower collapsed and the rest of the church was severely damaged.

July 2011-January 2012: Further moderate damage.

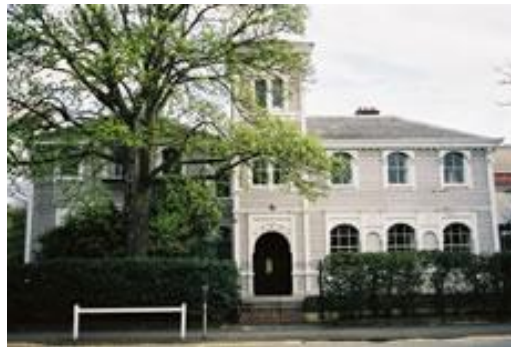
Christchurch Club

Level of Damage: September-December 2010: Minimal damage.

January-June 2011: Severely damaged: Latimer Wing collapsed and the rest of the building was moderately damaged. 50% of the building was demolished by USAR during the emergency response.

NZHPT post-earthquake response: In May 2011, the NZHPT recommended retention of the existing buildings and their interim propping and weatherproofing.

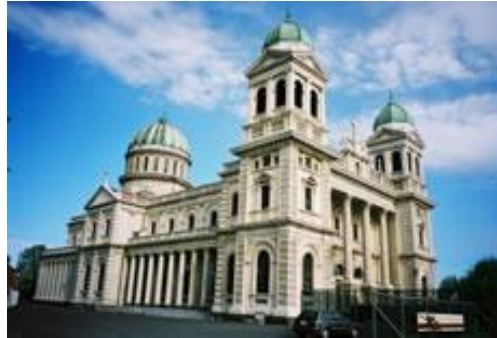
Level of Damage: September-December 2010: Minimal damage.

January-June 2011: Major damage and partial collapse of twin bell towers, main dome rotated and leaning, key stones and arches badly damaged, severe cracking.

July 2011-January 2012: Severe damage with cracking to the front façade and walls of the nave.

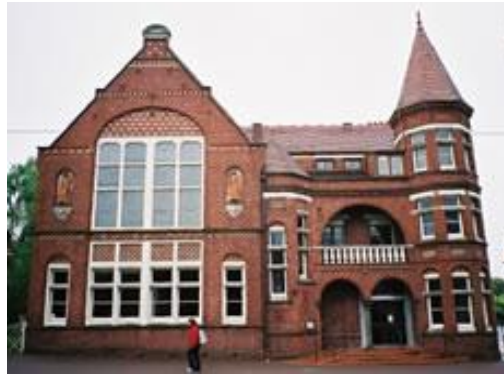
Former Municipal Chambers (Our City O'tautahi)

The toilet block on the northwest face appears to have settled differently with respect to the remainder of the building. This has resulted in cracks in the brickwork and voussoirs to the arch above the window dropping.

Cracks are apparent in a number of locations. In particular, cracks are evident within the Council Chamber, within the walls, ceilings and beams. Cracks have also occurred in the stairwell on the northwest face.'

Level of Damage: September-December 2010: Moderate damage.

January-June 2011: Severe damage.

July 2011-January 2012: Severe damage.

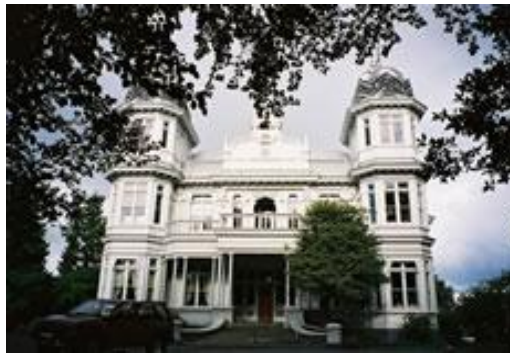
McLean's Mansion

Level of Damage: September-December 2010: Minimal damage.

January-June 2011: Severe damage.

Current status: Secured/made safe, with internal wall linings being replaced.

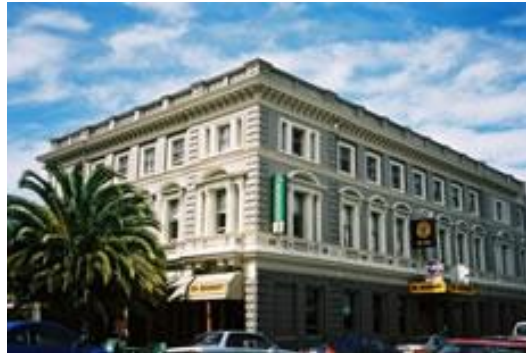
Excelsior Hotel

Level of Damage: September-December 2010: Minimal damage.

January-June 2011: Severe damage.

July 2011-January 2012: Minimal or no damage.

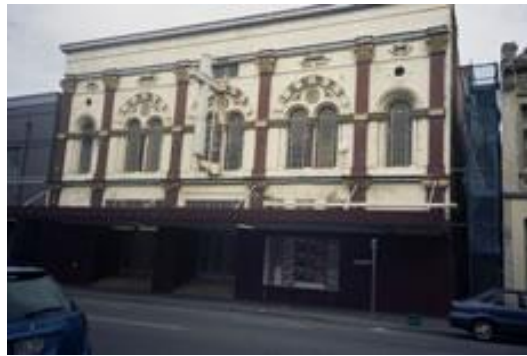
Odeon Theatre

Condition prior to September 2010: Poor

Level of Damage: September-December 2010: Moderate damage.

January-June 2011: Severe damage to theatre, roof and fly tower. Moderate damage to facade.

July 2011-January 2012: Severe damage.

NZHPT post-earthquake response: In July 2011, the NZHPT advised partial deconstruction and retention. Further comments in January 2012 by the NZHPT recommended façade and front of house retention, demolition of the fly tower and auditorium based on engineering advice.

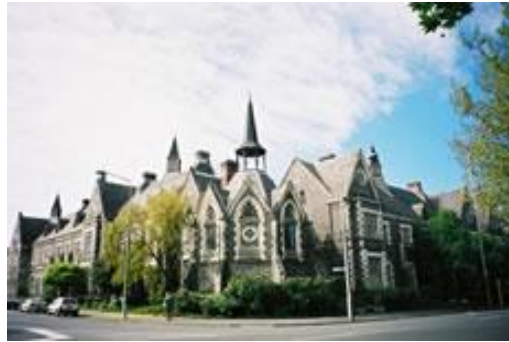
Former Normal School

Level of Damage: September-December 2010: Moderate damage.

January-June 2011: Severe damage and partial collapse - Octagonal Room collapsed and severe damage to the rest of the building.

July 2011-January 2012: Moderate damage.

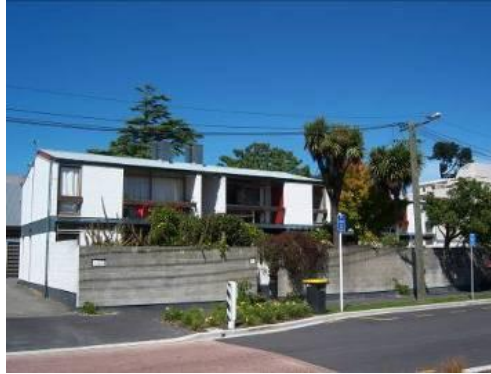
Level of Damage: September-December 2010: Minimal damage.

January-June 2011: Moderate damage.

July 2011-January 2012: Moderate damage.

NZHPT post-earthquake response: In October 2011, the NZHPT recommended retention with support from owners and Sir Miles Warren and is working with owners on retention proposal.

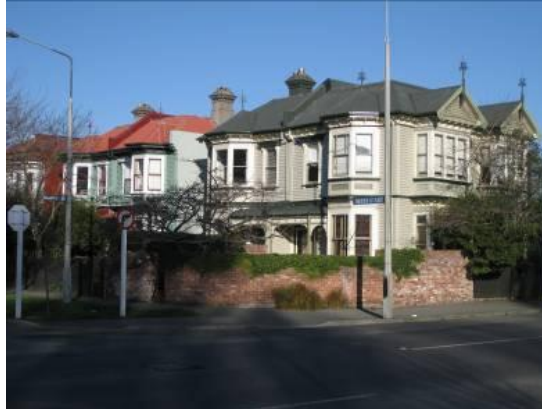
Houses (semi-detached)

Level of Damage: September-December 2010: Minimal damage.
January-June 2011: Severe damage.
July 2011-January 2012: Unknown.

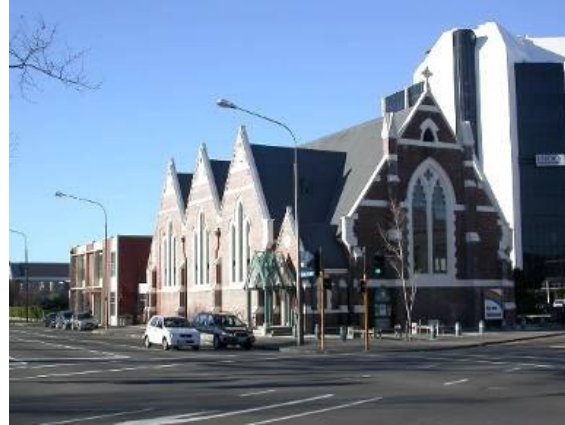
Knox Church (Presbyterian)

Level of Damage: September-December 2010: Minimal damage.

January-June 2011: Severe damage.

July 2011-January 2012: Moderate damage.

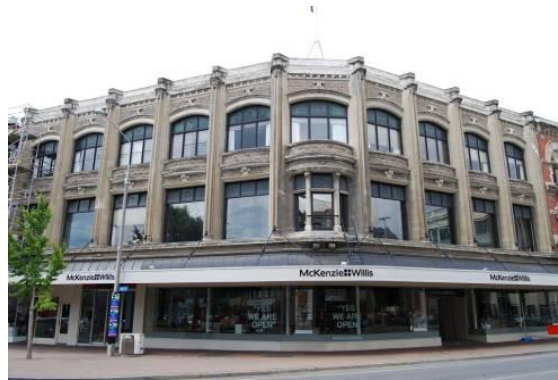
McKenzie & Willis Building

Level of Damage: September-December 2010: Minimal damage.

January-June 2011: Severe damage.

July 2011-January 2012: Minimal damage.

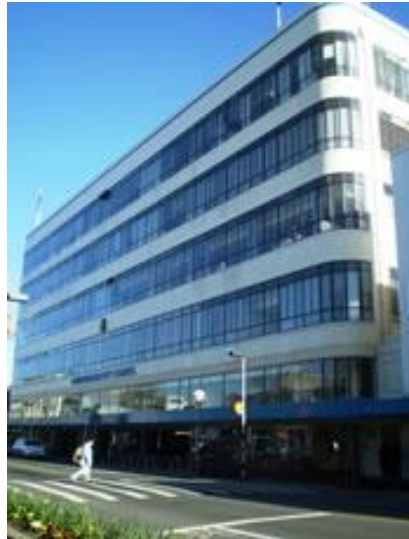
Level of Damage: September-December 2010: Minimal damage.

January-June 2011: Moderate damage.

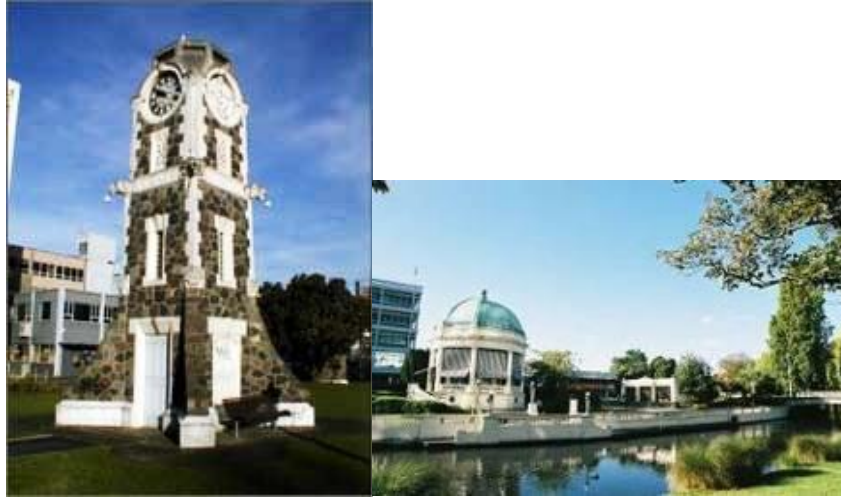
Level of Damage: September-December 2010: Minimal damage.

January-June 2011: Severe damage.

July 2011-January 2012: Moderate damage.

NZHPT post-earthquake response: NZHPT has commented on proposals for repair and strengthening work as part of a resource consent application for clock tower.

Current status: Christchurch City Council have prepared a resource consent proposal for repair and strengthening of clock tower. The future of the rotunda is uncertain at time of writing.

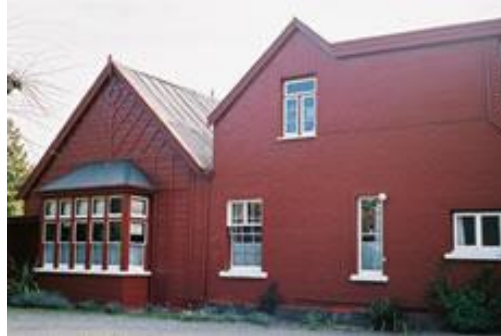
Condition prior to September 2010: Good

Strengthening history: The Cranmer Bridge Club informed the NZHPT in 1990 that the brick section of the building was an earthquake hazard as a consequence of cracks in the brickwork. These cracks were investigated by Jim Espie (Conservation Architect) in 1993 who considered they were caused by ground settlement (possibly as a result of adjacent new construction or by changes in ground water conditions). In addition to repair works, Jim Espie recommended that the cracks be monitored and that a structural engineer be engaged to design a strapping system and/or a bond-beam at coping level. The brick repair works were carried in 1994 out with the financial support of the NZ Lotteries Board. No specific earthquake strengthening work or structural repairs were undertaken to the knowledge of the NZHPT.

Level of Damage: September-December 2010: Minimal damage.

January-June 2011: Severe damage to brick residence, moderate damage to timber-framed addition.

July 2011-January 2012: Minimal damage.

NZHPT post-earthquake response: NZHPT recommended retention of the timber addition and is currently working with owners for redevelopment options.

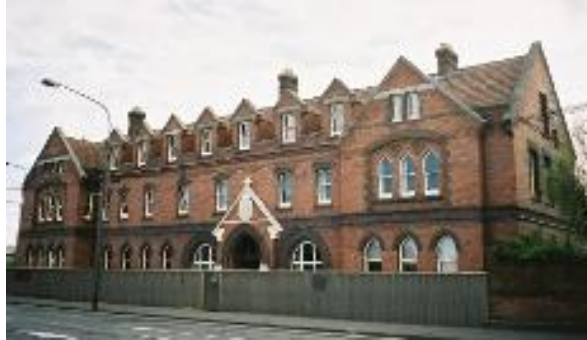
(Collins Building)

Condition prior to September 2010: Fair

Level of Damage: September-December 2010: Minimal damage.

January-June 2011: Severe damage to brick buildings, moderate damage to timber-framed building.

NZHPT post-earthquake response: The NZHPT recommended retention of the Collins building but demolition was approved.

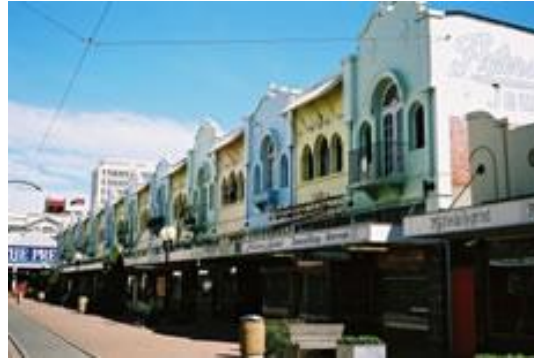
Condition prior to September 2010: Fair (conservation works under action)

Strengthening history: In 1990, the NZHPT was informed by Paul Dunlop, Optometrist of New Regent Street, that the walls of his shop were found to be very difficult and costly to demolish for alterations. This was because of the solid interlocked brick walls with two layers of steel reinforcing mesh. Further, the walls on each ends of the shop rows have reinforced concrete beams.

Level of Damage: September-December 2010: Minimal damage.

January-June 2011: Minimal and moderate damage.

July 2011-January 2012: Minimal damage.

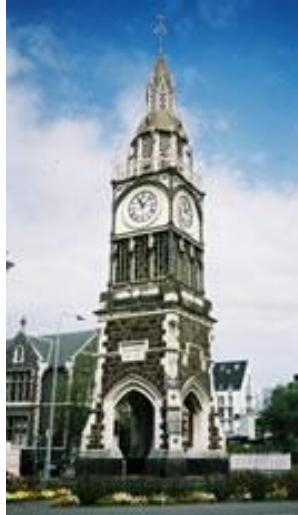
Victoria Street Clock Tower (Jubilee Clocktower)

Condition prior to September 2010: Good

Strengthening history: The clock tower was restored in 1978 and by the late 1990s was in a poor state of repair. A conservation plan was prepared by George W Lucking in November 2000 which highlighted the need for earthquake strengthening. In particular, the conservation plan outlined the need for strengthening of the stone base, reinforcing of the cast iron framed middle section, the attachment of the spire to the middle section and the attachment of the three different sections of the structure.¹²⁵ The conservation plan ensured that earthquake strengthening was one of priority actions for the conservation of the structure and part of the schedule of the proposed conservation works.

Level of Damage: September-December 2010: Minimal damage.

January-June 2011: Moderate damage.

July 2011-January 2012: Moderate damage.

NZHPT post-earthquake response: NZHPT recommended retention.

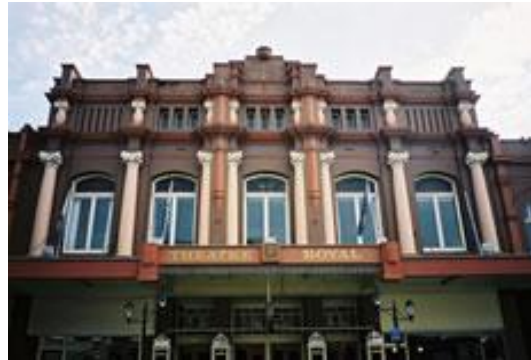
Theatre Royal (Isaac Theatre Royal)

Condition prior to September 2010: Good

Level of Damage: September-December 2010: Minimal damage.

January-June 2011: Moderate damage.

July 2011-January 2012: Severe damage.

NZHPT post-earthquake response: The NZHPT is working with owners to make safe, repair and strengthen.

Current status: Make safe and repair works ongoing, structural upgrade. Future uncertain at time of writing.

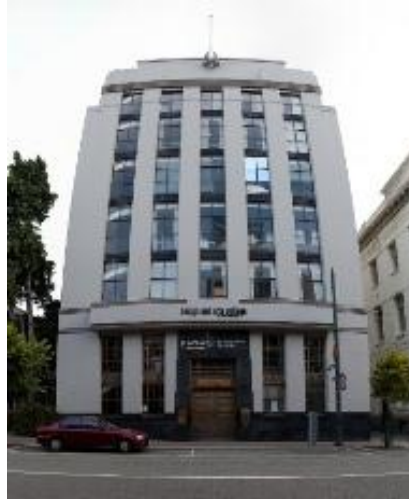
State Insurance Building (Former)

Condition prior to September 2010: Good

Level of Damage: September-December 2010: Minimal damage.

January-June 2011: Moderate damage.

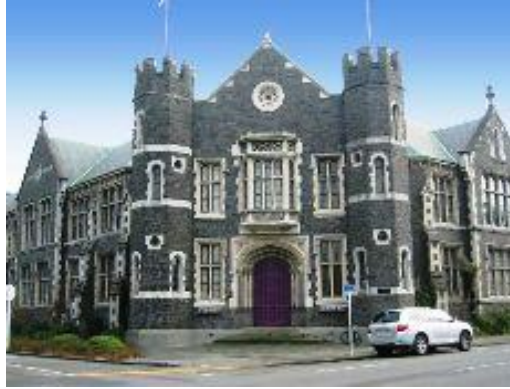
Former Teachers' College (Peterborough Centre)

Condition prior to September 2010: Good

Strengthening history: The building was vacated in 1978 by the Christchurch Teachers College and was unoccupied during the 1980s and early 1990s. During the early 1980s, the Arts Centre Trust investigated strengthening and retrofit of the buildings for community purposes. A preliminary report of April 1980 noted the need for strengthening work involving ties from the walls to the floors, roof, gable and tower bracing and horizontal pre-stressing at roof and first floor levels in the external walls.¹²⁹

Historical bracing and ties of walls, floor and roofs was observed following earthquake damage.¹³⁰

Level of Damage: September-December 2010: Minimal damage.

January-June 2011: Moderate damage.

July 2011-January 2012: Moderate damage.

NZHPT post-earthquake response: NZHPT is working with owners on a retention plan. Issues with on-going damage, multiple ownership and liquefaction.

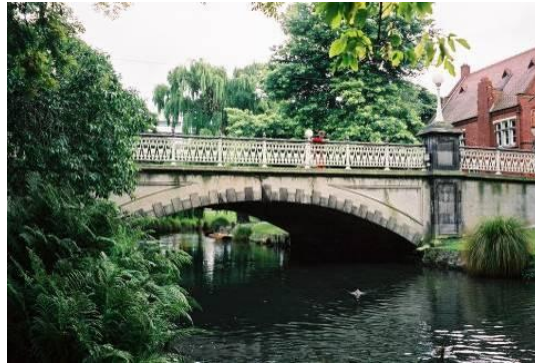
Worcester Street Bridge

Condition prior to September 2010: Good

Level of Damage: September-December 2010: Minimal damage.

January-June 2011: Moderate damage.

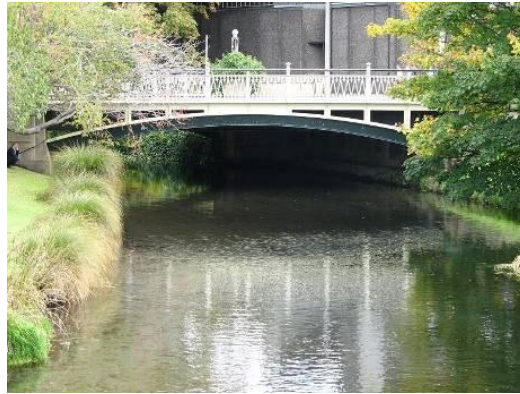
Colombo Street Bridge

Condition prior to September 2010: Good

Level of Damage: September-December 2010: Minimal damage.

January-June 2011: Moderate damage.

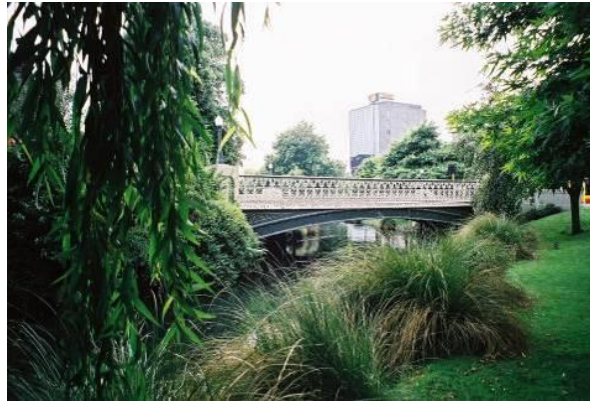
Gloucester Street Bridge

Condition prior to September 2010: Good

Level of Damage: September-December 2010: Minimal damage.

January-June 2011: Moderate damage.

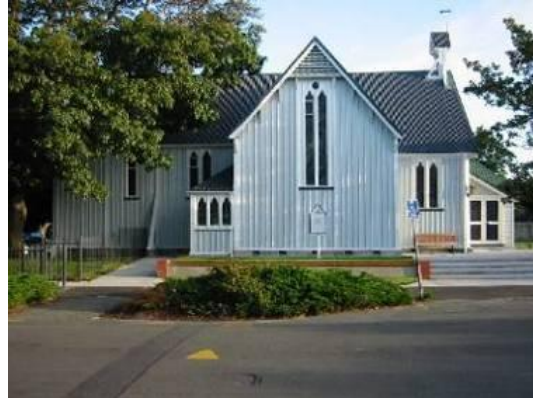
Condition prior to September 2010: Good

Level of Damage: September-December 2010: Minimal or no damage.

January-June 2011: Moderate damage.

July 2011-January 2012: Minimal damage.

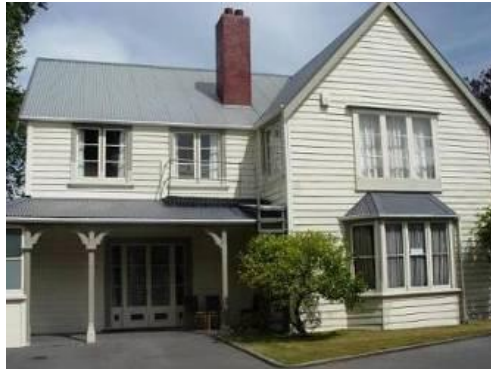
Girl Guide Headquarters

Condition prior to September 2010: Good

Level of Damage: September-December 2010: Minimal or no damage.

January-June 2011: Moderate damage

July 2011-January 2012: Moderate damage.

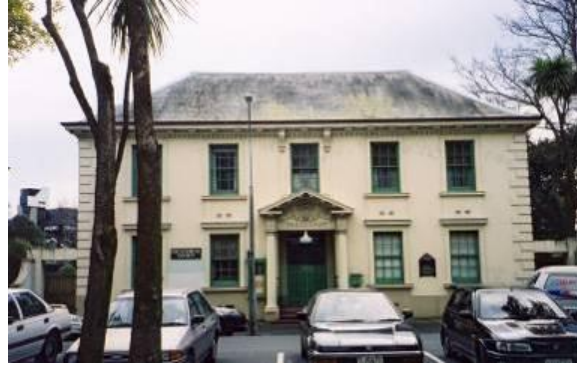
Condition prior to September 2010: Unknown

Level of Damage: September-December 2010: Minimal or no damage.

January-June 2011: Moderate damage

July 2011-January 2012: Severe damage.

NZHPT post-earthquake response: The NZHPT supported retention but the building has suffered severe damage from the 2-15 January 2012 earthquakes.

Current status: Due to be demolished due to severity of damage at time of writing.

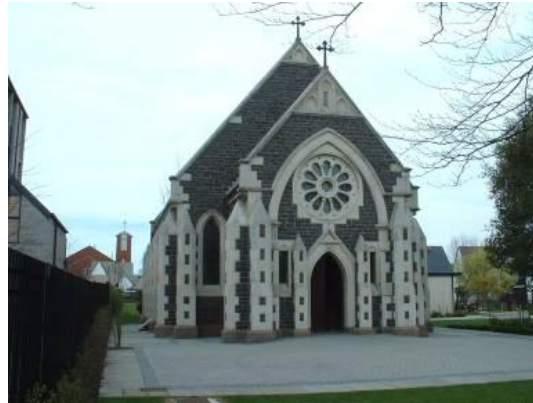
St Mary's Convent Chapel (Rose Chapel)

Condition prior to September 2010: Good

Level of Damage: September-December 2010: Minimal or no damage.

January-June 2011: Moderate damage.

- Repair of damaged walls and buttresses
- New steel tie rods and buttress ties.
- Grout filling of existing wall cavity.
- New steel ties from rafter to under-purlins.

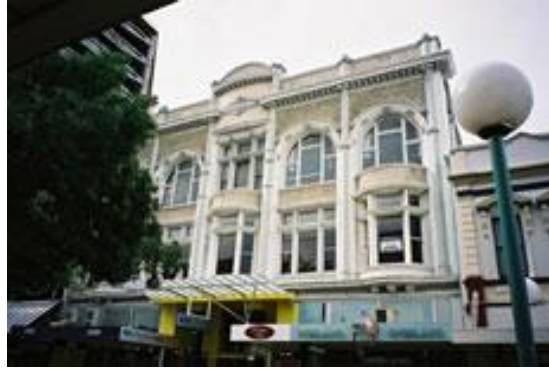
Cashfields (Southern Star Apartments, former DIC Cashfields Arcade)

Condition prior to September 2010: Good

Strengthening history: In 2006 the building was strengthened and extended (a new third floor addition) with the NZHPT's support.¹³¹ Historical bracing and ties of walls, floor and roofs was observed following earthquake damage.¹³²

Level of Damage: September-December 2010: Minimal or no damage.

January-June 2011: Moderate damage

July 2011-January 2012: Moderate damage.

Current status: Building is intact, with some parapet damage – made safe. But future uncertain at time of writing.

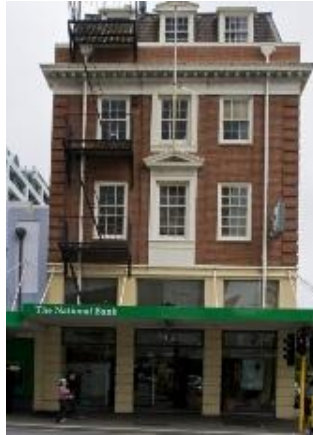
National Bank (former Cook and Ross Building)

Condition prior to September 2010: Good

Level of Damage: September-December 2010: Unknown.

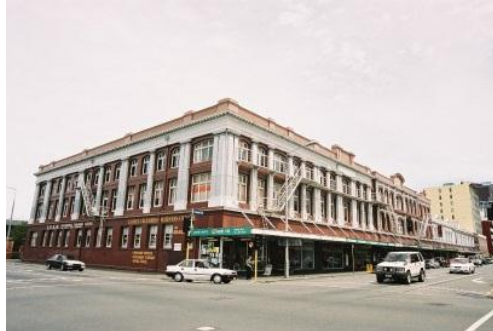
Cashel Chambers (Former Farmers Department Store) Façade only

Photo of the former Cashel Chambers prior to fire damage and partial demolition in 2005

Condition prior to September 2010: Unknown

Level of Damage: September-December 2010: Minimal damage (façade only).
 January-June 2011: Unknown.
 July 2011-January 2012: Unknown.

Current status: The bulk of the building was demolished in 2005 and was replaced by the IRD building. The retained historic façade is still surviving.

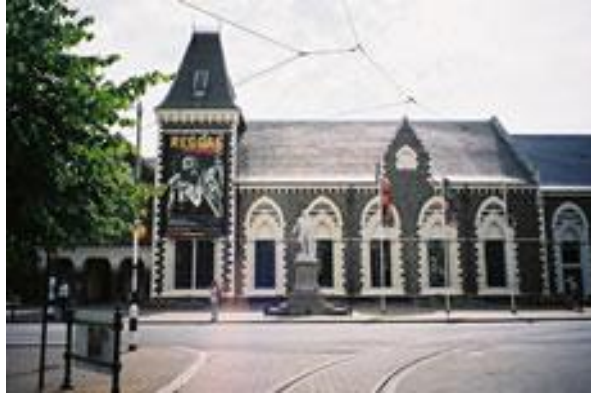
Condition prior to September 2010: Good

Earthquake strengthening of the Canterbury Museum began with the appointment of Michael Trotter as museum director in 1983. In 1989, Trotter recalled that just two days after he took office as director, a 'large lump of stone broke off from the front the building and fell onto a car parked below. Luckily no-one was hurt – we received a claim for damage to the car – but it did emphasise a fact that some of us had been aware of for some time: the Museum was in dire need of strengthening and maintenance.'¹³⁴ Following this incident, the Works and Planning Department of the

The condition report found that the Haastian buildings were in urgent need for maintenance and strengthening and one option suggested was the complete demolition of the buildings because of the high cost of strengthening and the modern access, display and storage requirements for the museum.¹³⁵ Demolition, however, was never ‘considered seriously by the Museum authorities.’¹³⁶

January-June 2011: Minimal damage.

With the NZHPT’s support, stage 1 strengthening of the 1876 extension began in 1988. This involved the pouring of 150mm thick reinforced concrete against the sides of the inside walls, new reinforced concrete foundations and installing new concrete floors with pryotyenax heating.¹³⁹ The walls were further supported by horizontal steel trusses and plywood diaphragms and complete roof restoration.

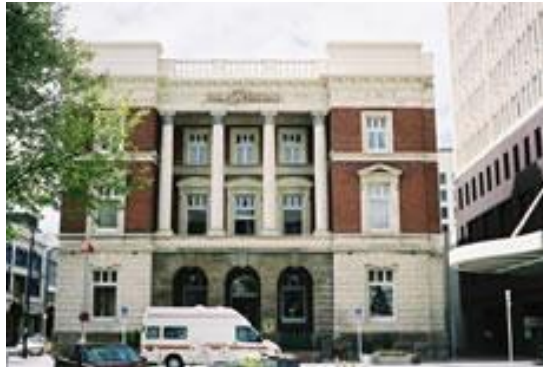
Old Government Buildings

Level of Damage: September-December 2010: Minimal or no damage.

January-June 2011: Minimal damage.

July 2011-January 2012: Minimal damage.

Current status: No major damage. Made safe and repaired. Currently assessed at 67%NBS

NZHPT post-earthquake response: The NZHPT is working with owner to repair and consents have been granted by Council (September 2011).

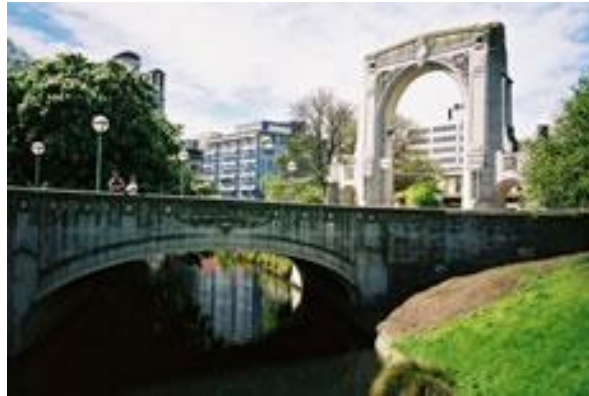
Bridge of Remembrance

Level of Damage: September-December 2010: Minimal or no damage.

January-June 2011: Moderate damage.

July 2011-January 2012: Minimal damage.

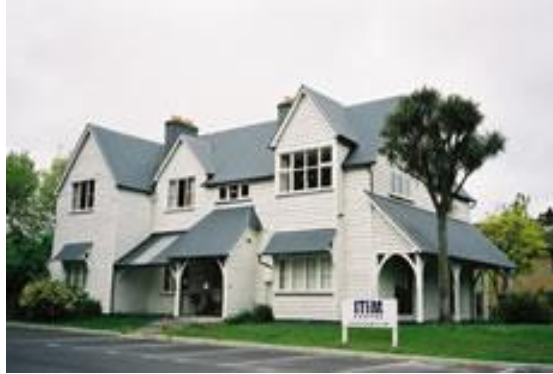
St Luke's Vicarage

Level of Damage: September-December 2010: Minimal or no damage.

January-June 2011: Minimal damage.

July 2011-January 2012: Minimal damage.

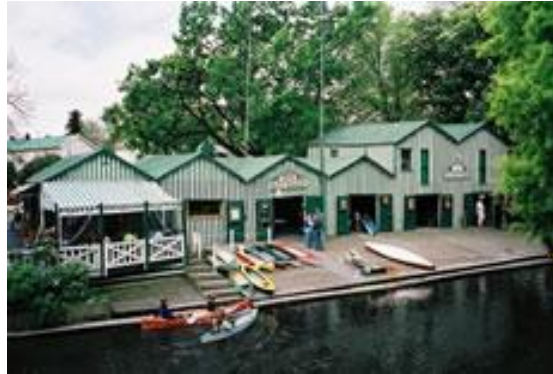
Level of Damage: September-December 2010: Minimal or no damage.

January-June 2011: Minimal or no damage.

July 2011-January 2012: Minimal or no damage.

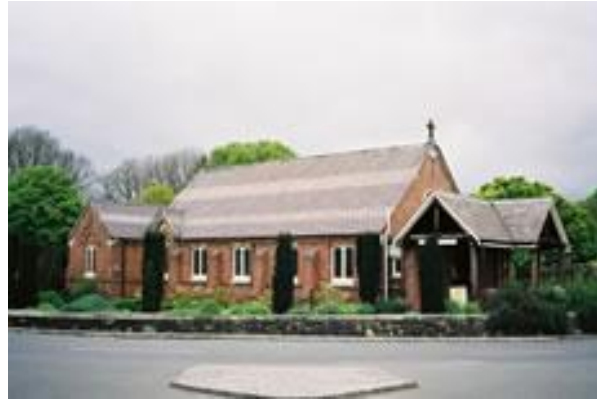
Level of Damage: September-December 2010: Minimal or no damage.

January-June 2011: Moderate damage (cracking of brick work, west and east walls, damage to north wall and internal arch).

Current status: Moderate damage, building secured and made safe.

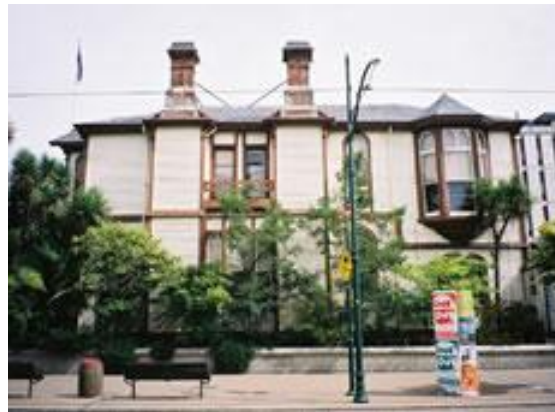
Level of Damage: September-December 2010: Minimal damage (damage limited to chimneys, internal cracking, sinking foundations).

January-June 2011: Moderate damage.

July 2011-January 2012: Minimal damage.

Current status: Repair and strengthening work underway.

NZHPT post-earthquake response: The NZHPT supported the owner to repair and strengthen the building.

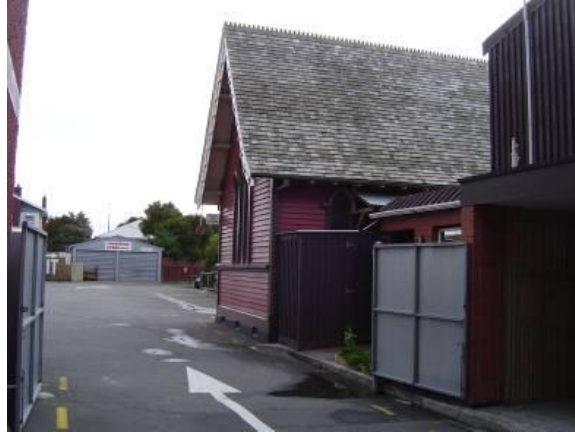
St Luke's Chapel (Christchurch City Mission)

Level of Damage: September-December 2010: Minimal damage.

January-June 2011: Minimal damage.

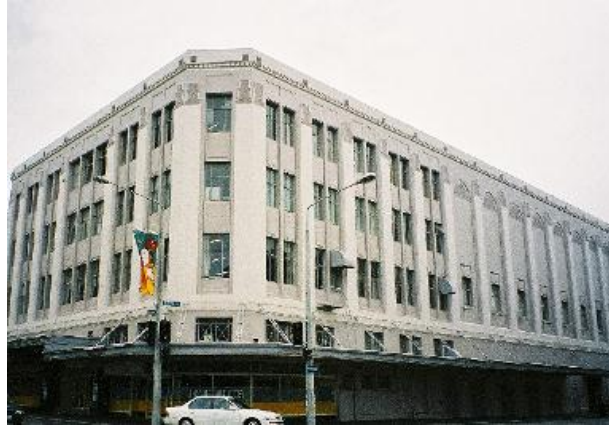
Former Majestic Theatre/New Life Centre

Level of Damage: September-December 2010: Minimal damage.

January-June 2011: Minimal damage.

July 2011-January 2012: Moderate damage.

Current status: Future uncertain at time of writing, potential demolition following further damage from the 2-15 January 2012 earthquakes.

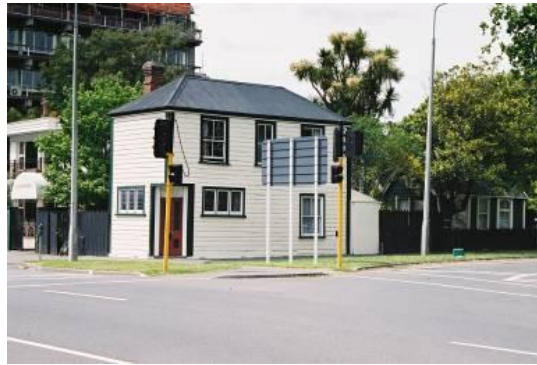
Level of Damage: September-December 2010: Minimal damage.

January-June 2011: Minimal damage.

July 2011-January 2012: Minimal damage.

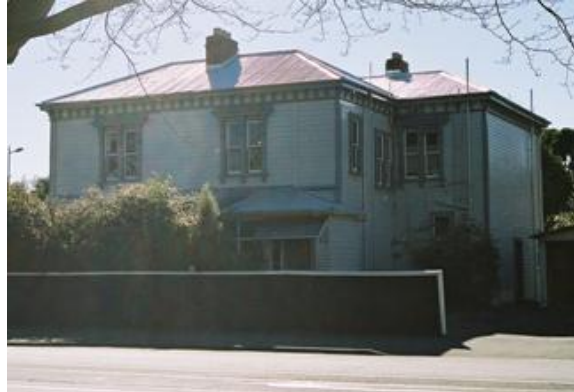
Dwelling, 2-storey (Christ's College)

Level of Damage: September-December 2010: Minimal damage.

January-June 2011: Minimal damage.

Current status: Made safe and repaired.

NZHPT post-earthquake response: The NZHPT supported consent to repair the building.

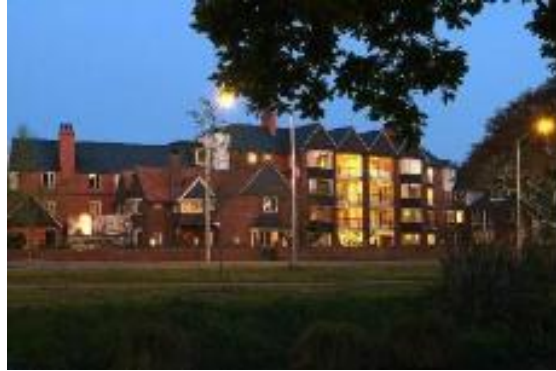
Fleming and McKellar Houses

Level of Damage: September-December 2010: Minimal damage.

January-June 2011: Moderate damage.

Current status: Some damage reported, waiting for engineering assessment.

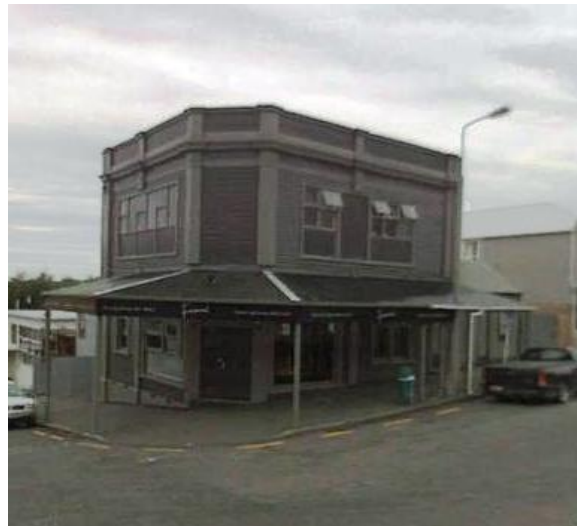
Commercial Building (Rat n' Roach Building, Changs Fruiterers, Chan's Cafe)

Level of Damage: September-December 2010: Minimal damage.

January-June 2011: Moderate damage (parapet collapse and partial collapse of western masonry wall).

July 2011-January 2012: Minimal damage.

Current status: Repair work carried out and the building is open and operating.

NZHPT post-earthquake response: The NZHPT supported repair and retention of the building based on engineering report.
