**ROYAL COMMISSION OF INQUIRY INTO
BUILDING FAILURE CAUSED BY CANTERBURY
EARTHQUAKES**

THE CTV BUILDING COLLAPSE

**STATEMENT OF EVIDENCE OF RONALD WILLIAM GODKIN
IN RELATION TO THE CTV BUILDING**

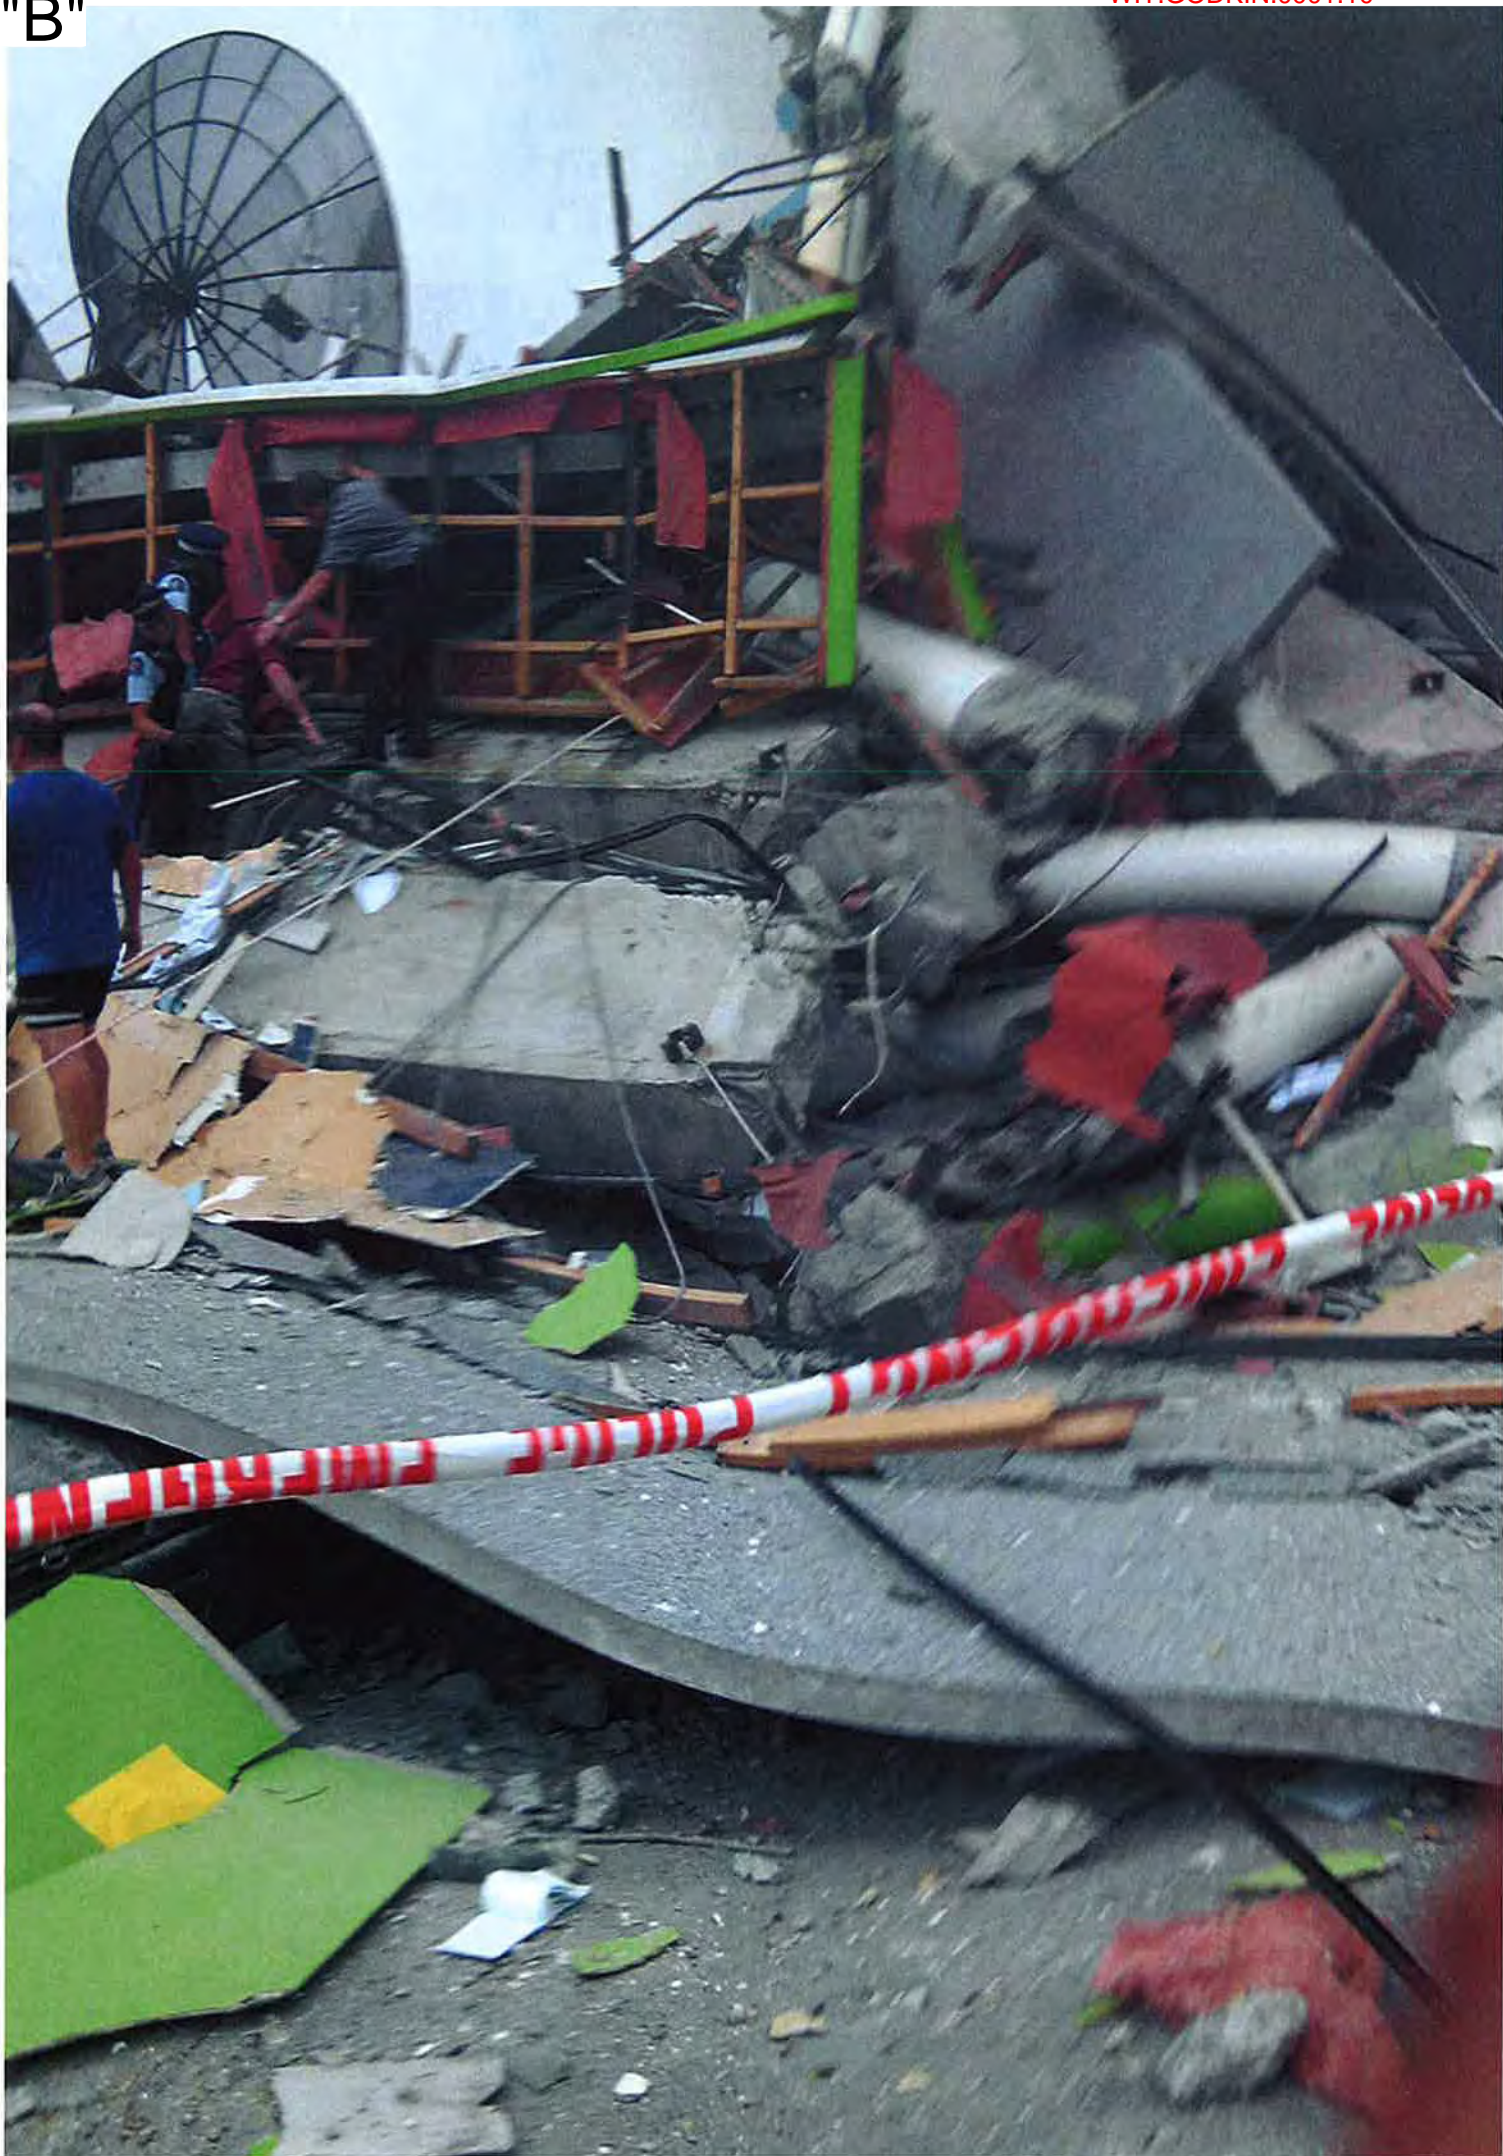
11. The "hump" I have referred to ran east to west across the foyer of the Building at the point marked "4" on the plan. It first appeared following the September earthquake but as we experienced more earthquakes the hump appeared to get bigger and become more and more noticeable. It was a matter of particular concern to me and to other staff. The effect of this hump was sufficient to cause a pencil to roll across the receptionist's desk, which did not happen before the September earthquake. As far as I am aware the vinyl floor coverings in the foyer were not lifted during either of the two inspections in order to examine the "hump", although I pointed it out to John Drew and the engineer on their second inspection and expressed the concern both my colleagues and I had about it. The engineer said that all concrete buildings "hump" between the supporting beams that hold the floors up when the concrete dries over the support. The engineer told me the Building was doing what it was meant to do following an earthquake and it was not a problem.

before the 22 February earthquake and during the course of the demolition. Both of these areas of damage were at ground level and could be seen from the ground floor car park. They have been marked “5” and “6” on the attached plan. The damage noted as “5” involved a concrete non supporting wall at the end of the car park area that had completely collapsed eastwards. The wall marked “6” was between two supporting pillars. It had dropped and separated from the roof above it by about 20 millimetres or so, but did not collapse. Neither of these walls were load bearing. After this occurred I checked the whole of the western wall, but I saw no other movement or cracking.

17. Areas of cracked glass developed along the southern wall, these are marked “7” on the plan. The majority of damage occurred to the windows nearer to the eastern end. Some of this was post September, but before the demolition commenced. Some of it was after the demolition commenced. The repair work for the glass was done by Cranfield Glass. Following Boxing Day I did not observe any additional glass damage.
