Plan Section at Typical Interior Column
(thru Bottom of Precast Log Beams)

SK GF 20120501

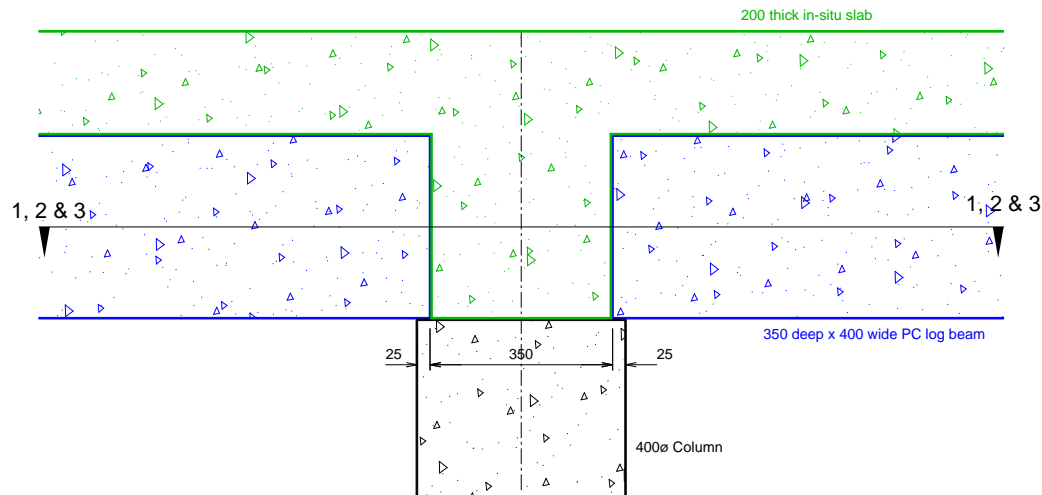
LONGITUDINAL SECTION - TYPICAL INTERIOR BEAM-COLUMN JOINT

Approximate location of last stirrup before column
Likely crack location

Compressive stresses at bottom of beam
under gravity load conditions.
(to balance top steel tension loads)

With smooth interface between precast (log) beam and 350ø column infill concrete longitudinal beam forces can't be transferred 'in line' across interface. So large RADIAL forces generated. Since there were no beam stirrups detailed to be located past start of curved end, there was nothing

to confine the concrete in the 'wings' or resist these radial/splitting forces. Vertical EQ acceleration loads would have increased the magnitude of all these forces and likely exceeded the tensile capacity of the unreinforced concrete 'wings' at the ends of the beams.

230 (as drawn)
(examples up to 300mm found in debris)

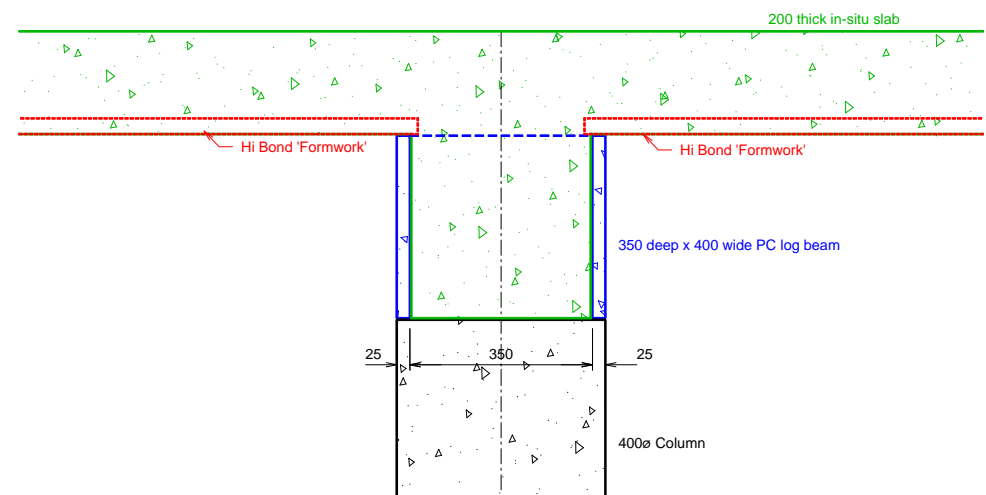
SECTION NEAR COLUMN CENTRELIN

Original Dwgs call for the gaps between beam ends to be sealed to prevent grout loss during insitu concrete (infill) pour. It's not clear to me what made up the fill in these nominal 25x20 'rebates' - PEF rod/ sealer/concrete.
