## EXECUTIVE SUMMARY

This report covers the structural damage sustained by the Canterbury District Health Board's Christchurch Women's Hospital, as a result of the series of Earthquakes that includes the Darfield Earthquake that struck at 4:36am on 4<sup>th</sup> September 2010, the Lyttelton Earthquake at 12.51 pm on the 22<sup>nd</sup> of February 2011, the June 13<sup>th</sup> 2011 (2:20pm) earthquake and December 23<sup>rd</sup> 2011 (1:58pm) event. The Darfield Earthquake produced force demands in the isolator system equal to Maximum Considered Earthquake (MCE for an IL2 building), or ultimate limit state (ULS), conditions for an Importance Level 4 building. The Lyttelton Earthquake by comparison did not induce such large horizontal forces, but likely took the structure through larger displacement demands at the isolator level. Consequently it is important that a full evaluation is performed.

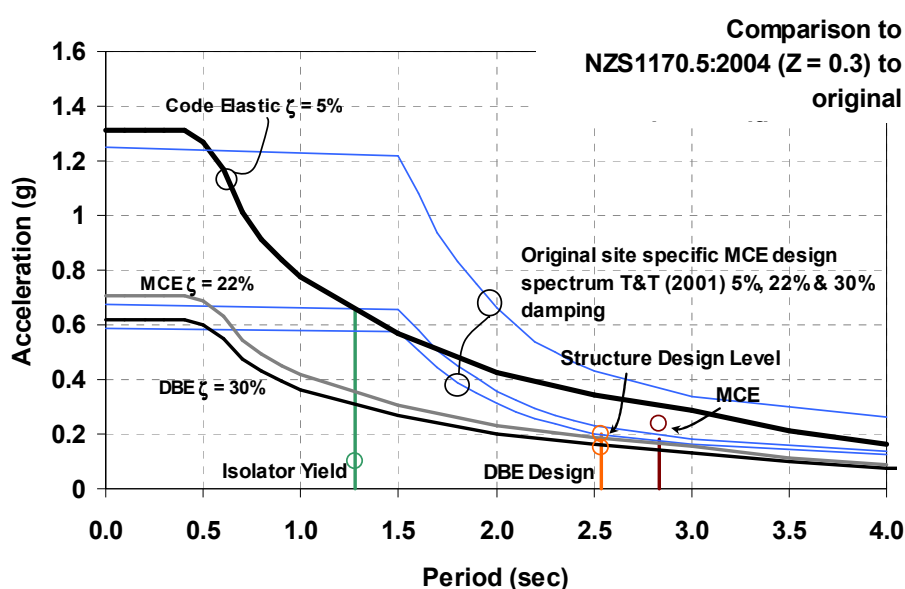
Figure 1-4: NZS 1170.5:2004 acceleration spectra at damping levels of 5%, 30% and 22% which correspond to Serviceability (SLS), Design Basis Earthquake (DBE) and Maximum Considered Earthquake (MCE) respectively. Circles indicate original design forces for each limit state.

The key points to draw from Figure 1-4 are that the original design spectrum exceeds the current NZS1170.5:2004 spectrum for periods over 0.6 seconds. The fundamental period of the structure prior to the isolators yield is 1.28 seconds. Once the isolators have yielded the effective period of the building becomes 2.54 seconds under DBE displacements, and 2.84 seconds under MCE displacements.

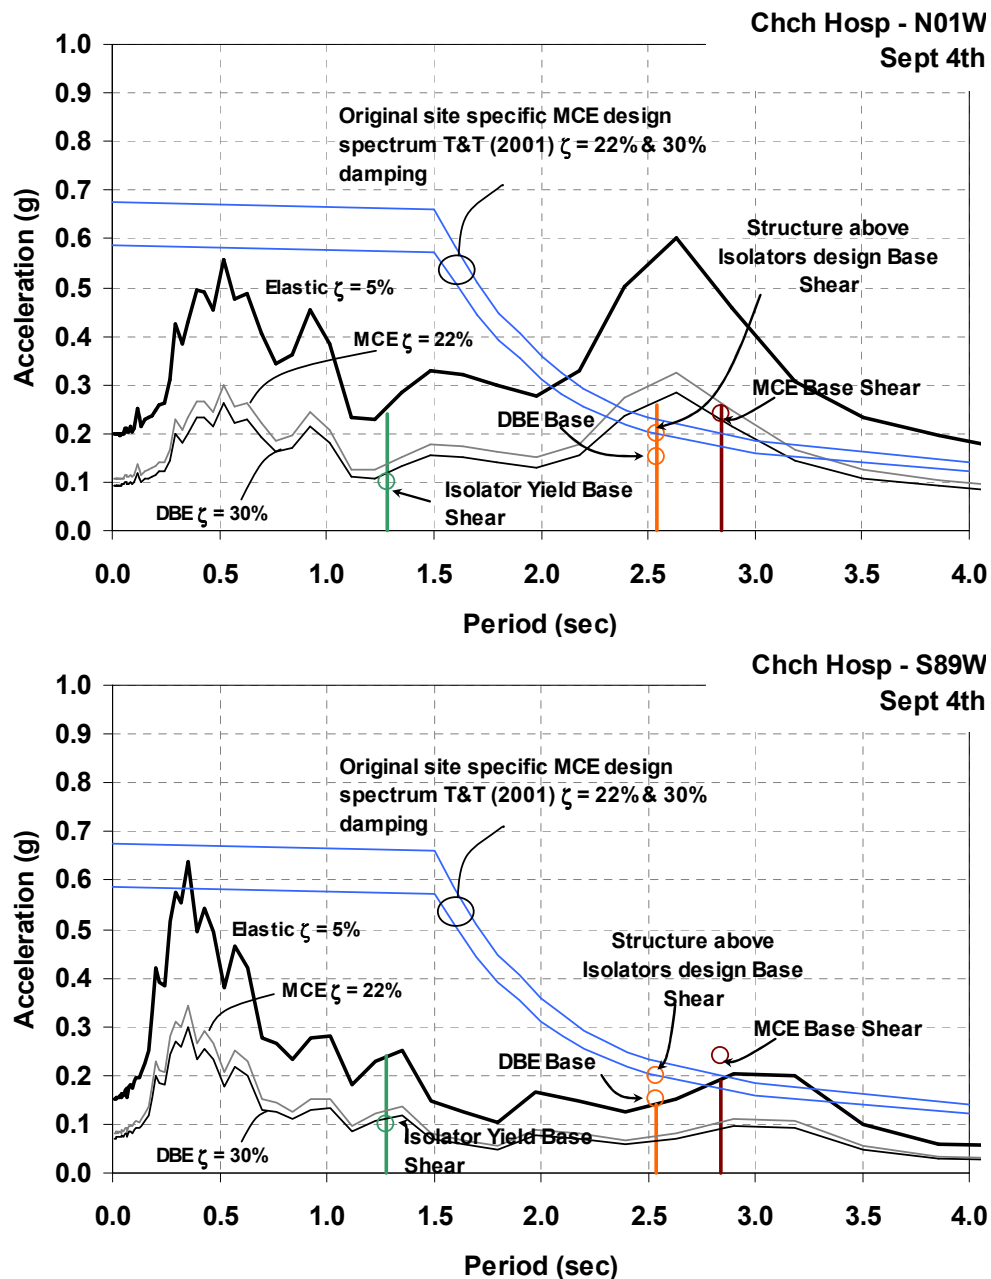
The Darfield earthquake had stronger ground motion in the north-south direction (N01W), than in the east-west (S89W). Figure 2-1 shows this response when comparison of the record spectra is made between (a) and (b). It is not possible to interpret the exact demands that the building experienced from these spectra, and in particular the behaviour of the building after the isolator units yield can only be generally interpreted. To this extent the indications are that the isolators would have yielded in both building principal axis directions when the structural period was approximately 1.28 seconds and apparent damping approximately 5%. Following the isolator yield the effective period of the building moved to 2.5 seconds at which point the next performance level is the DBE.

At a DBE level the seismic demand shown by the “DBE  $\zeta = 30\%$ ” curves (“ $\zeta$ ” represents damping) suggest that the building could have developed the DBE and MCE isolator base-shear levels and the design base-shear demand expected for upper structure. However as noted in Section 1.2.1 the as-designed overstrength has led to a structure that responds in an essentially elastic manner up to MCE levels. Thus even with these near-design level forces it is unlikely that significant structural damage would have occurred in the seismic system. Observations of the structural members suggest that this is in fact the case as the damage noted in the log does not correspond to significant demands in the upper structure.

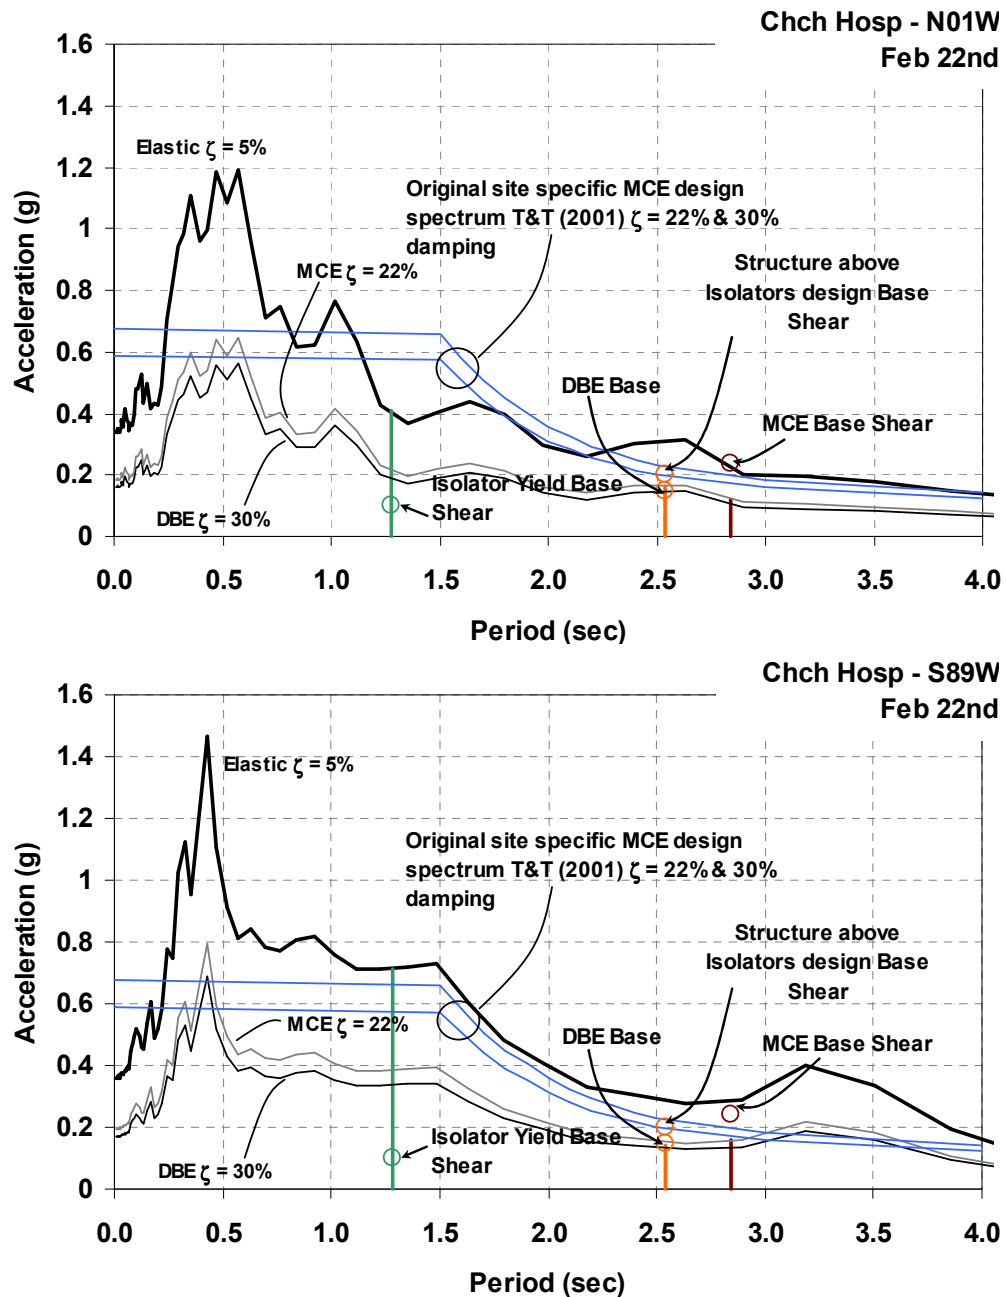
The apparent spectral response to the February 22<sup>nd</sup> earthquake is markedly different to the September 4<sup>th</sup> event. Similar to the discussion in Section 2.1 the sequential response of the building can be approximately interpreted from Figure 2-2(a) & (b).
