**ROYAL COMMISSION OF INQUIRY INTO  
BUILDING FAILURE CAUSED BY CANTERBURY  
EARTHQUAKES  
KOMIHANA A TE KARAUNA HEI TIROTIRO I  
NGA WHARE I HORO I NGA RUWHENUA O  
WAITAHA**

**STATEMENT OF EVIDENCE OF THOMAS RICHARD HAWKER  
IN RESPECT OF THE CTV BUILDING**

**DATE OF HEARING: COMMENCING 25 JUNE 2012**

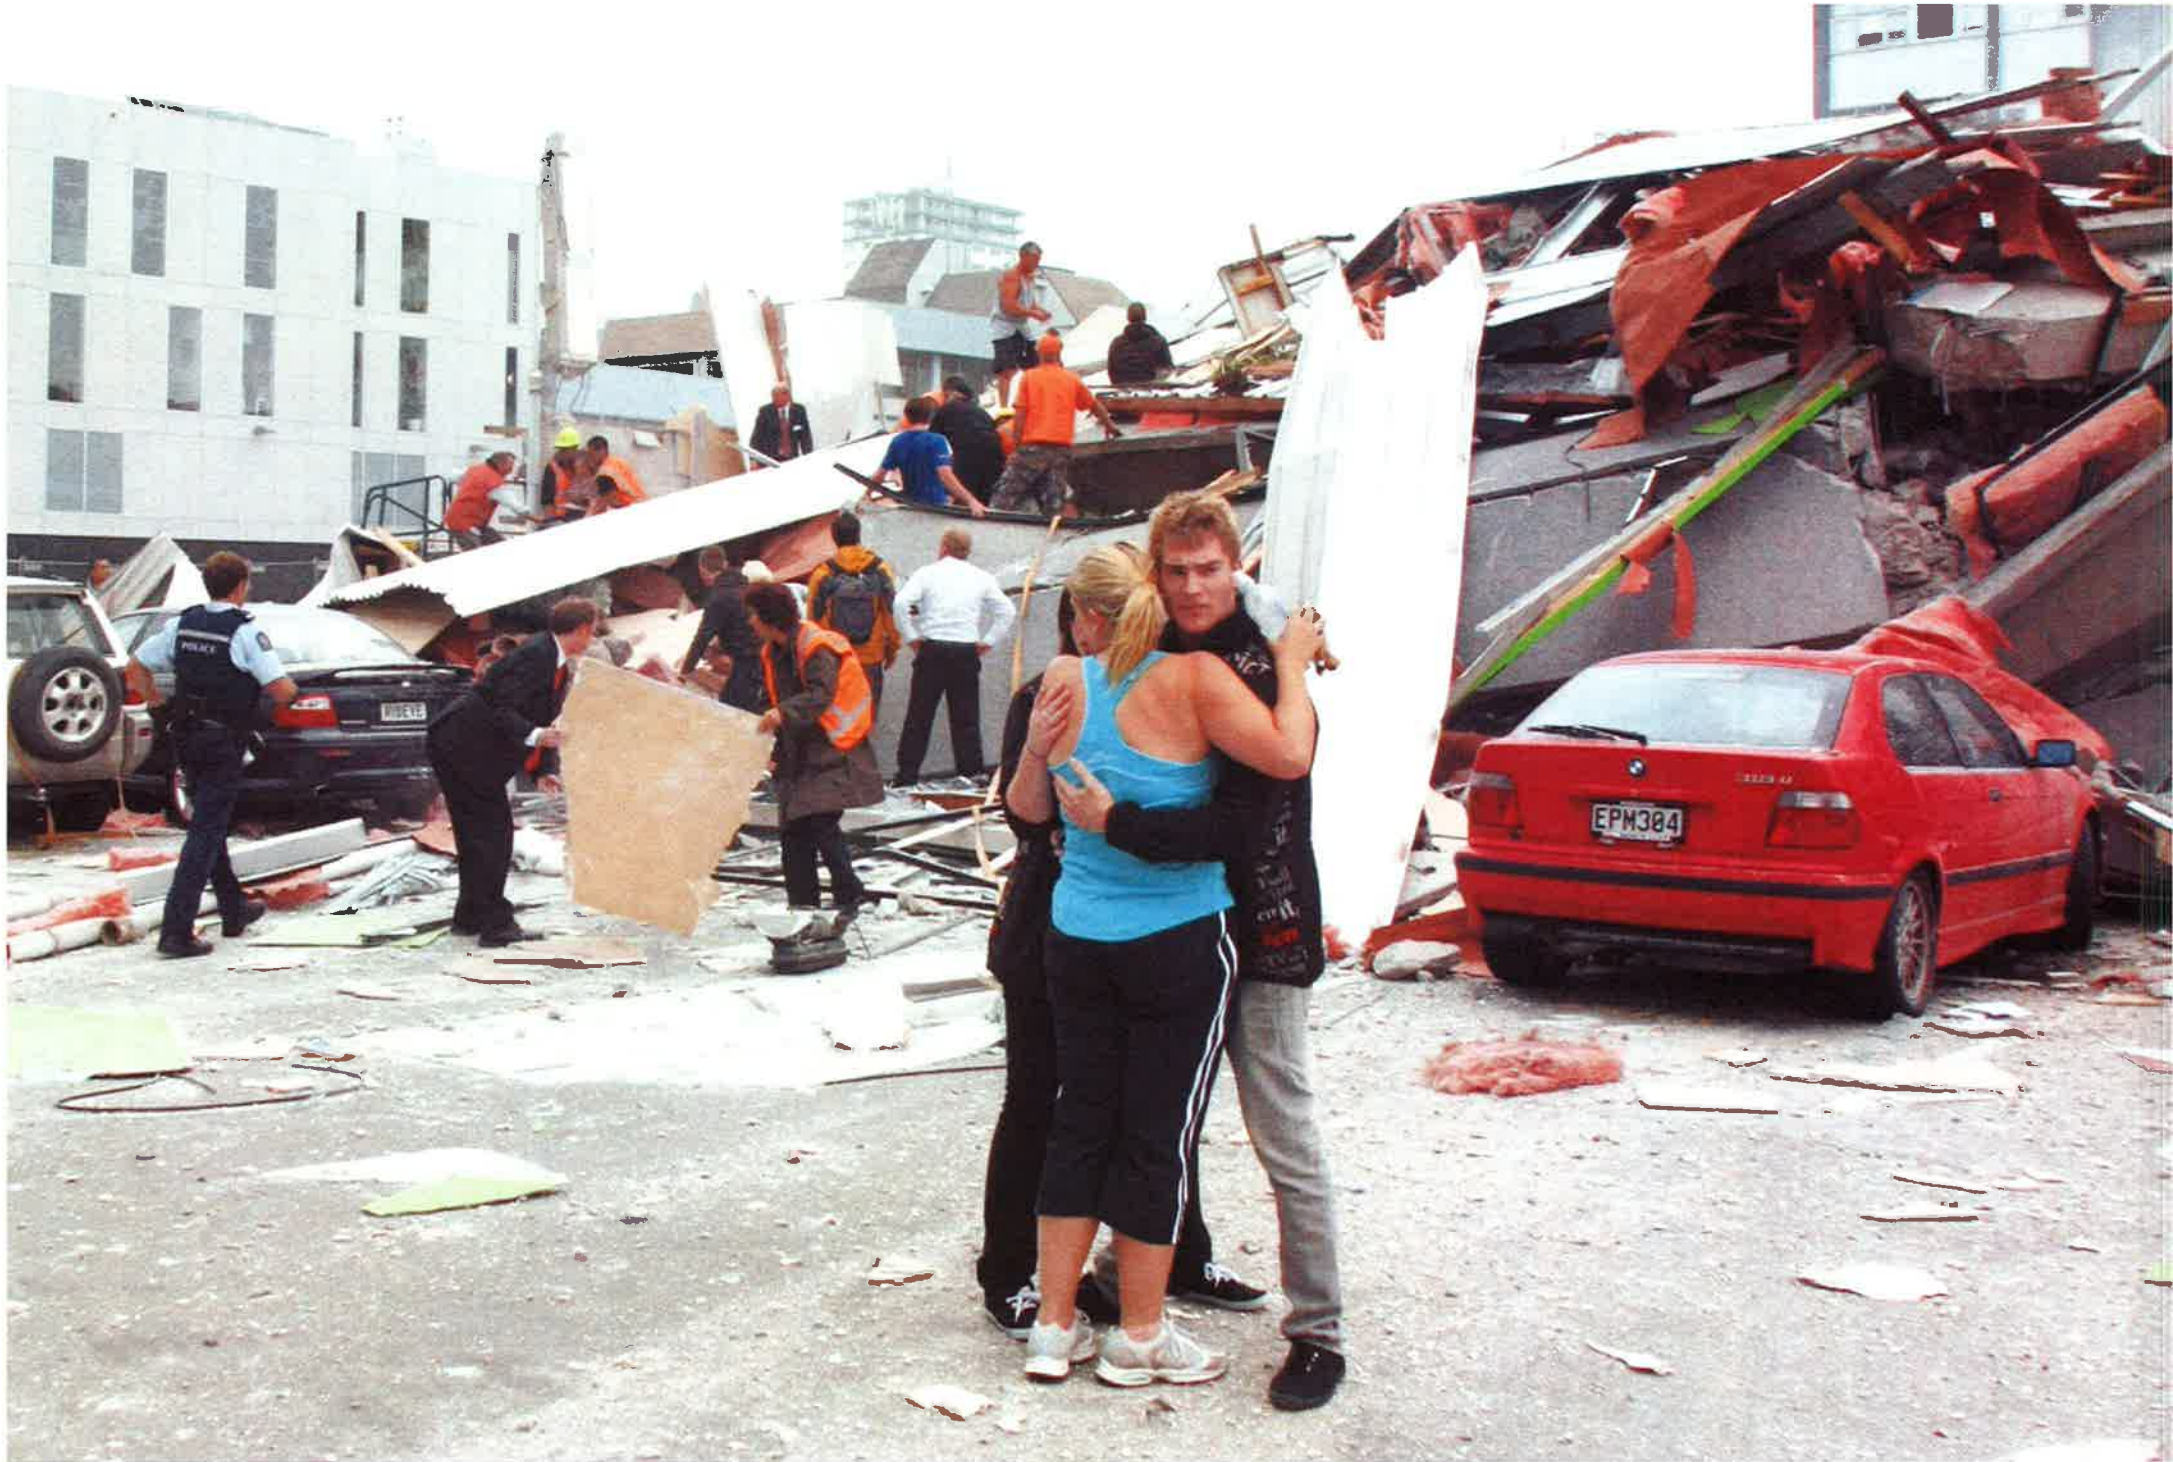
- 21 I had thought because of the way the Building was swaying it might fall towards us but it fell straight down. I know this because my car was parked right beside the south wall of the Building and I have marked its location with the letter "Y" on Plan 2. Only my bonnet, bumper and windscreen were damaged. A photograph of my car showing the damage was taken after it had been removed from the Building site. A copy of that photograph is annexed hereto and referenced WIT.HAWKER.0001.9.
