**ROYAL COMMISSION OF INQUIRY INTO
BUILDING FAILURE CAUSED BY CANTERBURY
EARTHQUAKES
KOMIHANA A TE KARAUNA HEI TIROTIRO I
NGA WHARE I HORO I NGA RUWHENUA O
WAITAHA**

**BRIEF OF EVIDENCE OF ROBERT JAMES HEYWOOD
IN RELATION TO THE CTV BUILDING**

BRIEF OF EVIDENCE OF ROBERT JAMES HEYWOOD IN RELATION TO THE CTV BUILDING

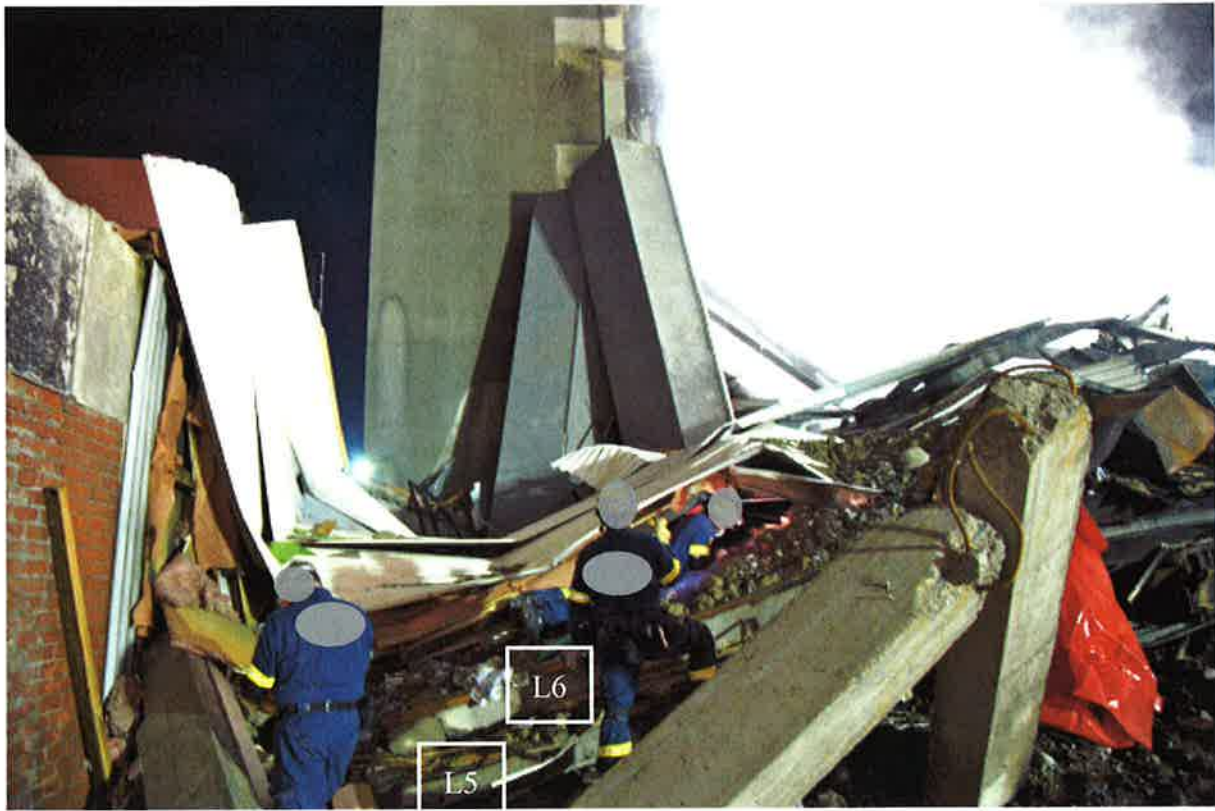
Figure 18

Northwest corner of the Building looking towards the North Core.

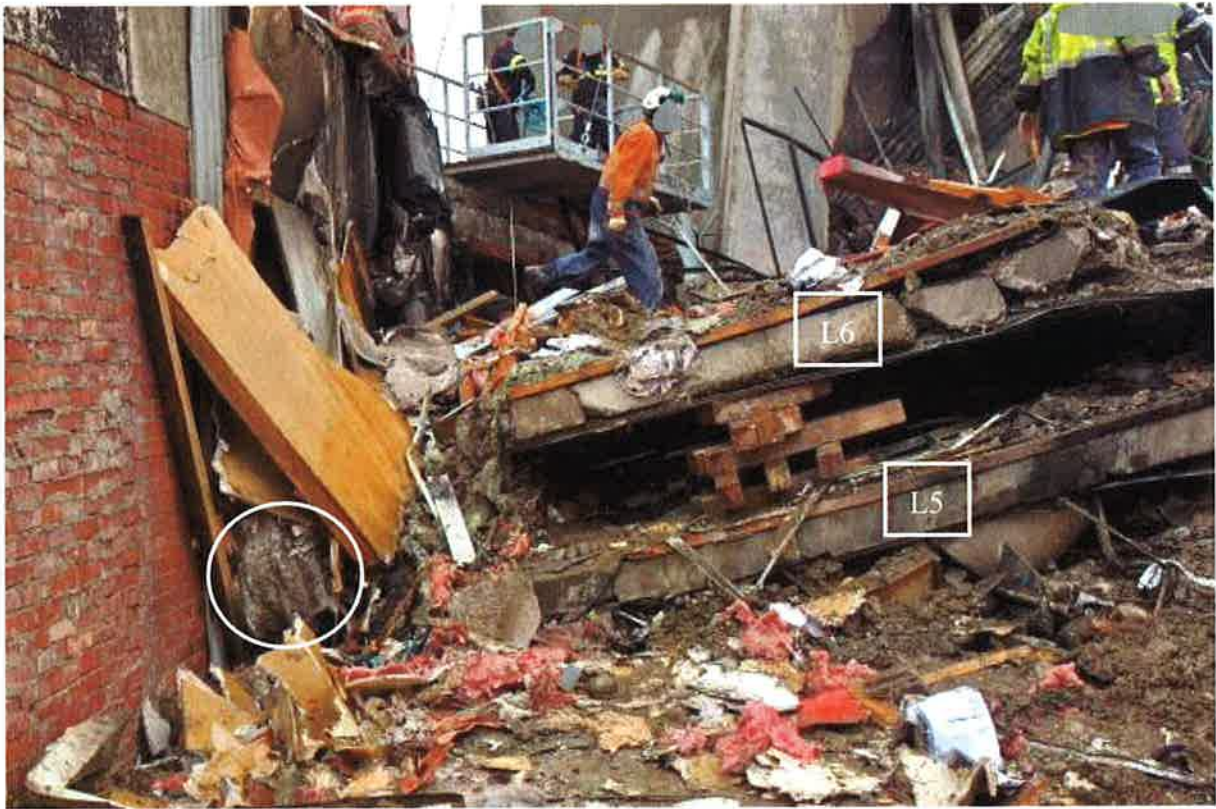
Figure 19

Northwest corner of the Building looking towards the North Core (9:10 AM 25 Feb 2011).

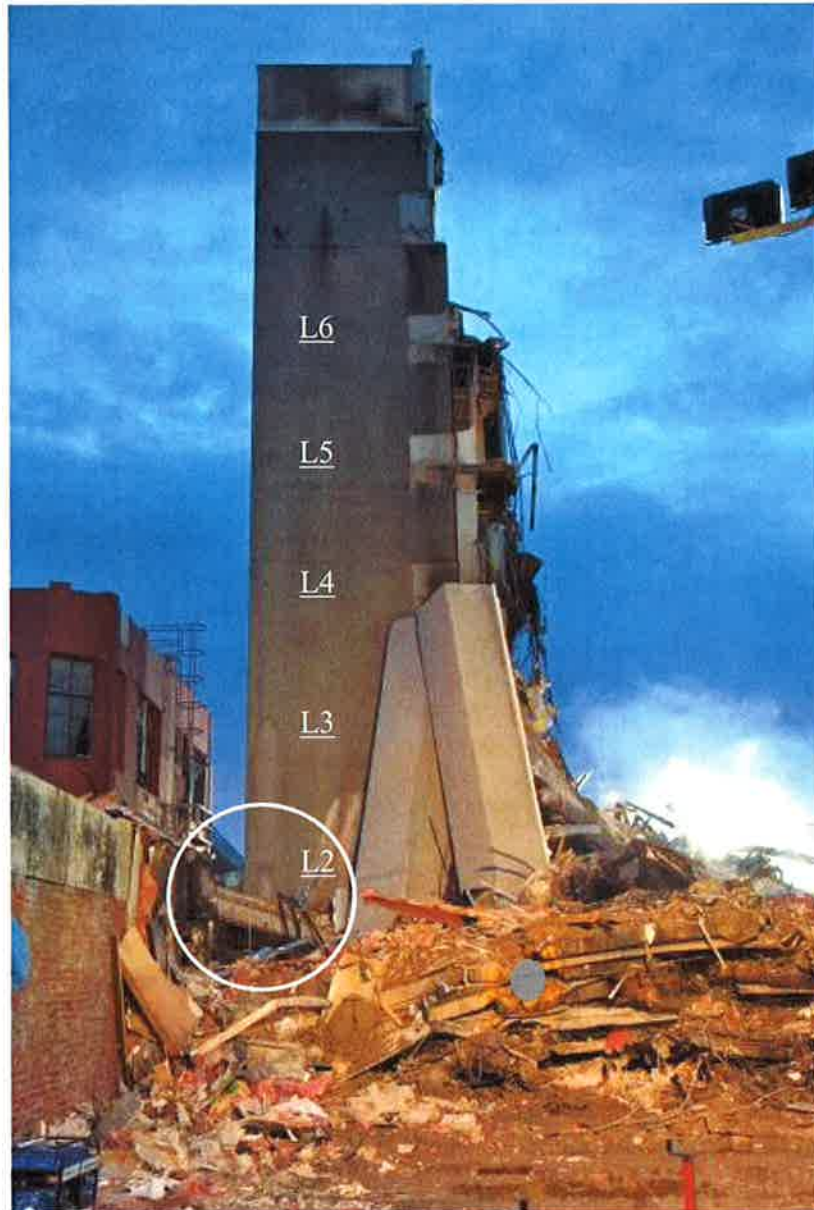
Figure 21

Western elevation of the North Core and collapsed building (5:45 AM 25 Feb 2011).

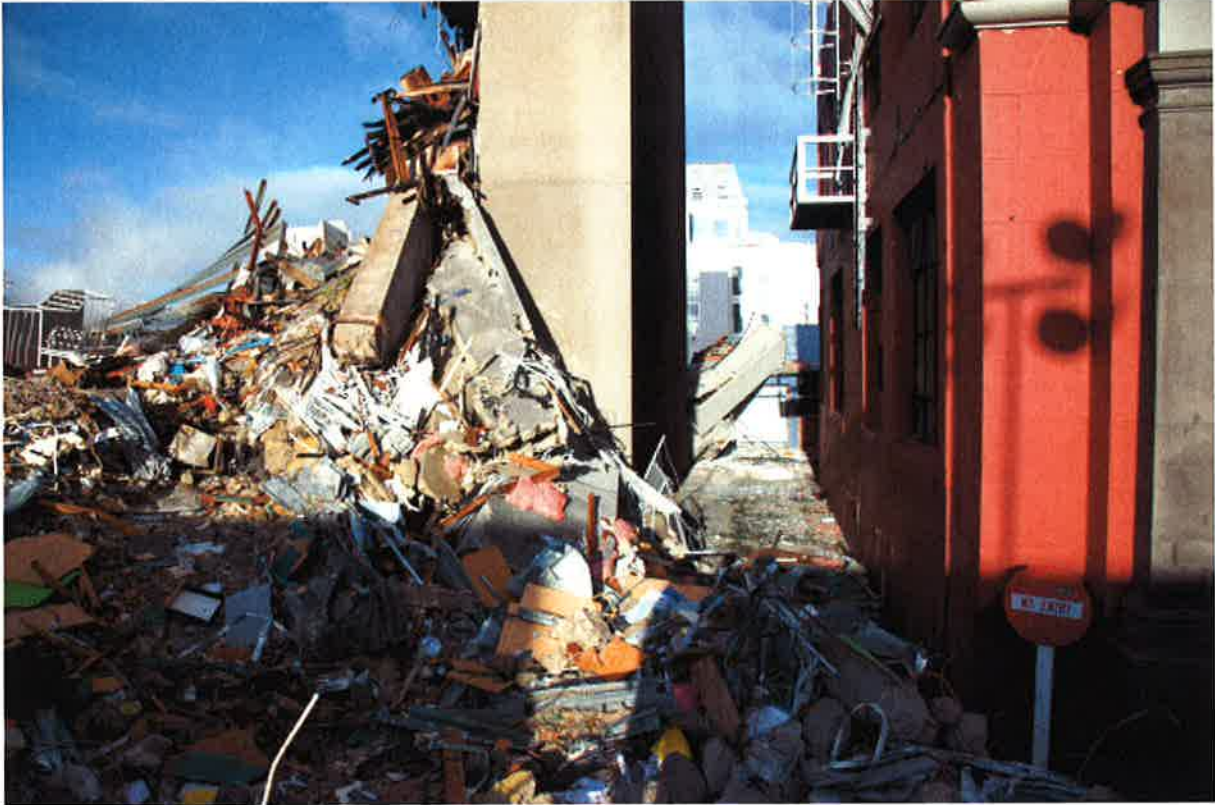
Figure 23

View of northern wall from Madras Street looking west. An edge beam and precast spandrel lie on top of the rubble. The top of the South Wall staircase and some roof framing are visible on the left and the spandrel of the northwest edge beam that fell onto the undercover car park can be seen at the end of the laneway (7:20 AM 24 Feb 2011).

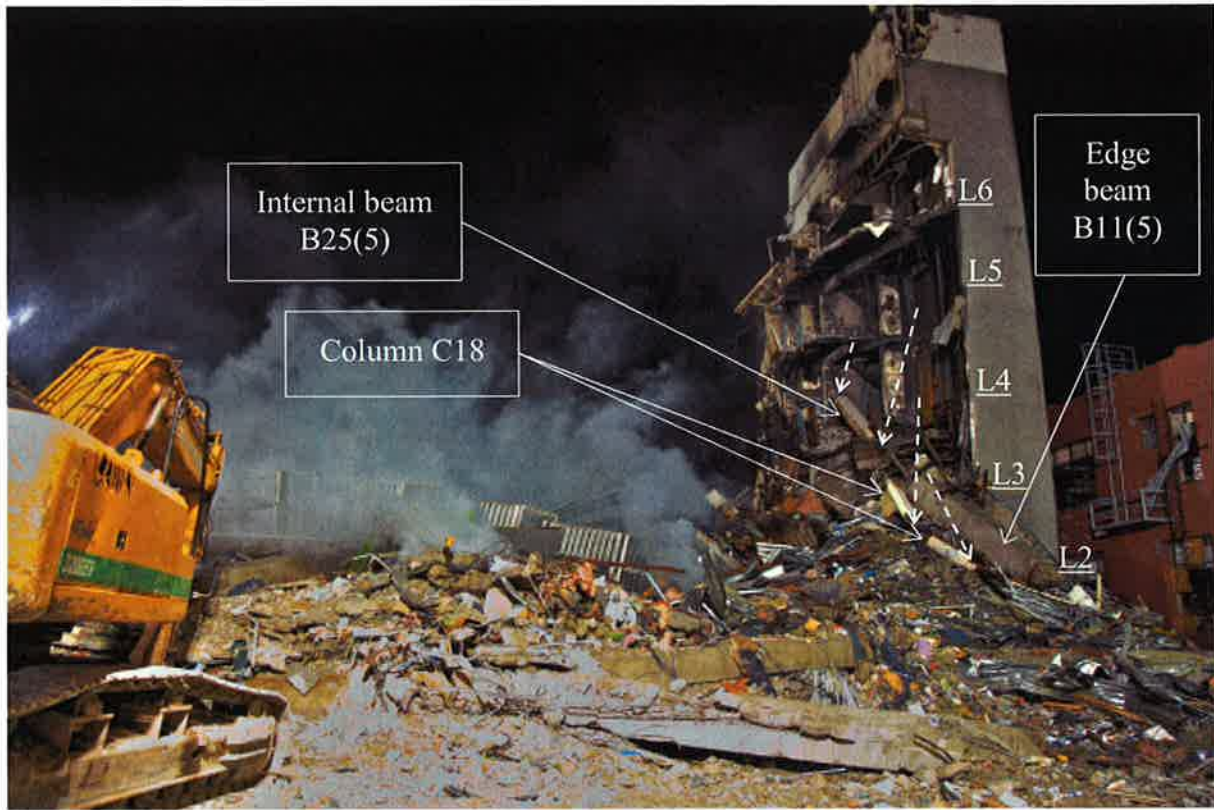
Figure 24

View of collapsed building and North Core from Madras Street looking west (4:00 AM 24 Feb 2011).

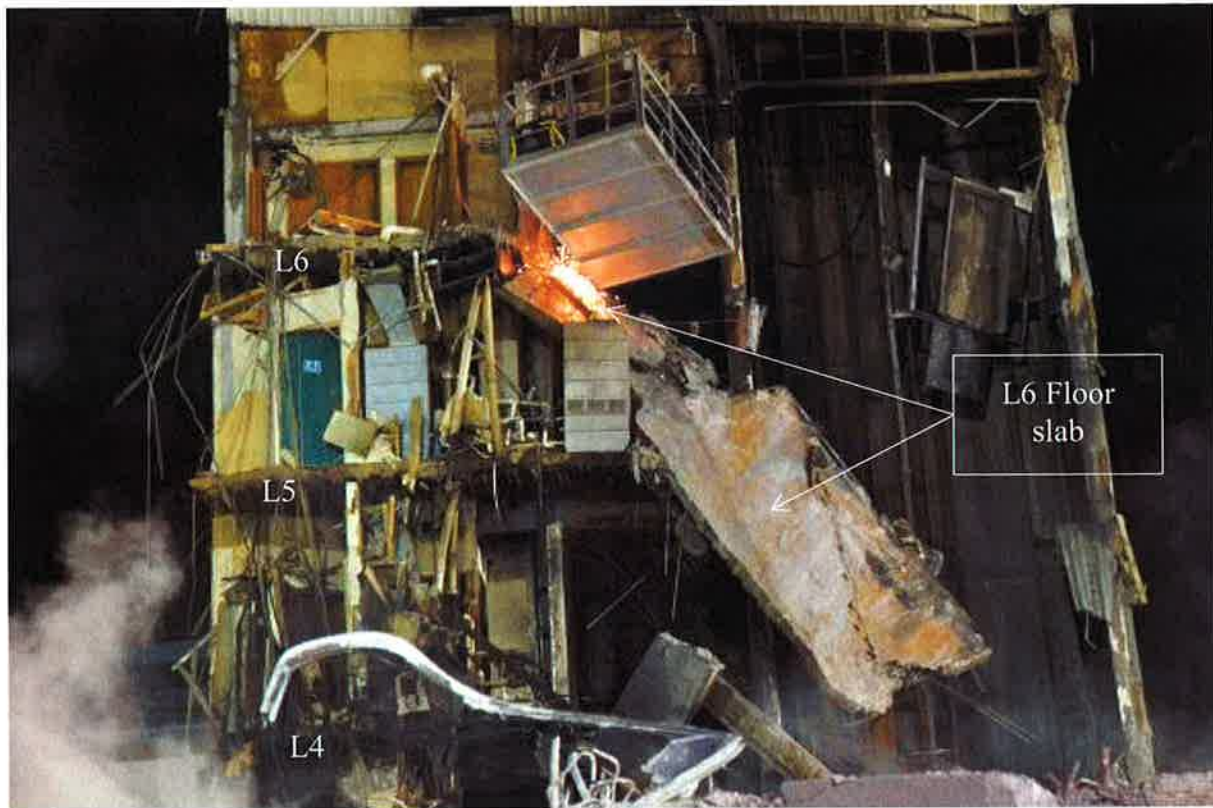
Figure 28

The remnant of the Level 6 slab being cut away from the North Core (1:00 AM 25 Feb 2011).

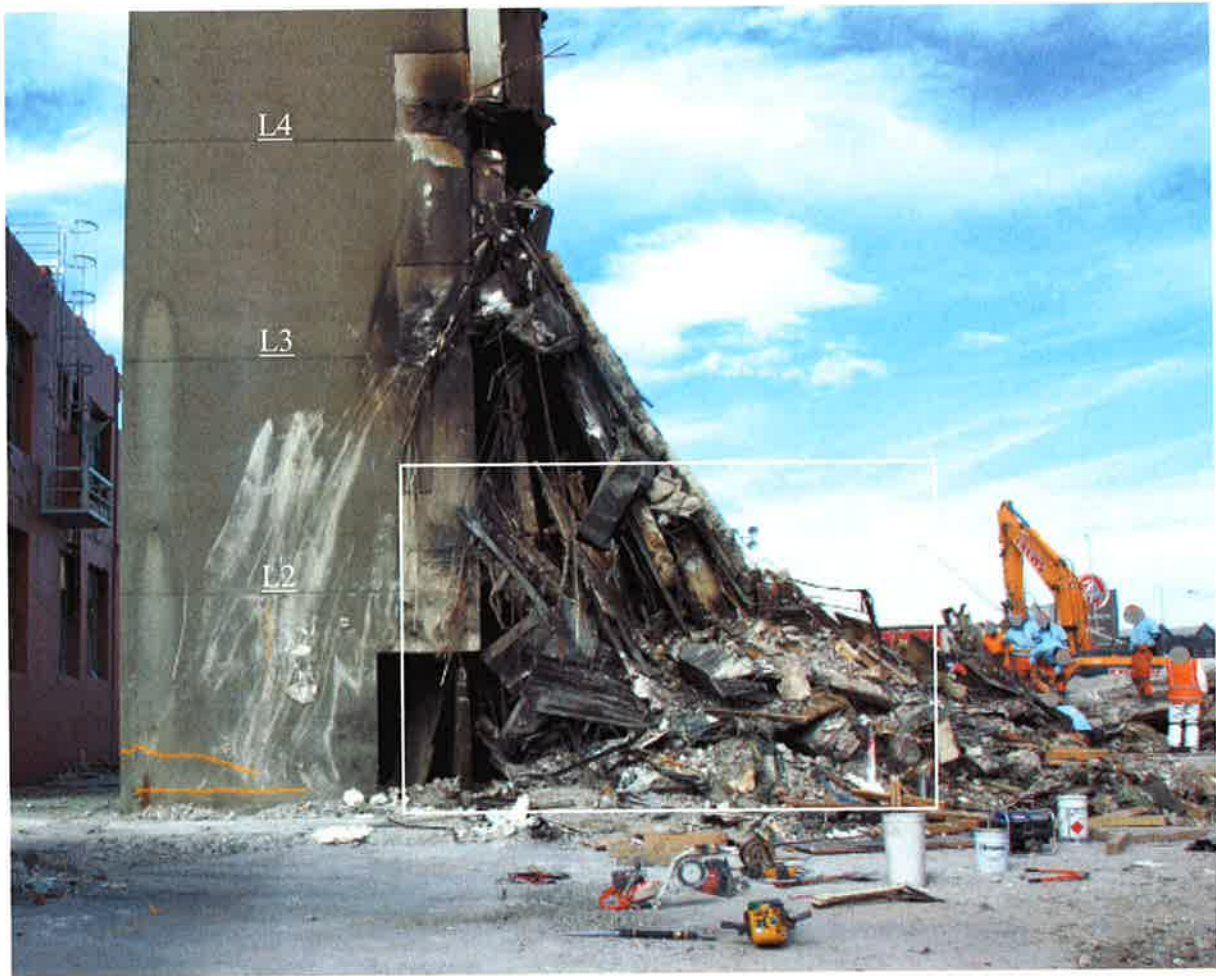
Figure 30

View of the western elevation of the North Core and the collapsed floors leaning against it (3:30PM 1 March 2011).

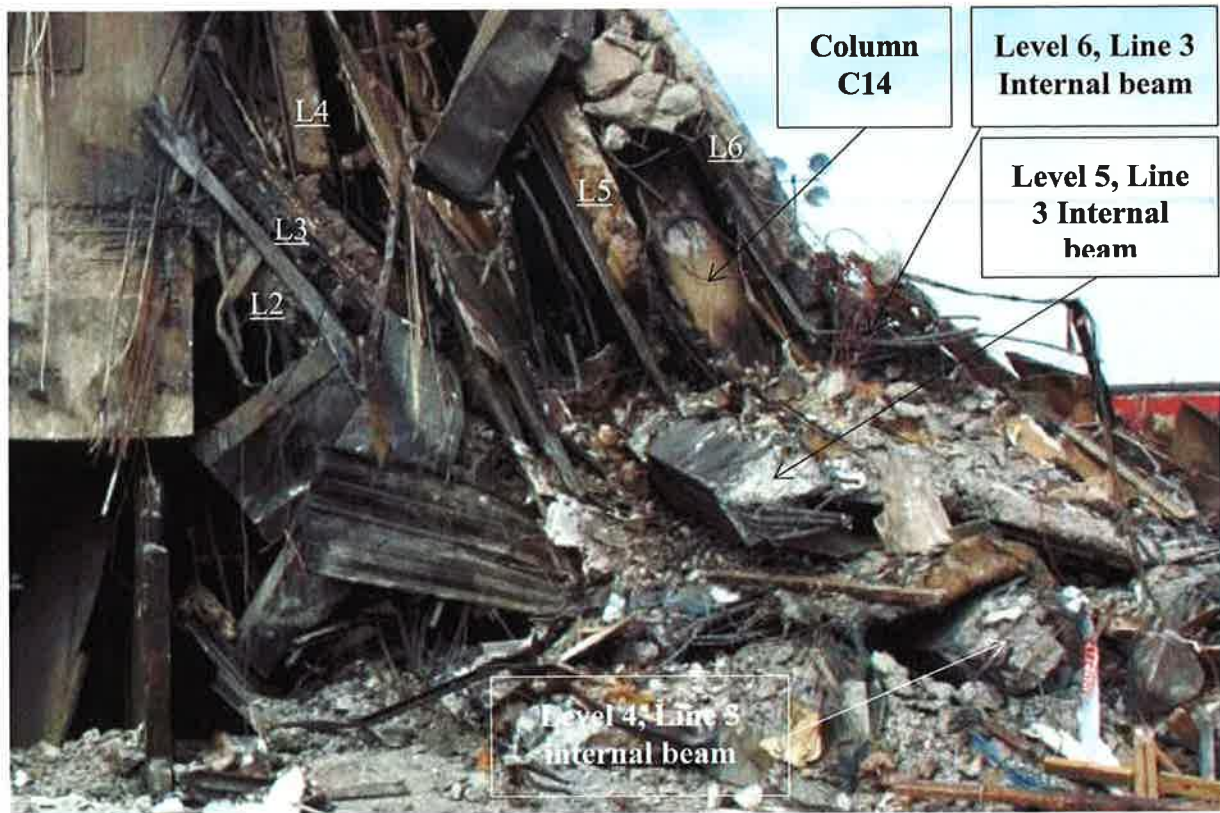
79. Two “hinges” have formed in the Level 6 floor slab at the internal beam on Line 3 – one “hinge” on the southern side of the internal beam, and the second “hinge” on the northern side of the internal beam (refer Figure 33). These hinges have rotated in opposite directions and the level of the floor slab changes level across the internal beam B10(6), which has rotated such that the top of the beam has moved towards the south compared to the bottom of the beam – or clockwise when looking east. This is the same direction of rotation evident in the Line 3 internal beam presented in Figure 31

View of the western elevation of the North Core and the collapsed floors leaning against it – the area contained in the rectangle in Figure 30 (3:30 PM 1 March 2011).

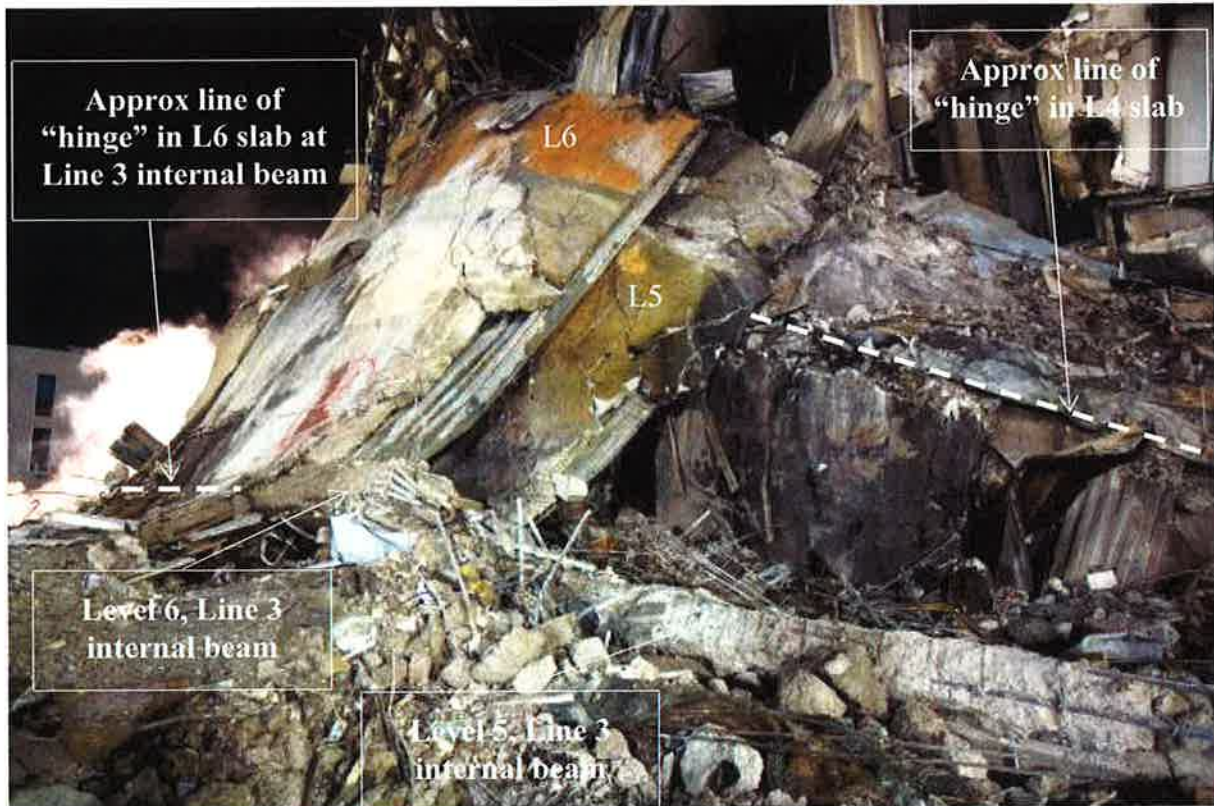
Figure 32

and Figure 32. A double “hinge” can also be observed in Figure 48 [WIT.HEYWOOD.0001.77].

View to the northwest of the slabs leaning against the North Core (4:20 AM 26 Feb 2011).

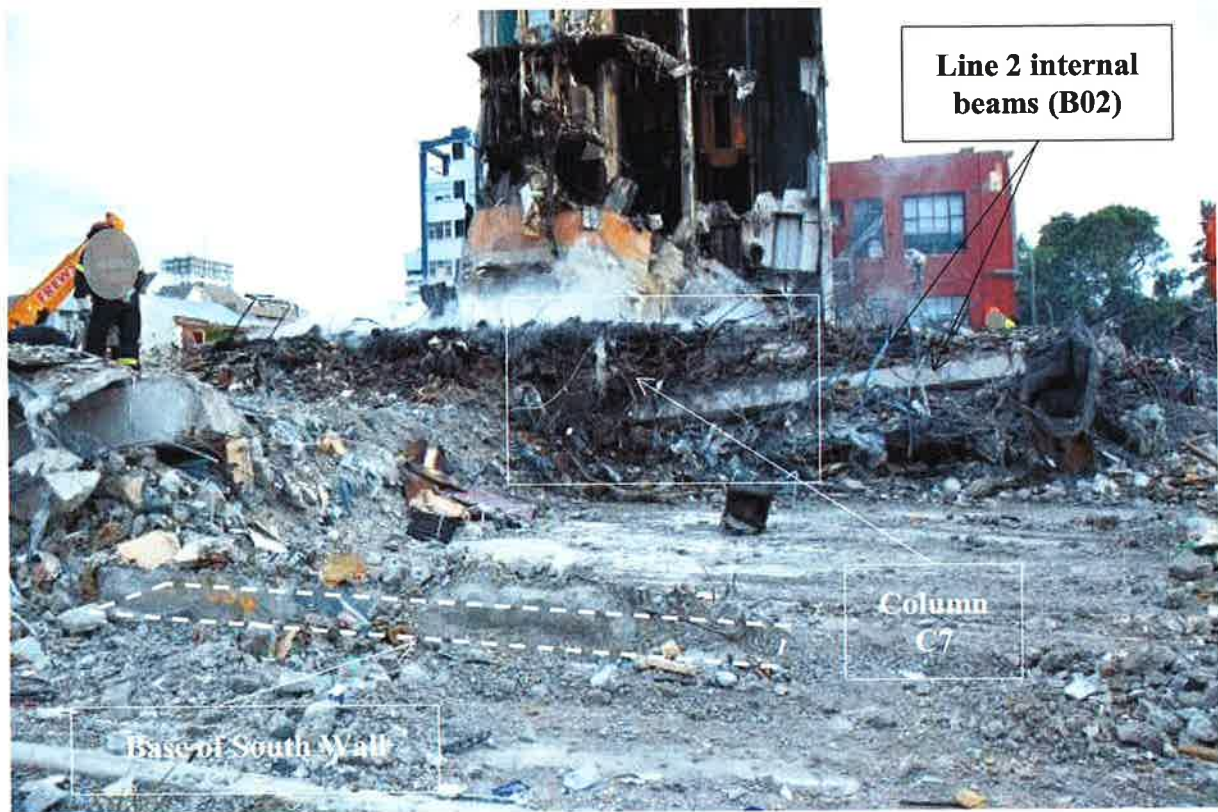
81. Two internal beams of Line 2 on the eastern side of the Building came to rest almost directly one above the other as shown in Figure 34 [WIT.HEYWOOD.0001.63] and Figure 35 [WIT.HEYWOOD.0001.64]. The South Wall and the floors to the south of Line 2 and to the east of Line D had been completely removed, exposing the beams on Line 2. The floor levels of the two beams that are visible are not known – probably upper floors.

View towards the north of the Line 2 internal beams and the North Core after the South Wall and the floors between Lines 1 and 2 had been removed. A more detailed view of the area approximately enclosed by the rectangle is presented in Figure 35.

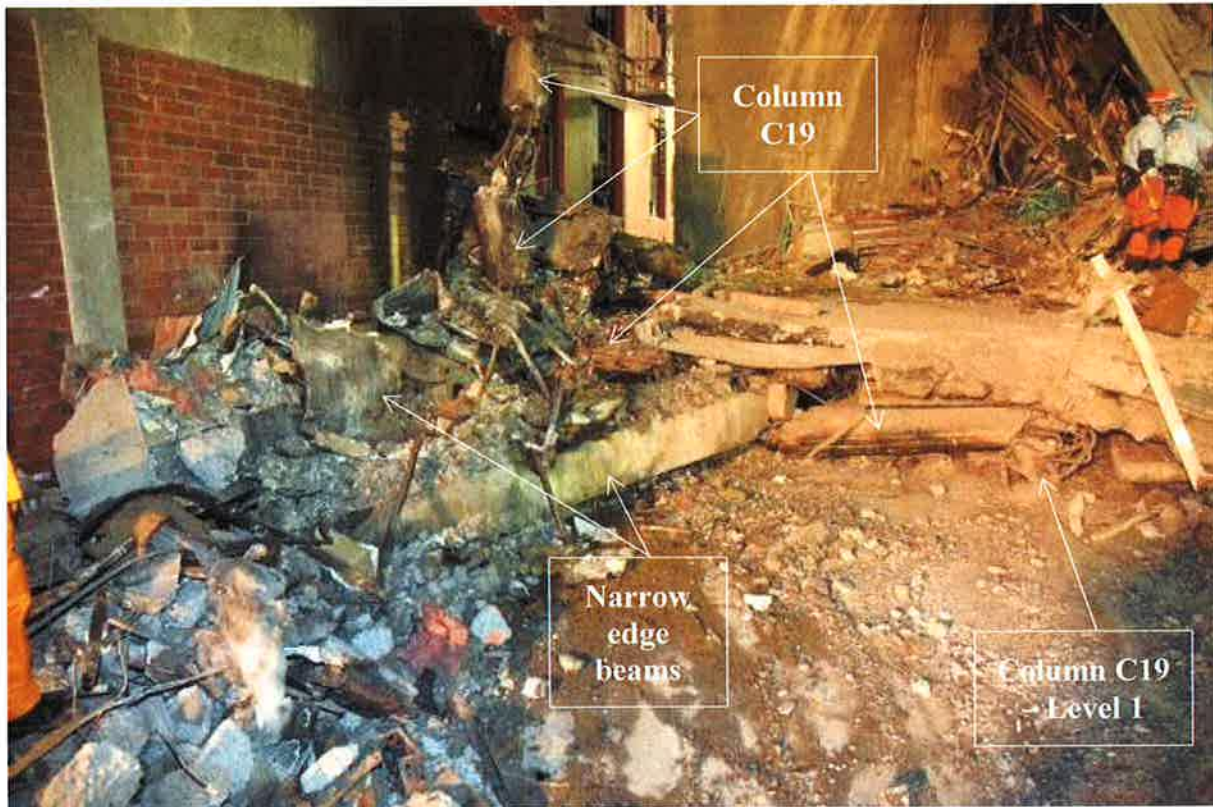
93. Column C19 on the northern elevation collapsed against the brick wall of the adjacent undercover car park (refer Figure 36 [WIT.HEYWOOD.0001.65]). The path of the column is complex. C19 appears to have been moved with the collapsing edge beams. The ends of the edge beam attached to C19 came to rest near the base of the North Core, on top of the roof of the adjacent car park, near the base of the adjacent car park, near the base of the North Core, and between those last two points.
94. Like the columns on the western wall, two storey-long segments of column C18 remained intact and joined by the column reinforcement. These columns came to rest on top of the floors they once supported. C19 is unique in that it was connected to the top of the North Core and so could support some loads even if the columns below had been lost.

View of the northwest corner of the Building looking towards the North Core after removal of edge beams, spandrel panels and some of the floor slabs. (3:50 AM 27 Feb 2012).
