# SUBMISSION TO THE ROYAL COMMISSION OF INQUIRY:

# AN ALTERNATIVE COLLAPSE SCENARIO FOR THE CTV BUILDING

John B. Mander PhD, F.IPENZ Inaugural Zachry Professor Texas A&M University College Station, TX 77843, USA

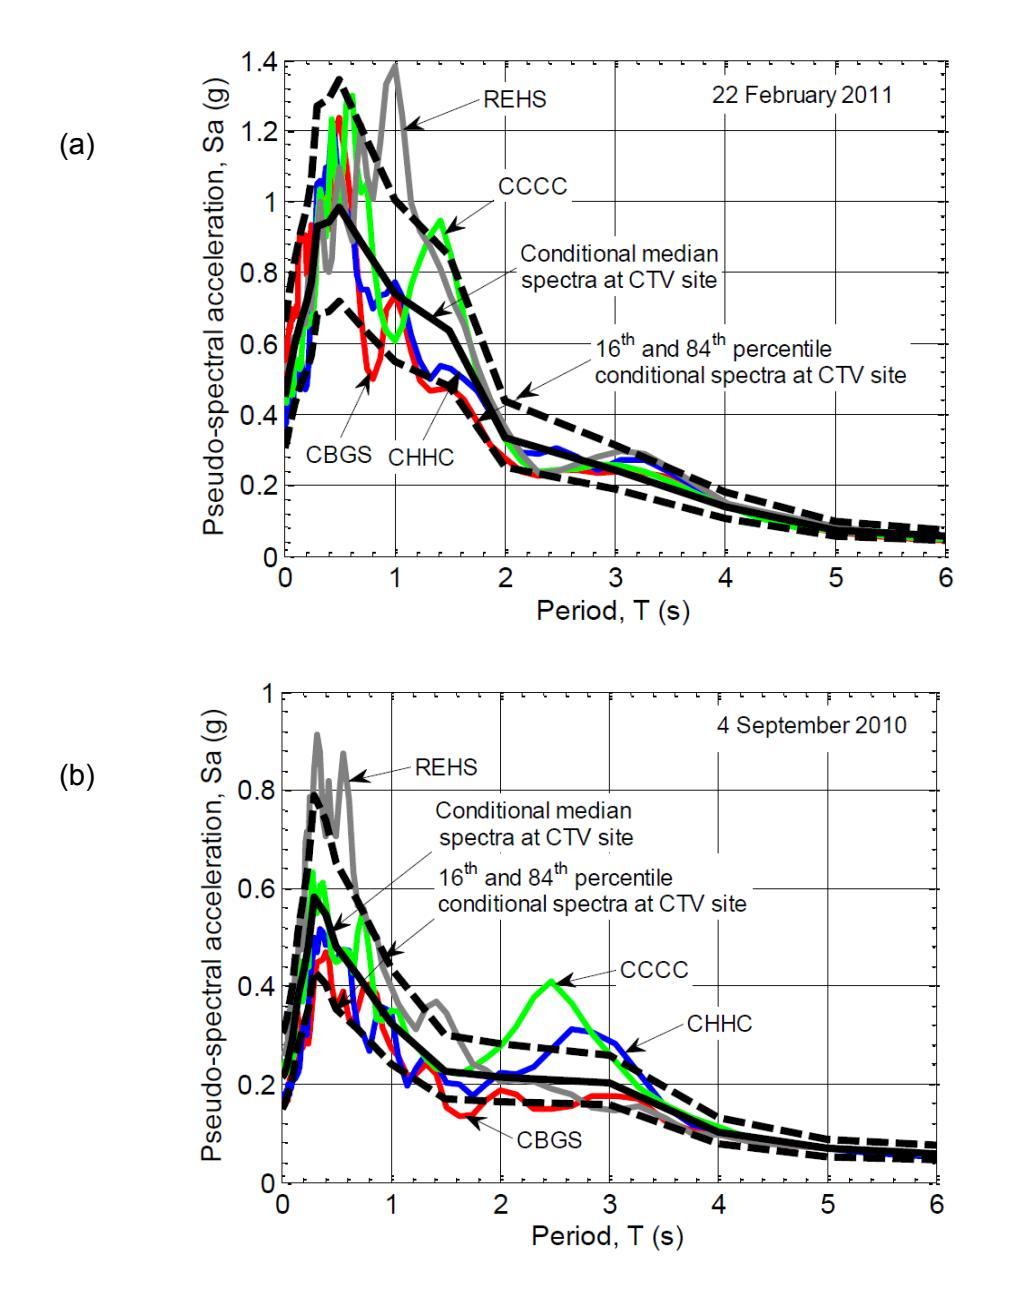
# Figure 2.1. The range of seismic demands expected at the CTV Building site showing the 16th, 50th and 84th percent fractals for: (a) the Christchurch Earthquake; and (b) the Darfield Earthquake.

Although the CTV Building had a natural period of vibration in the order of T = 1.0 seconds, due to inelastic response the Compusoft results show that the CTV Building vibrated at about 1.5 seconds and 2.0 seconds for the E-W and N-S directions, respectively. Over this particular range, the four ground motions fall mostly within the 16 to 84<sup>th</sup> percent fractals of probable behavior at the CTV Building site for both the Christchurch Earthquake and the Darfield Earthquake. Based on this analysis, there appears little reason to remove any one ground motion station from the suite.

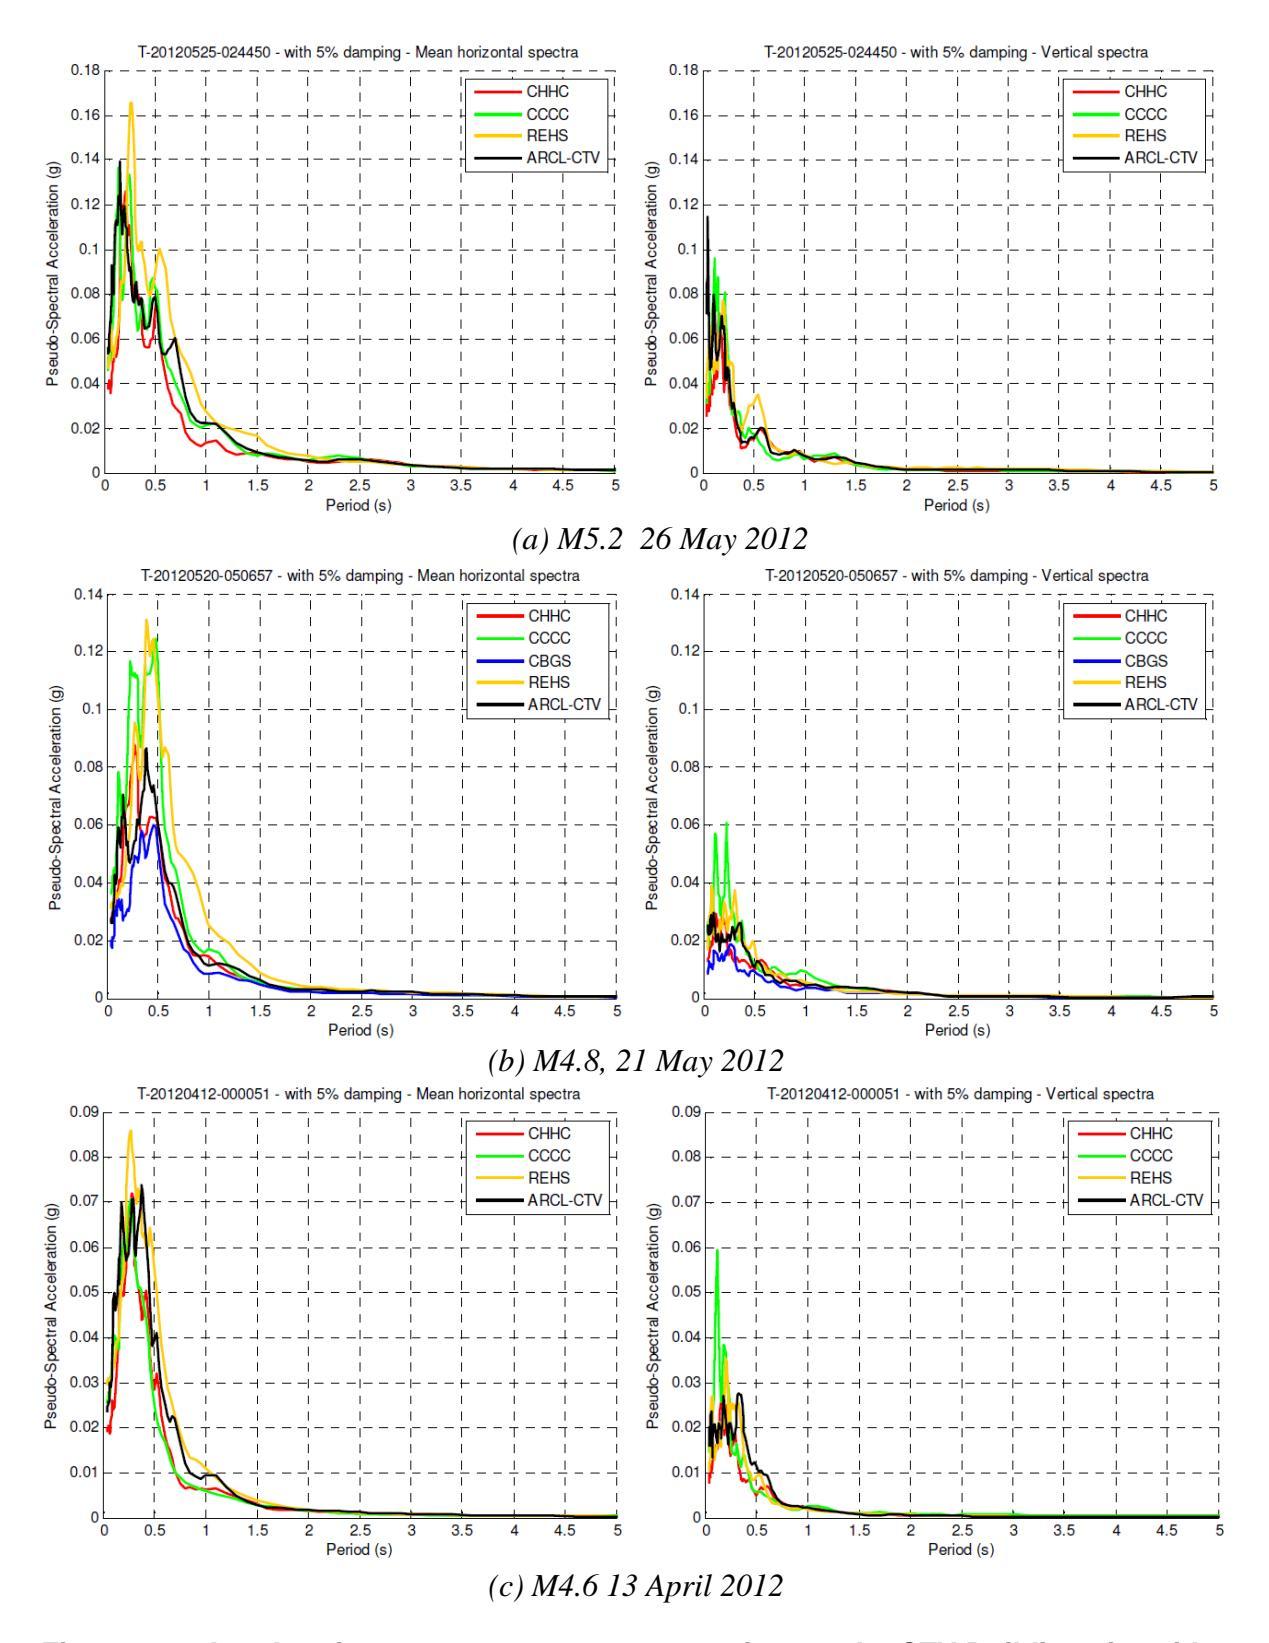
As shown in Figure 2.2, the CTV Building motion generally lies in between the CCCC and REHS results. Perhaps on reflection, this similarity should not be surprising, as the CTV Building site lies midway between the CCCC and the REHS stations, forming almost a straight line-of-sight back to the epicentral region.

- (i) The three records that were used by Compusoft to analyze the likely response of the CTV Building should continue to be used. Further, the REHS station ground motion that was not used by Compusoft displays similar responses to the other three recording station (CHHC, CBGS and CCCC) ground motions that were used. This confirms Bradley's assertion that there was no valid reason to exclude the REHS station from the Christchurch CBD station suite; the REHS site should be included in the four-record suite for any future analyses.
- (ii) The CTV Building records are all evidently bounded by one or more of the other earthquakes in the four-station suite of CBD ground motions. This independently validates Bradley's class of conditional seismic demand envelop that also encompasses the CTV Building site.

Figure 2.2. Acceleration response spectra comparison at the CTV Building site with the other Geonet recording stations within the Christchurch CBD (when actively recording).

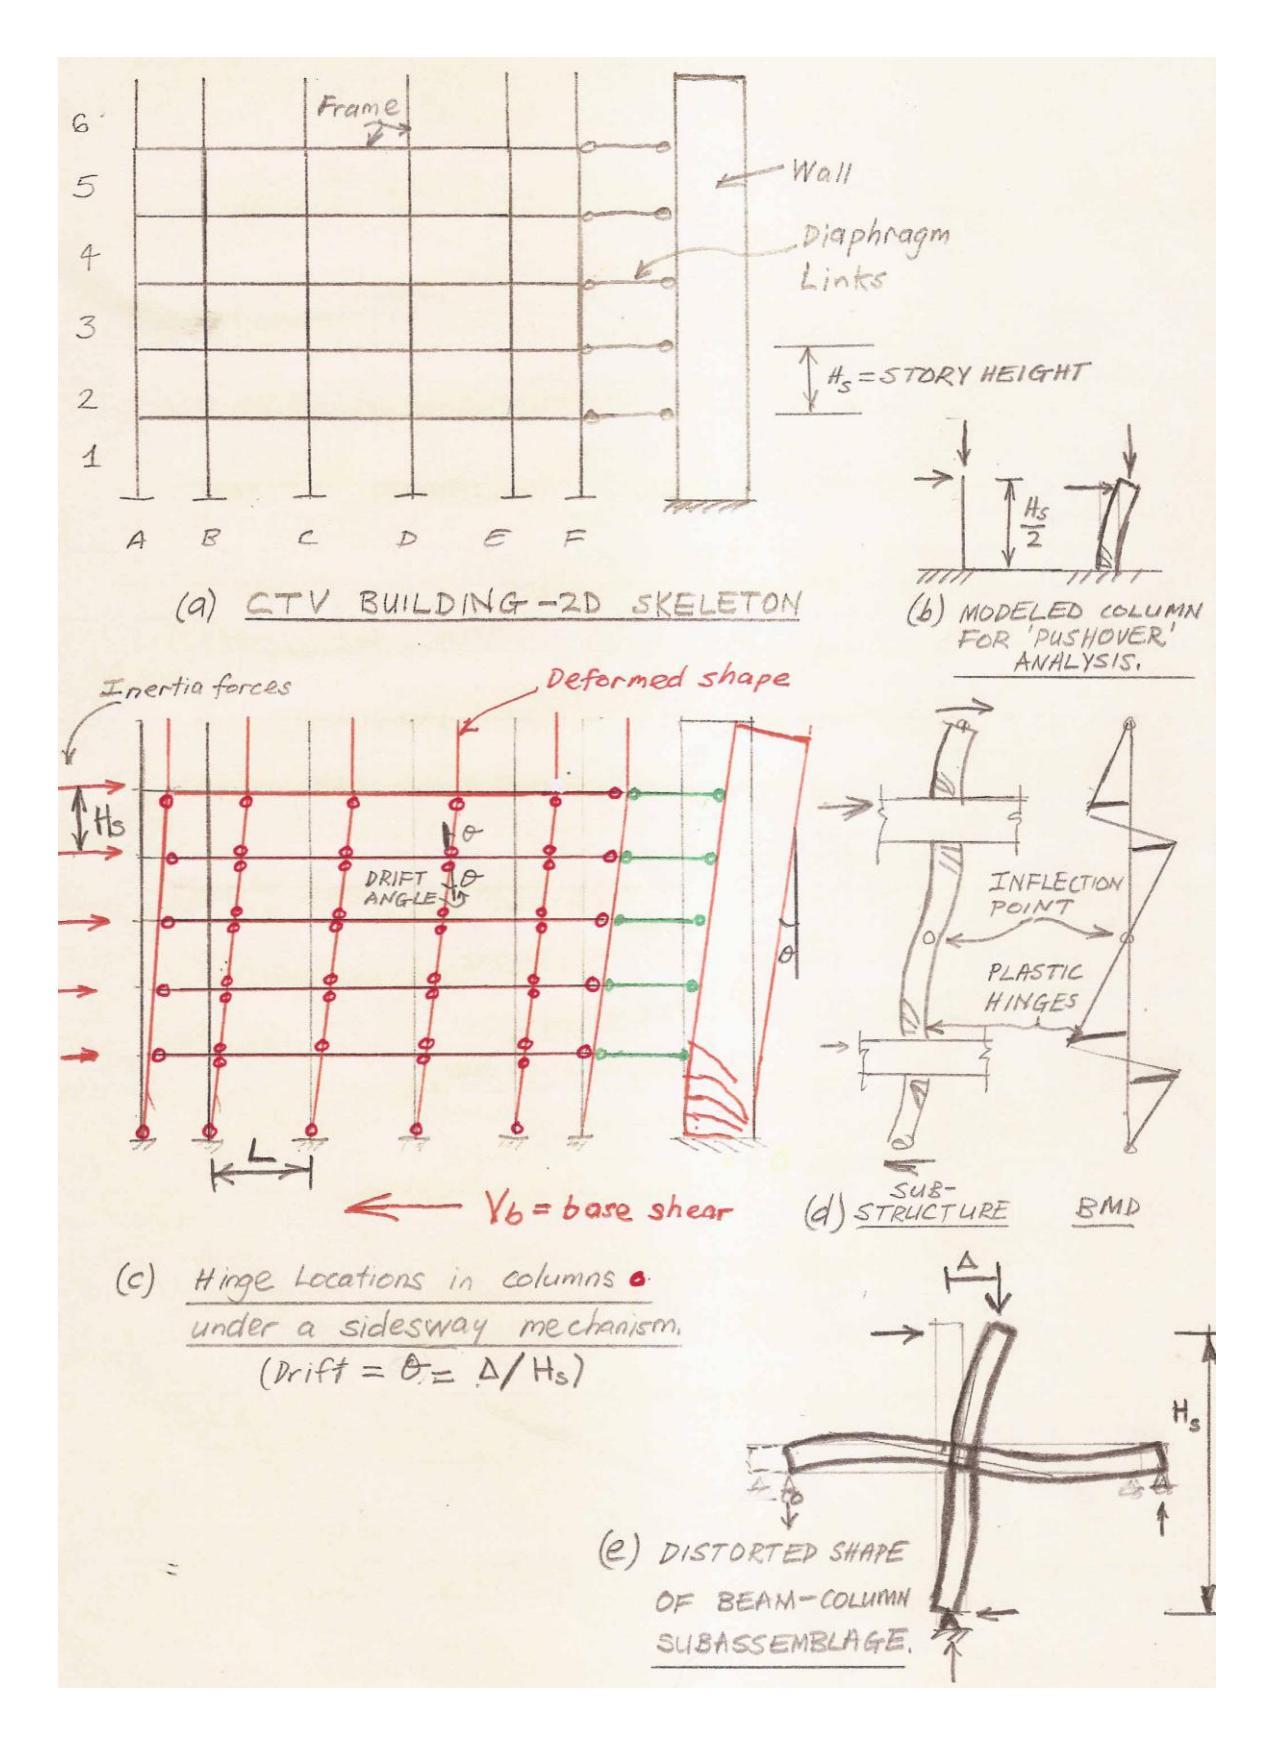
As shown in Figure 2.5, during an earthquake, the drift on any one story in the frame ( $\theta_t$ ) is imposed by the displacement compatibility with the North Core (shear wall) and South shear wall of the CTV Building—both the frames and the walls are constrained to have the same drift angles.

Figure 2.5. Initial seismic behavior of the CTV Building in a "sidesway mode"

The interstory drift for each story level is essentially constant, thereby putting the columns into double *bending* with inflection points at mid-story height. Thus over the height of the walls, the subassemblage representations shown in Figure 2.5(b) and also Figure 2.5(d) and 2.5(e) are a reasonable approximation of general seismic performance.

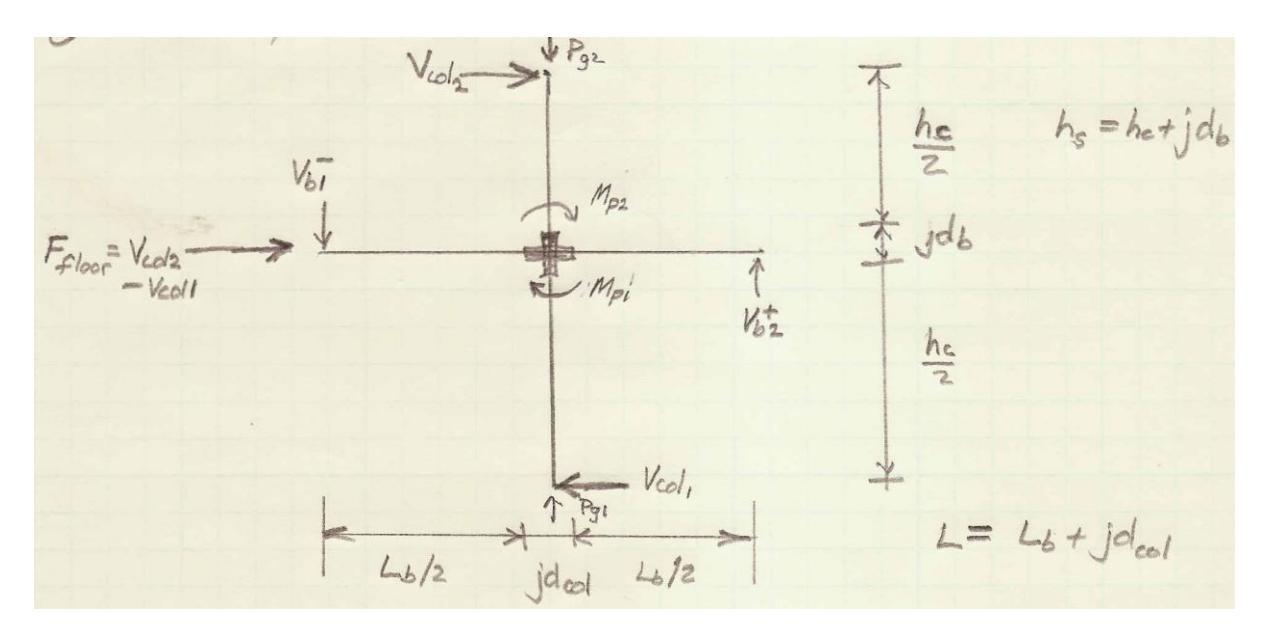
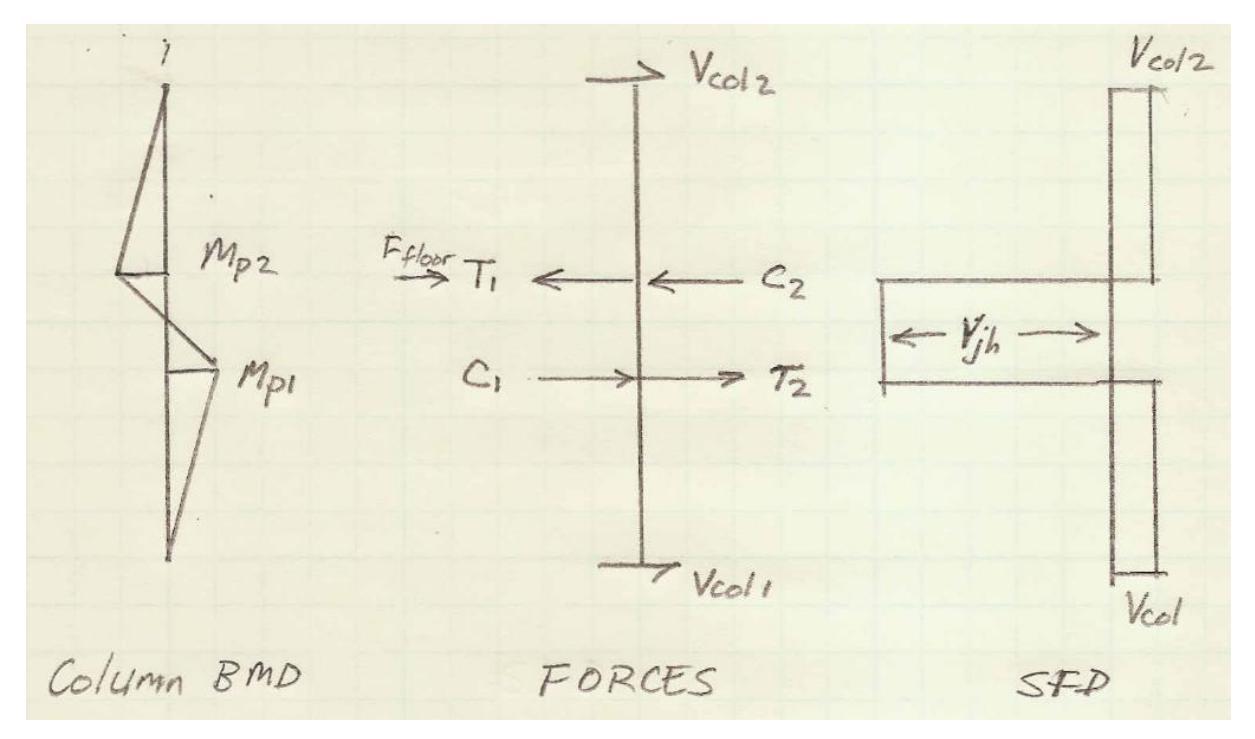
#### Figure 2.8. An interior beam-column joint subassemblage

The problematic high joint shear stress intensity is illustrated via the analysis presented in Figure 2.8. First, a subassemblage is extracted, as shown previously shown in Figure 2.5(e). The force actions at the inflection points (which are at the end of the members shown) are shown in Figure 2.8(a). Next, if the beams are removed, their effect must be replaced by applying equivalent beam-end forces arising from the loads carried by the reinforcing bars going into and out from the joint region, as depicted by Figure 2.8(b). The left-hand side of Figure 2.8(b) shows the bending moment diagram (**BMD**) for the column, including the effects through the joint region. By differentiating the column BMD over its member length, the shear force diagram (**SFD**) is derived as shown on the right hand side.  $V_{jh}$  is the (horizontal) shear force intensity through the joint; calculations show that this will be some 5.3 times greater than the column shear force, ( $V_{col}$ ) for the CTV Building.

(a) A typical interior beam column joint subassemblage showing the seismic loading actions under the frame, sidesway from left to right.

(b) The column extracted from the subassemblage in (a) above. Note: the beams have been removed, but the incoming and outgoing forces provided by the beam reinforcement are shown instead.

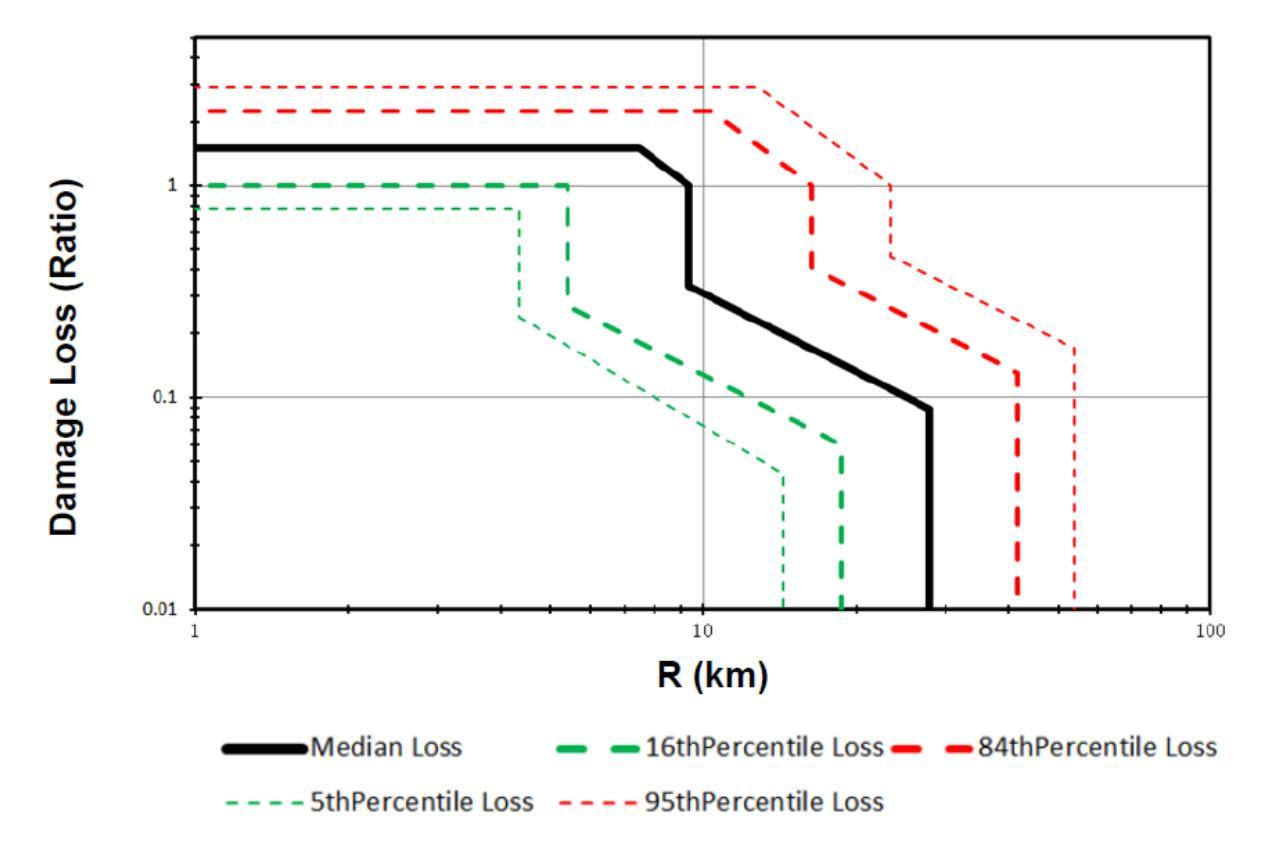
Figure 2.11. Damage loss attenuation of the Redbook Building for the Christchurch Earthquake. (Note, the loss ratio is defined as the repair to replacement cost with respect to the construction cost prior the earthquake when stable economic conditions existed. R is the distance from the epicenter of the earthquake to the location of the building under consideration.)

The extent of the CBD ranges from some 5 to 9 km from the epicenter. From an examination of Figure 2.11, it is evident that most structures (at least some 70%), particularly those closer than 10 km to the epicenter would not (theoretically) survive, and would require demolition and reconstruction. In fact there is already sufficient anecdotal evidence to support this analytical result. Thus in spite of modern buildings being constructed to "textbook" standards, they could not have been expected *a priori* to survive the Christchurch Earthquake.
