ROYAL COMMISSION OF INQUIRY INTO
BUILDING FAILURES CAUSED BY CANTERBURY
EARTHQUAKES

BRIEF OF EVIDENCE OF CLARK WILLIAM KEITH HYLAND
IN RELATION TO THE CTV BUILDING

DATE OF HEARING: COMMENCING 25 JUNE 2012

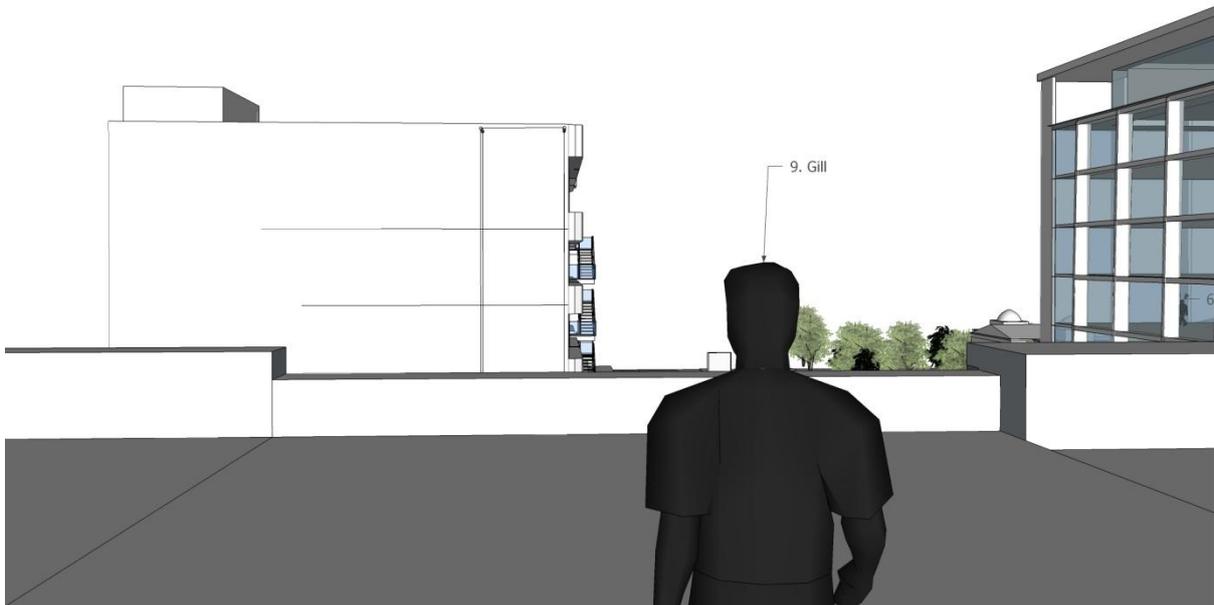
Figure 15 - View as seen by Stephen Gill from the top of the Les Mills Building. It seems to indicate that when he recalled seeing the bottom of the southwest corner column kicking out that it could have been the Level 3 to 4 column as it may have been at the bottom of his immediate field of view at that moment. See the review of his Statement of Evidence on page 23.

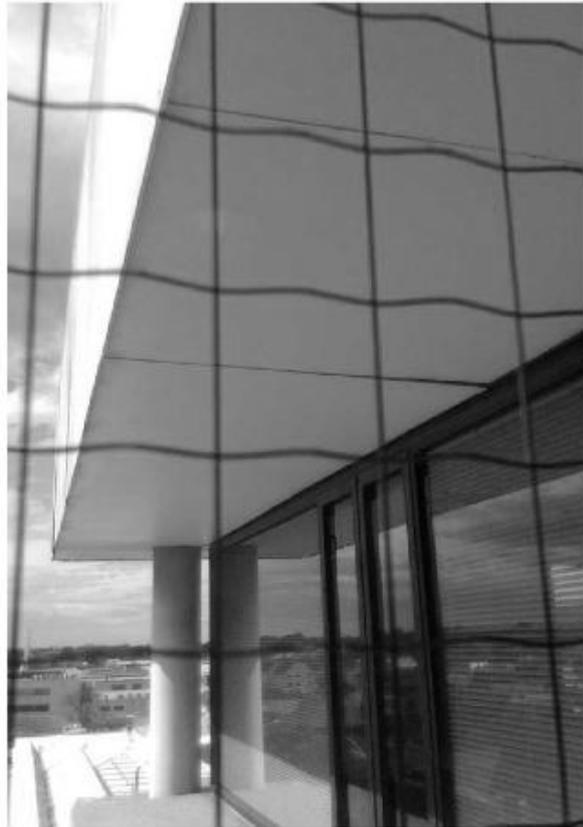
037

The cracking seen in the photos by Peter Higgins and Leonard Pagan in conjunction with the brownish coloured water damage to the attached ceiling indicates that severe damage had occurred to the connection of the column into the North Core. I was not previously aware of this damage.

Figure 22 - Collection as photographed by Pagan. Photo 37 shows the damage to the connection of the Column C18 into the North Core overhead wing wall on Line D/E.
