Submission to the Canterbury Earthquakes Royal Commission, on the role of professional societies in the engineering sector

A Sordid Saga of Corruption and Incompetence within the New Zealand Marine Industry and the Engineering Profession

Appendix 1 (Silver Wing)

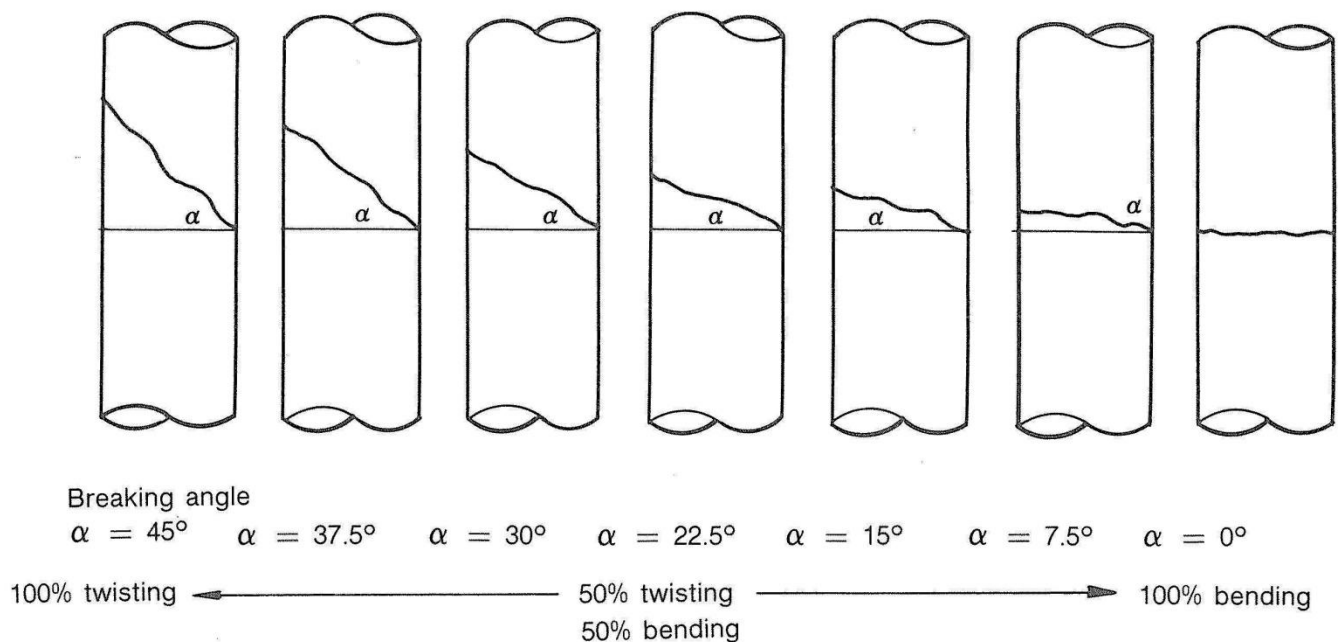
2. A bending overload failure would result in a break angle of 90° to the camshaft axis. This will not generate a sigmoidal breakage as proposed by Dr Gregory. The description of the failure mode by Dr Gregory is in error. Once this report was available to the plaintiffs, Timothy H. Smithson decided to do a destructive bending test on the Callagher camshaft to simulate this failure as proposed by Dr Gregory. This test showed that a bend overload failure generates a fracture at 90° to the camshaft axis. This is shown in Figure 25 from the Nissan Diesel Motor Co. "Classification and Analysis of Metal Part Failures" Pub. No. AMUDA88E/00.

Figure 25: Failure illustration showing breakage angle of metal caused by a variety of bending and twisting loads (From Nissan Diesel Motor Co. Handbook Pub No. AMUDA88E00).
