**79 CAMBRIDGE TERRACE
CHRISTCHURCH**

SITE INVESTIGATION REPORT

Reference Number: 3984

Date: 29 November 2011

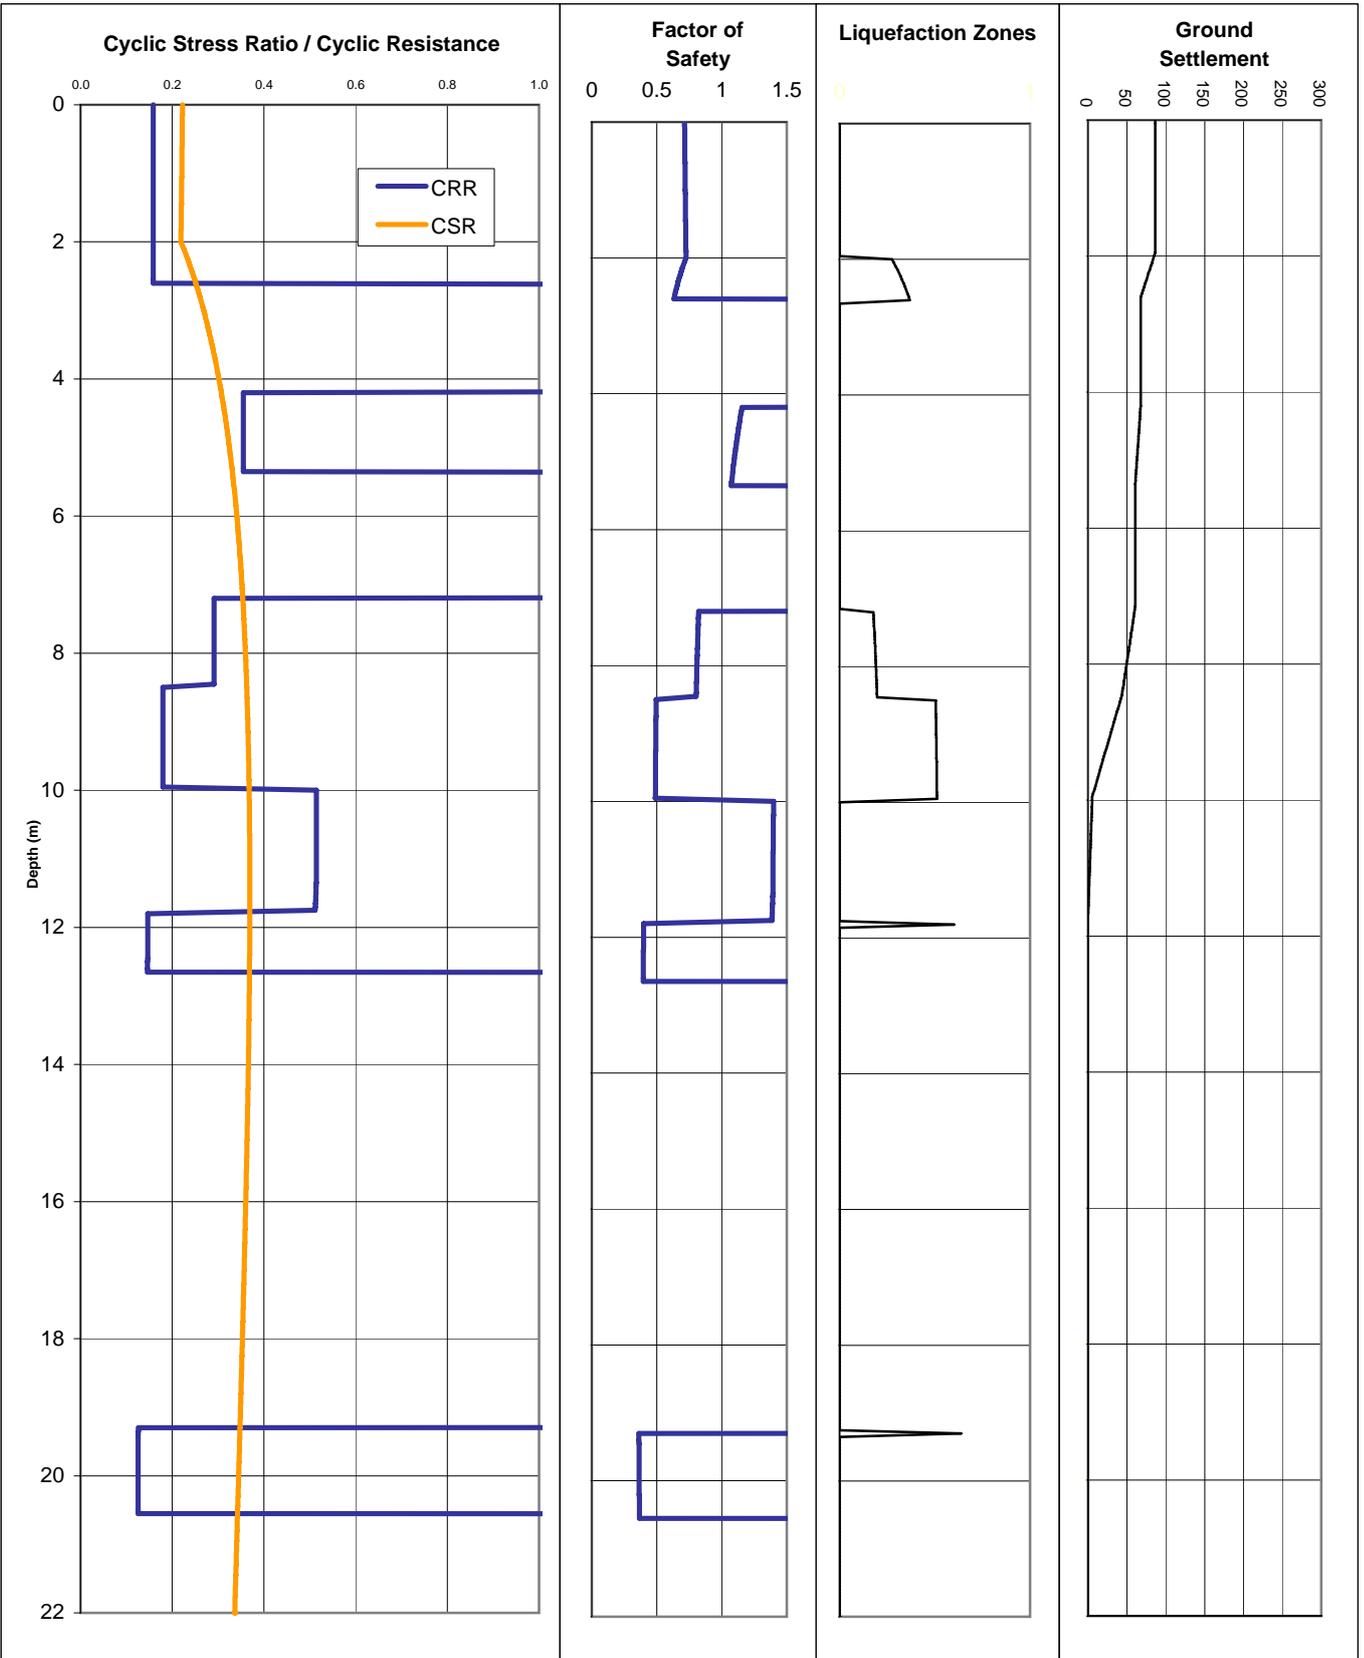
GEOTECH	<h2 style="margin: 0;">Liquefaction Potential Analysis</h2> <h3 style="margin: 0;">GEOTECH CONSULTING LTD</h3>		
	Project: 79 Cambridge Terrace Client: Buchanan & Fletcher Ltd	Hole No: BH1 Job No: 3984

Note: Based on Idriss & Boulanger (2006) and Ishihara & Yoshimine (1992) **ULS**
 $a(g) = 0.34$ M = 7.5

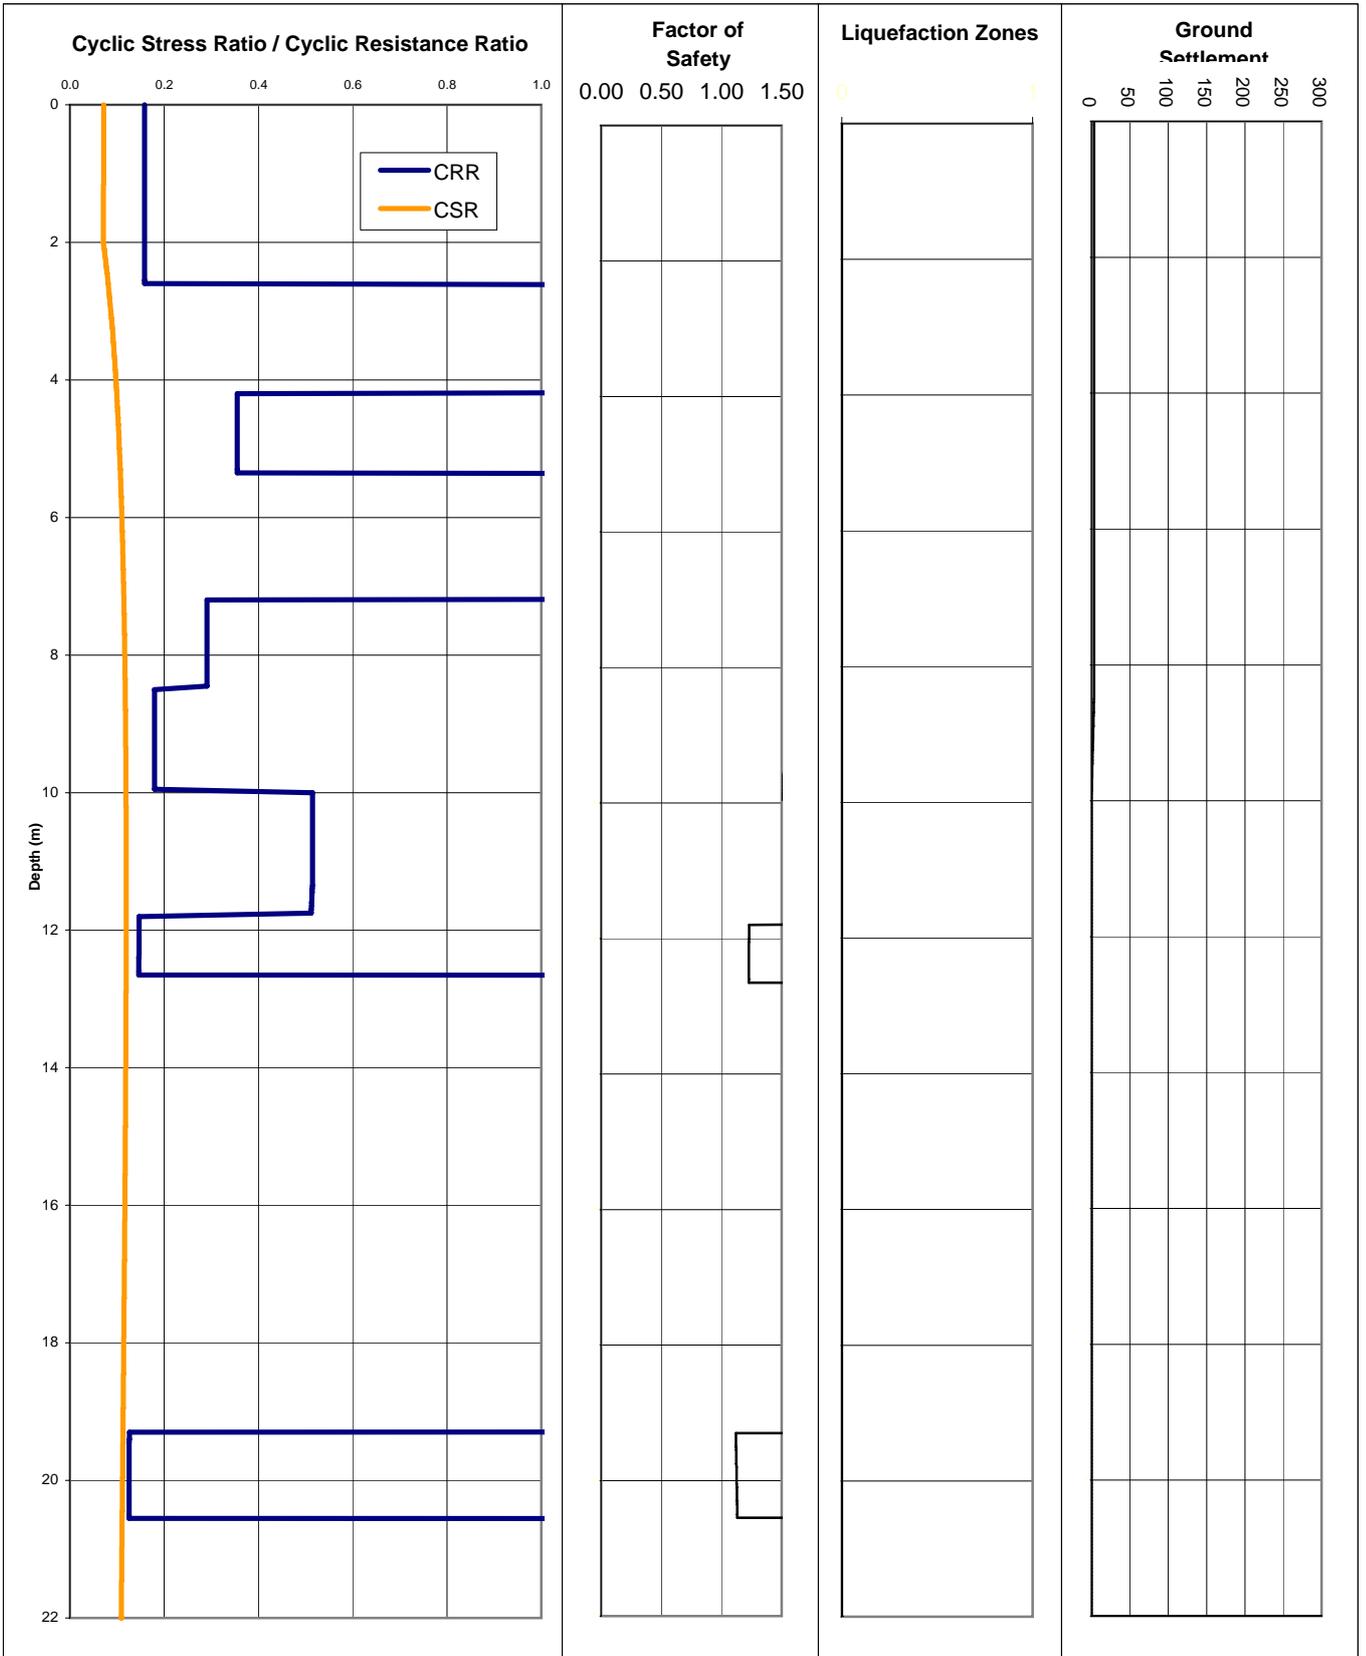
GEOTECH	Liquefaction Potential Analysis		
	GEOTECH CONSULTING LTD		
	Project:	79 Cambridge Terrace	Hole No:
Client:	Buchanan & Fletcher Ltd	Job No:	3984

Note: Based on Idriss & Boulanger (2006) and Ishihara & Yoshimine (1992) **SLS**
 $a(g) = 0.11$ **M = 7.5**

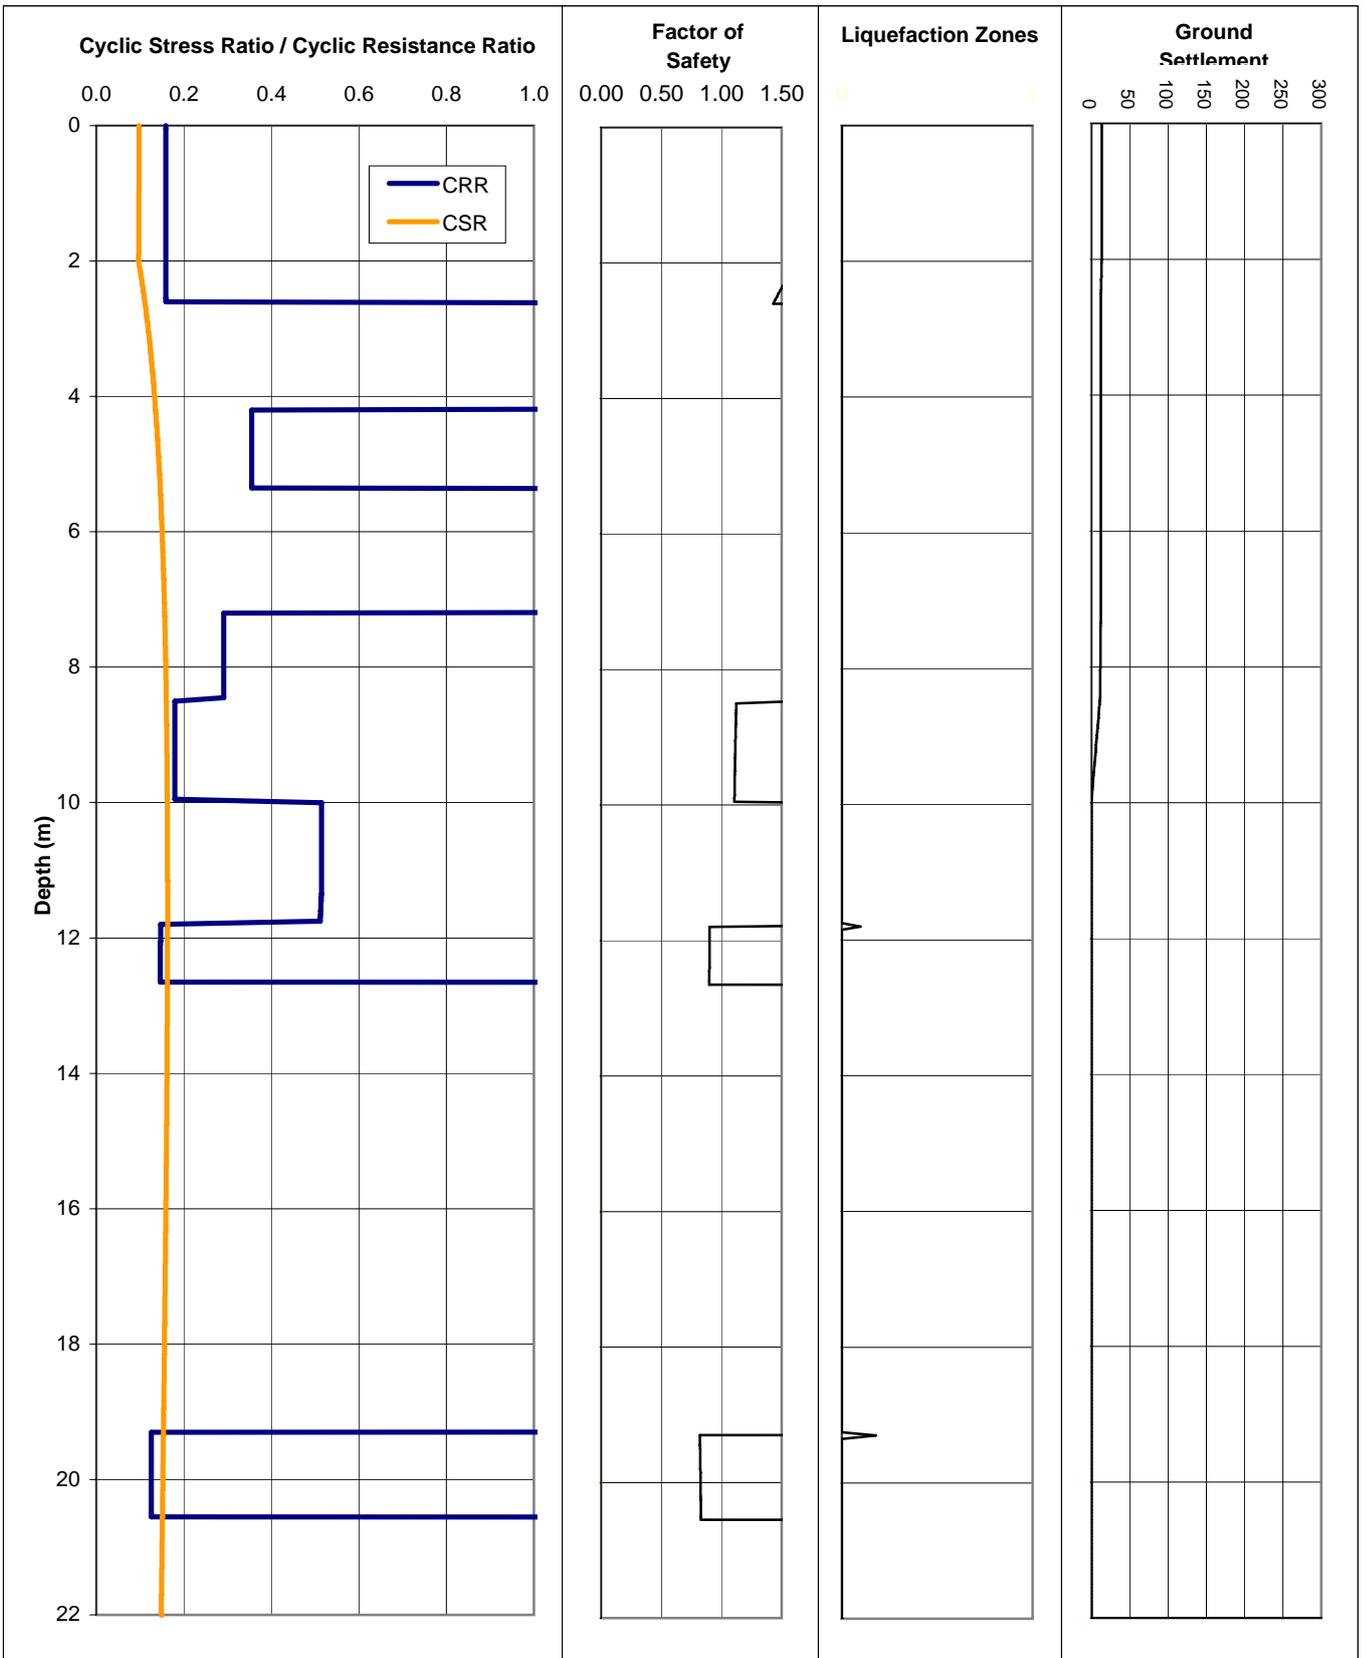
GEOTECH	Liquefaction Potential Analysis		
	GEOTECH CONSULTING LTD		
	Project:	79 Cambridge Terrace	Hole No:
Client:	Buchanan & Fletcher Ltd	Job No:	3984

Note: Based on Idriss & Boulanger (2006) and Ishihara & Yoshimine (1992) **SLS @ 0.15g**
 $a(g) = 0.15$ M = 7.5

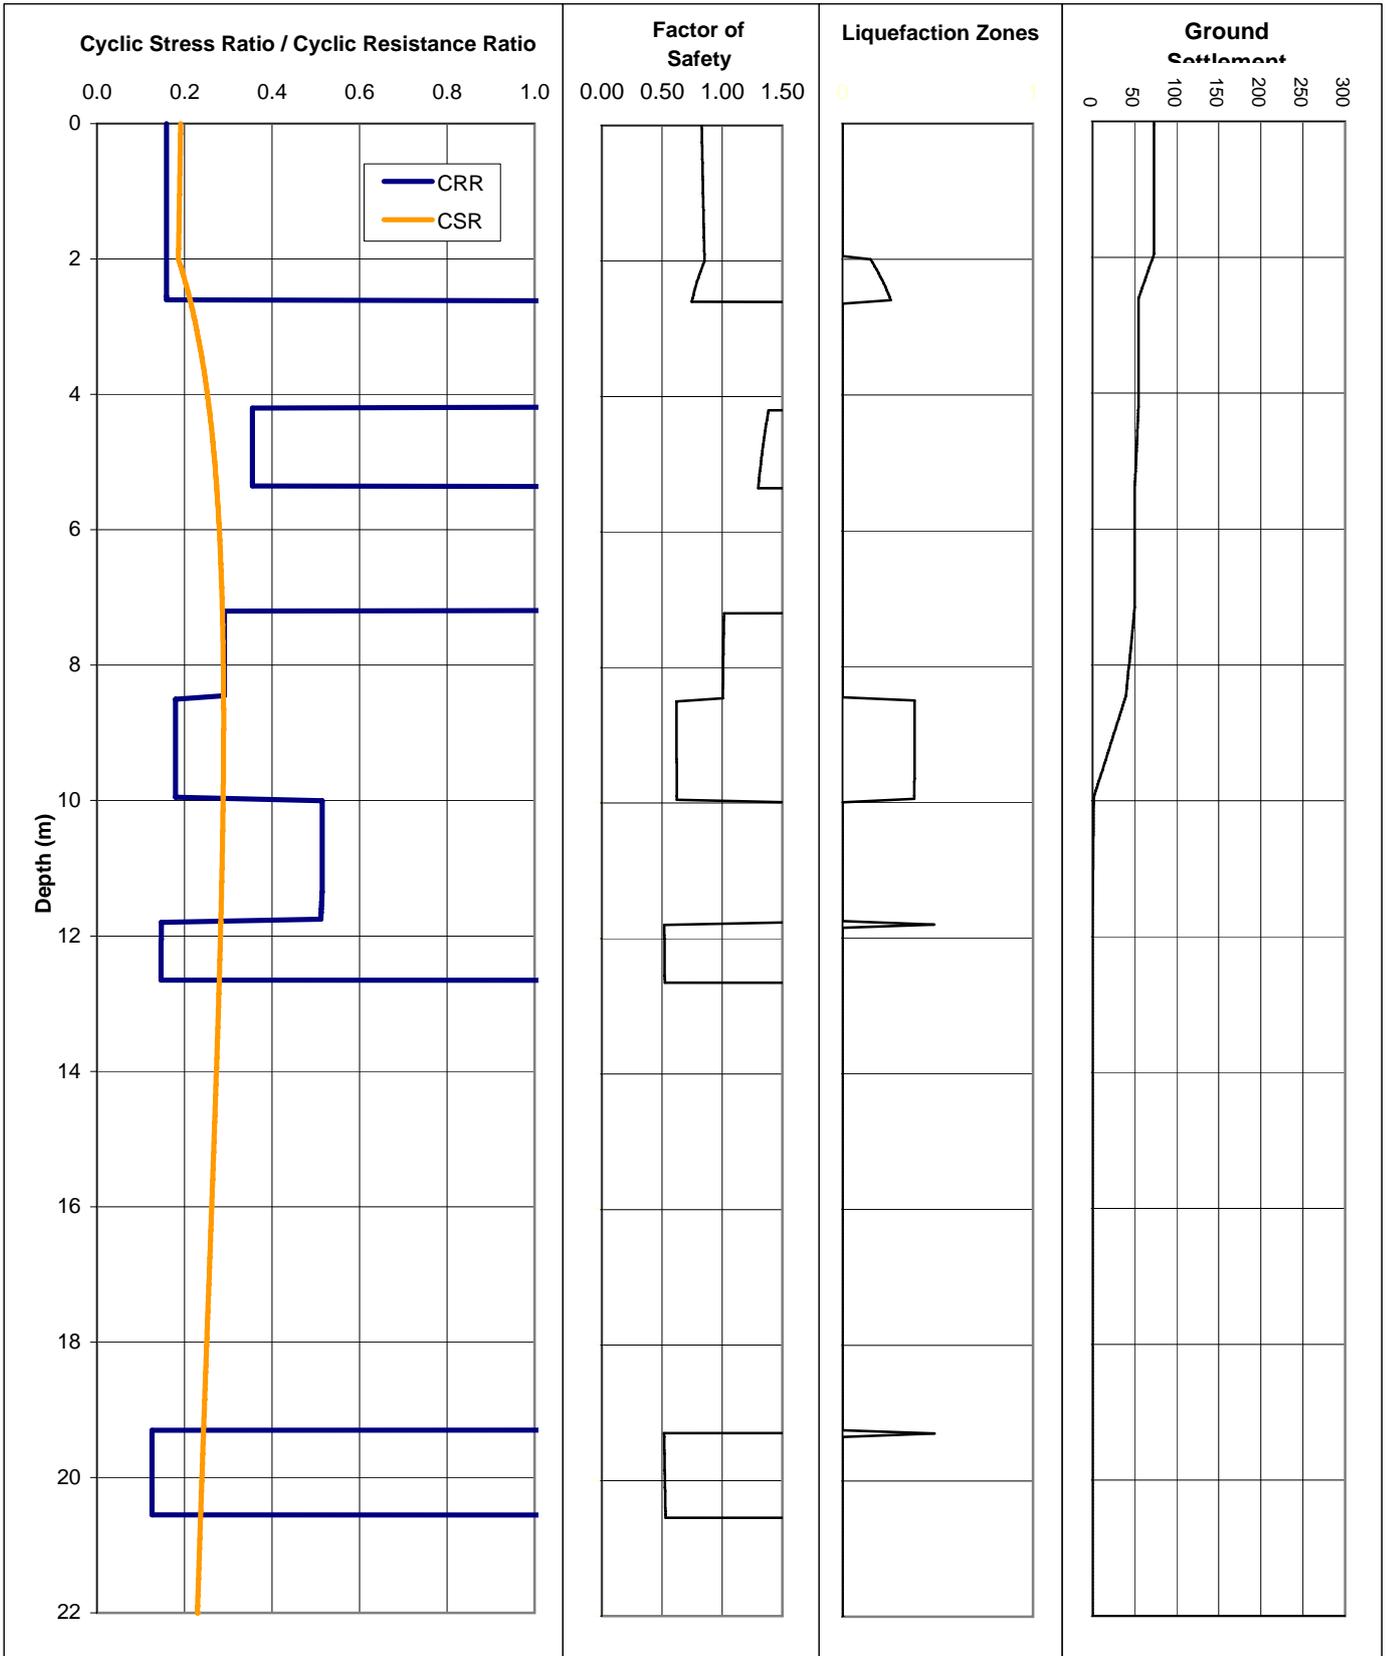
GEOTECH	<h2 style="margin: 0;">Liquefaction Potential Analysis</h2> <h3 style="margin: 0;">GEOTECH CONSULTING LTD</h3>		
	Project: 79 Cambridge Terrace Client: Buchanan & Fletcher Ltd	Hole No: BH1 Job No: 3984

Note: Based on Idriss & Boulanger (2006) and Ishihara & Yoshimine (1992) 22-Feb-11
 $a(g) = 0.4$ M = 6.3

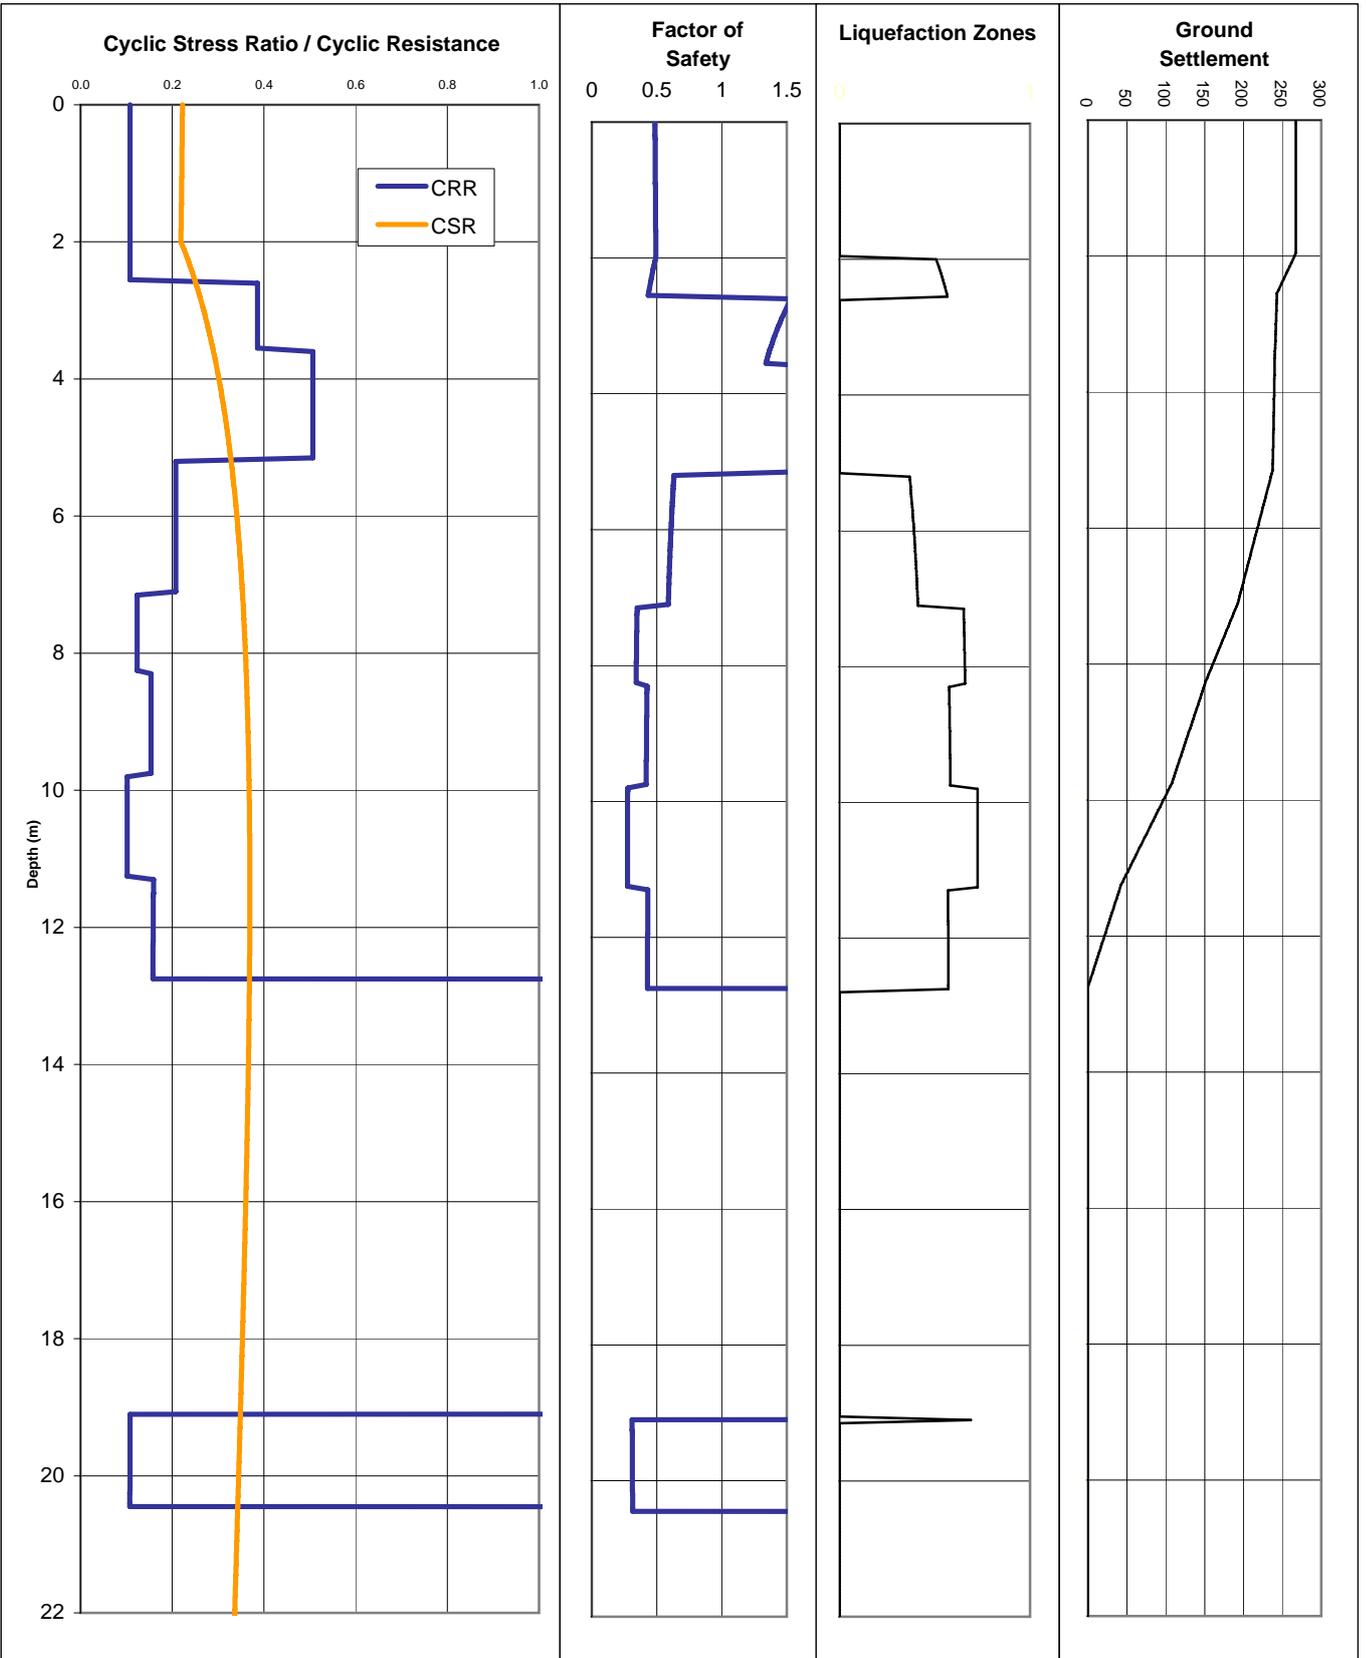
GEOTECH	<h2 style="margin: 0;">Liquefaction Potential Analysis</h2> <h3 style="margin: 0;">GEOTECH CONSULTING LTD</h3>		
	Project: 79 Cambridge Terrace Client: Buchanan & Fletcher Ltd	Hole No: BH2 Job No: 3984

Note: Based on Idriss & Boulanger (2006) and Ishihara & Yoshimine (1992) **ULS**
 $a(g) = 0.34$ **M = 7.5**

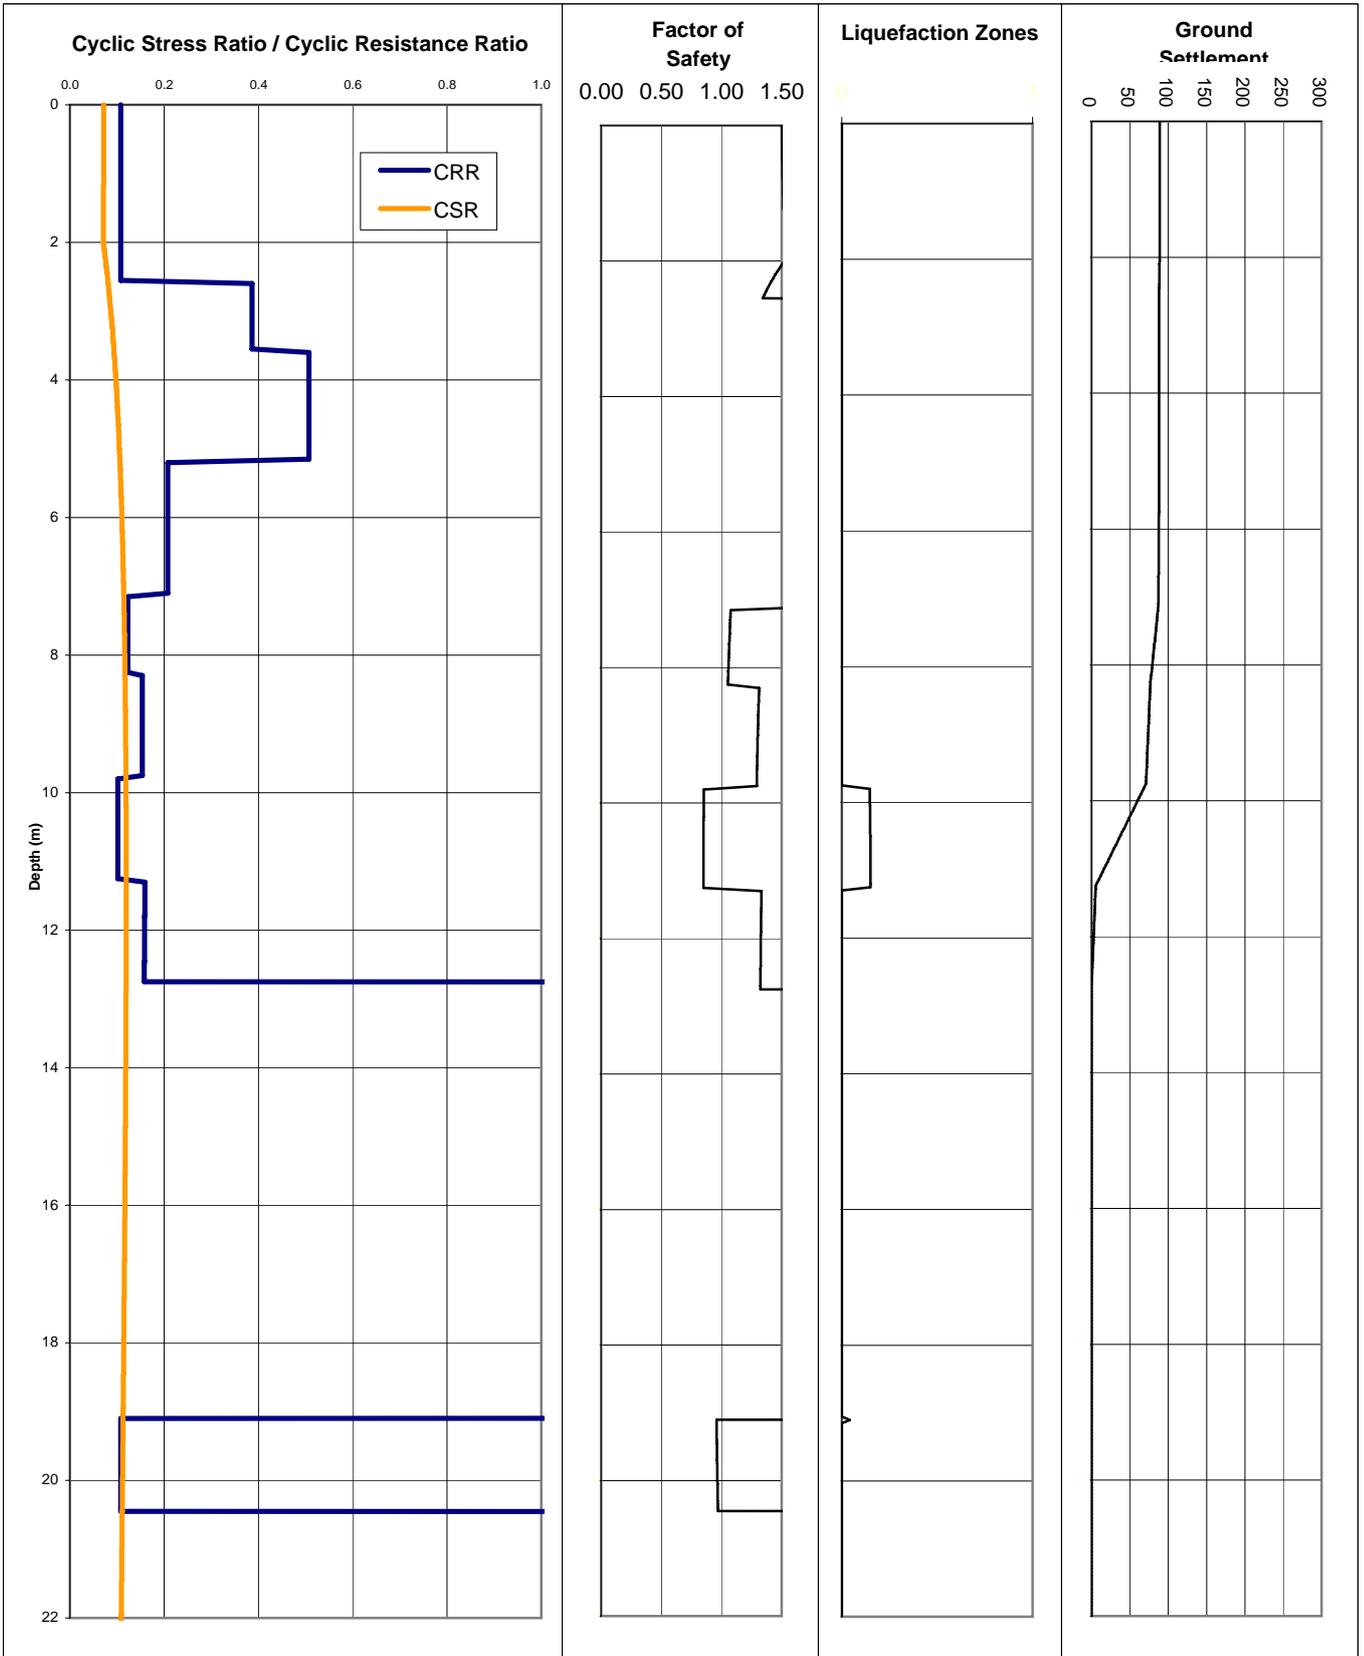
GEOTECH	<h2 style="margin: 0;">Liquefaction Potential Analysis</h2> <h3 style="margin: 0;">GEOTECH CONSULTING LTD</h3>		
	Project: 79 Cambridge Terrace Client: Buchanan & Fletcher Ltd	Hole No: BH2 Job No: 3984

Note: Based on Idriss & Boulanger (2006) and Ishihara & Yoshimine (1992) **SLS**
 $a(g) = 0.11$ **M = 7.5**

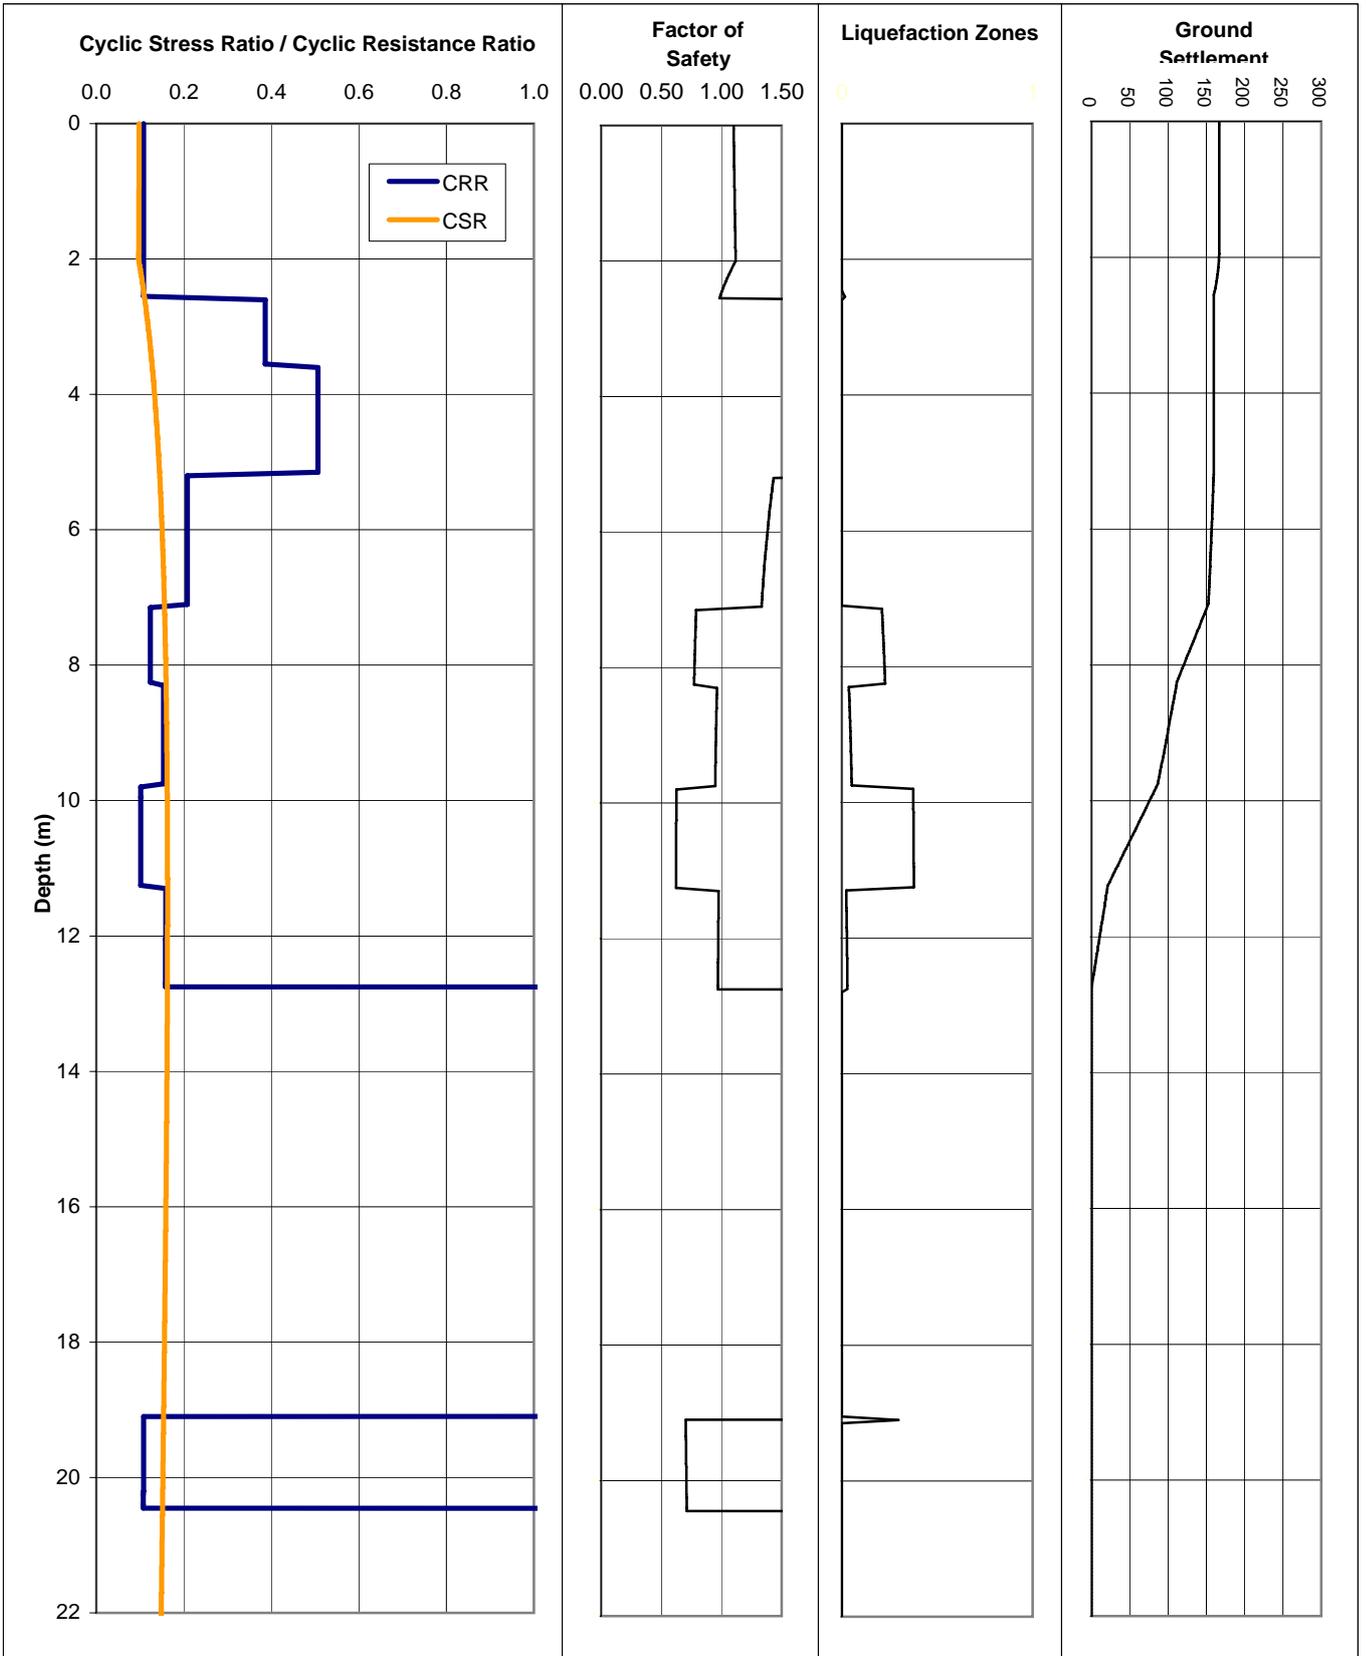
GEOTECH	Liquefaction Potential Analysis		
	GEOTECH CONSULTING LTD		
	Project:	79 Cambridge Terrace	Hole No:
Client:	Buchanan & Fletcher Ltd	Job No:	3984

Note: Based on Idriss & Boulanger (2006) and Ishihara & Yoshimine (1992) **SLS @ 0.15g**
 $a(g) = 0.15$ M = 7.5

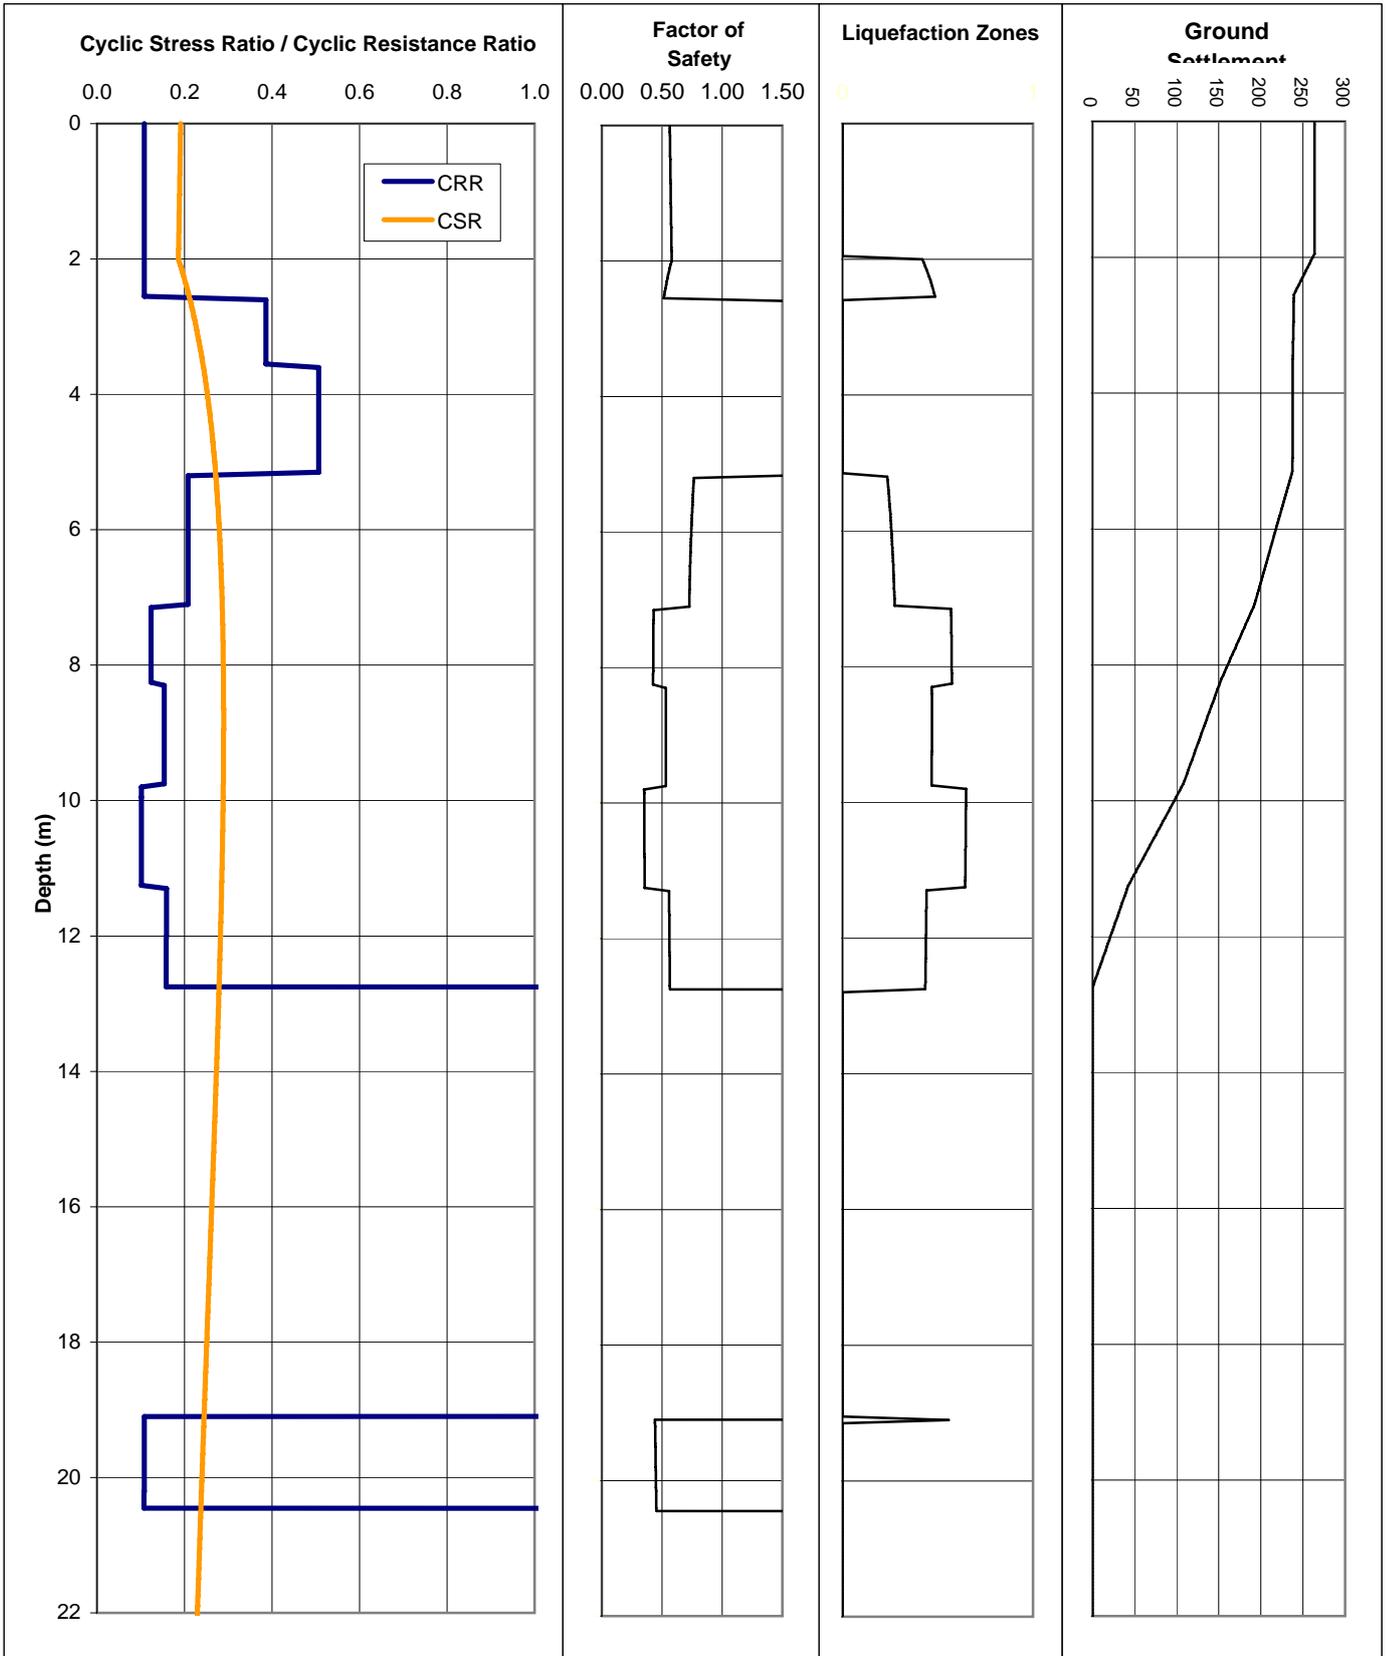
GEOTECH	<h2 style="margin: 0;">Liquefaction Potential Analysis</h2> <h3 style="margin: 0;">GEOTECH CONSULTING LTD</h3>			
	Project:	79 Cambridge Terrace	Hole No:	BH2
	Client:	Buchanan & Fletcher Ltd	Job No:	3984

Note: Based on Idriss & Boulanger (2006) and Ishihara & Yoshimine (1992) 22-Feb-11
 $a(g) = 0.4$ M = 6.3
