Section 5: Post-collapse investigations

5.1 Post-collapse examinations of building debris

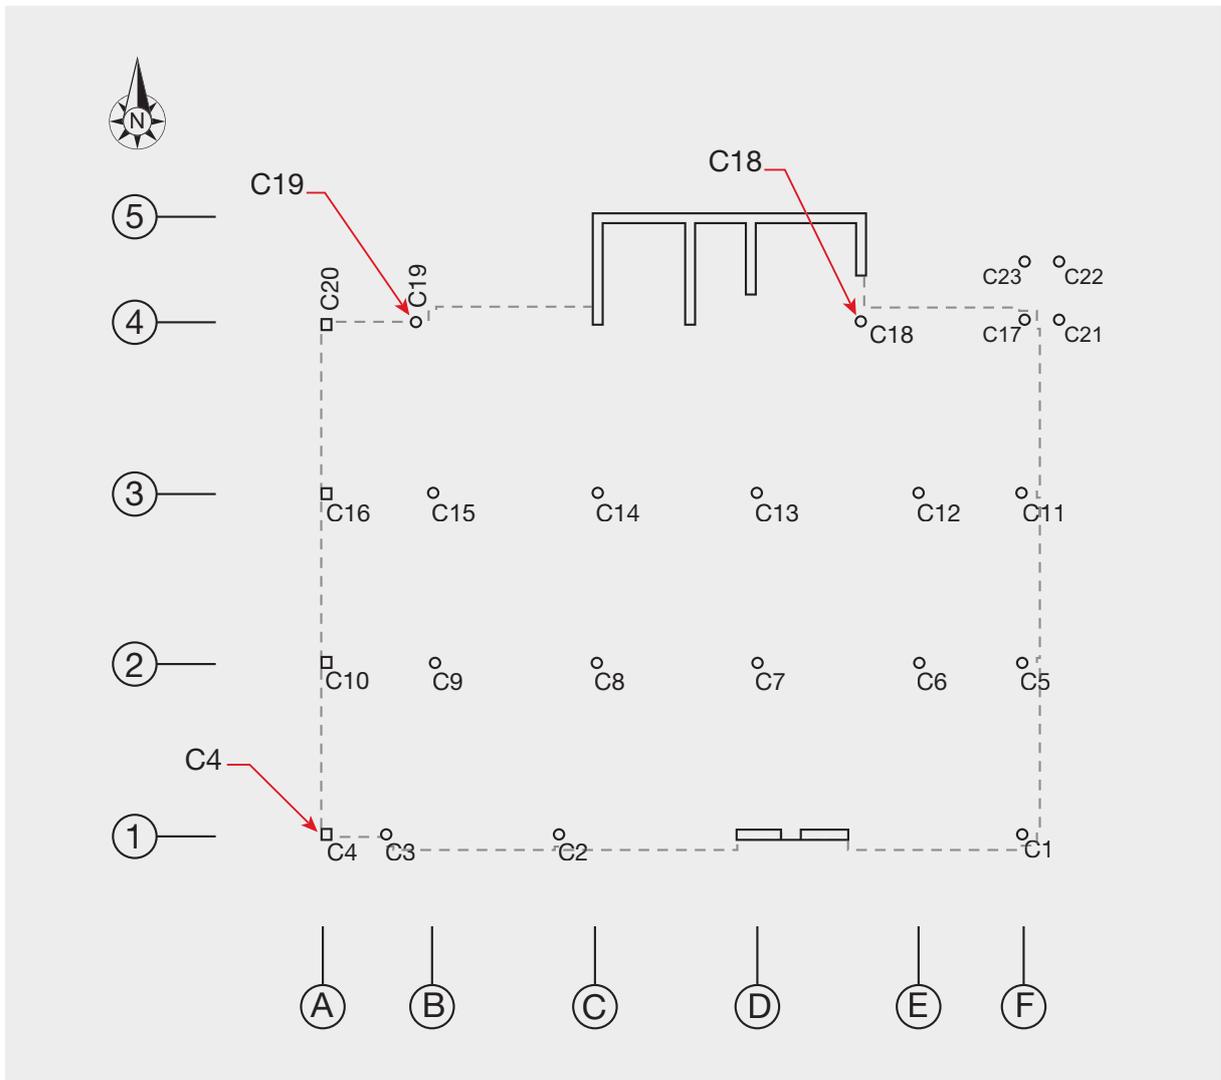
Figure 62(a): Plan of the building showing column locations

Mr Frost gave evidence that the only real damage that he saw to columns was at their ends. The central sections of the columns he saw were largely intact. Figure 62(b) shows where a precast spandrel panel adjoined a column. The unpainted area on the left of the column was covered by the spandrel panel. There was no damage to this column at the level adjacent to the top of the spandrel and Mr Frost saw no evidence of column hinging caused by spandrel panel interaction. Figure 62(c) shows the vertical and spiral reinforcement within a typical column.

Dr Heywood referred to photographs from the Hyland/Smith report (see Figures 62(d) and (e)) which show the column on the south-west corner visible. A part of column C4 (about one storey in length) (see the column location diagram in Figure 62(a)) remained vertical after the collapse although concrete was missing at its base. The rectangular columns on the western elevation were detached from the building as continuous lengths but the concrete in the vicinity of the beam-column joints had been lost. The segments of columns between the floors appeared to be sound with the segments connected by the column reinforcement.

to C19 came to rest near the base of the north wall complex at one end and on top of the roof of an adjacent building at the other end. He also described two storey-long segments of column C18 which remained intact and joined by column reinforcement (see Figure 62(g)). Column C18 was unique since it connected to the top of the north wall complex. This meant it could continue to support some loads even if the columns below it had gone.
