# Section 6:

## Technical discussions on structure

### 6.1 Design earthquake loading and analysis of the CTV building

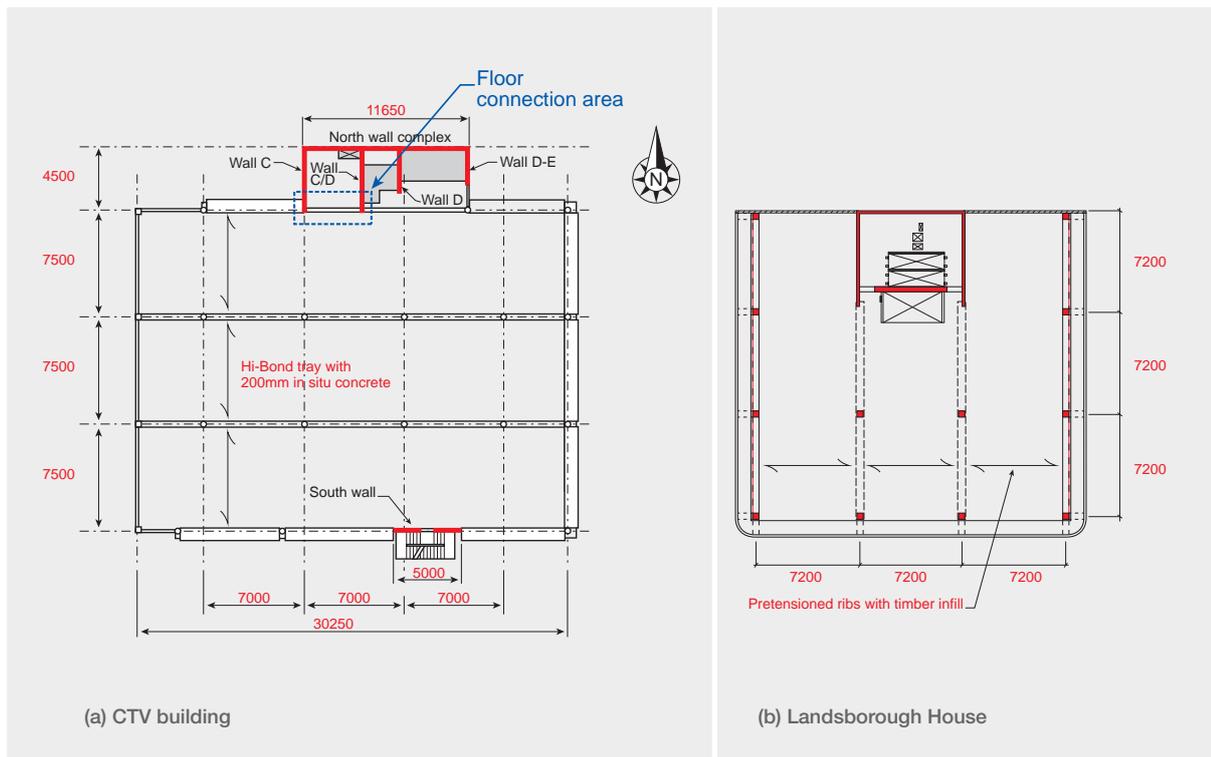
Figure 73: Comparison of shear wall layout and floor connection

Figure 73 shows the locations of the shear walls and beams in the Landsborough House and CTV buildings. In Landsborough House the centre of mass was highly eccentric to the centre of lateral stiffness. With this arrangement the greatest inter-storey drifts occurred in the east-west direction due to the torsional response of the building. In this structure the beams spanned in the north-south direction and the rotation of the columns (due to drift in the east-west direction) was only restricted by the floor slab at each floor level. As the floor was flexible compared to the columns there was little rotational restraint provided and this reduced the structural actions induced in the columns due to inter-storey drift.

The design of the CTV building can be distinguished from Landsborough House. In the case of the CTV building, the beams spanned in the east-west direction. Modal response spectrum analysis of the CTV building shows that, like Landsborough House, significant inter-storey drifts occurred in the east-west direction due to the torsional resistance of the building. However, in this case the orientation of the beams was such that they restrained the rotation of the columns at each floor, which increased the structural actions in the columns associated with inter-storey drift.

In the CTV building the only area where inertial force from the floors could be transferred to the north wall complex was through the drag bars (installed in 1991) and by flexure, shear and direct tension in the region between the walls on lines C and C-D. The tie force was dependent on the strength of this limited area (shown in Figure 73), which was reinforced with mesh, additional 12mm diameter bars and some embedded beams bars. The arrangement used in Landsborough House was more direct and robust.

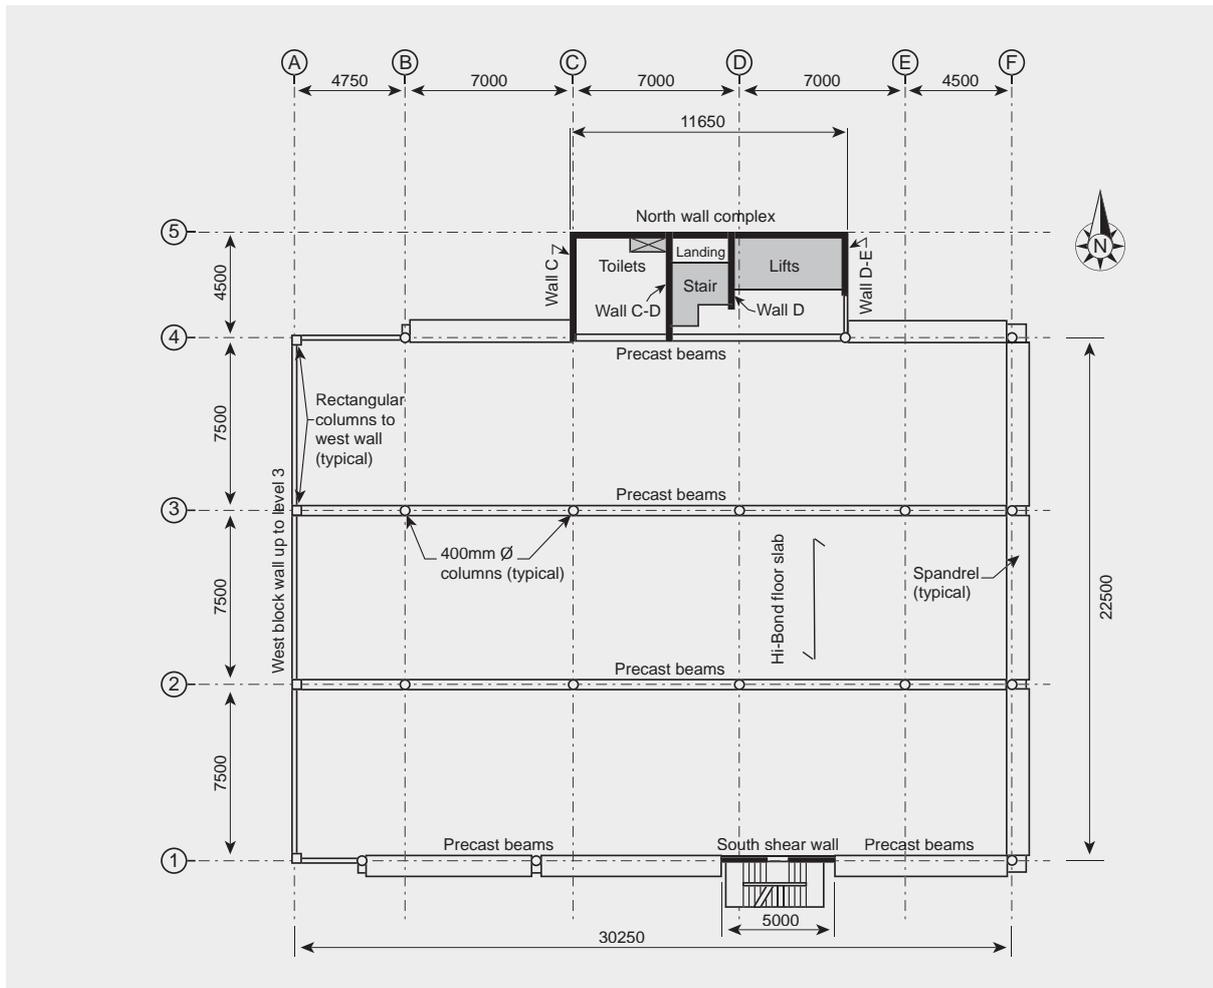
Figure 75: Floor plan for levels 3–6

Figure 75 shows a typical floor plan of the building for levels 3, 4, 5 and 6. Level 2 was similar except for a stairwell opening in the floor slab on the south side of the building. Level 1, at ground level, was a concrete floor cast on grade. The structural wall complex on the north side of the building provided the principal lateral-force-resisting elements for the forces in the north-south direction and approximately half the forces in the east-west direction. It consisted of a wall on line 5, which had a length of 11.65m, and four finger walls at right angles to the main wall that spanned between lines 5

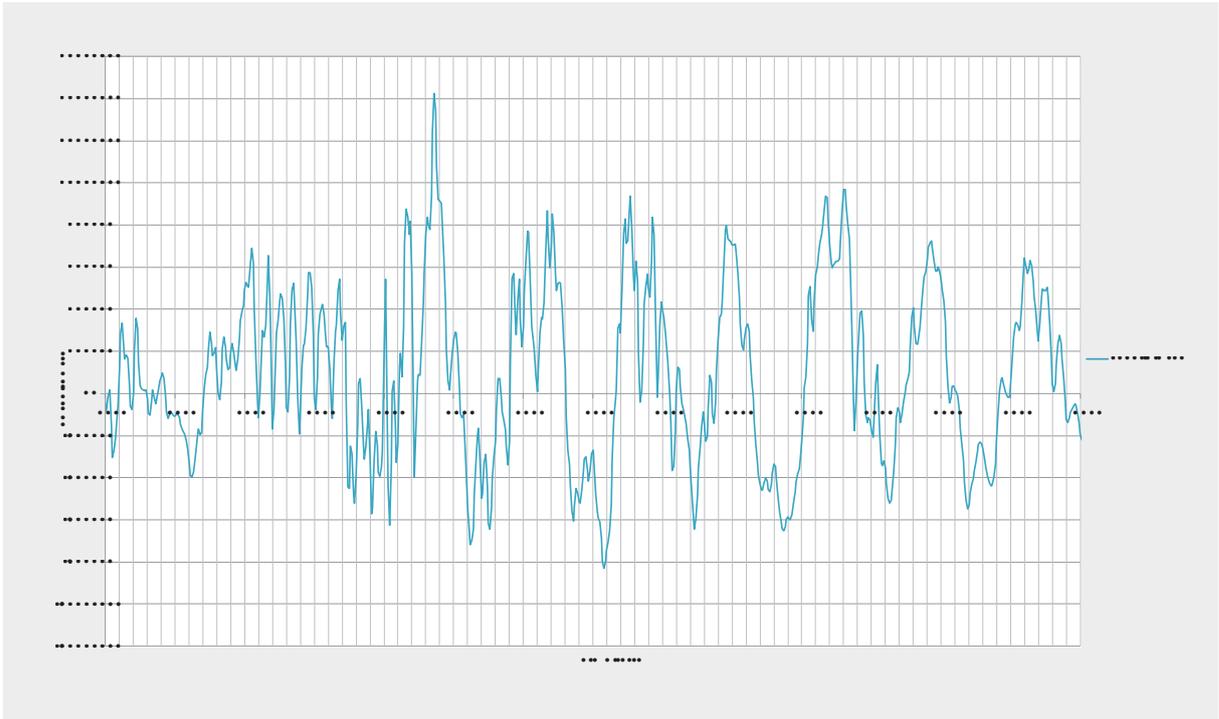
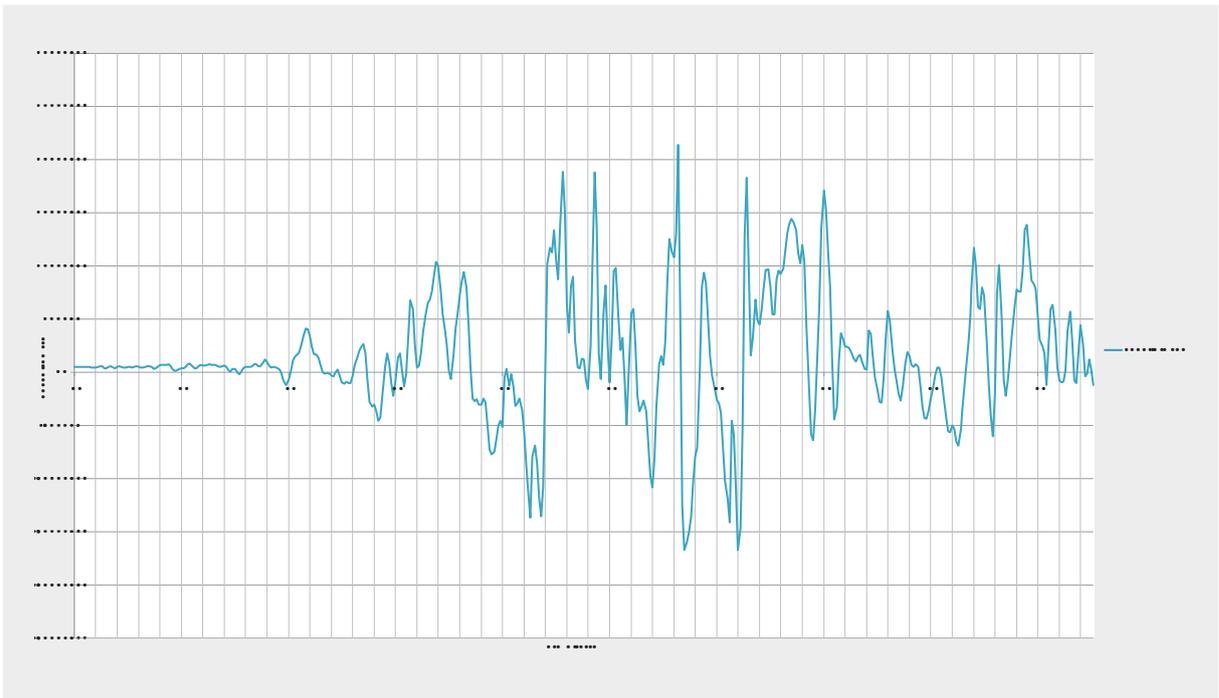
**Figure 77: Predicted tie forces between the level 6 floor slab and the north wall complex at line 4 for the CBGS ground motion records in the north-south direction in (a) the September earthquake and (b) the February earthquake**

Figure 77(a) shows the variation of the predicted tie forces between the level 6 floor and the north wall complex in the north-south direction during the September earthquake for the ground motion recorded at the CBGS site. From the variation of tie force with time it appears that there are two different contributions. First, there appears to be a cyclic variation that has a period of the order of one and a half seconds. Secondly,

there are a large number of high frequency cycles. The fundamental period given in the non-linear time history analysis report is 1.3 seconds for vibration in the north-south direction. This suggests that the 1.5 second variation in tie force is related to the fundamental period, which may have been increased due to rocking on the foundation and/or stiffness degradation associated with inelastic deformation. The high frequency components are likely to be related to higher mode vibrations. It is evident from the figure that these higher mode components make up a considerable portion of the maximum force that is induced.

From Figures 77 and 78 it is apparent that the high-frequency components of the tie forces between the floors and the north wall complex make up an appreciable proportion of the maximum values. The high frequency components are associated with small displacements; consequently, limited ductile behaviour in the ties could significantly reduce the design magnitude of the tie forces. The drag bars would have had very limited ductile capacity as failure would occur

either by yielding in shear of the bolts or by tensile failure of the concrete reinforced by brittle mesh. Ductile behaviour could have been obtained by connecting each of the walls C, C-D, D and D-E to the floors by three high-strength (380MPa) 20mm bars, which could have been anchored into the walls and extended into the floor almost to line 3. If this detail had been used it is probable that separation between the floor and walls would not have occurred even though the strength of these bars would be of a similar magnitude to that of the drag bars.

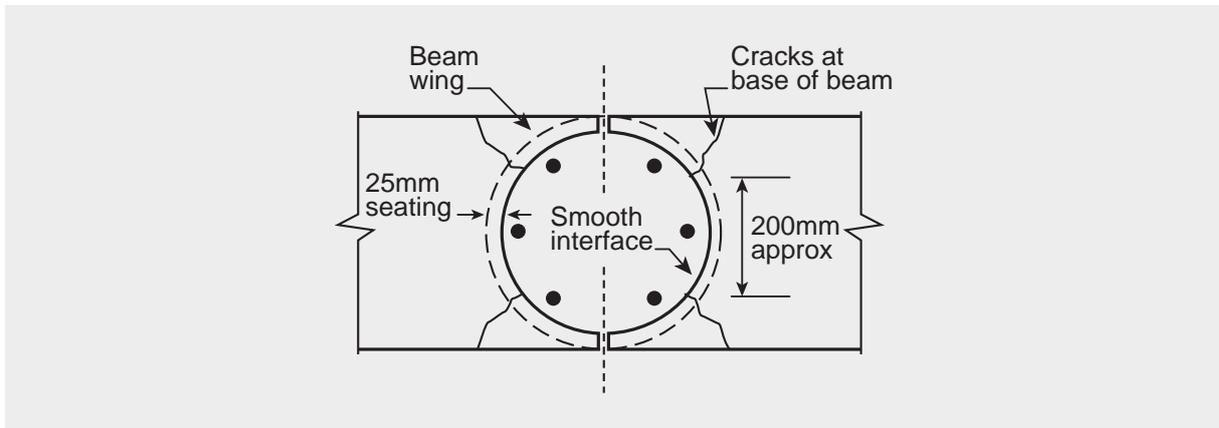
Figure 85: Plan of precast beams supported on an internal column

The ends of the precast beams were shaped to enable them to be supported on the circular columns as simply supported members during construction, as shown in Figure 85. The part of the beam between the circular shape for the column and the edge of the beam is referred to as a wing. There was no reinforcement to tie the wings into the beams. With this arrangement the beams had a 25mm support length on cover concrete. In most of the beams the bottom longitudinal reinforcement consisted of four high-strength 28mm bars. Two of these bars were terminated just short of the columns and the other two were hooked so that, when the columns were cast, they were anchored in the in situ concrete. These details are shown in Figures 87, 88, 89 and 90. In some of the shorter beams a lesser amount of reinforcement was used in the precast beams. However, in all cases the bars that extended into the beam-column joint zone were hooked in the in situ concrete.

As discussed in section 5.1, inspection of the CTV site after the collapse, and of the building debris at the Burwood landfill where it was stored, showed that in all cases the wings of the precast beams had broken off (see Figures 85 and 86). Inspection of the ends of the beams showed that the interface between the precast beam and in situ concrete in the column was smooth, with no adhesion between the precast and in situ concretes (see Figure 86). Mr Frost suggested that the wings could have broken off due to radial pressure between the column and the end of the beam (see section 5.1.3.3). Cracks may have been initiated by radial pressure between the beam and column due to negative moments generating a flexural compression, applying a compression force across the interface. Alternatively, thermal expansion of the concrete associated with heat of hydration when the column was cast, or the Poisson expansion of the column concrete, associated with the axial load and creep, may have generated pressure that initiated the cracks.

2. The beam is supported on a 25mm width of cover concrete. If the wings have broken off, as described previously, the effective bearing area is on a width of 25mm and a length of approximately 200mm (see Figure 85). The gravity load due to self-weight of the slab and beam, the added dead load and a nominal live load results in a contact force of approximately 160kN. The resultant contact average stress due to this load is close to 30MPa, which is at a level close to the failure load. This stress level could have been significantly increased by vertical seismic ground motion. If a positive moment acts on the beam a crack could open up at the smooth interface between the beam and the column. The opening up of this crack to even a small width may result in the

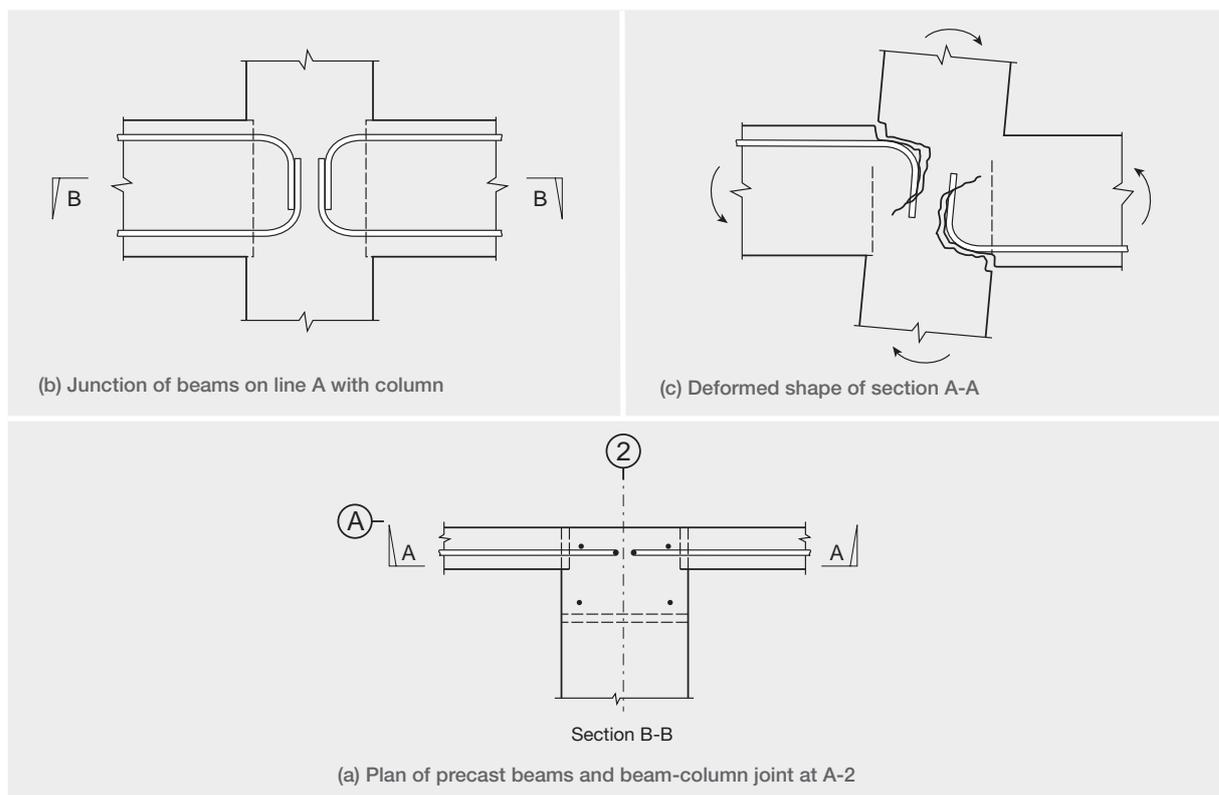
Figure 89: Junction of beams on lines 2 and 3 with external column on line F

Figure 89(a) shows the intersection of the beams on line A at levels 2 and 3 with the beams on lines 2 and 3. Single hooked bars in the precast beams in line A extend to 15mm short of the column centre-line as shown in part (b) of the figure. The bottom bar in each beam has a diameter of 24mm and the top bar 20mm. Under the action of sway in the north-south direction negative moments are induced in one of the beams and positive moments in the other. Tension would have been induced in the concrete immediately behind the bottom bar, which is resisting a positive moment, and behind the top bar that is resisting a negative moment. The concrete would crack and the joint zone ties of R10 bars at 250mm centres, giving a maximum number of two ties, would not have been anywhere near adequate to prevent the hooked bars pulling the joint zone apart, as shown in part (c) of the figure. Rapid strength degradation would occur. The only feature that could have prevented collapse of these joint zones in the north-south direction would have been sufficient strength and stiffness in the concrete block wall to prevent appreciable inter-storey drift from developing at the columns on line 1. However, we consider that is unlikely to have been the case. It may also be noted that the opening up of the cracks in the joint zone due to sway in the north-south direction would have caused elongation, which would have added to the deformations imposed on neighbouring beam-column joint zones.

The situation described above is particularly critical as the strength of the columns is considerably greater than that of the beams and this would have forced inelastic deformation into the beams. The actions in the joint zone associated with the beams on lines 2 and 3 for inter-storey drifts in the east-west direction are very similar to those described in Figure 88.

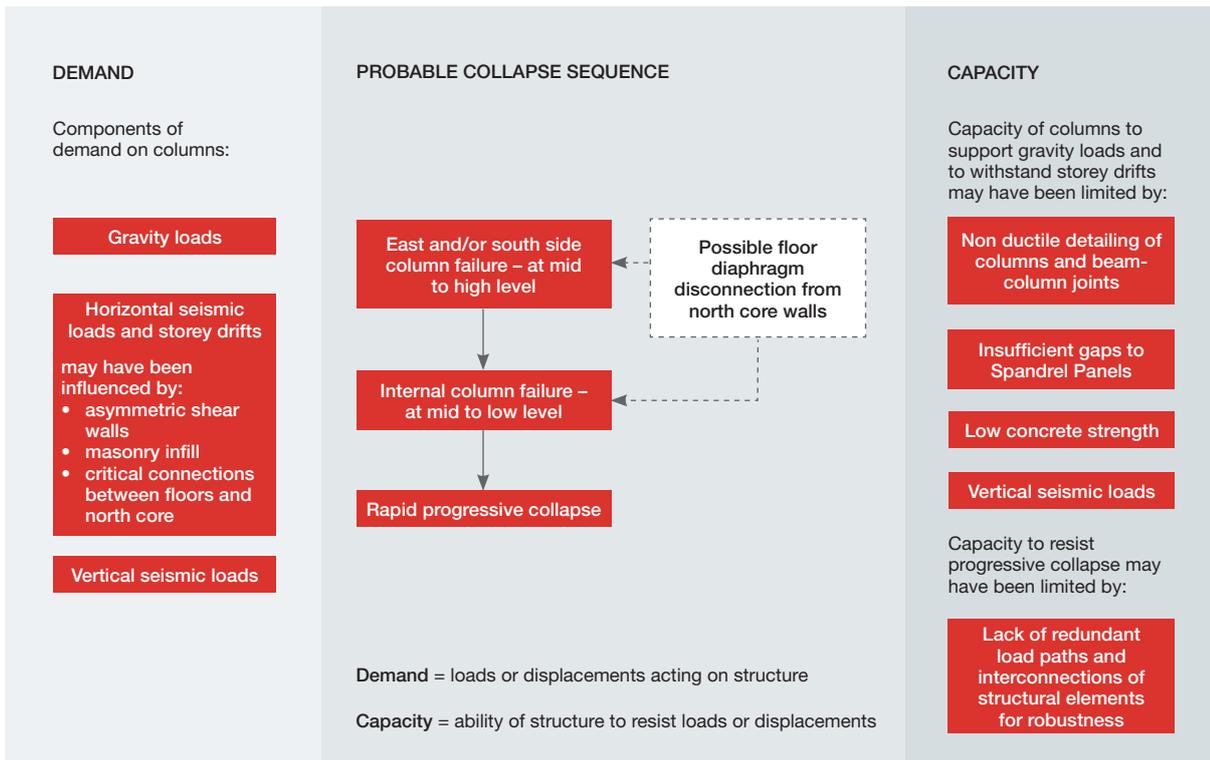
Figure 91: Collapse sequence flowchart produced in the Hyland/Smith<sup>1</sup> report

Dr Clark Hyland and Mr Ashley Smith evaluated various collapse scenarios for the purpose of identifying, if possible, the most likely. They produced a flowchart to illustrate the key considerations they used (see Figure 91).

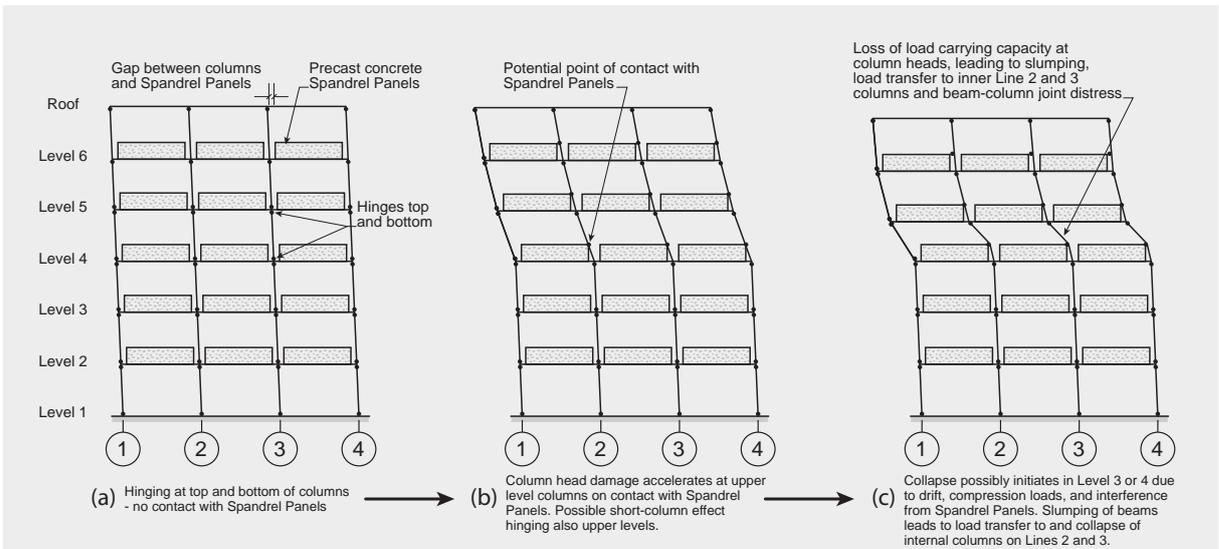
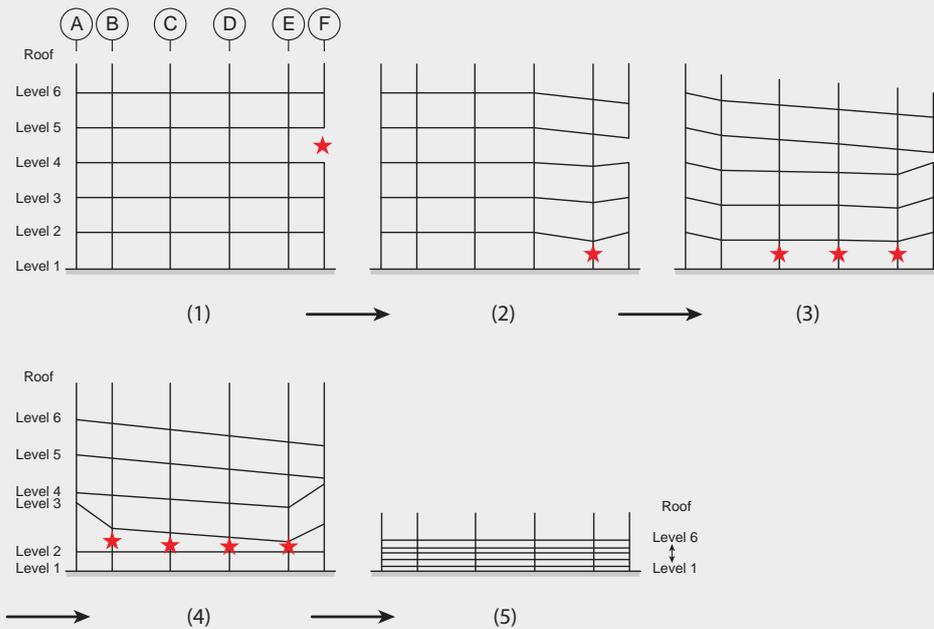
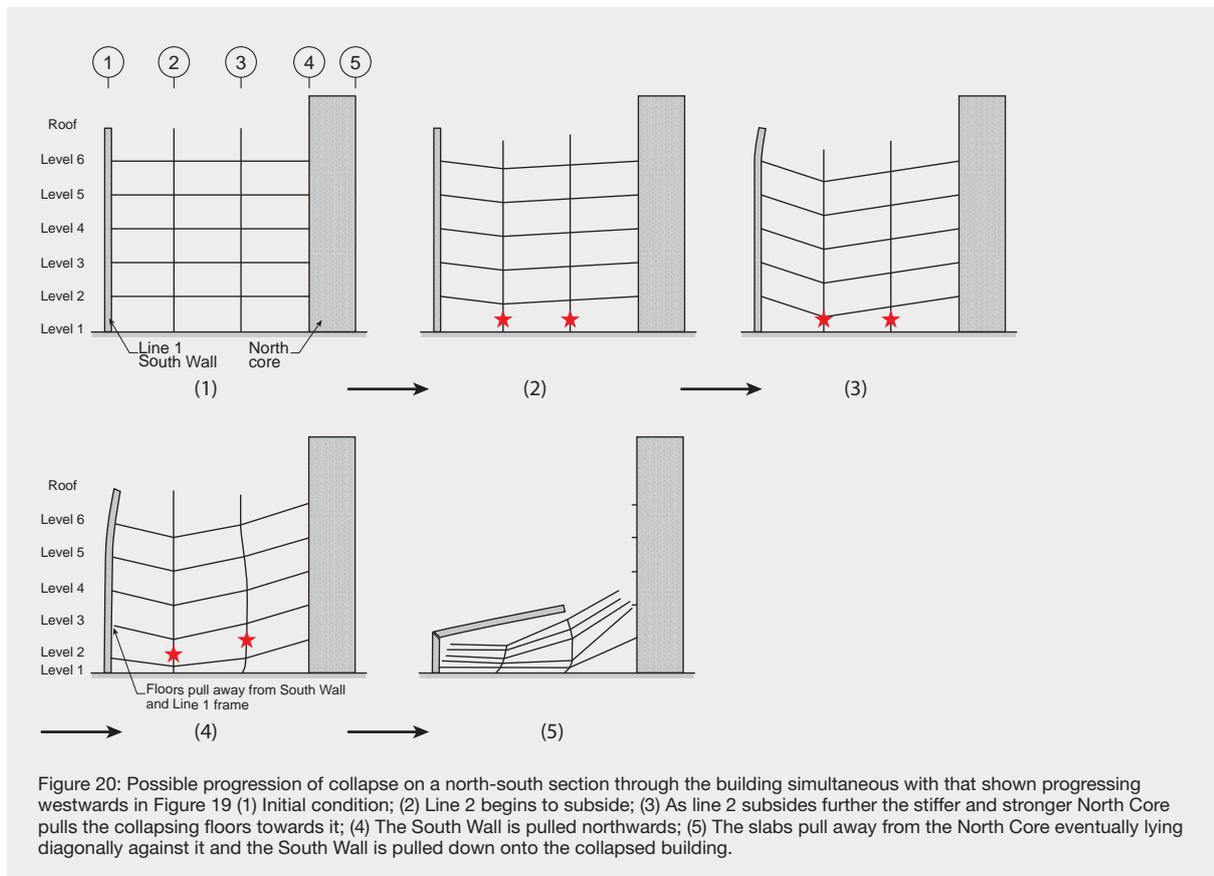
Figure 92: Figures 17, 19 and 20 from the Hyland/Smith report illustrating their preferred collapse scenario

With the loss of the load-carrying capacity of the columns on line F, the interior columns on lines 2 and 3 at a mid to low level would have become overloaded. The slabs and beams they supported would have pulled downwards and northwards on the south shear wall and frame on line 1. The slabs and beams connected into the columns at line A would have pulled downwards and inwards on those columns, which could explain the beam-column joints pulling out in some locations. The upper levels and roof above the column failure on line F could have dropped as a unit, with a slight lean to the east.

Dr Hyland and Mr Smith described this in their report as their “preferred collapse scenario”, given that some witnesses saw the collapse start in the upper third of the building, a witness reported a slight tilt to the east and debris was observed on Madras Street after the collapse. This scenario was represented in three figures in their report (see Figure 92):

Figure 17: Possible collapse sequence along Line F as inter-storey drifts reach critical levels and columns begin to fail from lack of displacement capability or from additional damage caused through contact with precast concrete Spandrel Panels. Displacements and damage are greatest in the upper levels, but inelastic drift capacity less in the lower levels. Also change in torsional stiffness at Level 4 due to the Line A masonry infill wall stopping at that level may have contributed to collapse appearing to initiate above Level 4.

Figure 19: Possible progression of collapse from loss of column capacity on Line F is shown sequentially as follows: (1) Collapse of Line F columns above Level 4 leads to extra floor area being supported of columns on Line E; (2) The Line E columns begin to collapse under the extra load; (3) As the Line E columns sink additional floor area becomes supported on the Line D columns which in turn begin to collapse, causing an eastward tilt in the upper levels; (4) The upper levels then hit the Level 4 Line F; (5) The collapse completes with all floors laying on top of each other. Note that collapse is also spreading in the north-south direction simultaneously to this as shown in Figure 19.

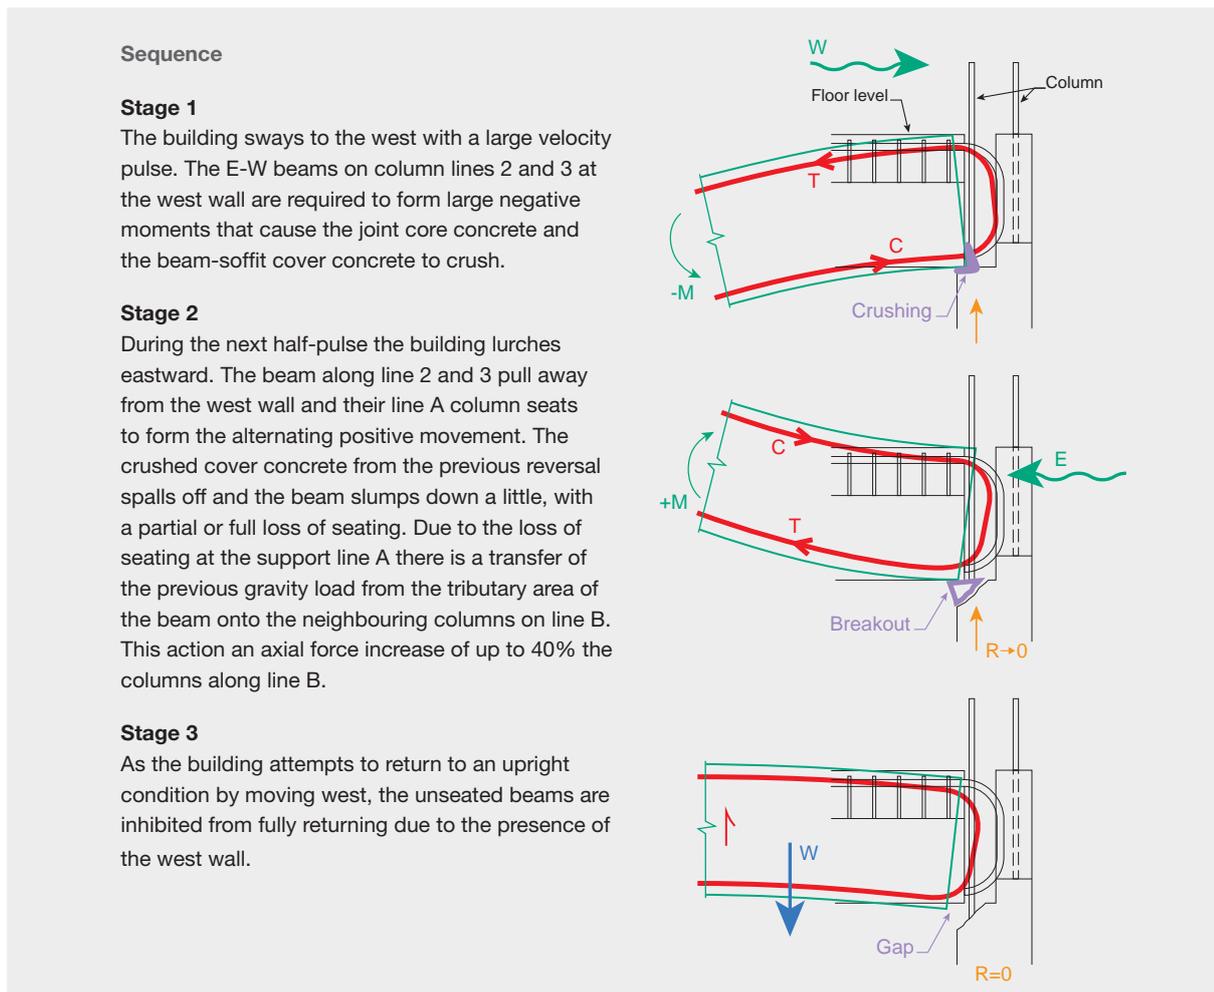
Figure 96: Professor Mander's diagram of the trigger for the east-west collapse failure mode

The inter-storey drifts in the east-west direction predicted from in the non-linear time history analyses carried out by Compusoft<sup>3</sup> were of the order of three per cent. Such displacements would have generated negative and positive moments in the beams on lines 2 and 3 where they were framed into the columns on line A. As illustrated in stage 1 in Figure 96, these bending moments would have generated cracks in the columns behind the hooked beam bars (see also section 6.3.5).

Professor Mander postulated that the positive moment rotation would have caused the concrete below the beam to spall, allowing the beam to drop (as shown in stage 2 in Figure 96) and become wedged between the columns on lines A and B. This action would have partially unloaded the support and transferred gravity loads to the adjacent column or columns on line B. Professor Mander proposed that, as the inter-storey drift decreased, the wedging action of the beam would have pushed the row of columns to the west as illustrated in stages 3 and 4 in Figures 97 and 98.

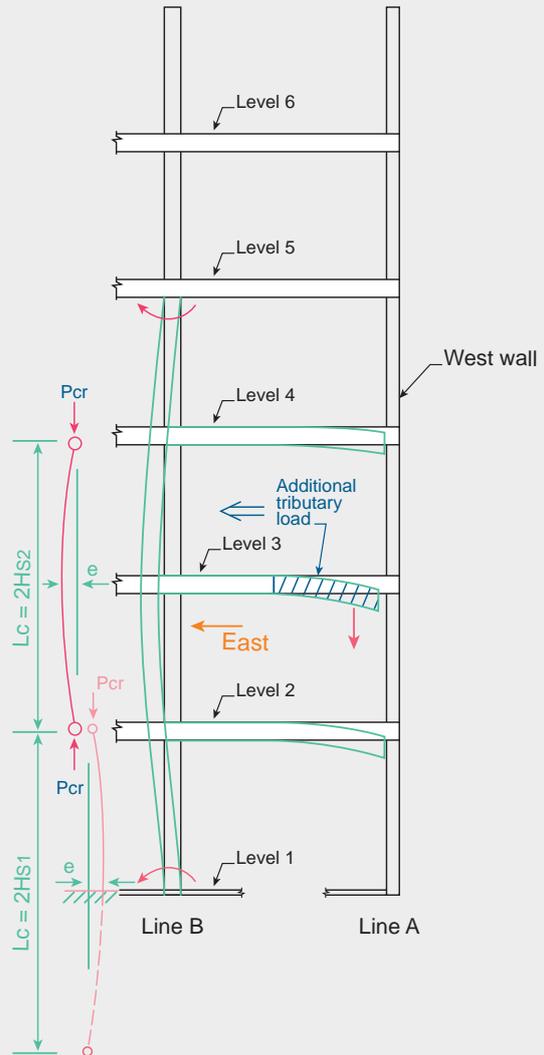
Figure 97: Professor Mander's diagram of four-storey double bending buckling failure starting on column line B leading to the east-west collapse failure mode

Professor Mander estimated that, including vertical load effects, there was an increase in axial load on the level 2 columns of 400kN, leading to the incipient collapse mechanism shown in stage 4 of Figure 97. He calculated that differential drifts of 1.15–1.3 per cent, depending on the concrete strength, would have been sufficient to cause a column or columns to fail. The final collapse mechanism is shown in Figure 98. Professor Mander noted that this mechanism is consistent with some of the eyewitness accounts.

Permanent differential deformations remain that inhibit the columns along line B from remaining straight. This sets the columns up for a classic Euler buckling type failure, especially under further axial load derived from vertical accelerations and their consequent vibrations.

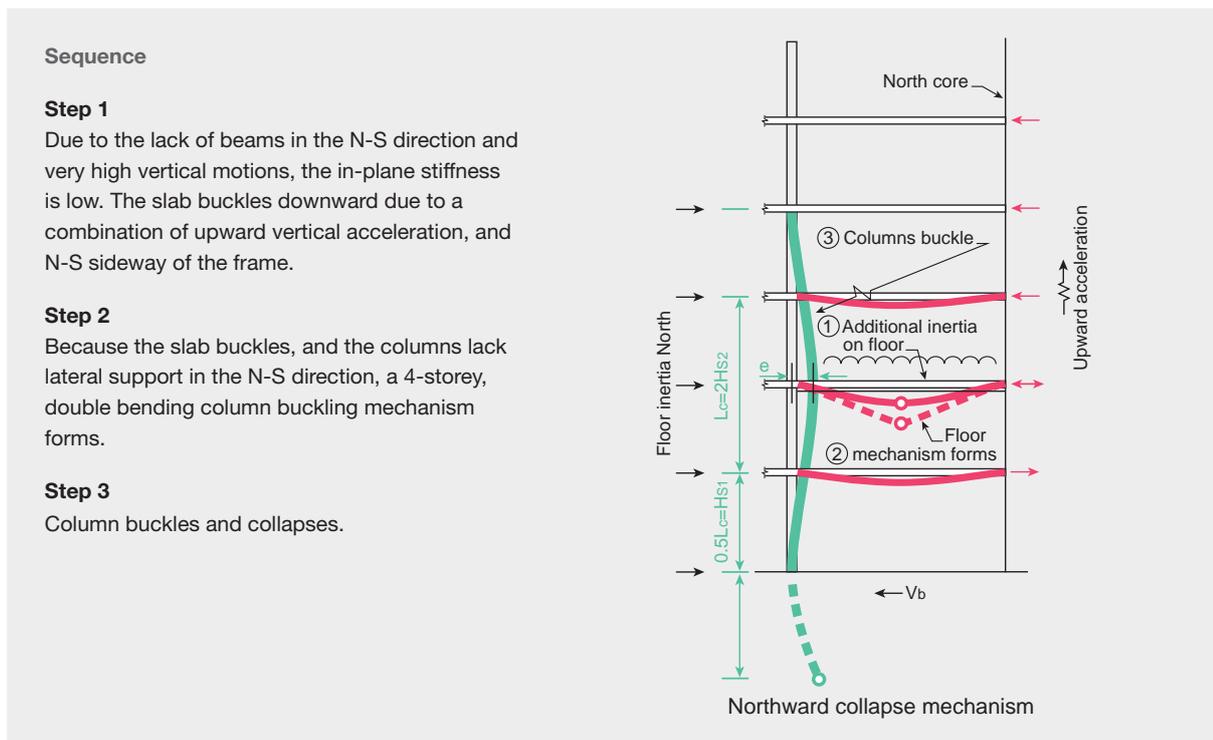
Figure 99: Professor Mander's possible collapse mode diagram for north-south shaking, northward mechanism

Professor Mander postulated that the metal tray in the composite floor debonded from the concrete due to the high vertical acceleration. He suggested that this debonding could have resulted in the deflection of the floors associated with the hump on level 4 which was noted by Ms Margaret Aydon, Ms Marie-Claire Brehaut and Mr Ronald Godkin from King's Education after the September earthquake and some subsequent aftershocks. This is an alternative explanation to that given by Mr David Coatsworth who believed deflection was due to differential shrinkage of the concrete, which was known to be a common cause of such slab deflections increasing with time.

This collapse scenario is based on the assumption that, in a strong northward earthquake pulse, the sagging floor in the bay between grid lines 3 and 4 would have sagged sufficiently due to gravity loading and vertical ground motion to cause it to fail due to P-delta actions (see Volume 1, section 3.2.5) when the floor was subjected to compression as it transferred inertial force to the north wall complex. Collapse of the slab would drag the columns on lines 2 and 3 towards the north resulting in a classic P-delta collapse of the columns, as shown in Figure 99. This figure shows the collapse being initiated by the sagging of a single slab, inducing a P-delta collapse mode in two or more storeys of a column or columns on line 3.

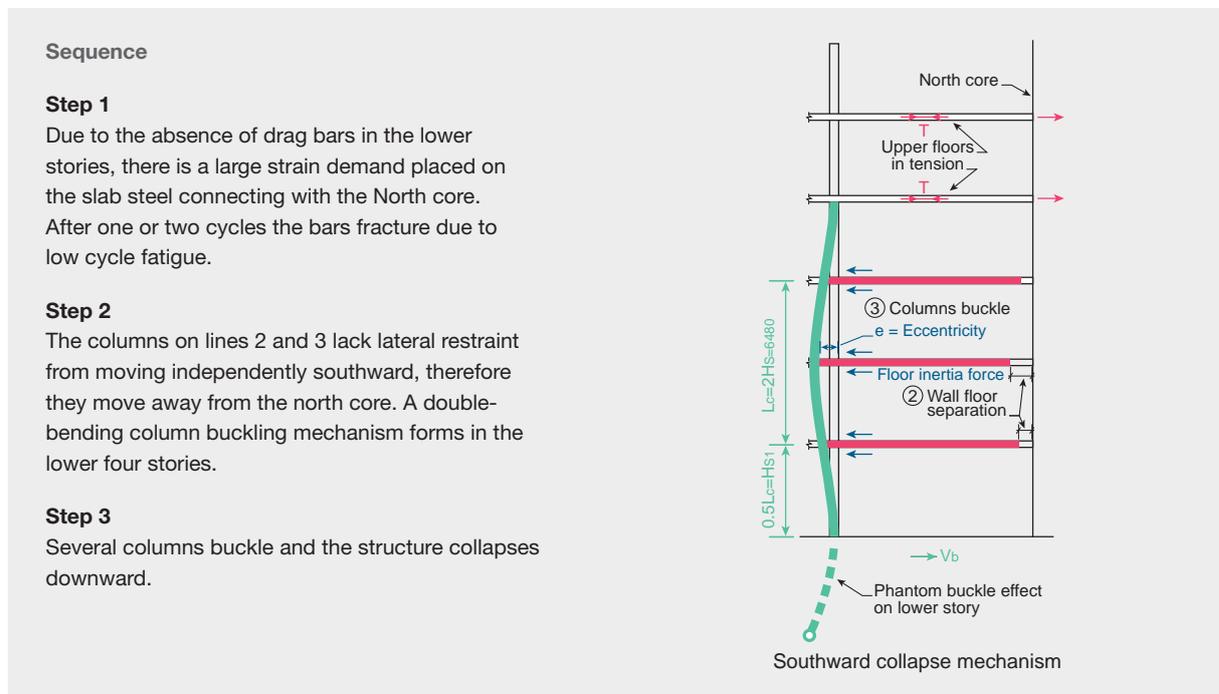
Figure 100: Professor Mander's possible collapse mode diagram for north-south shaking, southward mechanism

In this scenario southward inertial forces drag the slabs towards the south leading to disconnection of the slabs from the north wall complex. It is suggested that the lack of drag bars on the lower floor levels (2 and 3) would result in the reinforcement that connects the floors to the north wall complex fracturing in low cycle fatigue, after one or two cycles of displacement. The disconnected floors would enable the columns on lines 2 and 3 to form a classic buckling deflected shape (see Figure 100). The buckling failure of the most heavily loaded columns on lines 2 and 3 would result in their axial loads being transferred to other columns, leading to complete collapse occurring.

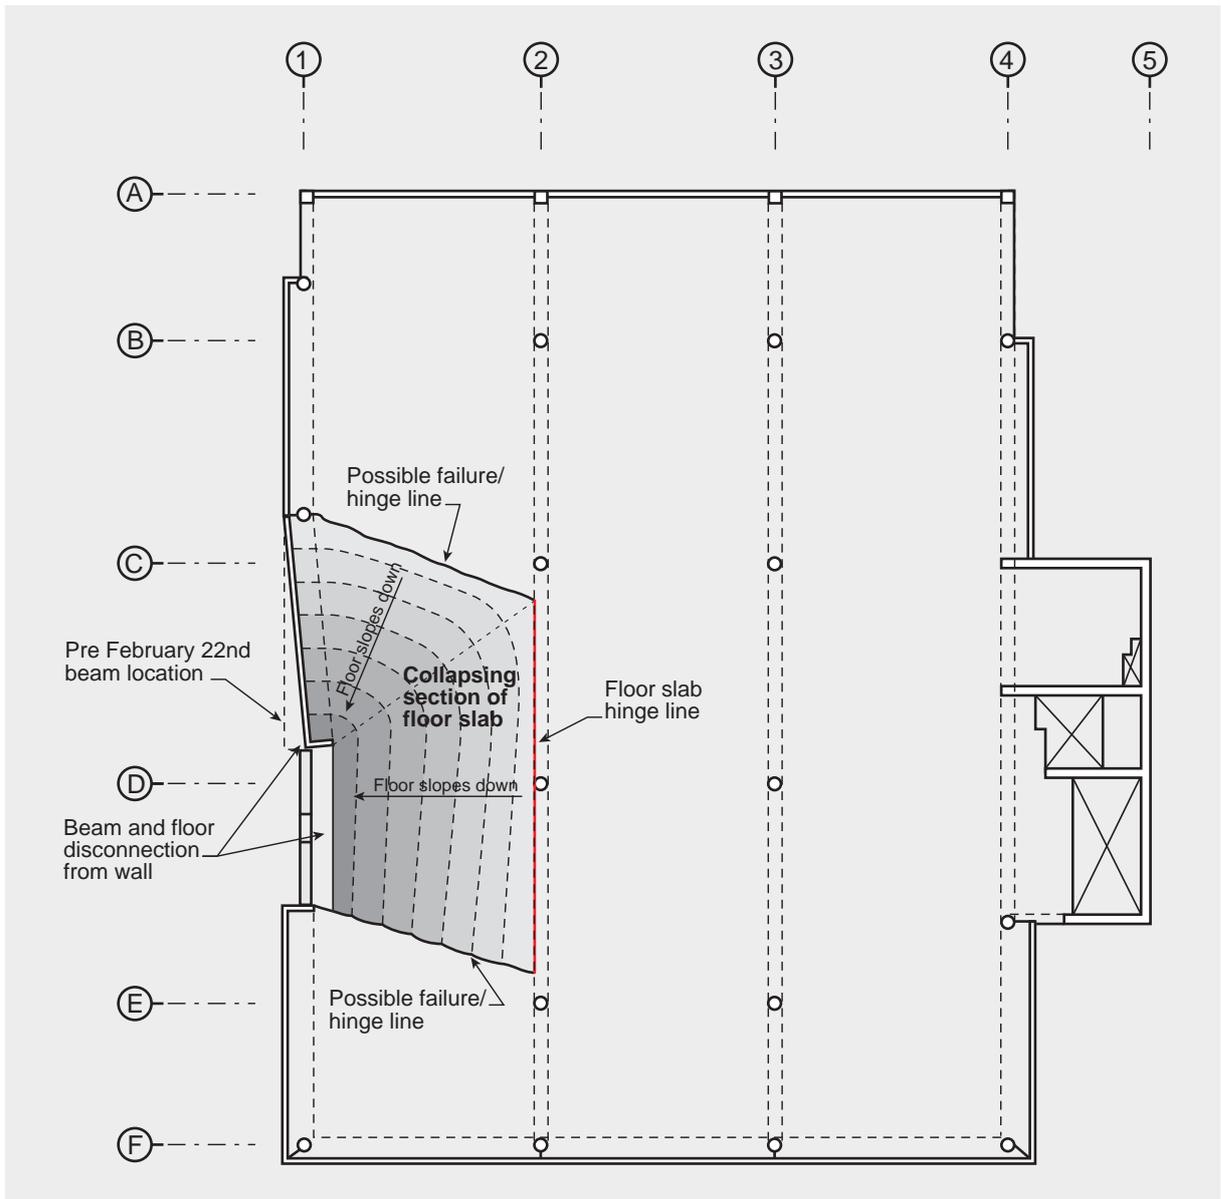
Figure 101: ARCL and Dr Reay's "Probable collapse mechanism stage 1 – level 3"

In closing submissions, counsel for Alan Reay Consultants Ltd (ARCL) and Dr Reay submitted that “the collapse probably initiated from the southern shear wall (leading directly to column and slab failure in the immediate vicinity followed by all elements save the north shear core)”. It was also submitted that collapse may not have occurred without the initial trigger of disconnection of the south shear wall. On this analysis the CTV building failed severely in part because of the damage caused by the September design level earthquake, which meant that the building, without repair, could not withstand the exceptional vertical and other forces experienced in the February earthquake.

A schedule titled “Probable collapse initiation mechanism” was attached to Mr Rennie<sup>7</sup> QC’s written submissions. This set out the argument in support of this failure mechanism, including references to evidence and a series of diagrams. The schedule described reinforcing failure in the connections of the floor slabs to the south shear wall causing the slabs at that point to disconnect from the wall and collapse. A hinging effect on the beams at line 2 commencing at level 3 was illustrated in a diagram (see Figure 101).

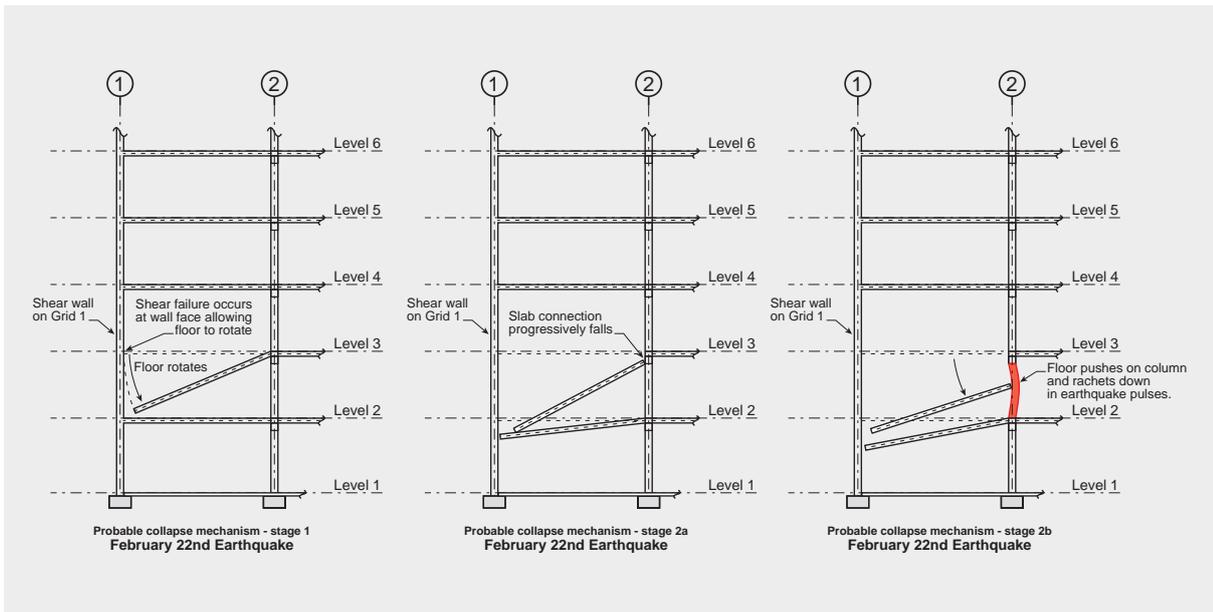
Figure 102: ARCL and Dr Reay's "Probable collapse mechanism"

The scenario is based on the premise that inter-storey drift of the order of 1.5 per cent would cause the reinforcement connecting the slab to the wall to fail, resulting in the slab on the third level collapsing onto the lower level as shown in Figure 102. It was postulated that this collapse would occur by hinging of the floor slab around the beams and columns on line 2, with the slab then acting as a prop that would bear against a column to cause it to bend and fail as indicated in the Figure 102. The schedule went on to say:

Once the collapse of the floors in that area occurred, it set in motion the collapse of the columns on line 2 (by the bending/buckling failure of the column/s). This occurred at the same time as the columns were subjected to additional high axial loads resulting from the very high vertical accelerations. The chain reaction that followed brought the building down.

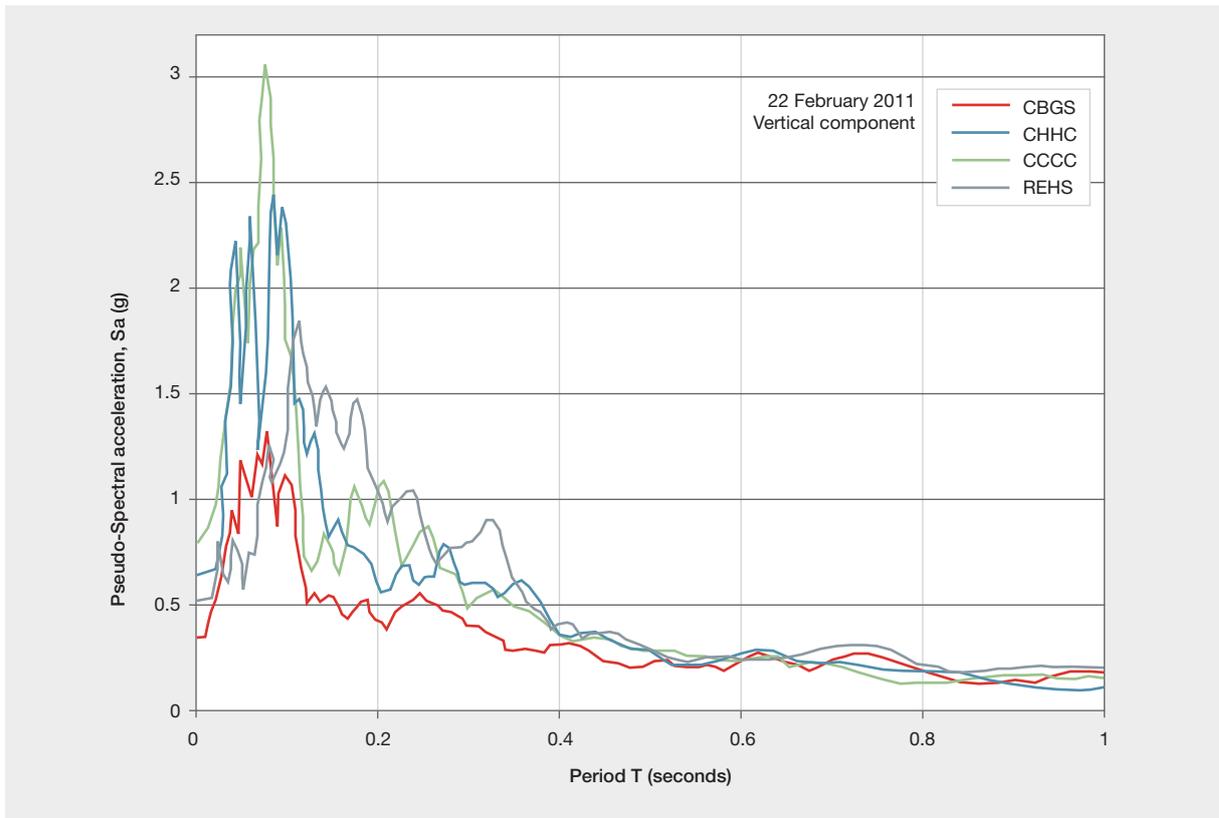
Figure 104: Response spectra of vertical ground motions observed during the 22 February 2011 earthquake (source: Brendon Bradley<sup>9</sup>)

Dr Bradley co-authored a paper<sup>11</sup> published in the *Bulletin of the New Zealand Society for Earthquake Engineering* on the strong ground motions observed in the February earthquake. In that paper it was noted that the large vertical ground motions observed were the result of the significant number of near-source recordings rather than any event-specific features. In a technical report<sup>12</sup> prepared for the Royal Commission, Dr Bradley assessed the ground motion aspects of the February earthquake related to the CTV building. Figure 104 illustrates the response spectra of vertical ground motions at the four CBD measuring stations in proximity to the CTV site. High vertical accelerations were recorded in the short period range, below 0.5 seconds. Dr Bradley's report established that the results of the four Geonet stations (that is, CCCC, CHHC, CBGS and REHS) were appropriate to model the ground motion at the CTV site in the September and February earthquakes. The REHS site had not been included in the first Compusoft analysis<sup>13</sup>, which formed the basis of the Hyland/Smith report. The Bradley report did not indicate any unique peculiarities at the CTV site, which would have substantially increased site ground motions.

Dr Reay anticipated a fundamental building period of 1.2 seconds in the east-west direction. The fundamental period for the vertical stiffness of the wall is much lower, about 0.2 seconds. The response spectra for vertical accelerations (see Figure 104) give a peak vertical acceleration of between 1.0g and 0.5g.

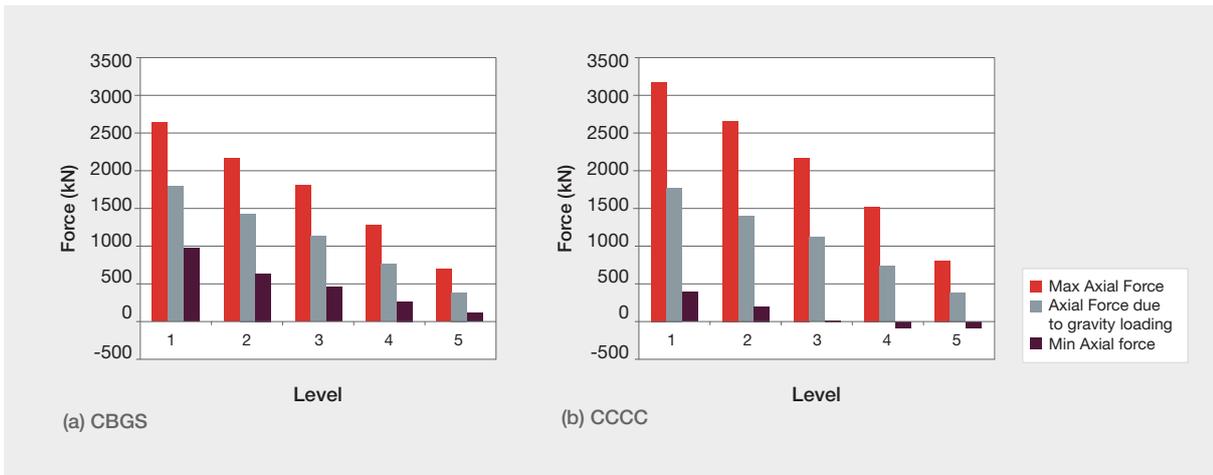
Figure 105: Column C2 axial load variation, 22 February earthquake (source: CompuSoft Engineering)

The effects of vertical accelerations were modelled in the Compusoft<sup>13</sup> non-linear time history analyses. In the second report<sup>3</sup>, prepared for the Royal Commission, the maximum variation in column axial load is shown in Figure 105. This Figure gives the predicted values for the internal column at the intersection of line C and line 2 when the analyses were run using the ground motion records obtained at the CBGS and CCCC Geonet stations.

Compusoft found that the CCCC ground motion record produced a much larger variation in the predicted axial loads in the columns than the corresponding values obtained with use of the CBGS record. This can be attributed to the difference in frequency components between the two records and the magnitude of the vertical accelerations present in each. Compusoft noted that the peak axial demands may not be concurrent with the peak bending actions that occur as a result of building drift. Consequently, when assessing vertical earthquake demands, consideration should be given to concurrency of actions.
