# Section 6:

## Technical discussions on structure

### 6.1 Design earthquake loading and analysis of the CTV building

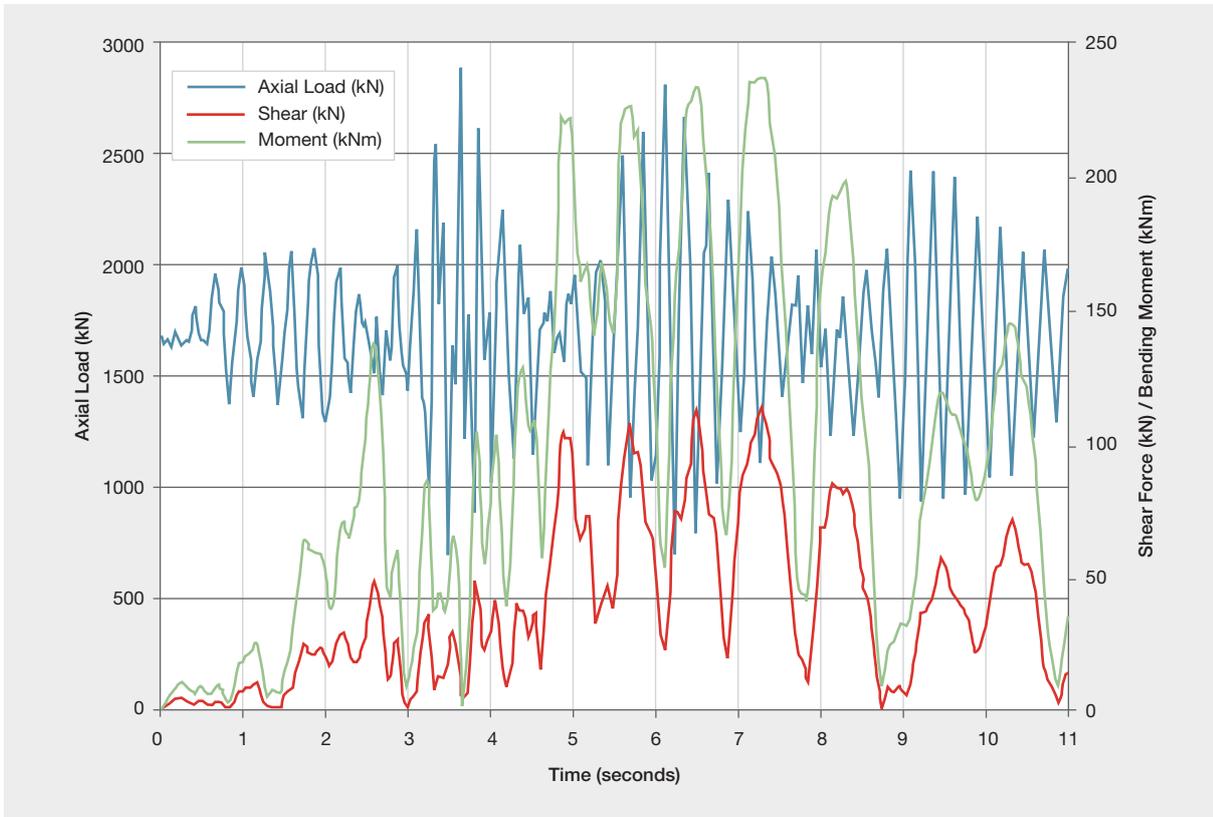
Figure 106: Predicted concurrent actions in column D-2 at level 1

Mr Smith (co-author of the Hyland/Smith report) presented in evidence a plot of the concurrent actions of shear, axial load and bending moments in a column at level 1 at the intersection of lines D and 2 during the February earthquake. The axial load (blue line), shear force (red line) and bending moment (green line) plotted against time are shown in Figure 106.

The design column gravity load assumed to apply with seismic load combinations is around 1700kN, which is the starting point for the blue line. The vertical oscillations are caused by vertical accelerations. Mr Smith mentioned that the damping value adopted was low and higher damping was used in subsequent analyses. He noted that vertical vibrations tend to decay earlier with higher damping values and there is therefore probably a slight overestimate of the effect of vertical accelerations. Mr Smith explained that this analysis is not exact and requires consideration of trends and general performance indicators. In particular he was looking for concurrent peaks of actions which may give critical conditions.

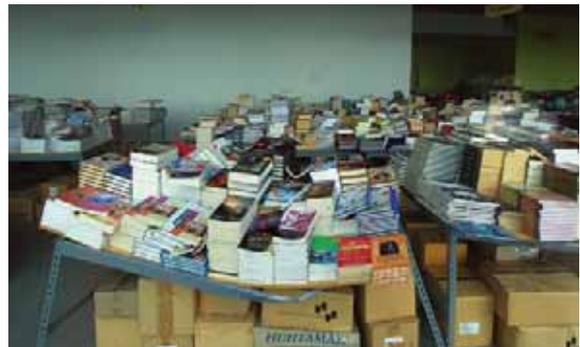
**Figure 107: Bookshop in the IRD buildings after the February earthquake (source: Ross Becker)**

Mr Harding referred to a photo taken by Mr Becker (see Figure 107), which shows books stacked up on steel trestle tables in the IRD building, at 224 Cashel Street directly opposite the site (we discuss the IRD building in section 6.5.3 of Volume 2). He observed that the lateral forces have not been sufficient to dislodge the books, however it appears the tables have a major sag in the middle “as if the books had tripled in weight”. He said this showed the site was subject to very high levels of vertical acceleration.

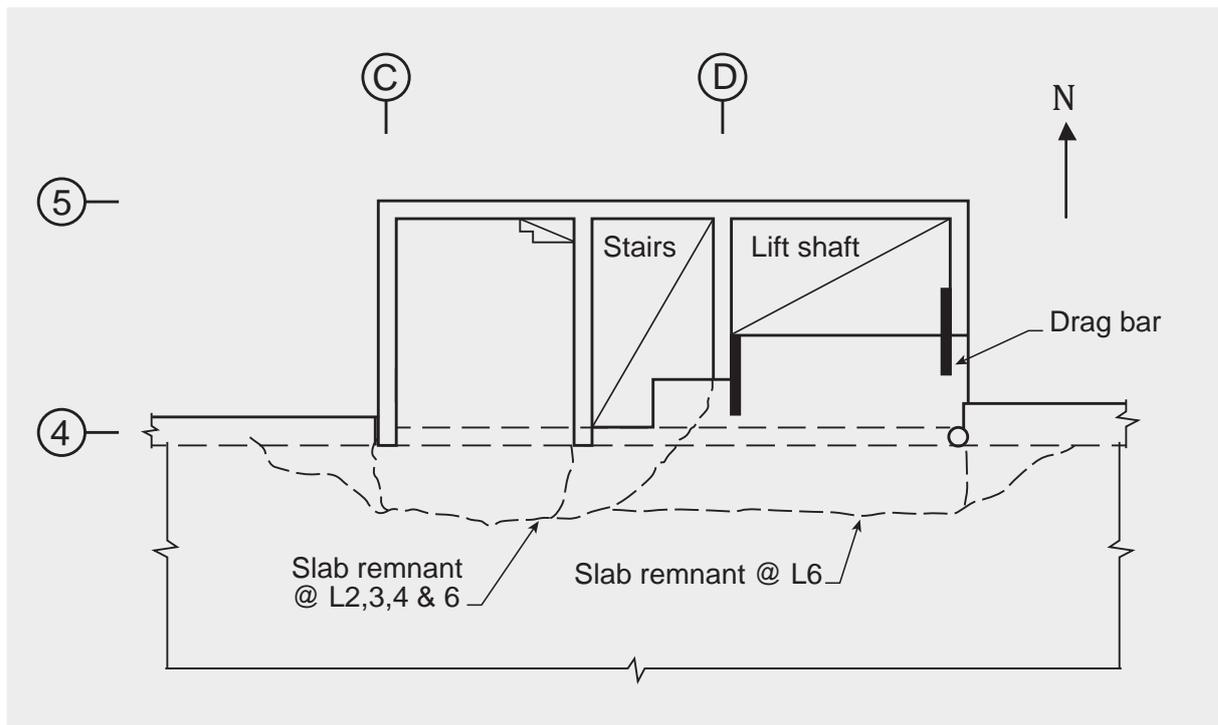
Figure 108: Remnant slab profiles at north wall complex after February earthquake (adapted from Figure 43 of the Hyland/Smith report)

We consider it likely that most of the drag bars failed in the early stages of the February earthquake with some tearing of the floors near line 4 in the region between walls C and D, as illustrated in Figure 108. Partial disconnection of the floors by the loss of the drag bars and the tearing of the floors, in this way, would have greatly increased the flexibility of the load path between the floor and the north wall complex. This would account for the lack of damage to the north wall complex. The tearing of the floor from the north wall complex would have been completed by the collapse of the floors. This process would account for the remnant portions of the floors remaining piled up against the north wall complex after the earthquake.

The failure of the drag bars and the partial disconnection of the floors from the north wall complex would have led to an increase in the inter-storey drifts in the structure. It is probable that the inter-storey drifts would have been sufficient to cause the collapse of the joint zones without the partial disconnection of the floors from the north wall complex. However, it is likely that this partial disconnection accelerated the failure of the building.

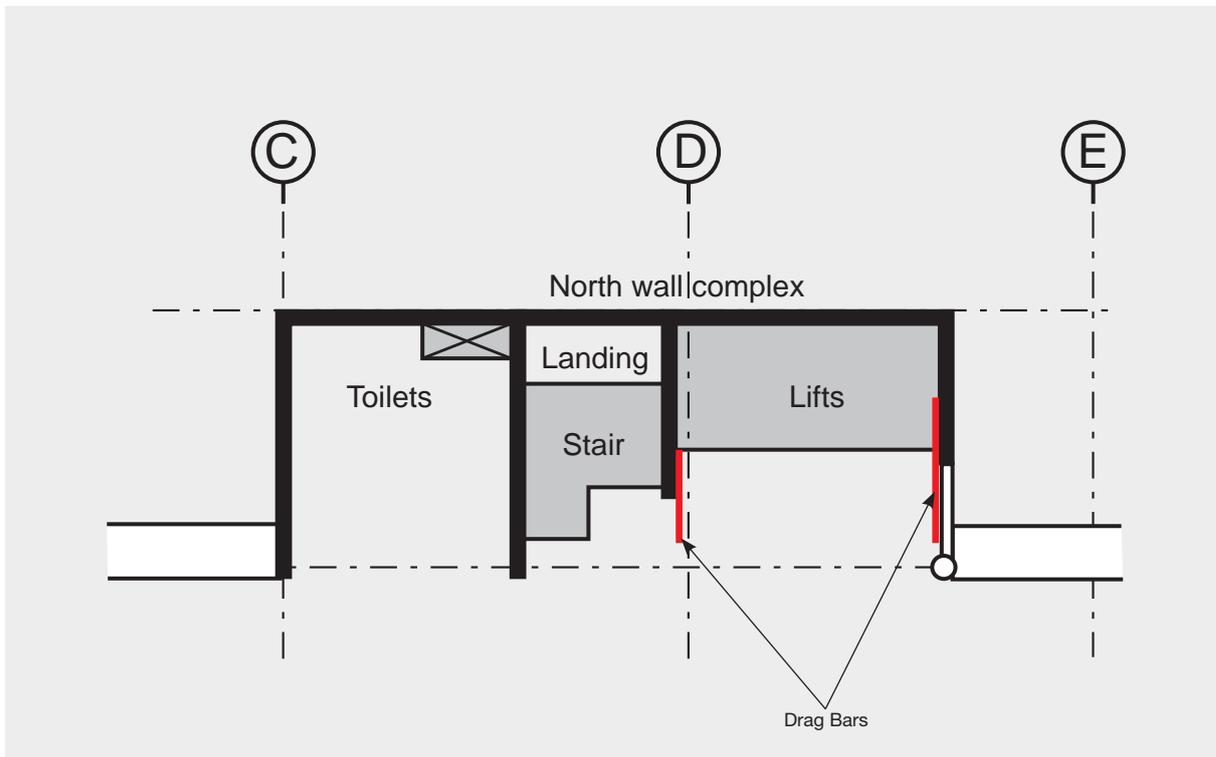
Figure 109: The north wall complex. The approximate locations of the drag bars, attached in 1991, are marked in red

The floors were connected to the north wall complex at various locations. A number of experts considered that the connections at lines D and D–E were inadequate. The Hyland/Smith<sup>12</sup> report pointed out that no specific reinforcing steel was specified in this region. Dr Hyland and Mr Smith characterised this as an “omission”. As discussed in section 2.4, Mr John Hare of HCG described it as “a vital area of non-compliance” with design codes current at that time. He said in his report to a potential purchaser in January 1990:

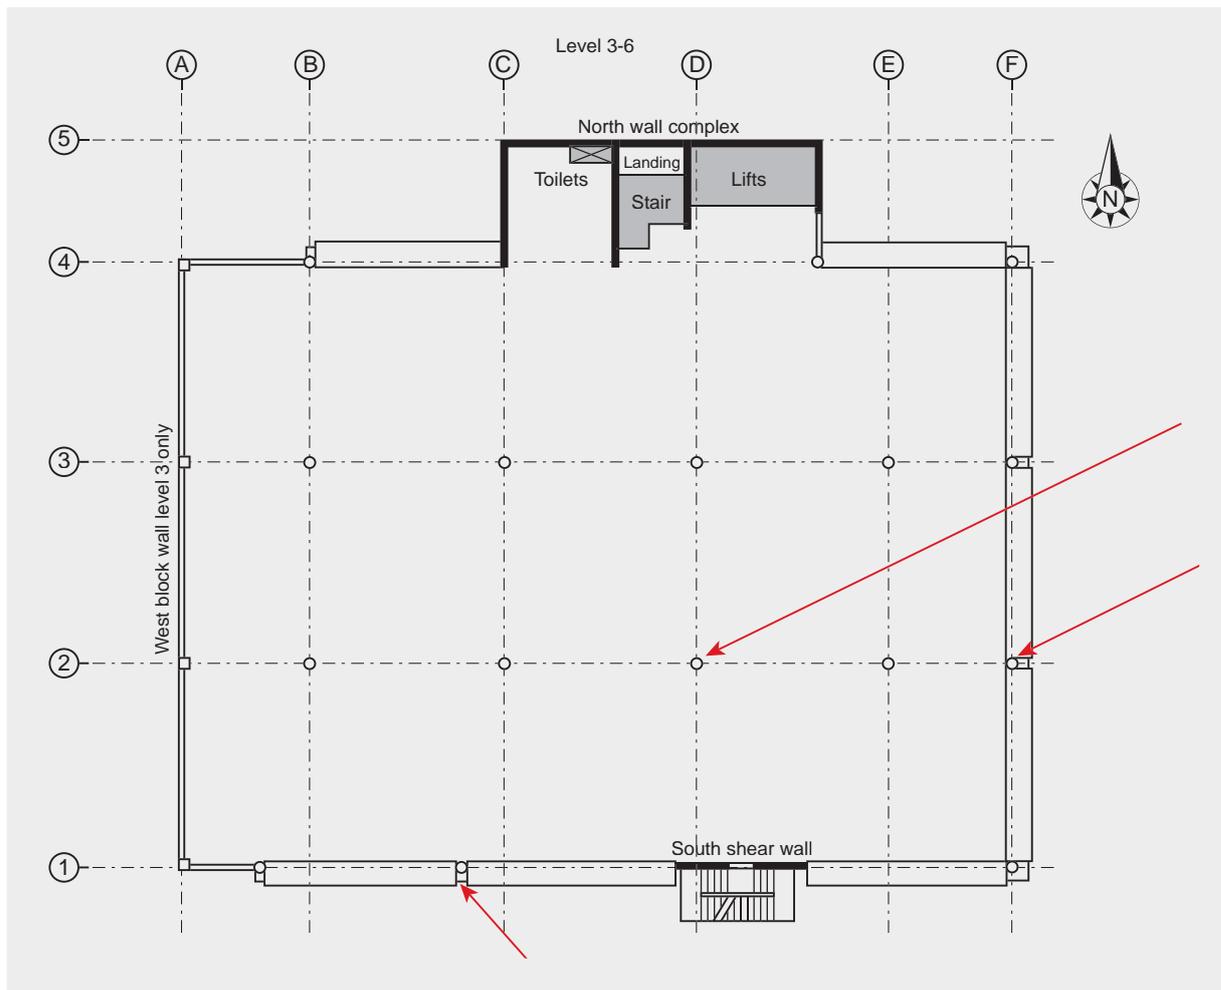
They selected columns on line 1 close to line C, at D-2 and at F-2 (see Figure 110) and calculated the design inter-storey drift as specified in NZS 4203:1984.

Figure 110: The indicator columns identified by Dr Hyland and Mr Smith were located at the intersection of gridlines D and 2, gridlines F and 2 and to the left of the intersection of gridlines C and 1

Dr Hyland and Mr Smith concluded in their report that columns on gridline 1, close to gridline C on levels 2–6 and at gridlines F–2 on levels 5–6 did not remain elastic at the design inter-storey drift. For this reason, they considered that the seismic provisions of NZS 3101:1982 should have been used for the design and detailing of columns of the CTV building. This finding was endorsed by the Department of Building and Housing’s Expert Panel and by Mr Jury, who gave evidence on behalf of the Expert Panel.

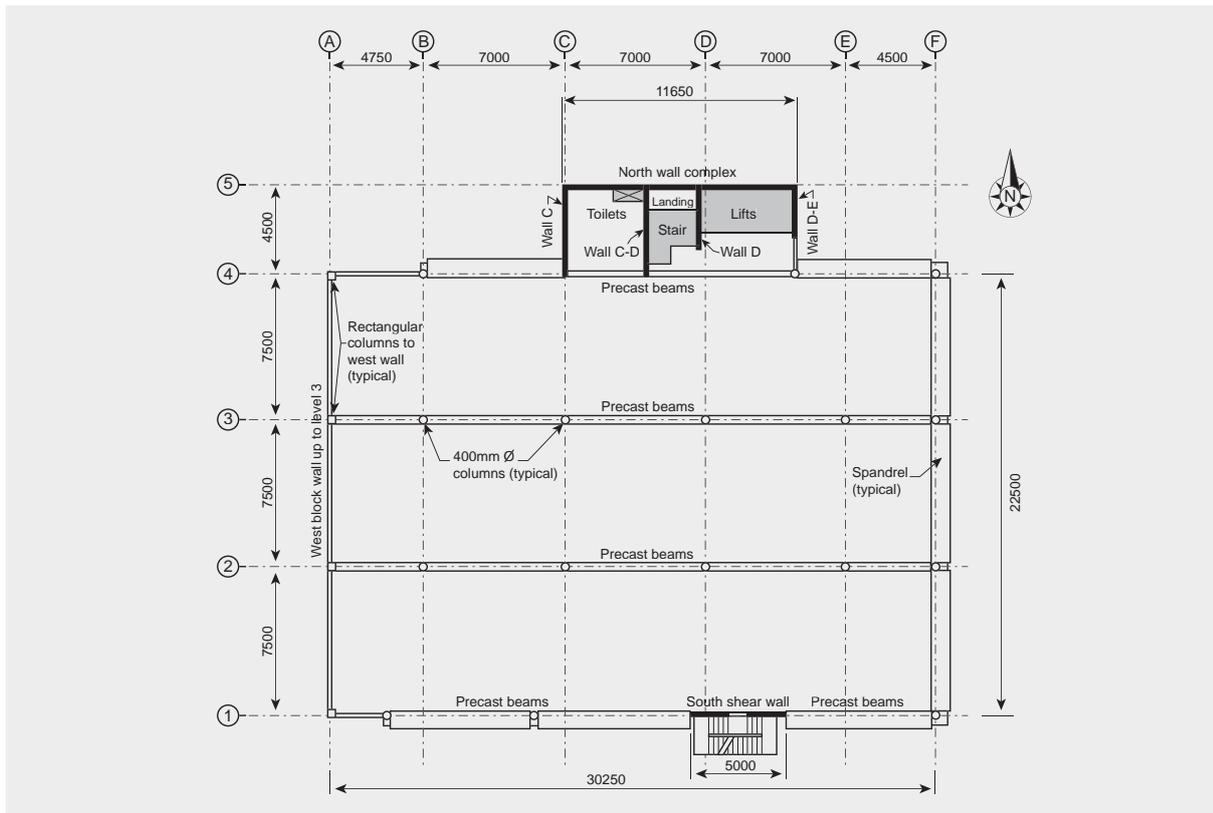
Figure 111: Typical upper floor structure

Figure 111 shows a typical upper floor structure of the building.

There is a major question in relation to Mr Harding's calculations of the extent to which the CTV building would deflect in an earthquake. Mr Harding based his calculations on deflections at the centre of mass and failed to allow for the increase in deformation due to torsional rotation of the building. This led to an underestimate of the inter-storey drifts of the columns on lines 1 and 2 in the CTV building (see Figure 111). This error had implications for the seismic performance of the building.
