FINAL REPORT

VOLUME 2

THE PERFORMANCE OF CHRISTCHURCH CBD BUILDINGS

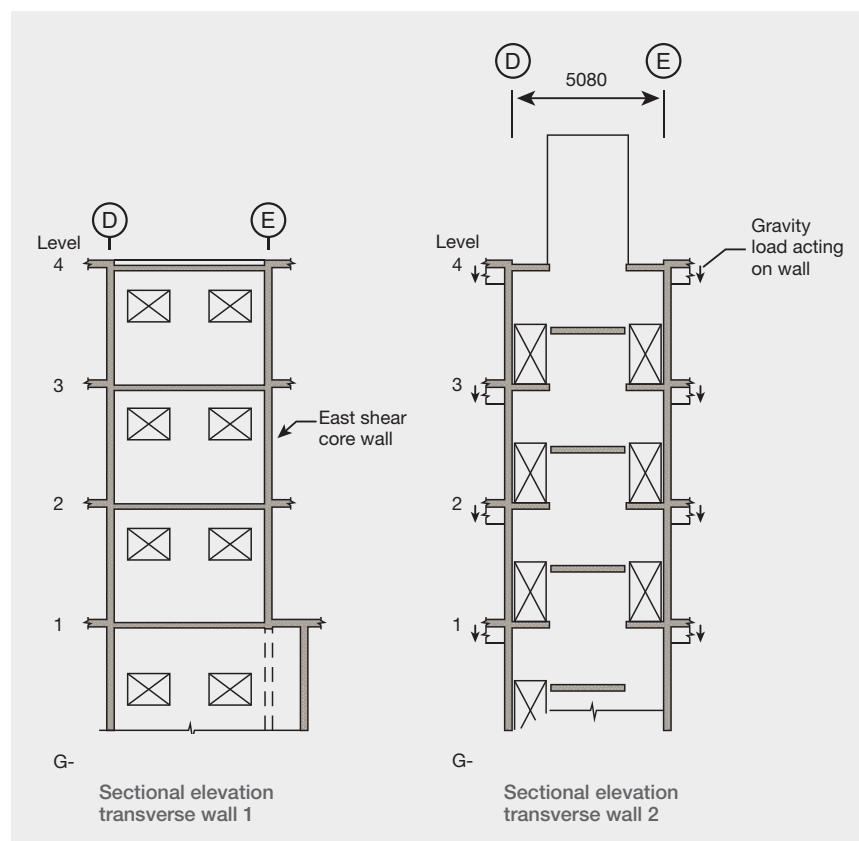
Figure 11: Elevations of transverse walls W1 and W2

3. The two transverse walls W1 (on grid line b) and W2 (close to grid line c) are shown in elevation in Figure 11. W2 was penetrated by doors at each level while W1 was penetrated by windows. There were a number of less significant openings in the transverse walls W3 and W4 located between grid lines d and e.

With reference to Figure 11, page 22, if a crack forms at level 1 the reinforcement at this location can sustain a force that is close to 2500kN. The beams on grid lines b, c, d and e apply gravity loads to both the eastern and western shear core walls. If the gravity load of the wall is included, these forces are of the order of 1250kN at each level on each wall. An assessment based on the locations of the walls and floor beams indicates that up to half the total forces applied to the western shear core wall would be likely to induce shear in the transverse wall W2. This would induce an average shear stress in the concrete above the doorways in excess of 3MPa. This and its associated bending moment could not be sustained by the wall as detailed. On this basis W2 could be expected to fail in a flexural shear mode.

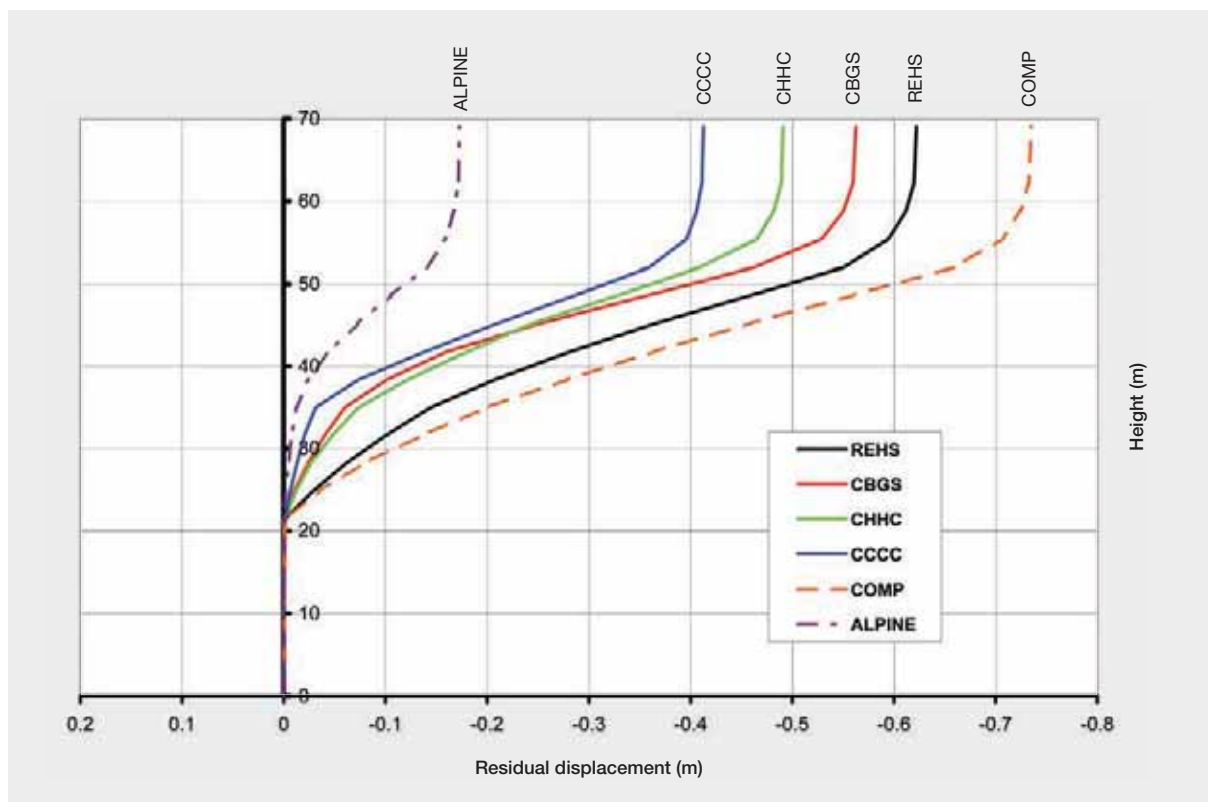
Figure 40: Residual displacement following earthquake ground motion

Figure 40 shows the residual predicted displacements over the height of the building after all motion has ceased for all the earthquake ground motion records. It can be seen that for the four CBD records the residual displacements were between 420 and 620mm.

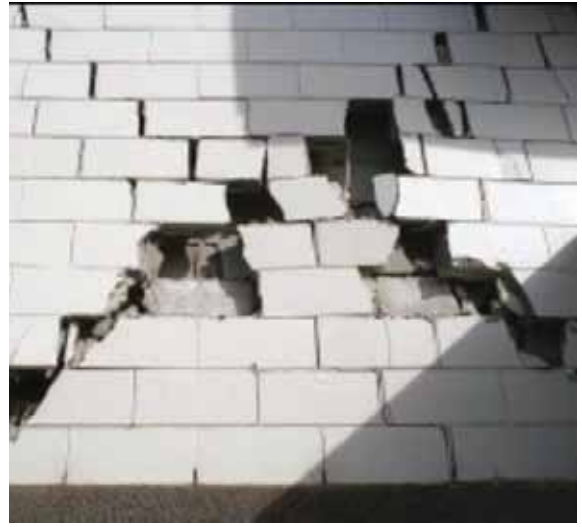
Figure 59: Punching shear cracking, 33 Lichfield Street

Buildings constructed using flat slabs supported directly on columns without beams are susceptible to punching shear cracking and failure (Figure 59). Demolition of these systems has shown them to be fragile with the potential of floor “pancaking”. Failure of slabs in punching shear can arise when inter-storey drift induces bending moments in the column, and these are then introduced into the floors. The shear stresses associated with the transfer of bending moments can greatly increase the stresses at the critical section and lead to a brittle failure.

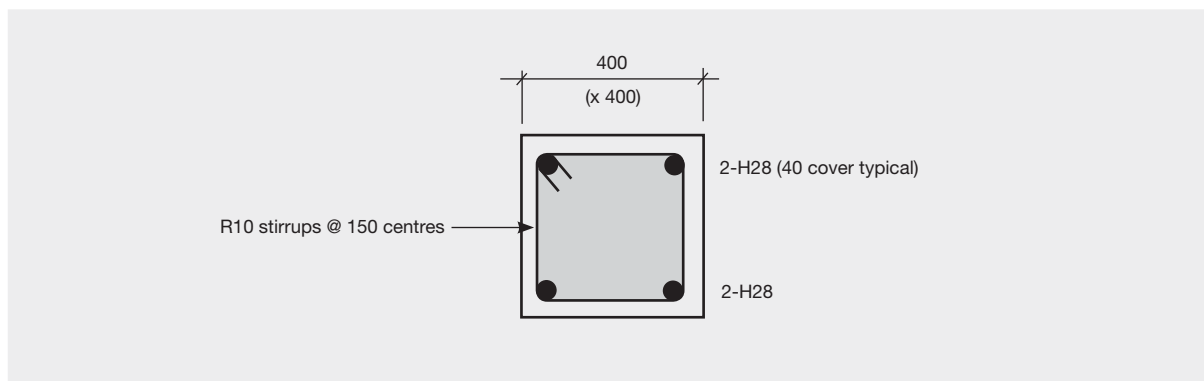
Figure 105: Section of columns from levels 2-6

Failure of a column would lead to a loss of gravity support that would highly stress other elements, potentially leading to the collapse of the building. The columns were inadequately confined with R10 stirrups placed at 150mm centres at the top and bottom of the column with minimal longitudinal bars. An approximate calculation of the nominal deformation capacity of the unconfined upper-level columns was in the order of 0.5 per cent inter-storey drift, which was below the design level demand of 0.8 per cent calculated in the inelastic analysis. The theoretical demand during the February earthquake was in the order of 2.4 per cent inter-storey drift.

In the Royal Commission's analysis, the deformation capacity was calculated conservatively by assuming full fixity at the top and bottom of the columns. In practice the slab would have rotated, reducing the rotations in the columns and accommodating a larger inter-storey drift. The damage observed after the February earthquake indicated that deformations in the columns caused the cover concrete to crack and spall.

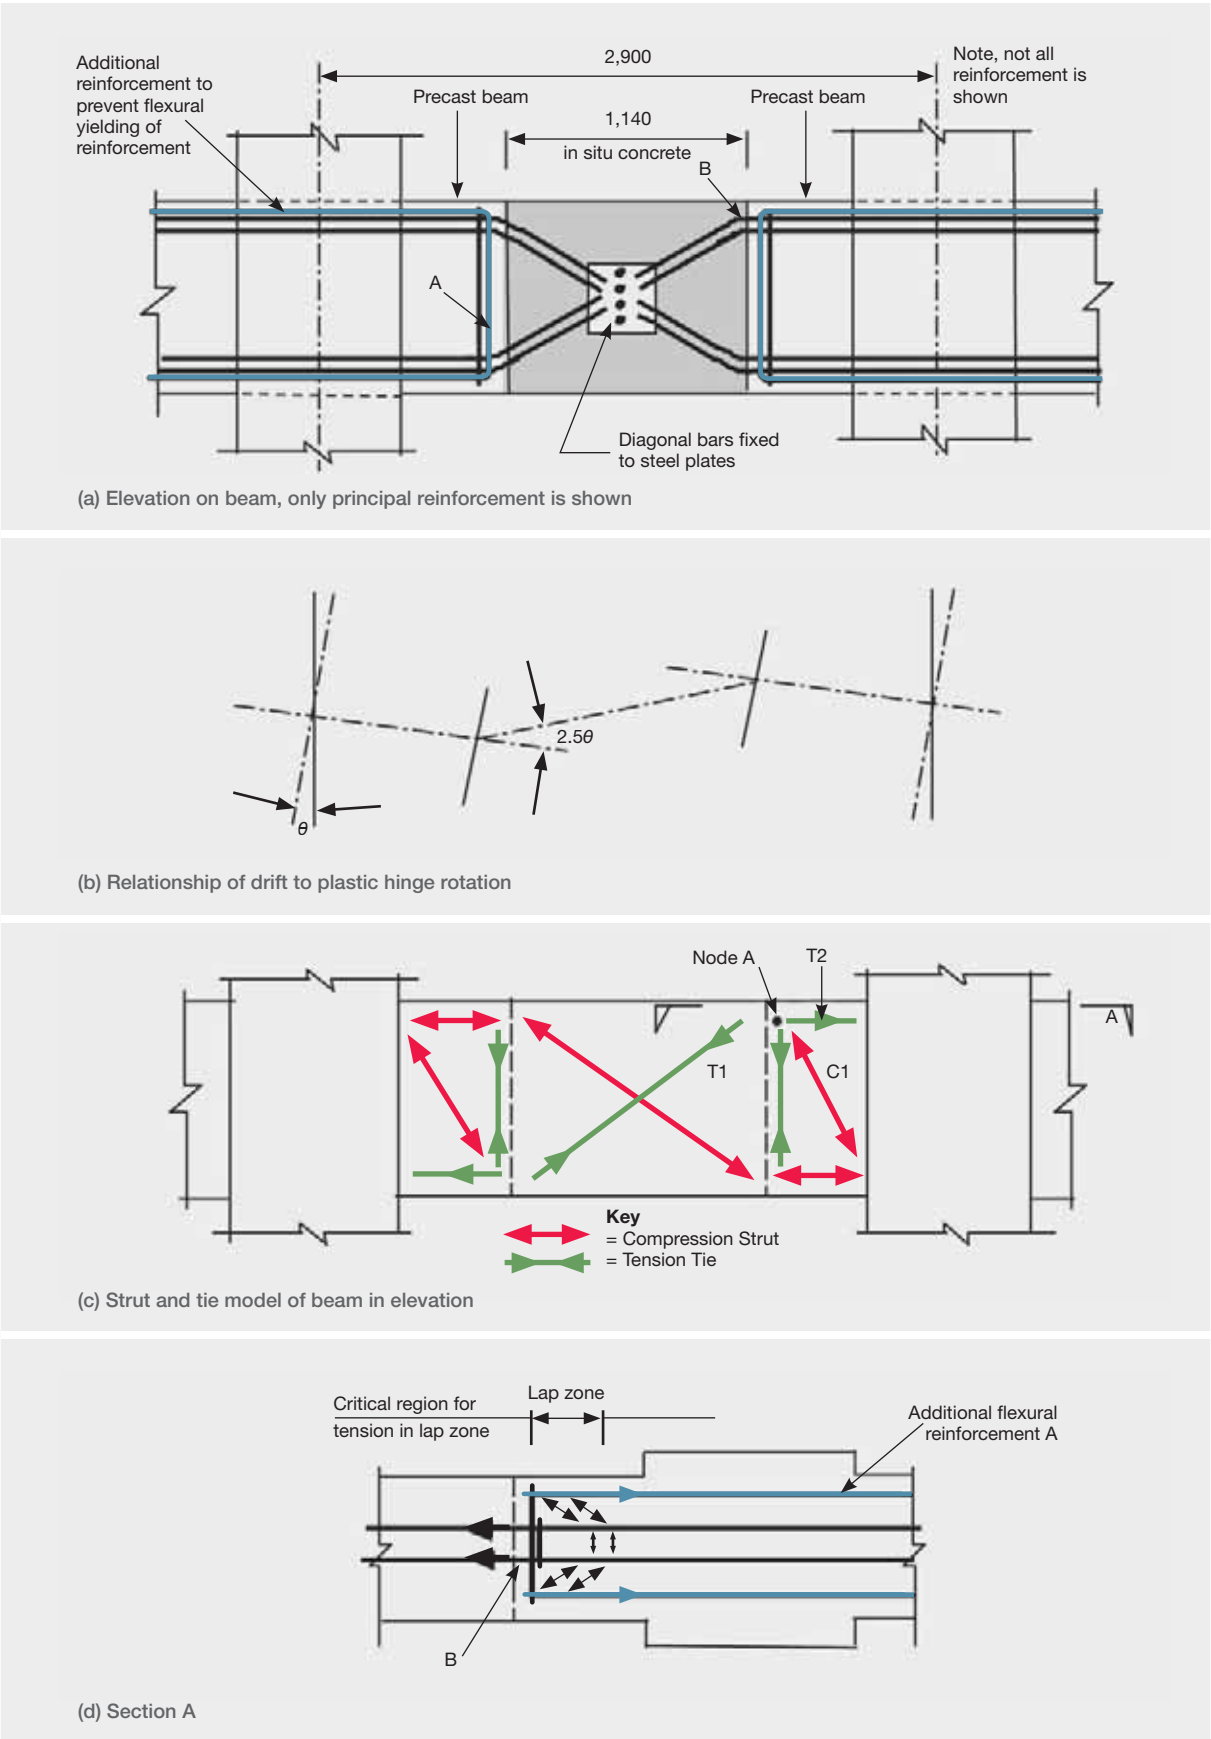
Figure 112: Strut and tie model of a coupling beam in the Clarendon Tower

To achieve the objective of limiting any inelastic deformation to the diagonal reinforcement when this detail is used in the mid-region of a beam, additional flexural strength must be added to the beam outside the zone containing the diagonal bars. In an attempt to achieve this objective, additional flexural reinforcement was placed in the precast beam unit. Looking at the beam in elevation, we consider this additional reinforcement formed a continuous loop around the perimeter of the beam with the bars bent at 90 degrees in the corners (see bars marked A in Figure 112).

As shown in Figure 112, this additional reinforcement was placed on either side of the bars that were bent diagonally down in the in situ concrete. Assessment of the strengths in accordance with standard structural theory would indicate that the flexural strength was adequate to achieve this objective. However, tests of the strengths, which were carried out a few years after the building was constructed, showed that the detail did not work as intended¹⁸.

A strut and tie analysis of the beam indicated that the critical section was located at the interface between the in situ concrete and the precast beam (see Figure 112(a)) and not in the diagonal reinforcement in the in situ concrete, as had been intended. The strut and tie model is shown in Figure 112(c). The magnitude of forces forming the strut and tie truss can be calculated from equilibrium. At node A in Figure 112(c), a tension force in the reinforcement, shown as T2, is equal to the horizontal component of the diagonal strut force, C1, plus the horizontal component of the diagonal bars' tie force, T1. The diagonal compression force, C1, provides the shear resistance and acts against the bend in the diagonal bars at node A. Consequently, tension force, T2, is resisted in the horizontal extension of the diagonal bars immediately on the column side of the in situ concrete. The magnitude of tension force, T2, in the bars reduces over a short distance as bond action transfers some of this force to the additional bars, marked A in Figure 112(a) and (d). As a result, only a short length of this reinforcement sustains the inelastic deformation. Strain levels in the reinforcement were, therefore, high. The situation was not improved by the location of the bend in the reinforcement that would have strain-hardened the bars and caused strain-ageing to occur.

Figure 112 shows the deflected shape of the beam associated with inelastic deformation of the bars at the ends of the precast beam segments. It can be seen that the rotation of the plastic hinges is about 2.5 times the drift angle, which is much greater than would have occurred if the plastic hinges had formed at the column faces. It is clear that this detail greatly increased the elongation induced in the east-west direction of the building.

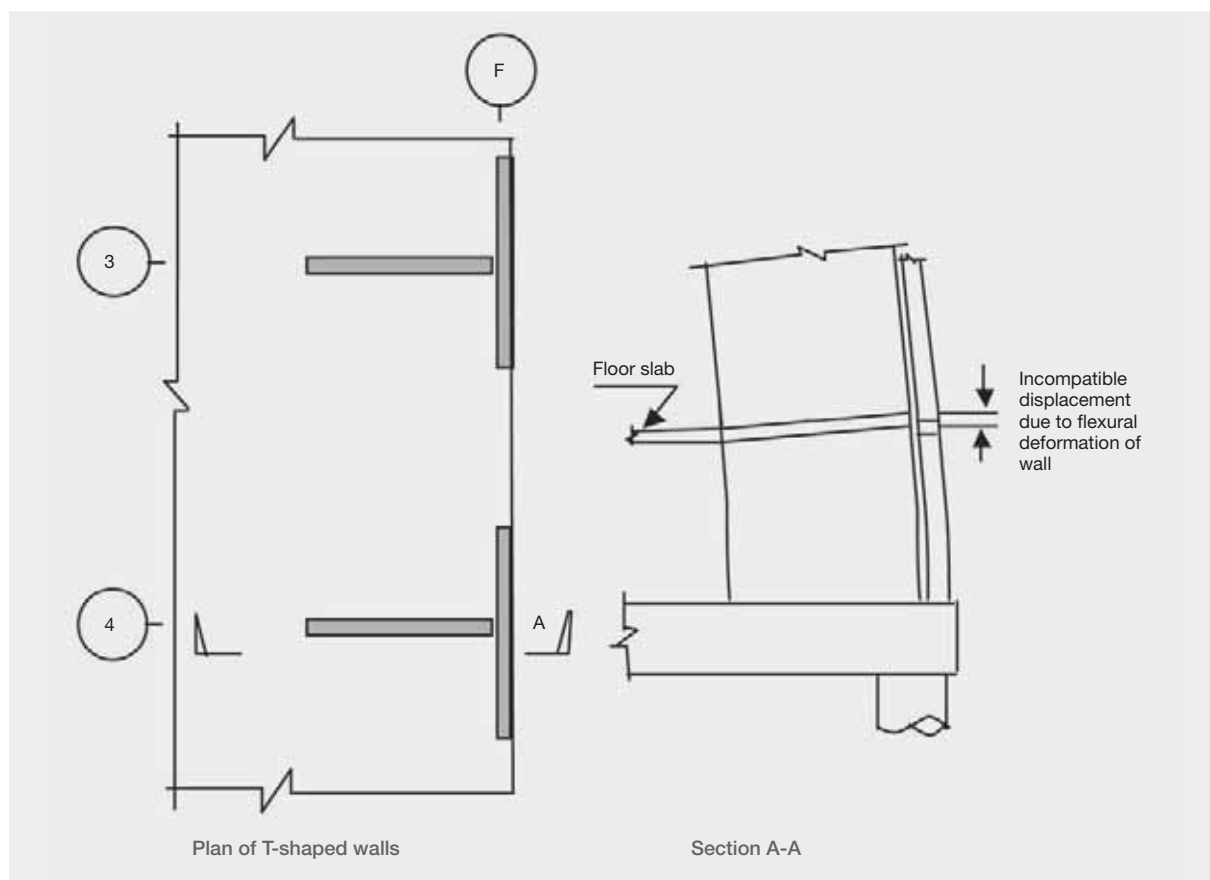
Figure 121: Incompatible displacement between structural walls

The walls on grid lines 3 and 4 are positioned close to separate walls on grid line F. These four walls formed two pairs, each in a T-shaped configuration (see Figure 121). In each pair the two walls were connected to the floors but not directly to one another. When the walls were subjected to seismic actions in the east–west direction incompatible displacements were induced between them, as shown in Figure 121. This deformation broke up the floor in the area close to the junction of the walls.

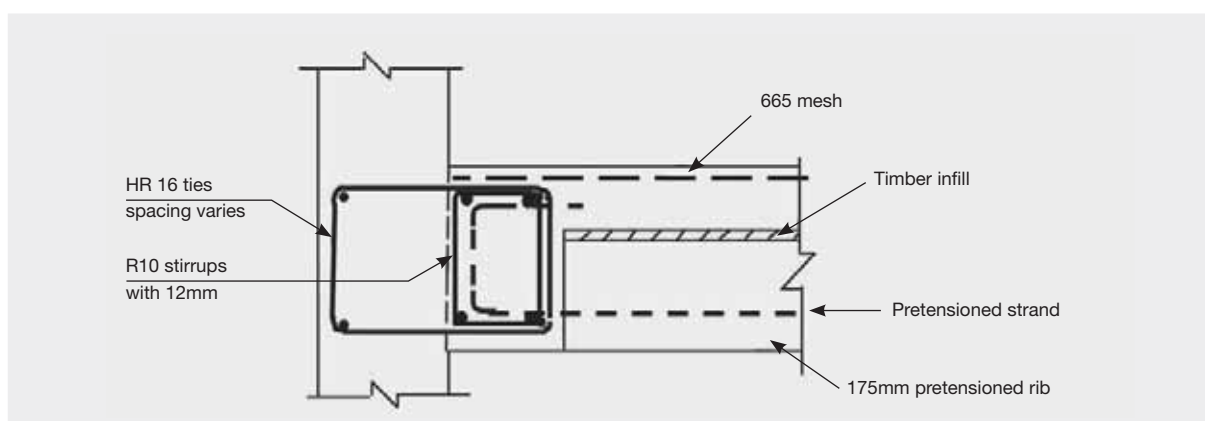
Figure 122: Support of the pretensioned rib on the edge beam

The Interspan ribs were supported on in situ concrete edge beams cast against concrete panels that formed the structural wall. A typical detail is shown in Figure 122. With this arrangement, the web of the pretensioned rib was supported by shear friction. This detail did not perform well and spalling occurred in the ribs and in the edge beam. Figure 123 shows the spalling that exposed the pretensioned strands. At the ends of the ribs in the transfer length of the strands, there were high bond stresses that increased the tendency for spalling to occur.

Shear friction strength decreases with increasing crack width. Reliance on shear friction for load transfer in such situations was uncertain. Out-of-plane displacement of the wall would apply a prising action to the rib and the pretension strands anchoring it into the edge beam. Consequently the clamping force acting across the crack, which supports the rib, can be lost. In this event, the rib relied on support through the in situ concrete topping. A diagonal tension force must be sustained in the web of the rib, as shown in Figure 122, to transmit this force to the topping concrete. This is not a reliable load path, so positive bearing support on the lower surface of precast floor units should be used.

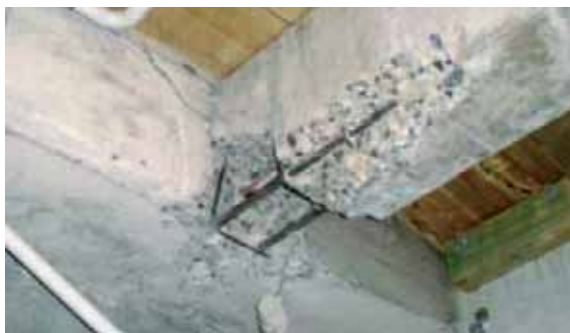
Figure 123: Exposed prestressing strands from the Interspan rib into the edge beam (source: Spencer Holmes Ltd)

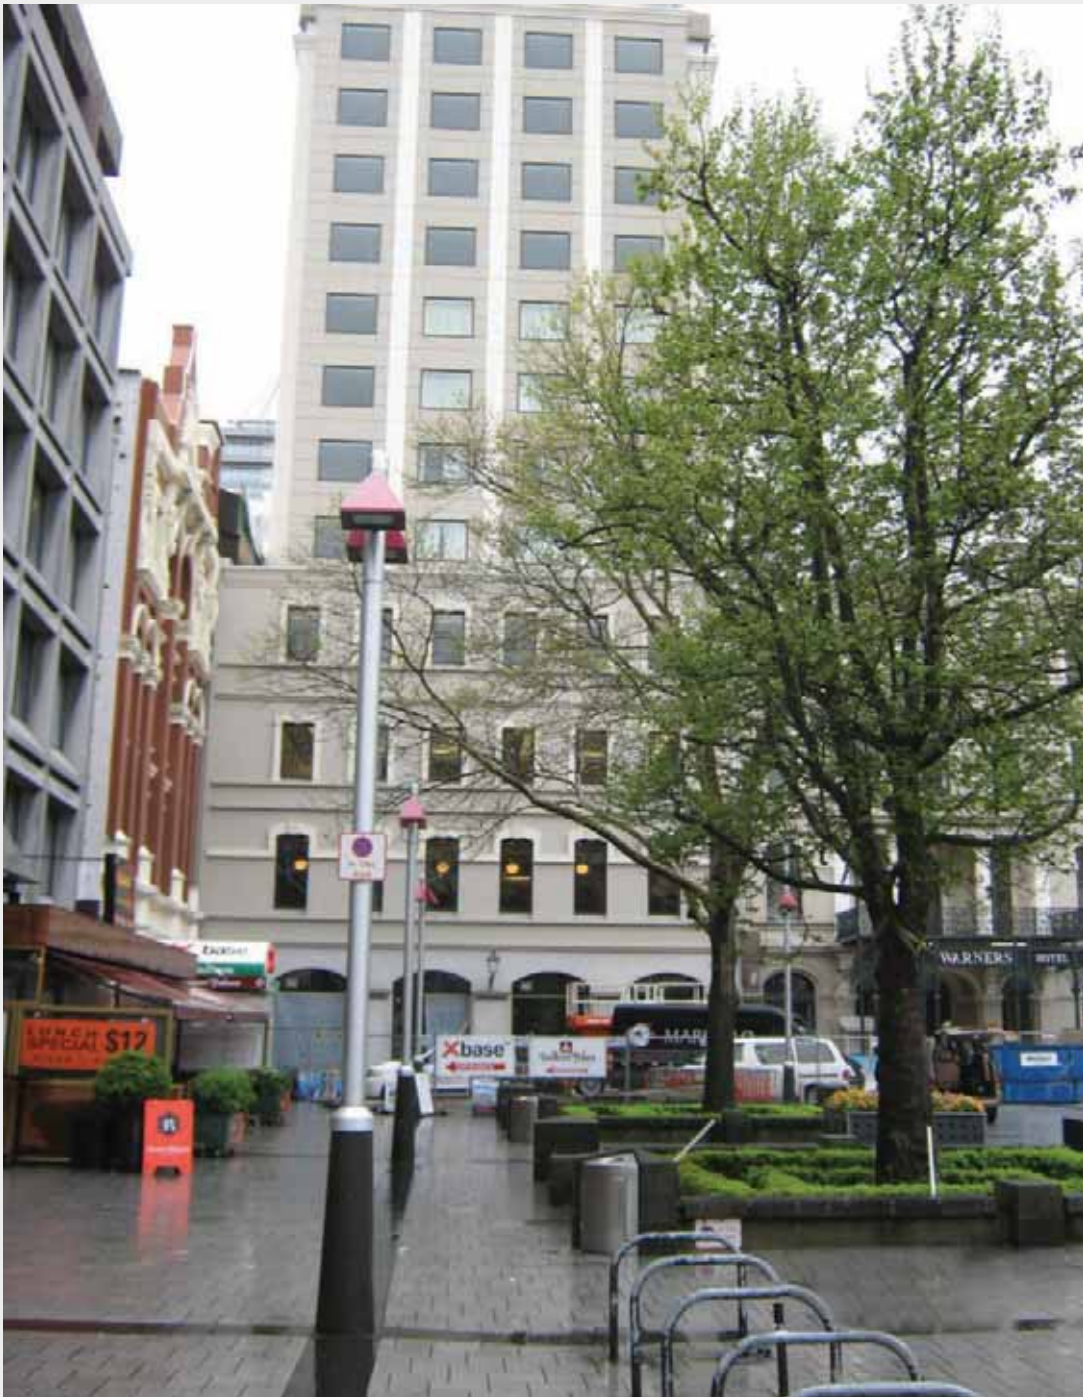
Figure 133: View looking east from Cathedral Square (source: CCC)

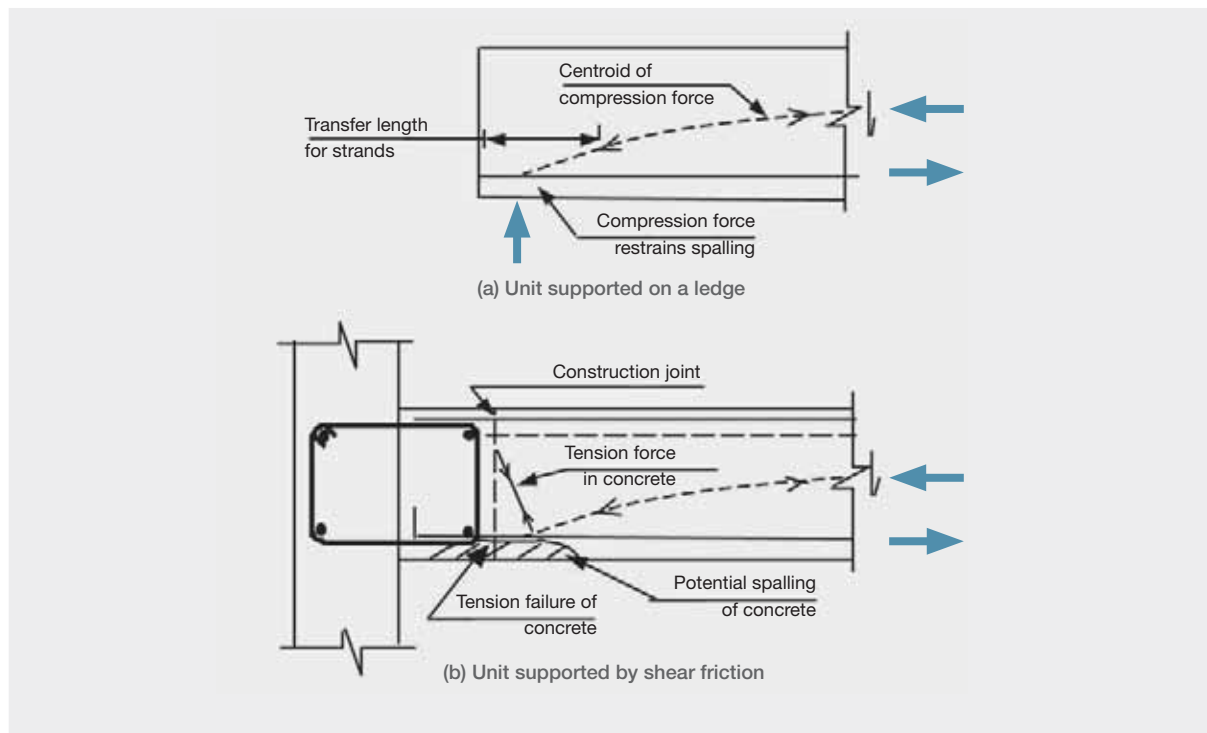
Figure 138: Support of precast floor units.

The usual arrangement is to support precast floor units on a ledge. With this arrangement the reaction from the support balances the transfer force from the pretension strands and the inclined compression force in the unit, as shown in Figure 138(a). The spalling of concrete below the strands in the transfer length is prevented by the compressive reaction from the supporting ledge.

In two structures (the IRD and Gallery Apartments buildings) some units were supported by shear friction between the back face of the unit and the face of the supporting structural element. One detail is shown in Figure 138(b). In this case there was no compression force from the support to suppress tension stresses in the transfer length, and consequently the spalling resistance was diminished in the concrete below the pretension strands.

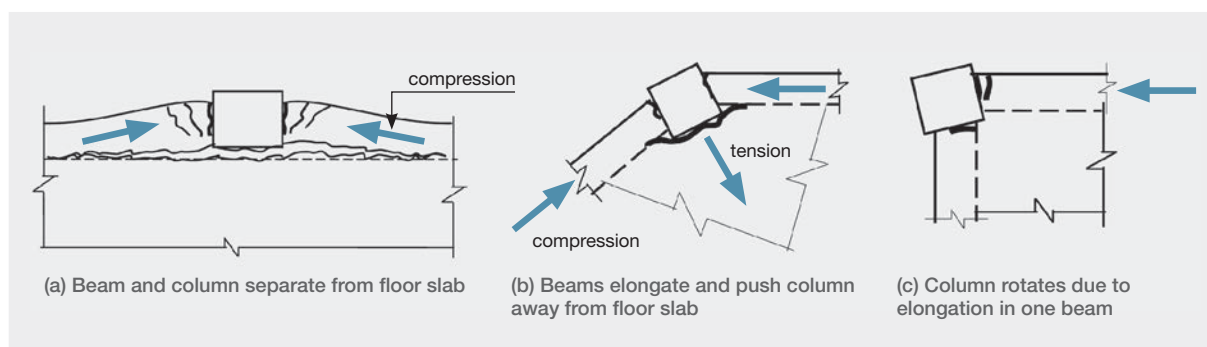
9.2.9 The restraint provided to beams by floor slabs, particularly where the floor slab contains prestressed precast floor units, can induce significant axial compression force in beams. This can cause the beams and associated columns to separate from the floors as illustrated in Figure 143(a). This type of separation occurred in the Clarendon Tower building. It would have been prevented if there had been a beam framing into the column at right angles to the perimeter beam. Alternatively, reinforcement that ties the column into the floor can be provided, as detailed in clause 10.3.6 of the Standard. Figure 143(b) shows the form of deformation seen in the Westpac Tower building. In this case the deformation cannot be practically restrained as very high forces would be required. Some form of ductile tie could be used to enable any cracks that are generated to be repaired. The column rotation shown in Figure 143(c) was observed in structural tests by Peng.⁵

Figure 143: Compression forces induced by elongation and boundary elements
