UNDER	THE COMMISSIONS OF INQUIRY ACT 1908
IN THE MATTER OF	ROYAL COMMISSION OF INQUIRY INTO BUILDING FAILURE CAUSED BY CANTERBURY EARTHQUAKES KOMIHANA A TE KARAUNA HEI TIROTIRO I NGA WHARE I HORO I NGA RUWHENUA O WAITAHA
AND IN THE MATTER OF	CTV BUILDING COLLAPSE

SECOND STATEMENT OF EVIDENCE OF TIMOTHY JOHN ENTRICAN SINCLAIR IN RELATION TO CTV BUILDING
DATE OF HEARING: COMMENCING 25 JUNE 2012

CTV Building Geotechnical Advice - Addendum 2

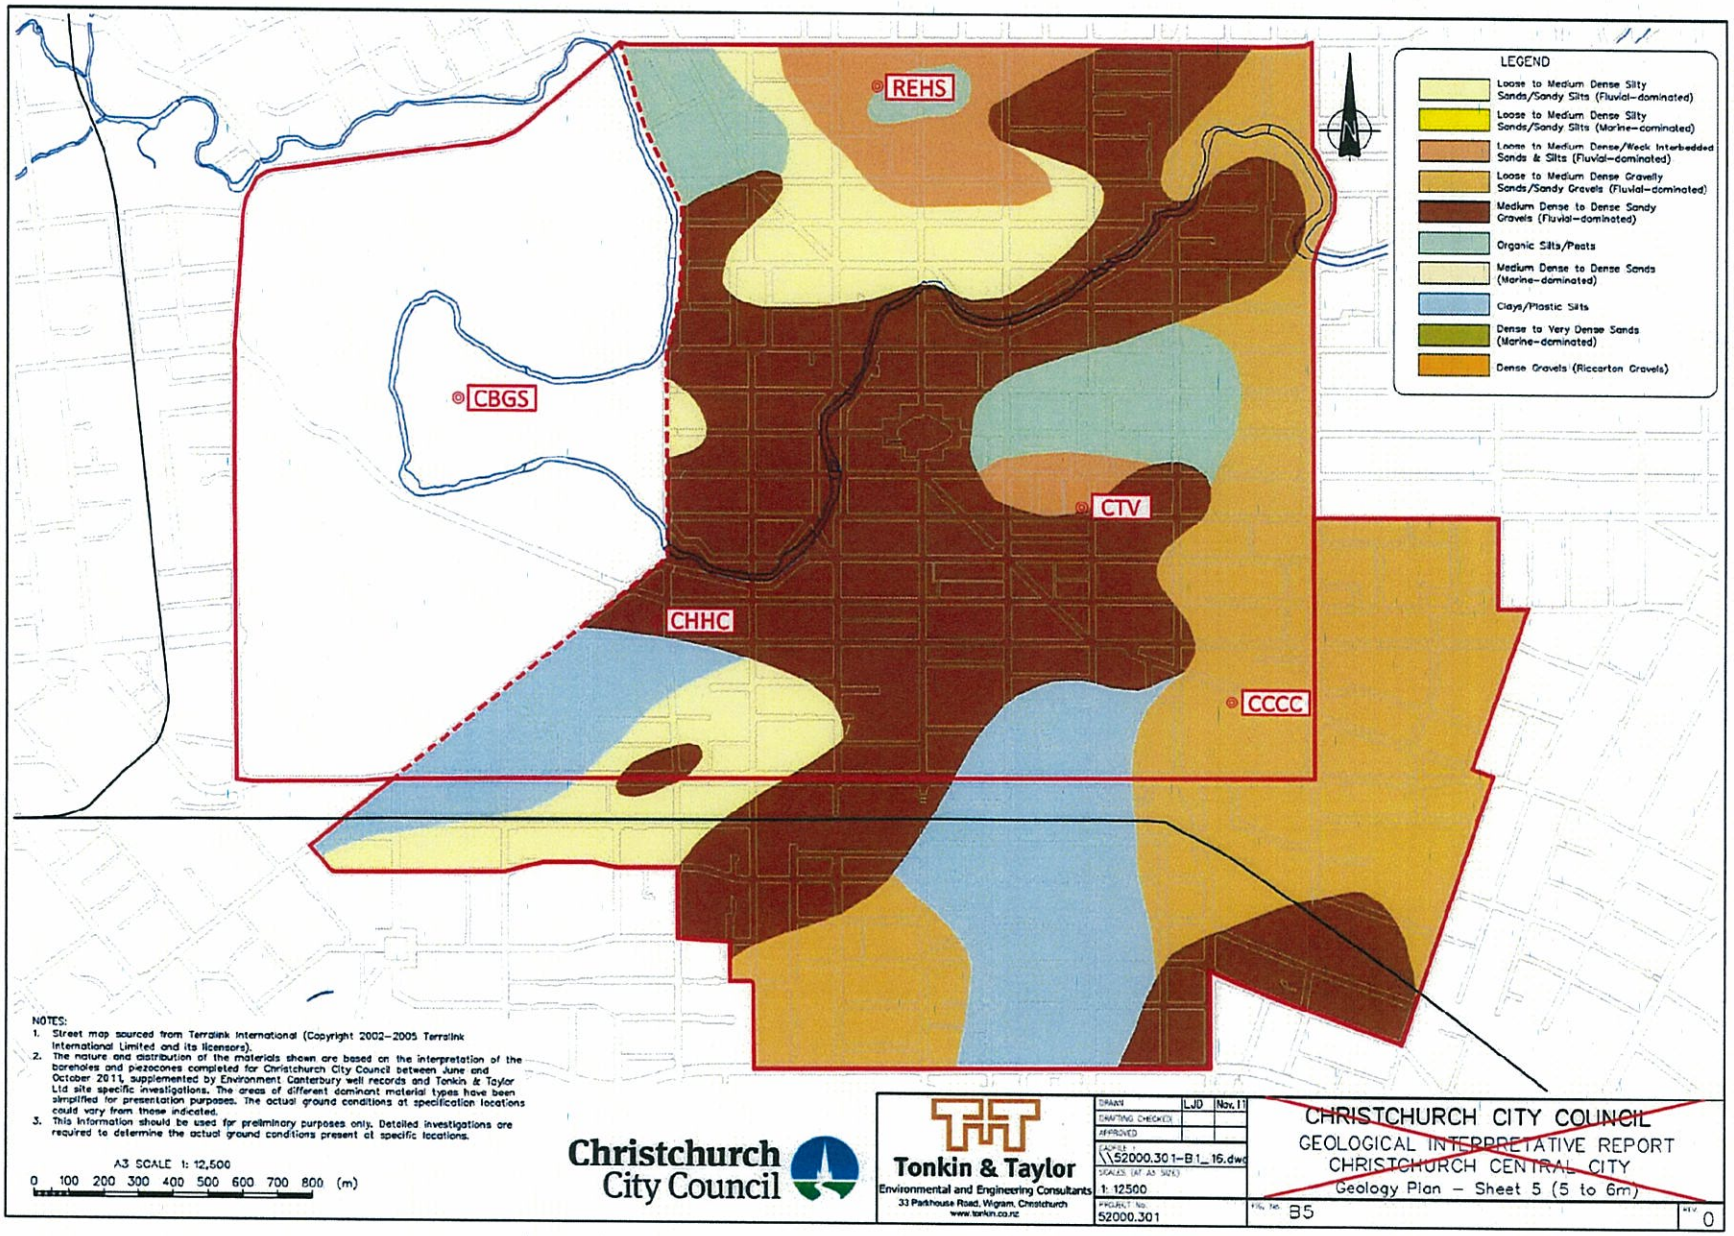
ii. The soil profile data collected from this investigation, supplemented with existing historic borelog data held by Environment Canterbury, was compiled and interpreted to produce a generalised three-dimensional model of the simplified soil profile across the CBD. This model provides an indication for regular depth intervals of the predominant soil types which are present. An example generalised geological plan is shown in the attached Figure 1, showing predominant soil types across the city between a depth of 5m and 6m. The dark brown shading across much of the CBD on this map represents medium-dense to dense sandy gravels.

Figure 1: Example generalised area-wide geological map used to compile soil profiles. This map shows predominant soil types between 5m and 6m depth. Maps available for a range of depths in T&T Appx B at http://www.ccc.govt.nz/homeliving/civildefence/chchearthquake/centralcityplan.aspx

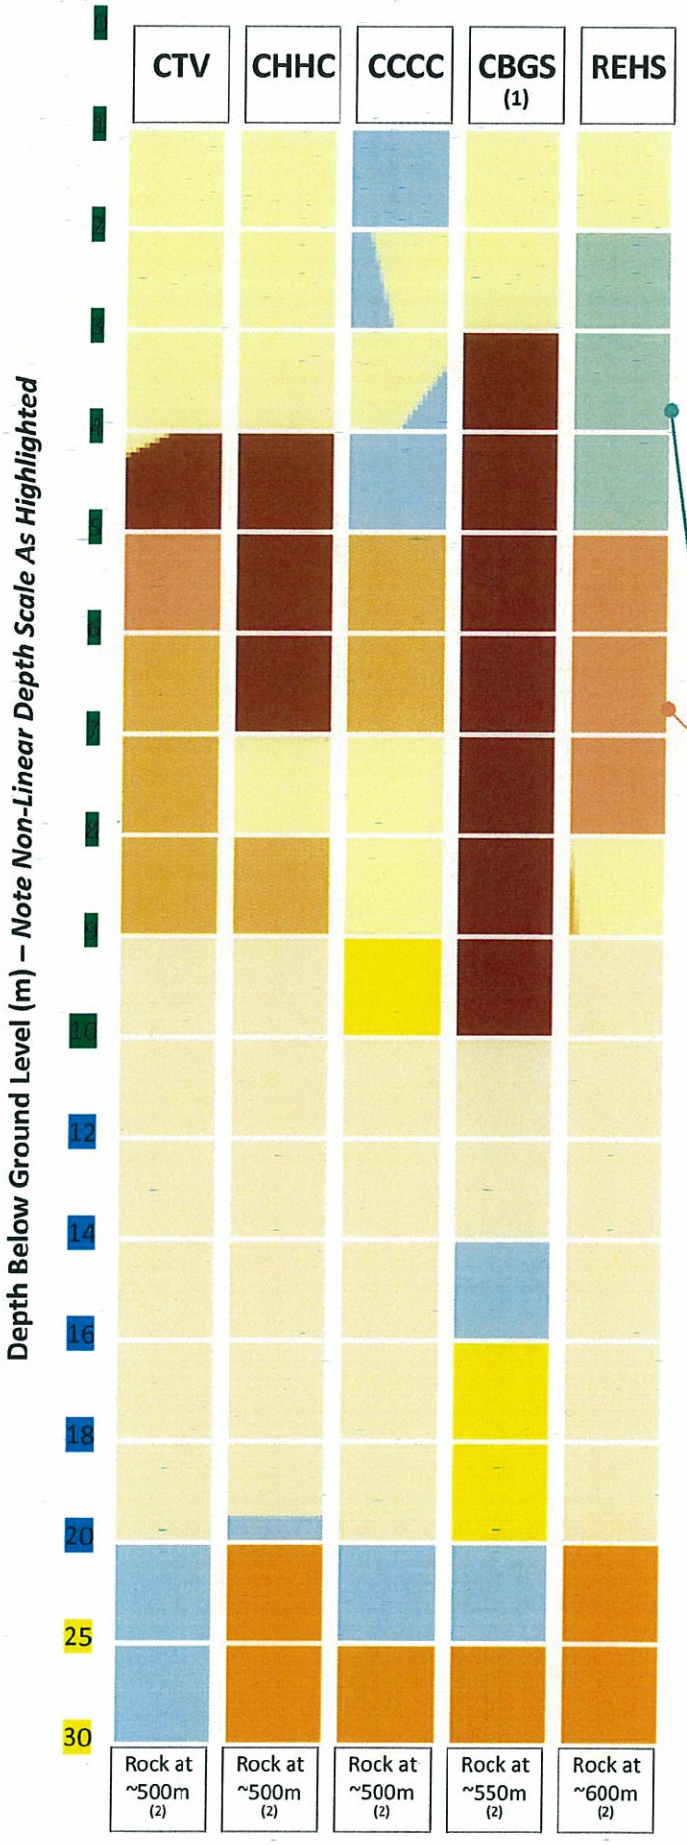
Figure 2: Comparison of generalised ground conditions at Christchurch CBD strong motion sites to CTV Building site.

v. The area-wide assessment of ground conditions in the vicinity of each site of interest is summarised in the attached Figures 2 and 3. These figures have been compiled by taking a local snapshot of the generalised geological map for each depth interval. At the centre of each snapshot square is the location of each site of interest. The width of the snapshot square is 20m for Figure 2, so for the most part this figure can be interpreted as a simplified soil profile log for each site. For Figure 3 the width of the snapshot square is 500m, so this enables the area-wide geological trends to be inspected for each depth interval across the various sites. This provides a sense of the general nature and variation of the wider geological environment.

vi. These generalised area-wide soil profiles show that soils in the vicinity of the REHS site appear to be generally softer than in the vicinity of the other GeoNet sites and the CTV building. Between the surface and about 5m depth at REHS the predominant soil types are soft organic or silty soils, whereas at the other sites there is predominantly loose to medium dense silty sand or sandy silt over this depth range. Between about 5m and 9m depth at REHS there are predominantly loose to medium dense sands and silts, whereas at the other sites much of this

depth range predominantly comprises stiffer gravelly soils. Below about 9m depth, down to the Riccarton gravels all the sites appear to have reasonably similar predominant soil types.

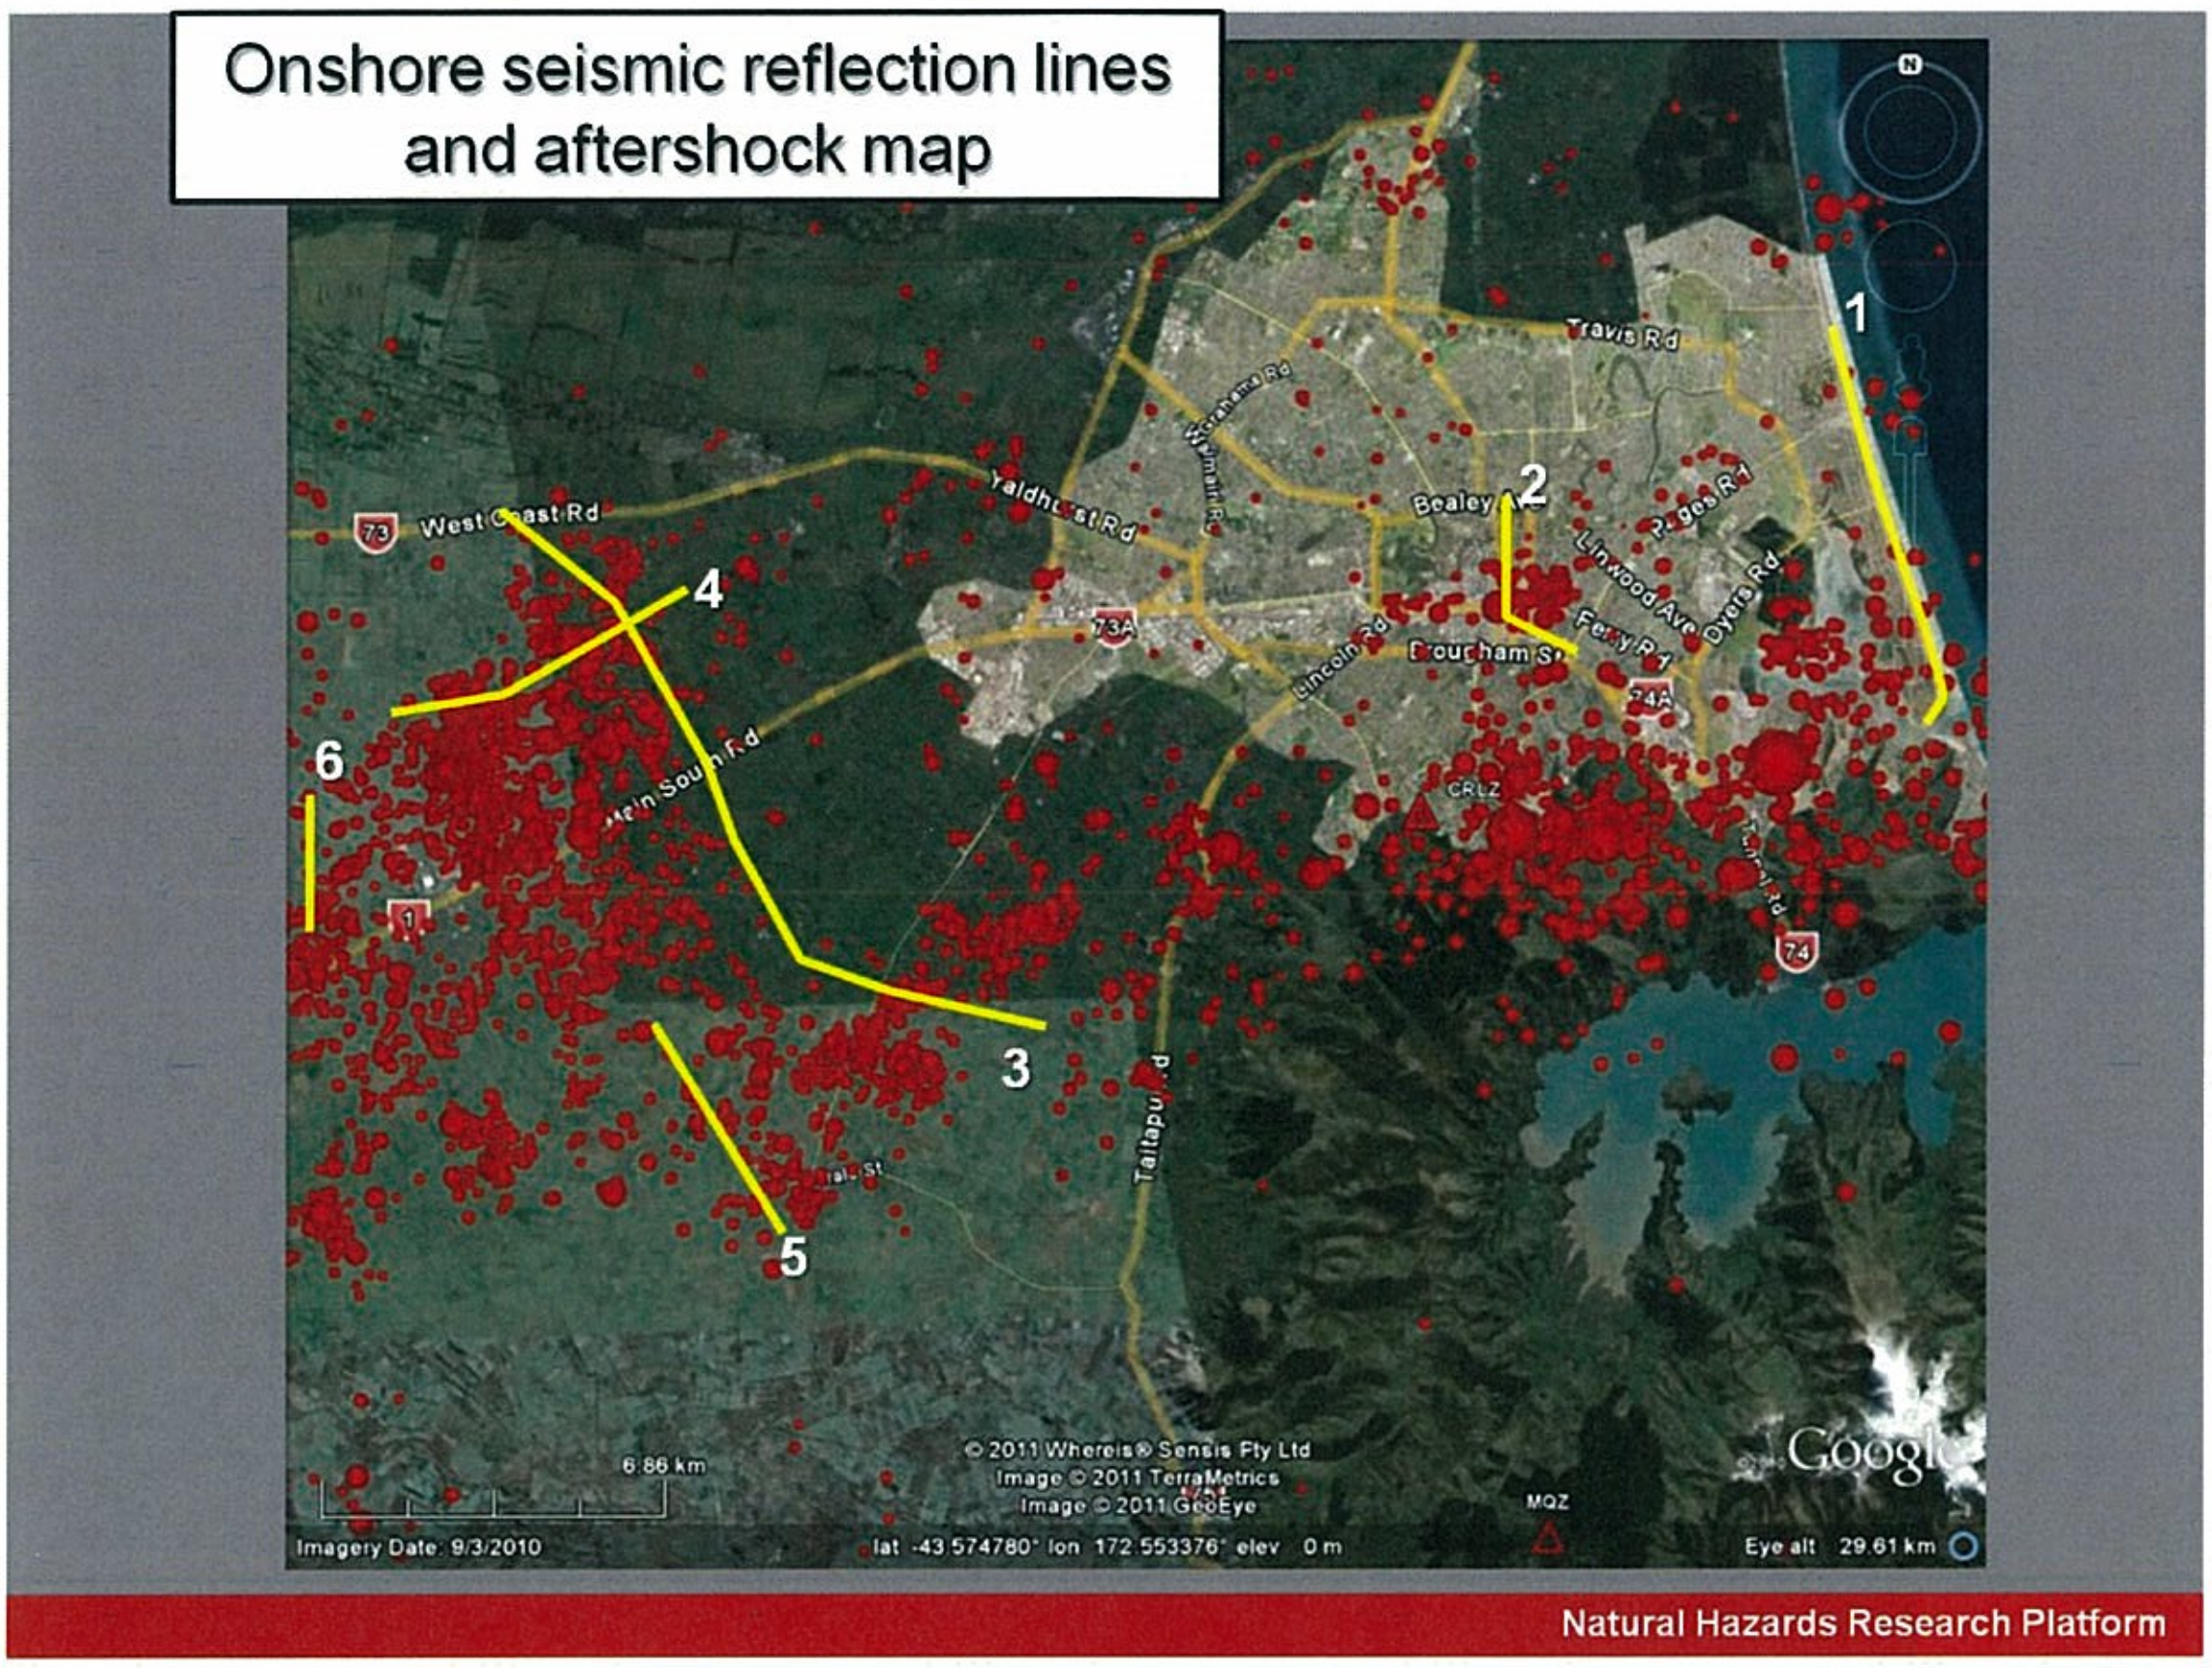
(2) Depth to rock estimated from inferred position of Lyttelton Volcano Paleo-topography on cross section 2 (runs up Barbadoes St) from the deep seismic reflection study undertaken by GNS / UC (from presentation by Berryman, Gerstenberger, Barnes & Pettinga "Progress in understanding the Canterbury Earthquakes" 6-Jan-2012).

Onshore seismic reflection lines and aftershock map
1
2
3
4
5
6
Travis Rd
Bealey
West Coast Rd
Yaldhurst Rd
Lincoln Rd
Linwood Ave
Ferry Rd
Dyers Rd
Main South Rd
Tai Tapu Rd
Imagery Date 9/3/2010
6.86 km
© 2011 Whereis® Sensis Pty Ltd
Image © 2011 TerraMetrics
Image © 2011 GeoEye
Google
Eye alt 29.61 km
Natural Hazards Research Platform

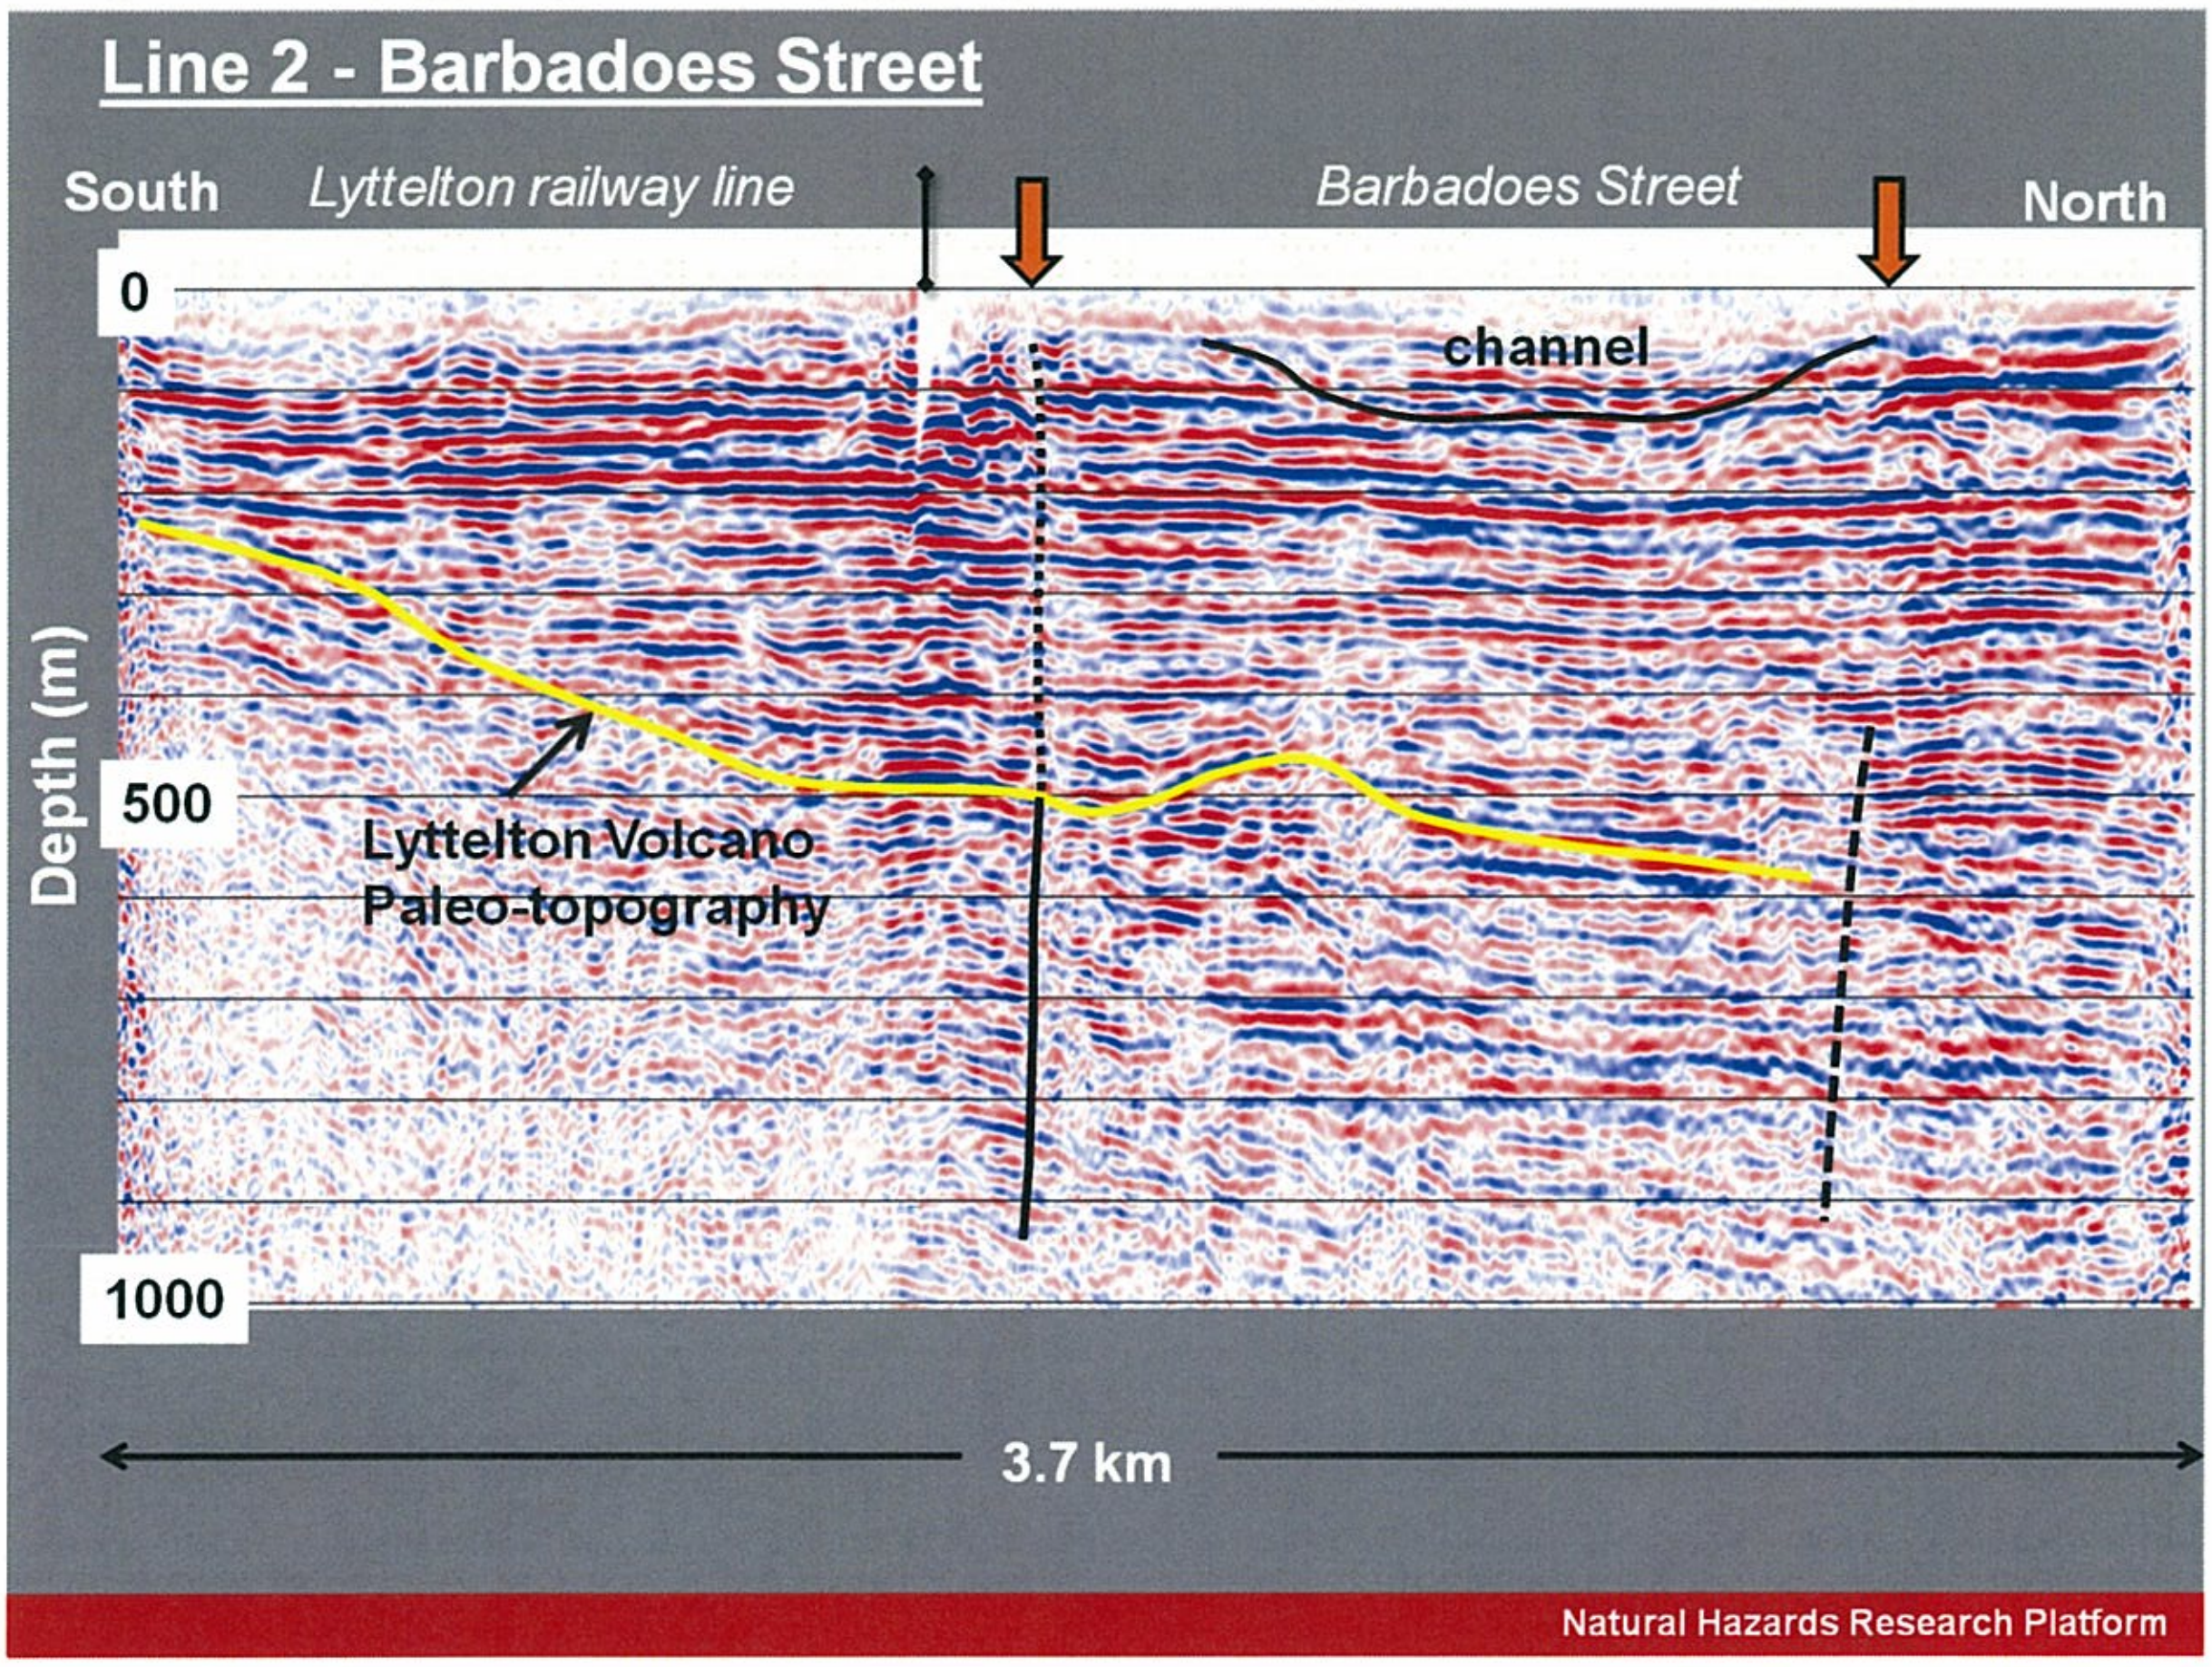
viii. From this deep geophysical testing, the research team working on this project has been able to infer the location of the buried profile of the Lyttelton Volcano – i.e. the top of rock. This is shown in Figure 4. This indicates that there is a potentially significant variation in the depth to rock across the CBD along this section. The estimated depth to rock increases from about 500m in the southern part of Barbadoes St (in the vicinity of the CCCC and CTV sites) to about 600m at the northern end near Bealey Ave (in the vicinity of the REHS site).
