Southern Cross Hospitals Ltd Endoscopy Consultants' PRESSS Building

structex Endoscopy Consultants' Building

- Endoscopy Consultants' building similar in form & plan area to ENT building
- \$7.2M budget
- 4-storey building including half depth basement
- Building footprint 19.3m x 30.2m
- Gross floor area 2940m²
- Budget cost \$2,450/m²
- Designed as Importance Level 3 structure
- Soft site to 9m requiring piles

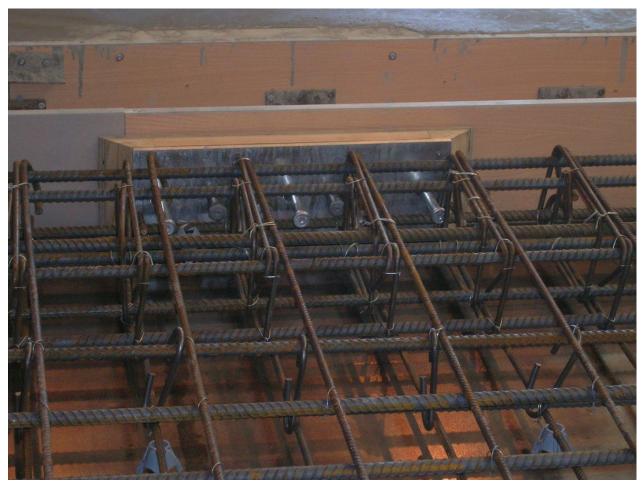
Shear Wall Detailing precast panel with Pi15 insert (including bolts) P[15 Insert (including bolts) cast in 20 panel dimension on elevation 40 19 目 旧 -日 ıН 20 \$ -日 ١H 800 20 rad 40 Ъ 25 panel reinforcing -Pi15 insert 3 (stirrups not shown) (including bolts) cast in (plan) (elevation) 200 x 20 flat (G300) galv, bent as shown with 40mm panel edges beyond inside radius, with 4-22 dia holes for 4-M20 bolts at (40 thick) centres to match Pi15 and central across 200 dimension, bend after galvanising Pi15 insert PC21 (section)
