## Section 2:

# The Architectural Characteristics and the Number and Seismic Vulnerability of Unreinforced Masonry Buildings in New Zealand

## The Performance of Unreinforced Masonry Buildings in the 2010/2011 Canterbury Earthquake Swarm

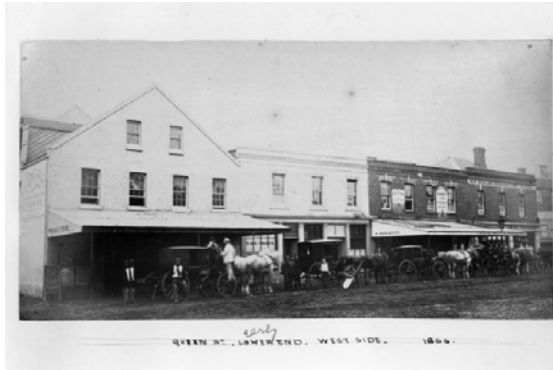
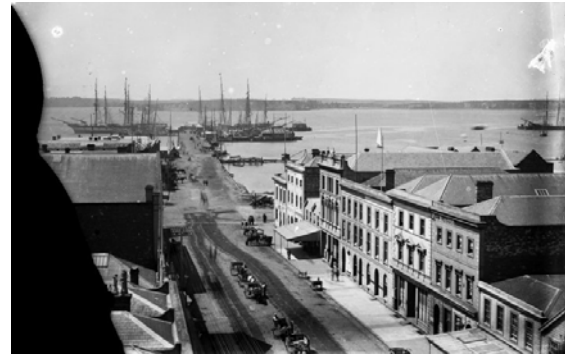
**Figure 2.1 Early masonry construction in Auckland**

(a) 1866 View of the lower end, west side, of Queen Street, Auckland [Alexander Turnbull Library]

(b) Queen Street and Queen Street Wharf, Auckland, 1882 [Alexander Turnbull Library]

Construction in Auckland in the period from 1840 to 1880 was primarily of timber for residential and small commercial buildings, but masonry buildings also began to appear close to the harbour (see Figure 2.1). Oliver (2006) reports that clay bricks were first manufactured in Auckland in 1852, with production of about 5,000 bricks per day. Timber was in plentiful supply and so it was only natural that outside the central city nearly all buildings were constructed of timber. Within Auckland central city the construction of timber buildings was not restricted until the City of Auckland Building Act of 1856. A fire in central Auckland in 1858 provided further impetus for the transition from timber to clay brick masonry construction.

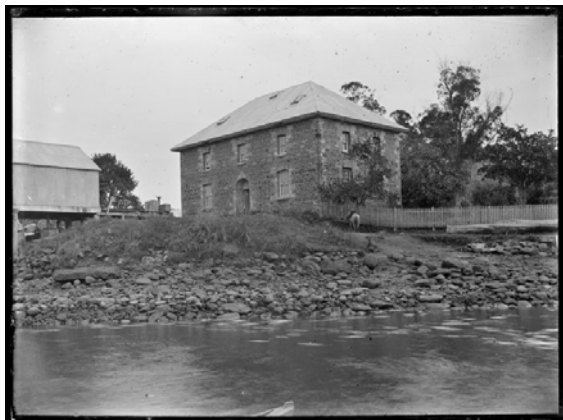
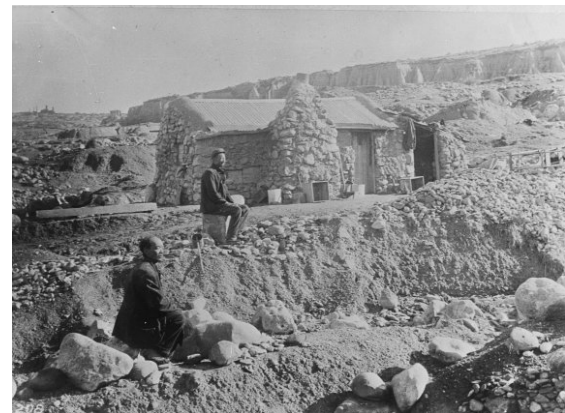
**Figure 2.2 Examples of early masonry construction in New Zealand**

(a) The 1833 Stone Store at Kerikeri was built by the Church Missionary Society [Alexander Turnbull Library]

(b) Two Chinese miners in front of a stone cottage in central Otago, ca. 1860 [Alexander Turnbull Library]

The lack of durable local building stone meant that the great majority of Auckland city's masonry buildings were constructed of clay brick with a stucco finish. In other parts of New Zealand there was a more plentiful supply of natural stone, with New Zealand's earliest masonry building having been constructed of stone in 1833 (see Figure 2.2(a)). Figure 2.2(b)<sup>2</sup> shows an example of early rural construction in parts of New Zealand where timber was scarce and natural stone was the primary construction material.

<sup>2</sup> Note that the style of unreinforced masonry construction shown in Figure 2.2(b) is not representative of the New Zealand URM building stock remaining today, and is not further considered in this report. Elsewhere in the world where this style of construction remains prevalent, past large earthquakes have repeatedly led to widespread and catastrophic collapse of this type of construction.

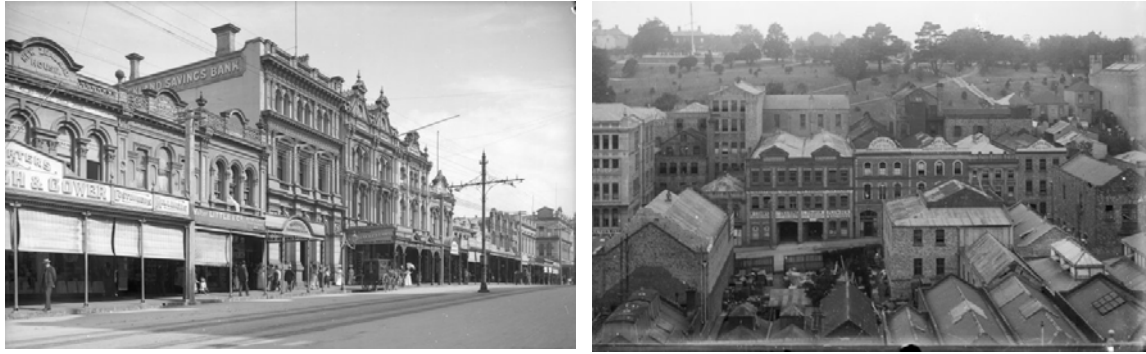
**Figure 2.4 Masonry building stock in Auckland in 1910**

- (a) Looking along a row of commercial buildings on Queen Street, Auckland, ca. 1910 [Alexander Turnbull Library]
- (b) Lorne Street, Auckland, ca. 1910 [Price Collection, Alexander Turnbull Library]

Figure 2.3(a) shows Auckland at a time when the majority of buildings were constructed of timber, but a number of masonry buildings were becoming prominent. However Figure 2.3(b) shows that not all masonry buildings were well constructed. Hodgson (1992) reports that inferior materials and uncertain ground conditions were not uncommon in building projects of this period. Hodgson also reports that Auckland city went through a transformation during the 1870s when almost all timber buildings were replaced by masonry buildings. Figure 2.4 shows that by 1910 the central city was composed almost entirely of URM buildings.

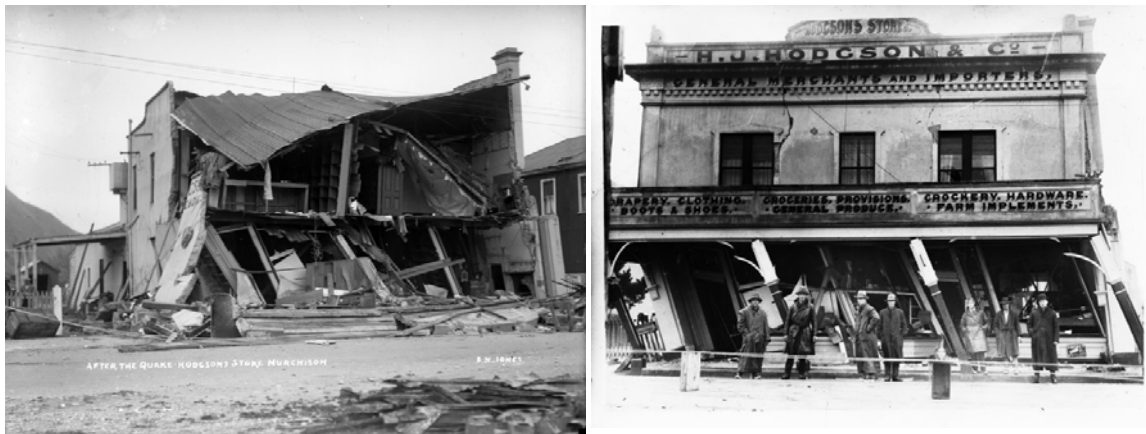
**Figure 2.5 Damage to masonry buildings in the 1929 Murchison earthquake**

- (a) General store damaged by the 1929 Murchison earthquake [Alexander Turnbull Library]
- (b) Damaged business premises after the earthquake of 17 June 1929 [Alexander Turnbull Library]

thousands of square kilometres. Nonetheless, the shock impacted with damaging intensities as far away as Greymouth, Cape Farewell and Nelson (see Figure 2.5). Fifteen people were killed in the Murchison earthquake.

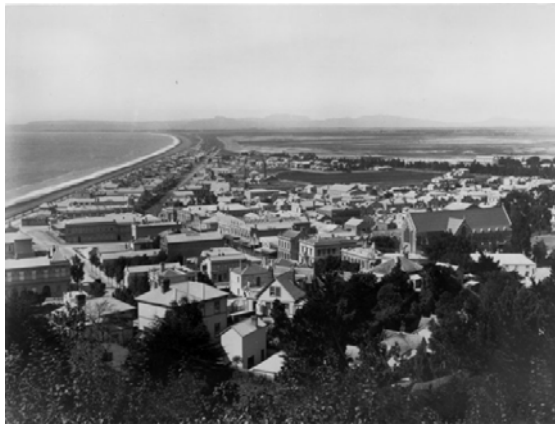
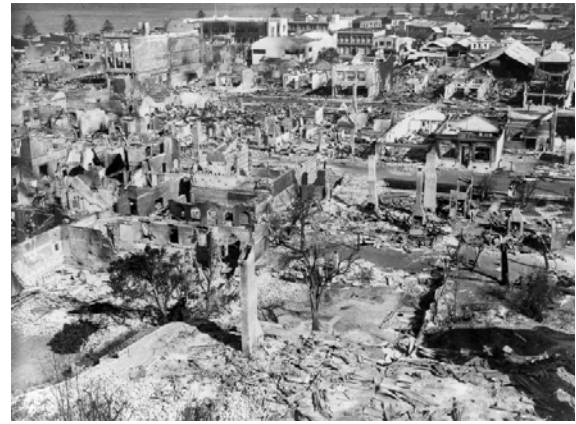
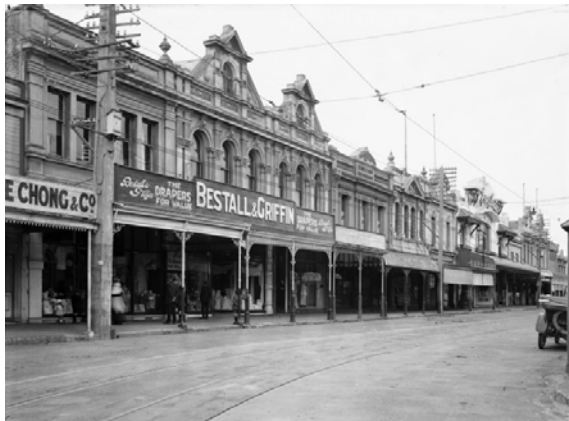
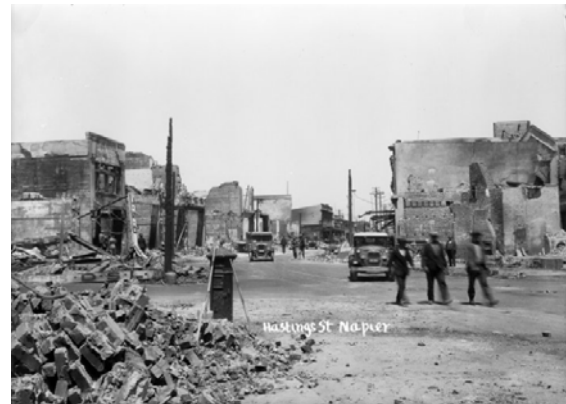
**Figure 2.6 Damage to masonry buildings in the 1931 Hawke's Bay earthquake**

(a) Overlooking Napier City, ca. 1900 [Alexander Turnbull Library]

(b) Overlooking Napier at the buildings ruined by the 1931 earthquake and the fires [Alexander Turnbull Library]

(c) Hastings Street, Napier, ca. 1914 [Alexander Turnbull Library]

(d) View down Hastings Street, Napier after the earthquake 1931 [Alexander Turnbull Library]

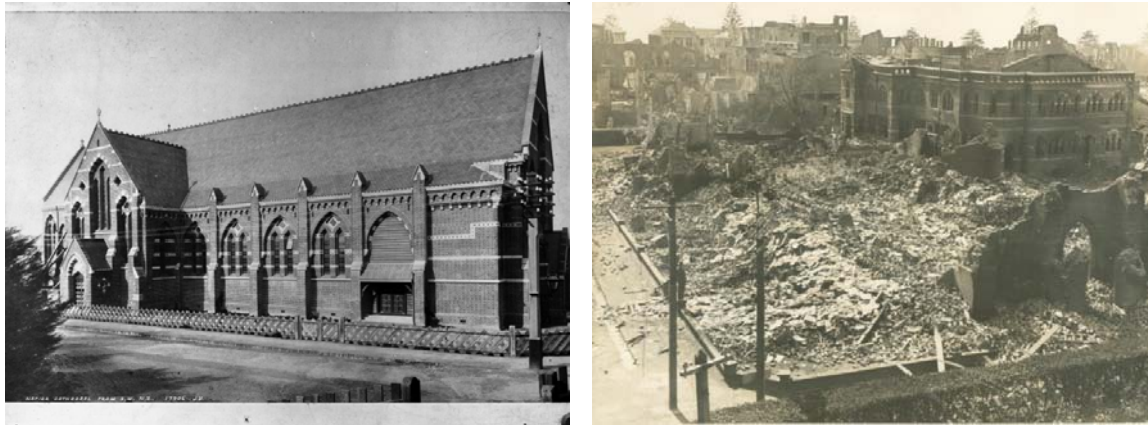
**Figure 2.7 Napier Anglican Cathedral before and after the 1931 Hawke's Bay earthquake<sup>3</sup>**

(a) St John's Anglican Cathedral in Napier, ca. 1885 [Alexander Turnbull Library]      (b) Ruins of the Napier Anglican Cathedral after the 1931 Hawke's Bay earthquake [Alexander Turnbull Library]

As reported above, it was the combustibility of timber buildings that prompted the focus in Auckland towards building in clay brick unreinforced masonry, and occasionally in stone masonry. Early earthquakes in the Wellington region resulted in a slower adoption of masonry construction. This caution proved to be well justified. On the morning of 3 February 1931 the Hawke's Bay region of the eastern North Island was struck by a M7.8 earthquake that destroyed much of the city of Napier (see Figure 2.6). Fires swept through the wreckage, destroying much of what was left. Perhaps the largest brick masonry building to collapse was the Napier Anglican Cathedral (see

Figure 2.7). The shaking resulted in damage from Taupo to Wellington, and left 30,000 people homeless. The official death toll was 256, and the event currently remains the worst disaster of any type to occur on New Zealand soil (Dowrick, 1998; Dalley & McLean, 2005).

<sup>3</sup> Note the parallels to the damage observed to the Christchurch Cathedral as reported in section 5.1.1.
