The performance of unreinforced masonry buildings in the 2010/2011 Canterbury earthquakes

Jason Ingham

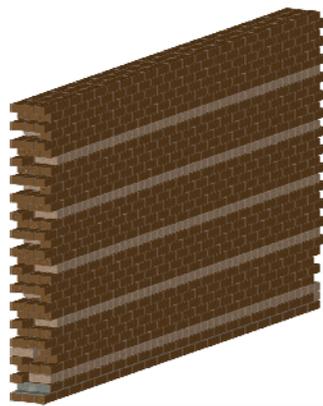
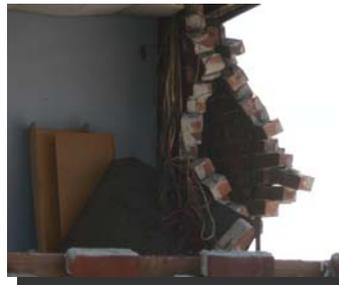
- Stretcher, header
- Bond pattern
- Bed, head, collar joint
- Leaf (wythe)
- Cavity

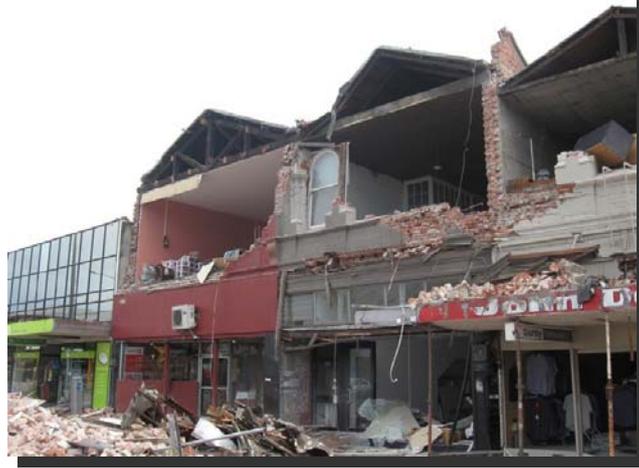
Types of construction:
Clay brick **UnReinforced Masonry (URM)**

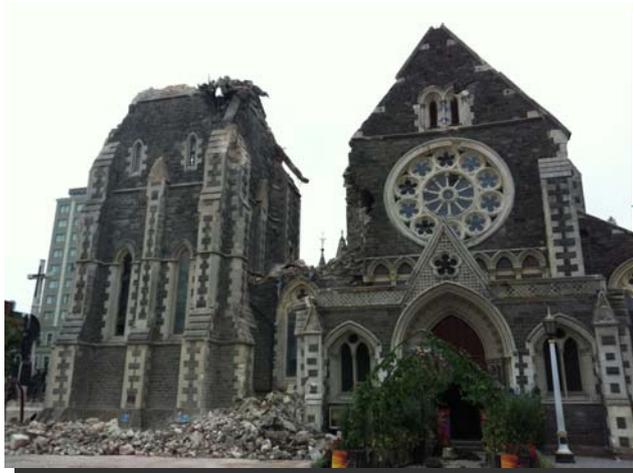
Types of construction:
Natural stone unreinforced masonry

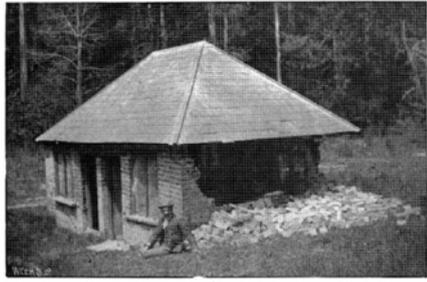
AFTER THE CHEVIOT EARTHQUAKE, 1901. *2072 photo.*

1901 Cheviot earthquake

- “There was not a brick building or chimney left standing”

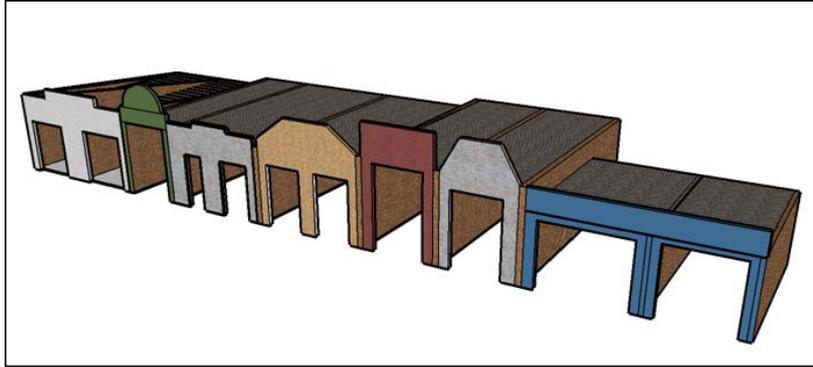
Typology B

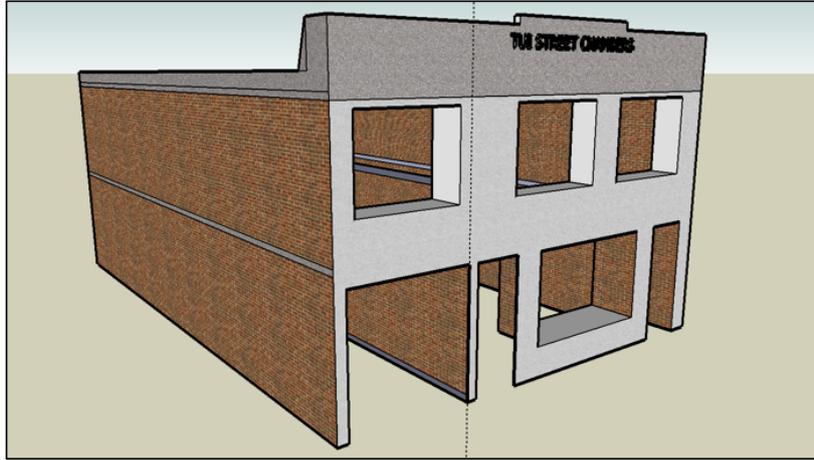
Typology C

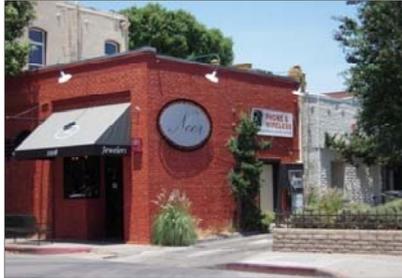
Report 2, Figure 2.1:
Comparison of New Zealand and Californian URM building stock

(a) San Luis Obispo, Cal -Typology A

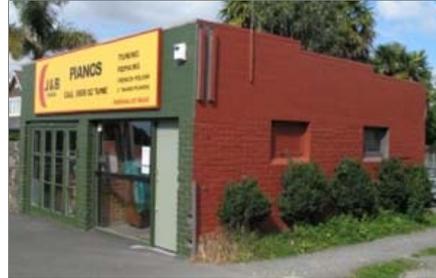
(b) Auckland, NZ - Typology A

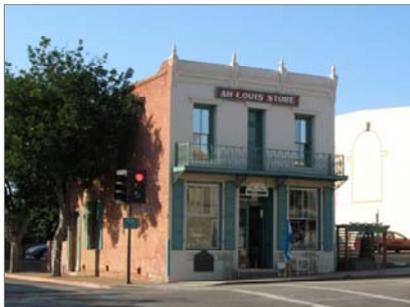
Report 2, Figure 2.1:
Comparison of New Zealand and Californian URM building stock

(a) San Luis Obispo, Cal -Typology C

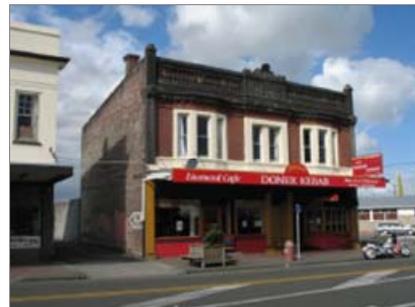
(b) Bulls, NZ - Typology C

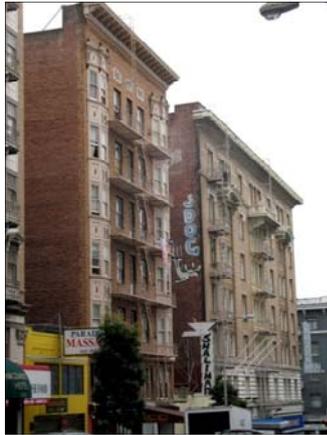
Report 2, Figure 2.1:
Comparison of New Zealand and Californian URM building stock

(a) San Francisco –Typology E

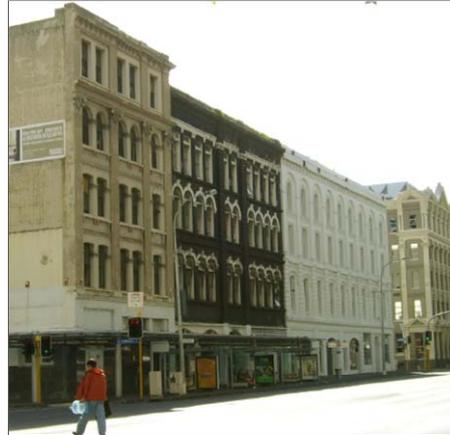
(b) Auckland –Typology F

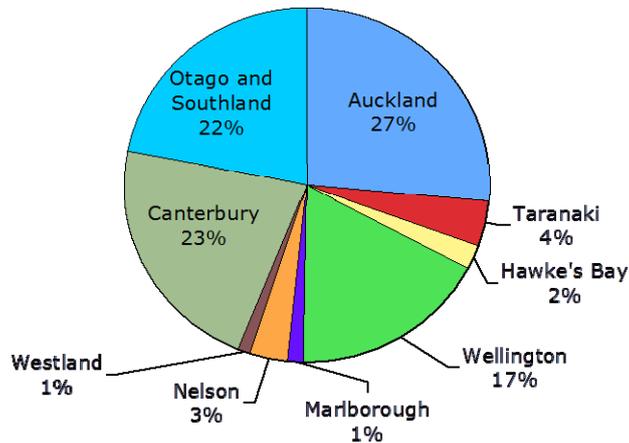
Pre-earthquake estimate of distribution

Estimate based upon census population

Province		Pre-1900	1901-1910	1911-1920	1921-1930	1931-1940	Total
Auckland	Population	175,938	193,581	278,357	393,639	516,886	
	URM	16	55	40	737	178	1026
Taranaki	Population	34,486	45,973	48,546	63,273	76,968	
	URM	3	11	7	118	25	164
Hawke's Bay	Population	37,139	46,906	51,569	65,037	77,652	
	URM	2	6	5	72	0	85
Wellington	Population	132,420	189,481	199,094	261,151	316,446	
	URM	27	127	169	243	111	677
Marlborough	Population	13,499	15,177	15,985	18,053	19,149	
	URM	1	3	2	27	6	39
Nelson	Population	33,142	45,493	48,463	49,153	59,481	
	URM	3	10	7	91	19	130
Westland	Population	15,042	15,194	15,714	14,655	18,676	
	URM	1	3	2	27	6	39
Canterbury	Population	145,058	166,257	173,443	206,462	234,399	
	URM	7	190	211	233	211	852
Otago and Southland	Population	174,664	156,668	191,130	206,835	224,069	
	URM	8	179	233	233	202	855
Total URM Building population by decade		68	584	676	1781	758	3867

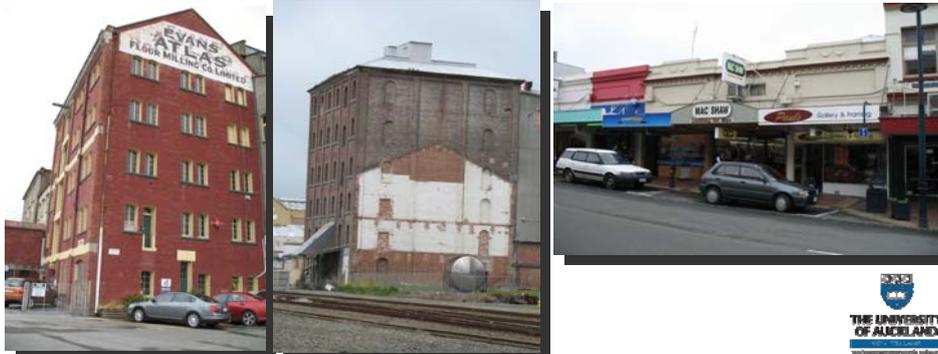
High density URM locations

- Probably there are ‘pockets’ of URM buildings where the data undercounts, based on comparative wealth in 1860-1900:
- Wanganui and Timaru – port cities in 1900s
- Paeroa/Waihi and Dunedin/Otago – gold fields
