Canterbury Earthquakes Royal Commission

7 Riccarton Road, Christchurch

The Royal Commission of Inquiry into Building Failure Caused by the Canterbury Earthquakes is currently inquiring into the failure of a number of buildings in Christchurch, including the building that was located at 7 Riccarton Road (the Building).

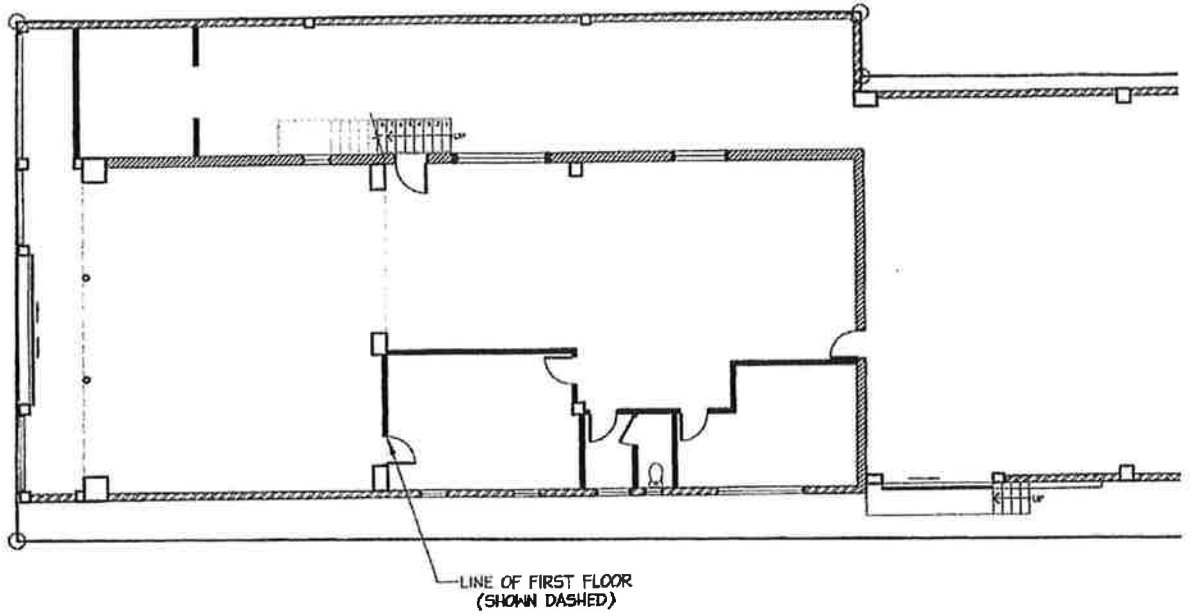
SITE PLAN
SCALE: 1:200

RICCARTON ROAD

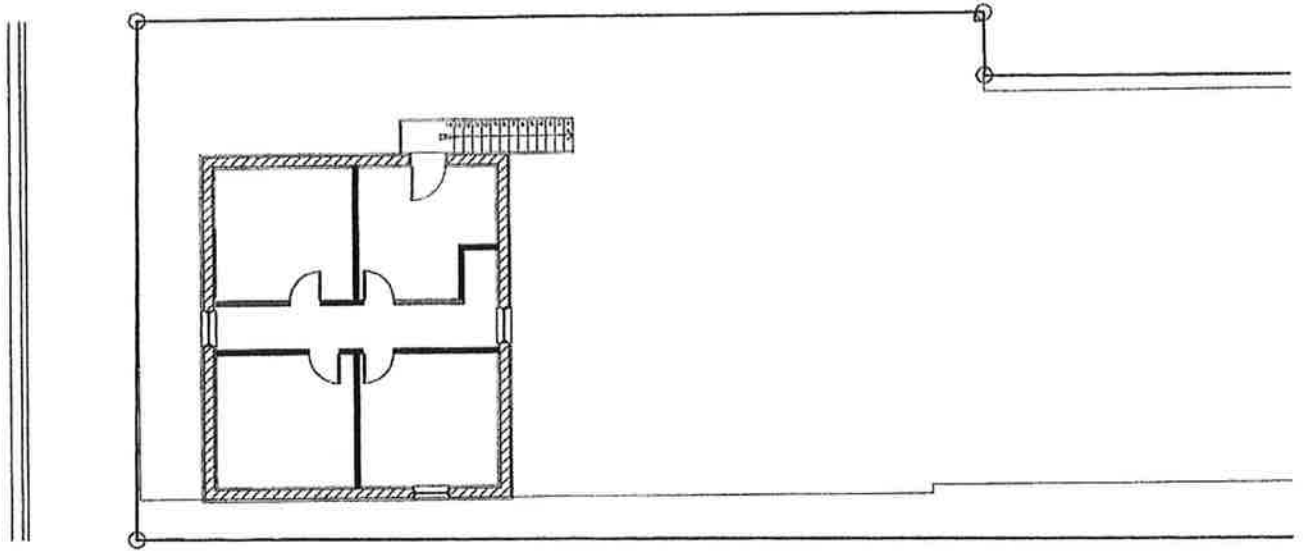
RICCARTON ROAD

SCALE: 1:200

ED ALTERATION CARTON ROAD RISTCHURCH	DRAWING TITLE: FIRST FLOOR LAYOUT PLAN	SCALES: 1 : 200		
		DATE: 11 / 01 / 2011		
		DRAWN BY: IAN		
		JOB No. XXXXXX	SHEET No. 1 OF X	REVISION No. A
