Report for the Canterbury Earthquakes Royal Commission – Heritage Buildings, Earthquake Strengthening and Damage

Heritage Buildings, Earthquake Strengthening and Damage

The Canterbury Earthquakes September 2010-January 2012

Report for the Canterbury Earthquakes Royal Commission

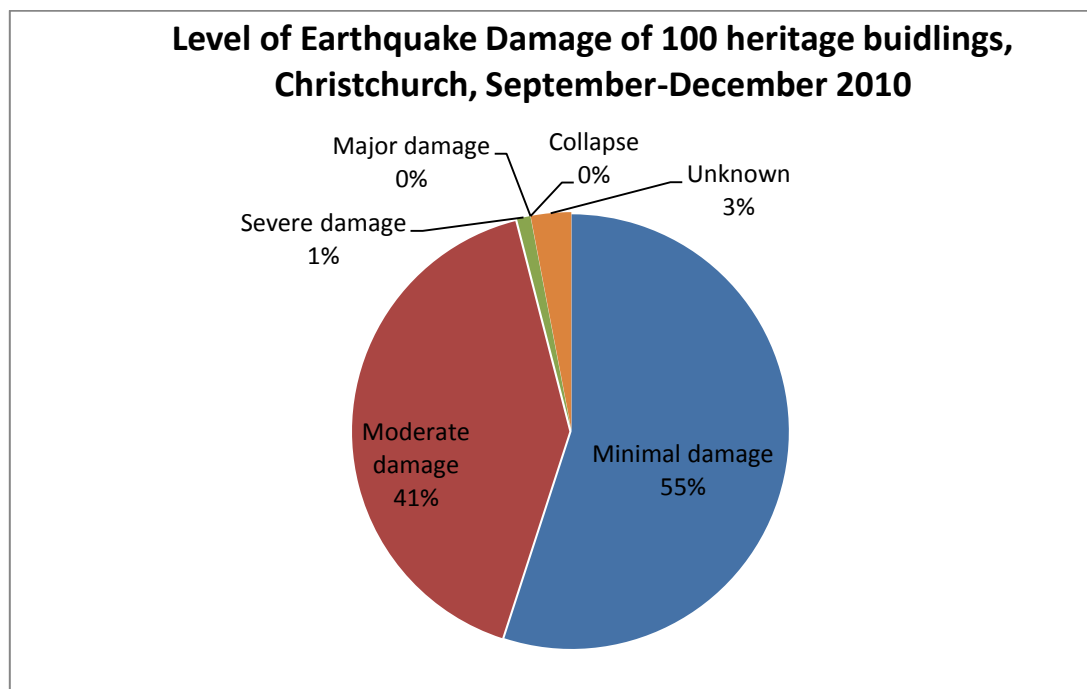
As indicated in Figure 1 and the table below, the level of damage was largely either minimal or no damage or moderate damage by the end of 2010. Only one building of the 100 heritage buildings was severely damaged and demolished being the Manchester Courts building. Some 52 buildings had only minimal damage and another 44 sustaining moderate damage.

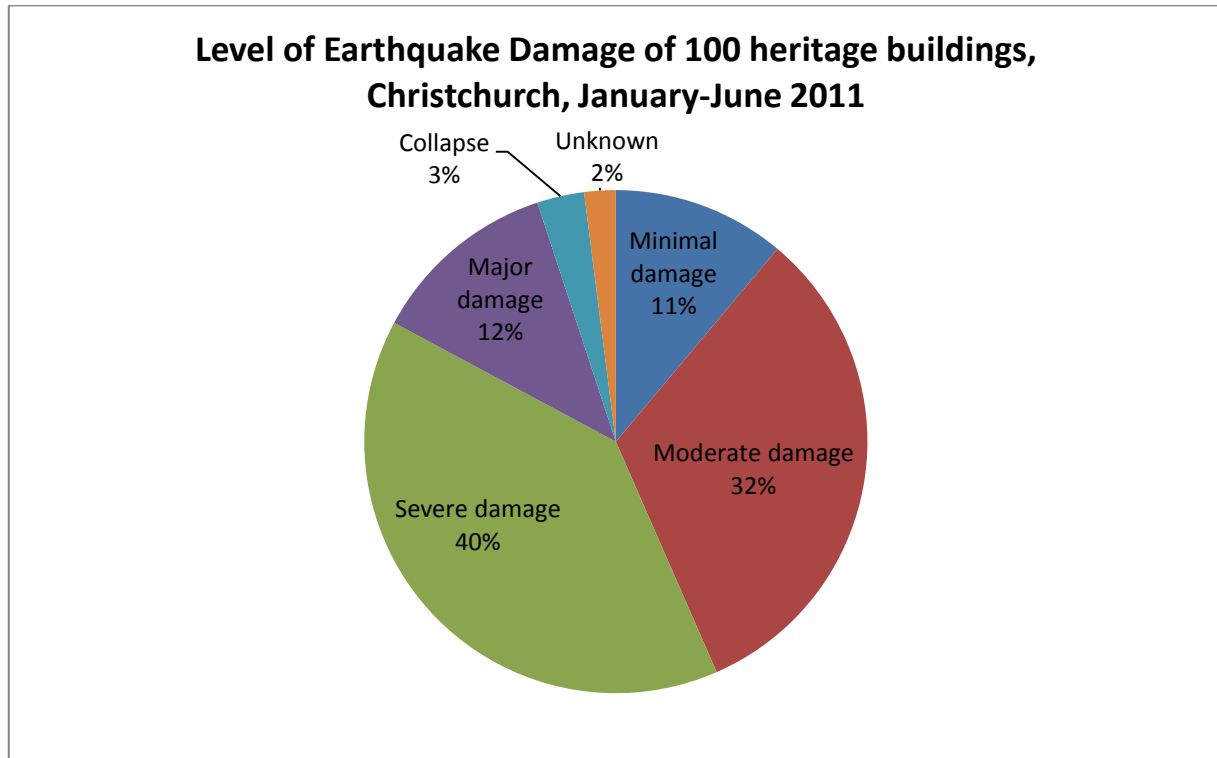
Figure 2

This situation changed dramatically with much greater damage occurring following the January-June 2011 earthquakes. The damage resulted in the collapse of 3 buildings with major and severe damage to 51 buildings with only minimal damage to 11 buildings of the 100 sample list (Figure 2). Nearly all of the severe and major damaged buildings have been demolished.

Damage Assessment of 100 Heritage Buildings, Christchurch, September 2010-June 2011						
	Minimal damage	Moderate damage	Severe damage	Major damage	Collapse	Unknown
September-December 2010	55	41	1	0	0	3
January-June 2011	11	32	39 ³⁵	12	3	2

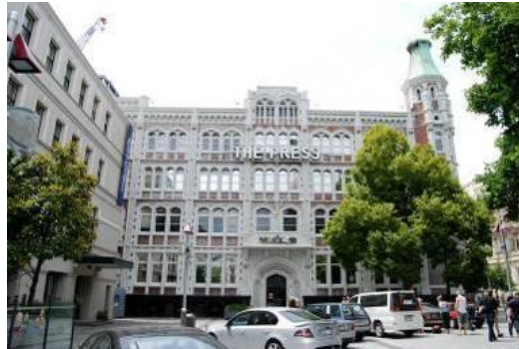
Significance: The Press Building (1903) was a distinctive feature of Cathedral Square and, in conjunction with the Lyttelton Times building, illustrates the history of the two main Canterbury newspapers. The Press Building was a noted example of the work of Armson, Collins and Harman in the 'Perpendicular Gothic style' and was technically important as one of the earliest reinforced concrete buildings in Christchurch.

Construction: Reinforced concrete

Level of Damage: September-December 2010: Moderate damage (damage to corner tower).

January-June 2011: Major damage (collapse of top floor, damage to façade).

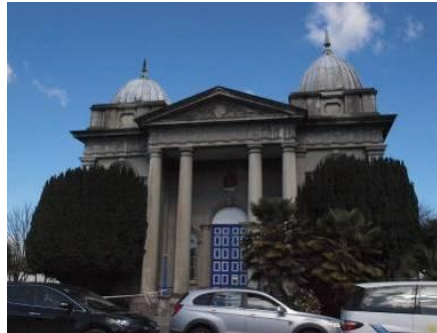
St Paul's-Trinity-Pacific Church

Construction: URM

Level of Damage: September-December 2010: Moderate-severe damage.

January-June 2011: Major damage (dome, roof and wall collapse).

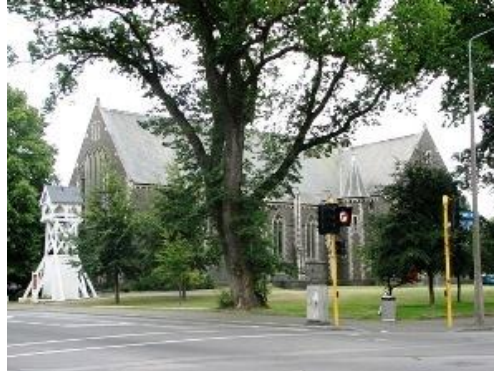
Church of St Luke the Evangelist

Construction: URM

Level of Damage: September-December 2010: Moderate damage.

January-June 2011: Major damage (partial collapse, cracking and liquefaction).

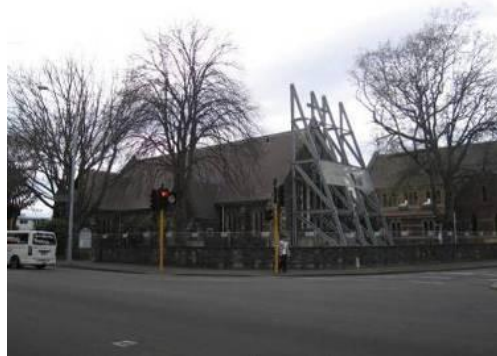
Significance: St John the Baptist Church was the first stone church to be built for the Anglican community in Christchurch. The church was designed by Maxwell Bury (1825-1912), an architect who arrived in Lyttelton in 1854 and who was also responsible for the Nelson Provincial Council Chambers. The church was gothic revival in style and built of stone and was distinguished by a squat Norman tower and polygonal chancel. The Church stood as a reminder of the detailed planning of the Canterbury Association and of their desire to establish a wholly Anglican settlement in NZ.

Construction: URM

Level of Damage: September-December 2010: Moderate-severe damage.

January-June 2011: Major damage (collapse of bell tower, partial wall collapse, cracking).

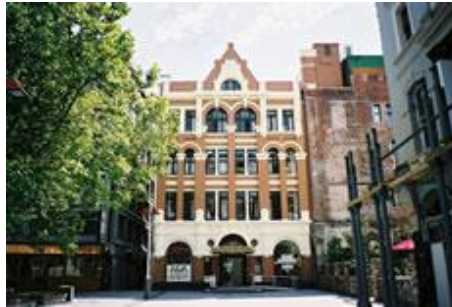
Lyttelton Times Building

Significance: The Lyttelton Times building formed part of a significant group of heritage buildings fronting Christchurch's Cathedral Square, which were built around the turn of the nineteenth century at a time of economic growth. Its primary significance was its architectural merit, as the first building to introduce elements of the Chicago skyscraper style to New Zealand. The newspaper began in Lyttelton in 1851 and moved to Christchurch in 1863 where it first occupied a small cottage on Gloucester Street and then a two-storey timber building that fronted onto Cathedral Square. Internally, the building was substantially modified in the 1930s to accommodate new rotary presses and some strengthening work occurred at this time.⁴⁸

Construction: URM

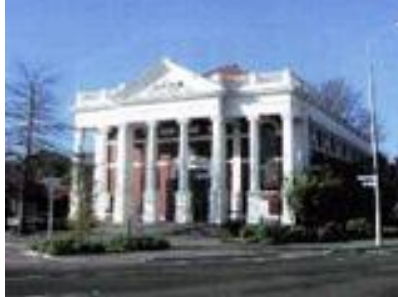
Oxford Terrace Baptist Church

288 Oxford Terrace
1882
Saunders Architect
Registered Category II historic place
Listed Group 1
Private ownership

Construction: URM

The building was damaged by the September-December 2010 earthquakes and was in the process of being secured. The building suffered severe damage and collapse following the February 2011 earthquake and was demolished.

Level of Damage: September-December 2010: Moderate damage.

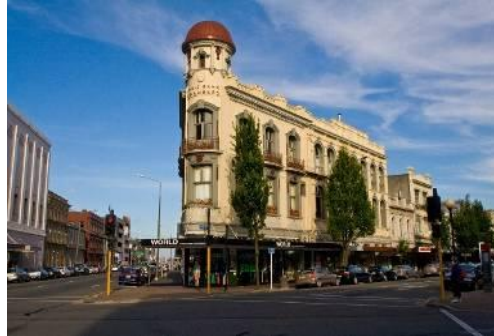
ANZ Bank (former)

188 High Street
1908-12
Clarkson & Ballantyne Architects
Registered Category II historic place
Listed Group 2
Private ownership

Construction: URM

Historical bracing and ties of walls, floor and roofs was observed following earthquake damage.⁵²

Level of Damage: September-December 2010: Moderate damage (parapet damage).

NZHPT post-earthquake response: The front section partially collapsed on 22 February 2011 and was demolished without NZHPT input. The NZHPT did not oppose demolition of rear section after assessment by NZHPT engineer due to severity of damage.

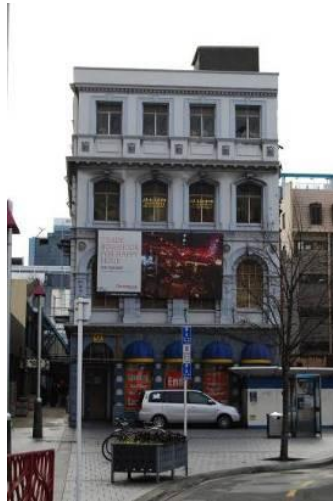
Construction: URM

Since 1995 the building has been largely vacant and has been suffering neglect for some time. On 3 August 2009, the Council issued a 'dangerous building' notice under section 124 of the Building Act 2004 requiring work be carried out to reduce or remove the danger due to broken window glass falling onto the pedestrian route at Chancery Lane. The Council required the owner to secure all windows, secure the building, ensure regular inspections are undertaken and attach a notice to warn people not to approach or enter the building. The building was damaged in the September-December 2010 earthquakes, but was considered to be repairable. Severe damage occurred following February 2011 earthquakes.

Level of Damage: September-December 2010: Moderate damage (cracking in main façade).
January-June 2011: Severe damage.

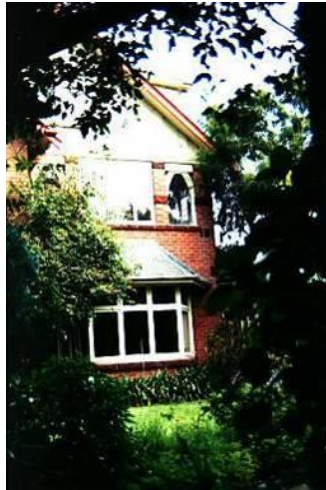
The Deanery

80 Bealey Avenue
1920
England Bros Architects
Registered Category II historic place
Listed Group 2
Private ownership

Construction: URM

Level of Damage: September-December 2010: Moderate damage.

January-June 2011: Severe damage.

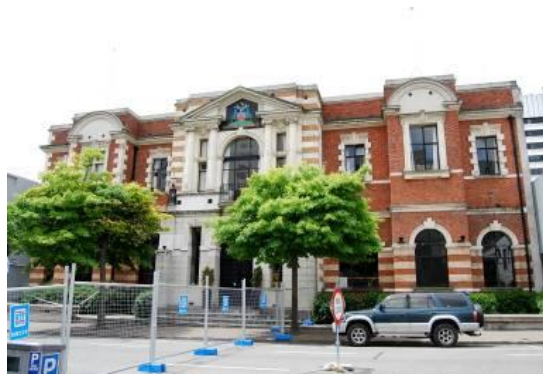
City Council Civic Offices (Former)

Construction: URM

Strengthening history: The rebuilding of the former Christchurch City Council Offices in 1920-22 and various alterations resulted in a URM façade and a reinforced concrete structure. A report by William Fulton of Stewart Ross Team Architecture Ltd in 2002 identified some deterioration of the main façade and some spalling concrete on the northern elevation which had exposed rusting reinforcing. Cracking to the concrete parapets on the south side was also identified. William Fulton recommended the preparation of a structural report to investigate these issues. While repairs of exterior stonework were undertaken in March 2003, there is no record on the NZHPT's file of substantial earthquake strengthening works.

Level of Damage: September-December 2010: Moderate damage.

January-June 2011: Major damage (front façade removed by USAR).

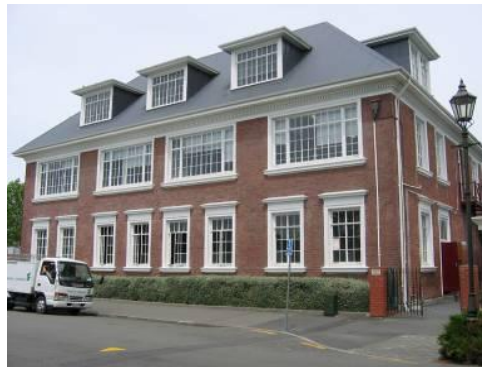
Cathedral Grammar School Main Block

8 Chester Street West
1928
Tren Grove Architect
Registered Category II historic place
Listed Group 2
Private ownership

Construction: URM

Damaged in the September 2010 earthquake and further severe damage in February 2011.

Level of Damage: September-December 2010: Moderate damage.

January-June 2011: Severe damage (partial collapse).

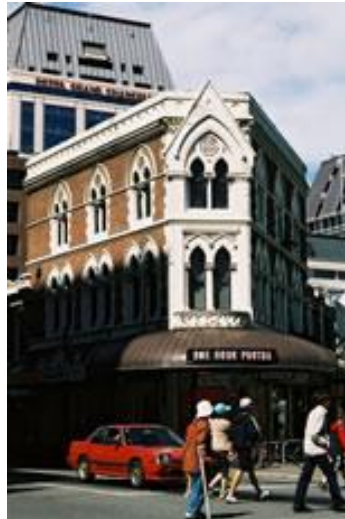
Fisher's Building (Former)

Construction: URM

The building suffered minor damage in the September and December 2010 earthquakes. Major damage occurred in the February 2011 earthquake and the building was demolished.

Level of Damage: September-December 2010: Minimal damage.

January-June 2011: Severe damage (partial collapse of upper level and extensive cracking)

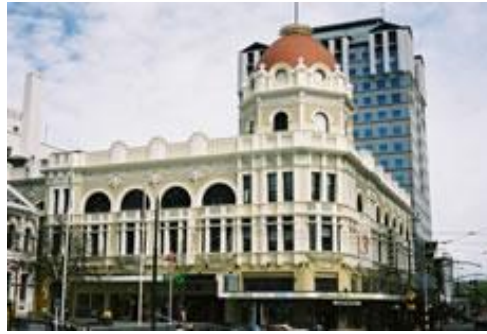
Construction: URM

Strengthening history: The NZHPT was aware that internal alterations and strengthening was carried out for the twin cinema (date of strengthening unknown) with work involving a braced steel frame to support the tower and floor ties to walls. Historical bracing and ties of walls, floor and roofs was also observed following earthquake damage.⁵³

The building suffered moderate damage in the September and December 2010 earthquakes. Major damage occurred in the February 2011 earthquake and the building was demolished in July 2011.

Level of Damage: September-December 2010: Moderate damage (parapet damage).

January-June 2011: Moderate damage (parapet damage, cracking, dome roof collapse).

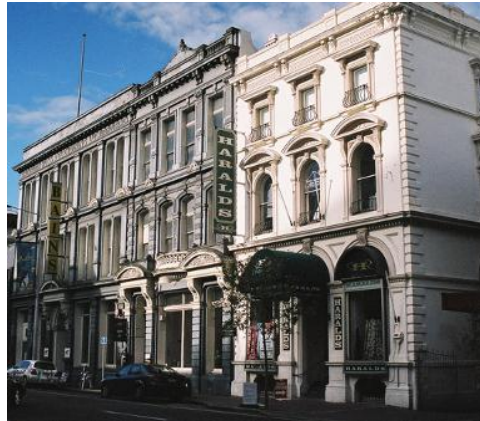
Harald's Building

Construction: URM

Level of Damage: September-December 2010: Moderate damage (parapet and chimney damage).

January-June 2011: Severe damage to upper level.

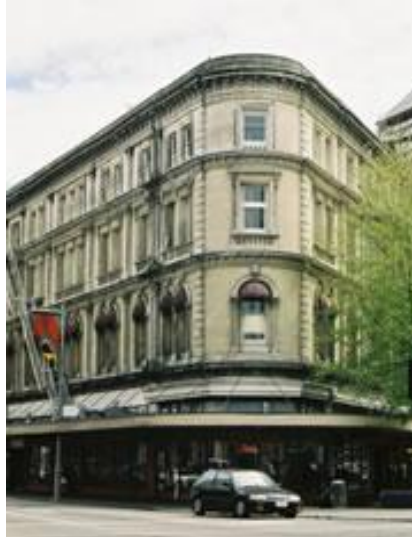
Strange's Building

Construction: URM

Strengthening history: The building was refurbished in 1987 with some earthquake strengthening work undertaken.⁵⁴ No details of the work have been identified on the NZHPT file. Historical bracing and ties of walls, floor and roofs was observed following earthquake damage.⁵⁵

Level of Damage: September-December 2010: Moderate damage.
 January-June 2011: Severe damage.

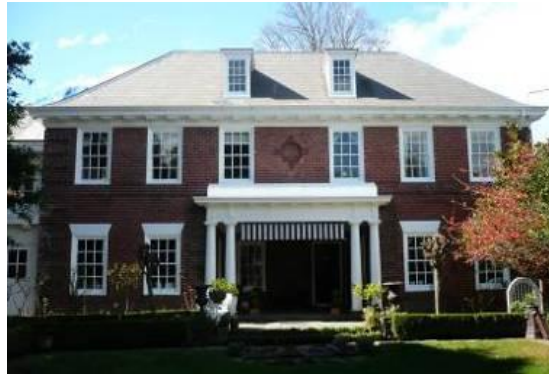
Significance: Weston House was significant as a fine example of a Neo-Georgian house designed c.1923 by well-known NZ architect, Cecil Wood, built for George T Weston, a Christchurch solicitor. The west facade of this substantial two-storied brick house exhibited the complete range of Neo-Georgian elements, including a centralised porch, brick walls, symmetrically arranged windows, a deep cornice and a hipped roof with dormer windows.

Construction: URM

Damaged in September 2010 and repairs were proposed by the owners. The building was further damaged following the February 2011 earthquakes and deteriorated over time.

Level of Damage: September-December 2010: Moderate damage (three chimneys were damaged).

January-June 2011: Severe damage (partial collapse and cracking)

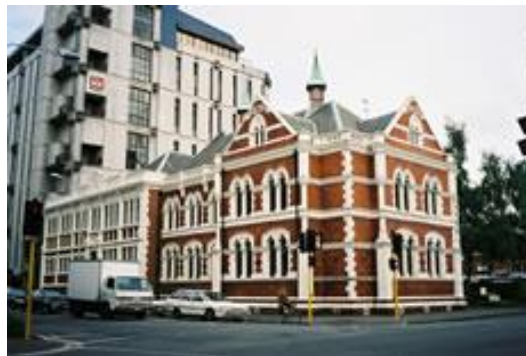
Construction: URM

Level of Damage: September-December 2010: Moderate damage.
 January-June 2011: Severe damage (parapet damage, liquefaction, cracking).

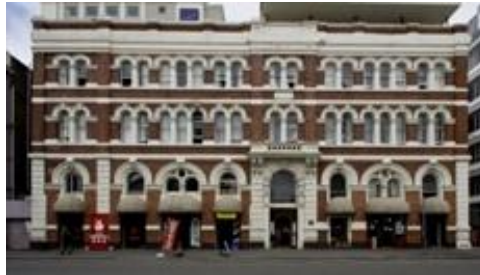
Construction: URM

Level of Damage: September-December 2010: Minimal damage.

January-June 2011: Moderate damage (parapet and corner damage)

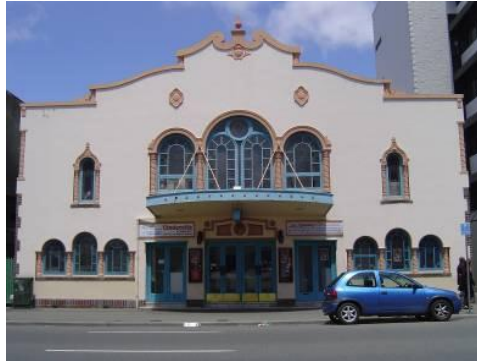
Construction: URM

In 2007, a conservation report was prepared for the theatre which stated that a major problem was the inability of the building to meet the Council's Earthquake-Prone, Dangerous and Insanitary Buildings Policy adopted in 2006.⁵⁷ It noted that R.D. Sullivan, Consulting Engineer, has been engaged to examine the building and 'has advised that the building is a Category A building which means that it has a highest priority for upgrading and the overall strengthening programme should be carried out within fifteen years. This figure is not confirmed but is anticipated that the street frontage should be stabilised within two to three years.'⁵⁸

The NZHPT supported an application by the Canterbury Repertory Theatre Society to the NZ Lotteries Board for funding assistance to undertake earthquake strengthening work in April 2009. Work had not yet started in September 2010 and earthquake repairs were planned in early 2011. The building was severely damaged after February 2011.

Historical bracing and ties of walls, floor and roofs was observed following earthquake damage.⁵⁹

Level of Damage: September-December 2010: Moderate damage.

January-June 2011: Major damage.

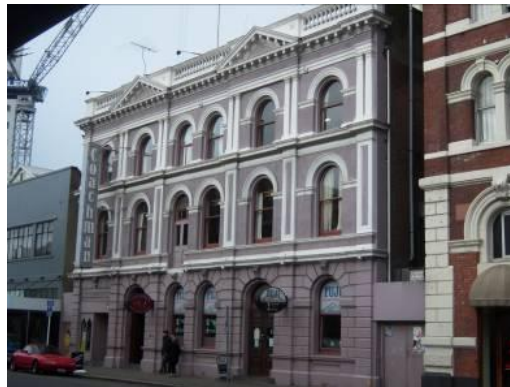
Coachman Inn

Construction: URM

The building experienced damaged parapets in the September-December 2010 earthquakes and repairs were being planned. Further damage followed the February 2011 earthquake and the building was demolished in July 2011.

Level of Damage: September-December 2010: Moderate damage (parapet damage).

January-June 2011: Moderate damage (rear wall partial collapse, damage to parapets, cracking).

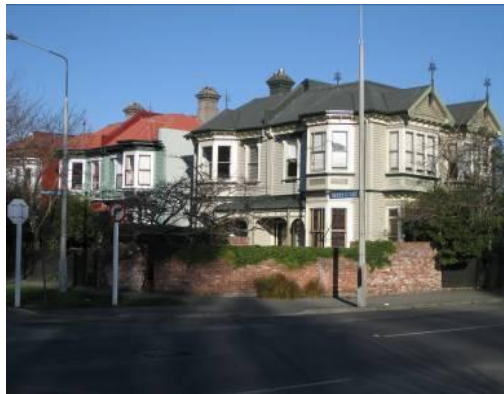
Houses (semi-detached)

Construction: Timber-framed, brick party walls.

Level of Damage: September-December 2010: Moderate damage.

January-June 2011: Severe damage.

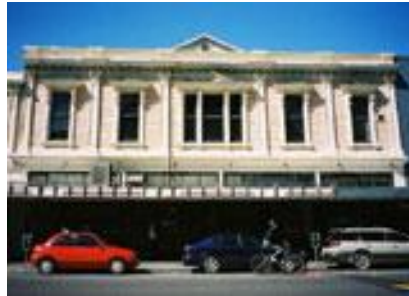
Old Theatre Royal

Significance: The Former Theatre Royal had architectural and aesthetic significance primarily for its flush-boarded timber facade, designed to resemble masonry. At the time of its construction by little-known Christchurch architect, Alfred Simpson, and builders Allen and Son, the theatre would have been one of the largest and most impressive of the city's buildings. The building represented the final phase of the timber-built city before masonry construction became derigeur in the inner city in the 1880s. This was the last timber classical facade and was the most significant of the city's remaining timber commercial building facades to remain extant.

Construction: URM/Timber-framed

Level of Damage: September-December 2010: Moderate damage.

January-June 2011: Severe damage (damage behind the façade).

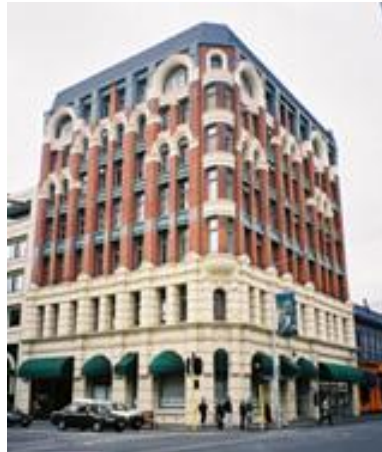
NZ Express Co Building (MLC Building or Manchester Courts)

Construction: Reinforced concrete foundations, ground and first floor. URM above first floor with steel ties and standards.

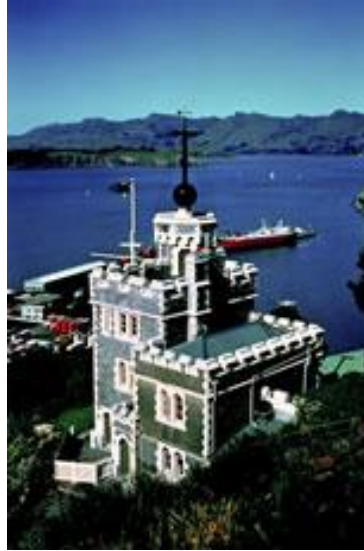
Significance: The Lyttelton Timeball Station (1876) was one of a handful of timeball stations that have survived throughout the world, and was the only original one that was standing in New Zealand. It illustrated the role of the timeball stations within the history of Western navigation and shipping, and its connection to the accurate calculation of longitude is of particular significance. The construction of the timeball station reflects the positive economic state, and the associated pre-eminent role within New Zealand that Canterbury, along with Otago, enjoyed in the last years of the provincial government system. It was a major landmark for Lyttelton and was an important part of the town's historic identity. Timeball Station was constructed in three principal stages: the original 3-storey stone building and tower (1876), stone kitchen (1878) and a large 2-storey brick addition (1912).

Construction: URM.

As a result of the 4 September 2010 earthquake, Timeball Station sustained moderate damage with loss of a chimney, widespread cracking of masonry walls and damage to parapets. Following the earthquake, Ruamoko Solutions Ltd were engaged to prepare options for the repair and strengthening of Timeball Station. Ruamoko estimated that the building had a strength of approximately 50%NBS in East/West direction and around 26-36%NBS in the other N/S direction. Ruamoko recommended strengthening work involving installation of stainless steel pins to the rubble-filled masonry walls, use of new 'Helifix' veneer ties to brick walls, new concrete walls and floor diaphragms, new ply ceiling diaphragm, parapet ties and rebuilding of chimneys in reinforced concrete.

As the NZHPT prepared to repair the building, severe damage resulted from the 22 February 2011 earthquake with parapet collapse and major cracking. The damage involved:

- 2-storey building 1912: Partial collapse and extensive cracking. The Tower: Extensive damage, wide cracking, unstable and could collapse at any time.
- 3-storey building 1876: Brick and stone sections on North wall are relatively undamaged; East wall - parapet and upper two level collapsed outwards; South wall – parapet collapsed, large cracks in wall; West wall – parapet and upper level have collapsed, extensive cracking in remaining walls.
- 1-storey building 1878: minor cracking of brick sections.

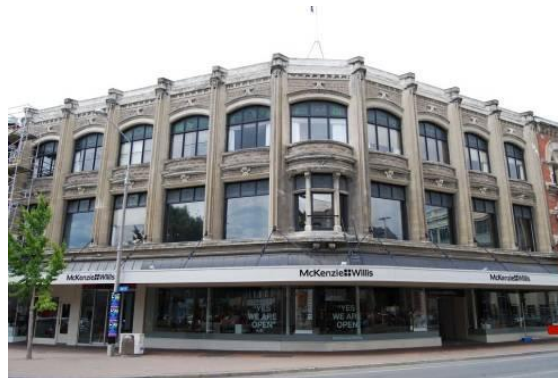
McKenzie & Willis Building

Corner 179 High and 238 Tuam Street
1910
England Brothers Architects
Registered Category II historic place
Listed Group 2
Private ownership

Construction: URM

Level of Damage: September-December 2010: Minimal damage.

January-June 2011: Severe damage.

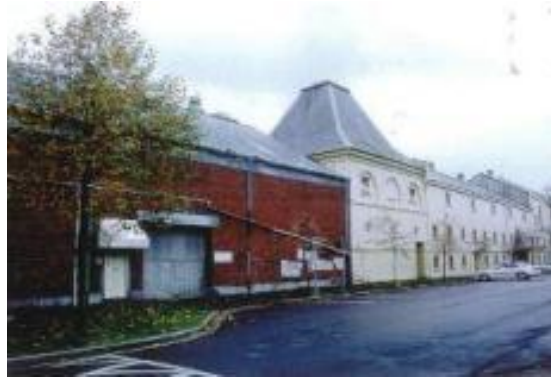
Construction: URM

Strengthening history: In 2003, the Crichton Cobbers Youth Club applied to the NZ Lotteries Board for financial assistance to undertake earthquake strengthening work to the former Malthouse. At the time the building had an estimated resistance of about 25% of the NBS as detailed in a building condition report.¹²⁰ The work involved the erection of a SHS horizontal truss in the ceiling plane, spanning the full length of the hall to portals with 5 columns at each end of the hall.

Level of Damage: September-December 2010: Moderate damage.
January-June 2011: Severe damage.

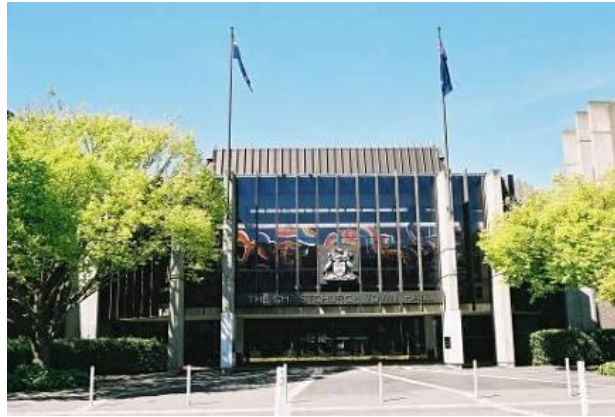
Christchurch Town Hall

100 Kilmore Street
 1965-1972
 Warren & Mahoney Architects
 Not registered by the NZHPT
 Listed Group 1
 Public ownership (Christchurch City Council)

Construction: Reinforced concrete

January-June 2011: Severe damage.

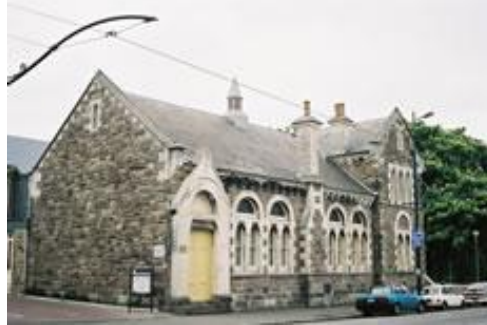
Construction: URM

Strengthening history: The former Magistrates Court was substantially upgraded in 1997 for the purpose of a Family Court. The work involved changes to the interior of the building including demolition of original cells, removal of internal walls and division of the large courtroom into smaller spaces. As part of this work, earthquake strengthening involved the stripping of brick walls and replacement of the interior brick layer with reinforced concrete. Also floors were completely replaced and mezzanines were installed within the double-height court room ceilings.¹²¹ Chimneys were removed and replaced with lightweight replica structures.

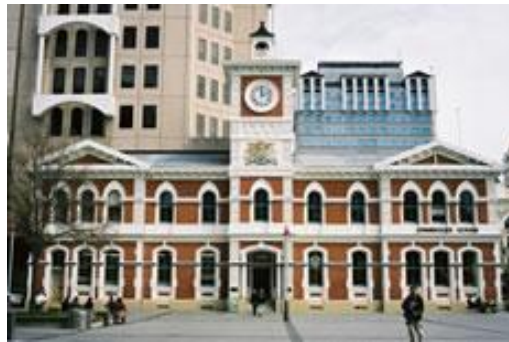
Former Chief Post Office (facade only)

Cathedral Square
1877
Clayton Architect
Registered Category I historic place
Listed Group 1
Private ownership

Construction: URM

Strengthening history: In 1974, the Post Office Department proposed partial-demolition of the building with façade retention. This proposal sparked public debate and pressure to 'save' the building. The NZHPT engaged Smith Leuchars Consultants in 1980 to undertake a structural assessment. The consultants considered that earthquake strengthening of the Post Office was possible for a cost of the order of 90% of that required to construct a new replacement building. After some negotiation, Telecom Property Services (replacing the Post Office Department) agreed to façade retention and the structural upgrading of the Clock Tower in 1985. As work progressed during the early 1990s, a greater proportion of the interior was preserved than originally planned and demolition was limited to the rear third of the east facing part of the building. Details of the earthquake strengthening work undertaken by Telecom Property Services are not recorded in the NZHPT file.

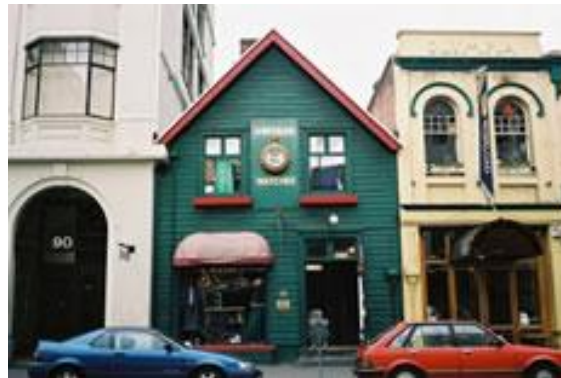
Shand's Emporium

88 Hereford Street
1860
Architect unknown
Registered Category I historic place
Listed Group 2
Private ownership

Construction: Timber-framed

Strengthening history: In 1979, the owners (Hereford Holdings Ltd) were informed by the Council that the building was 'unsafe' and did not meet current building codes in terms of fire ratings, earthquake strengthening and egress requirements. There is no record of earthquake strengthening work being undertaken on the building to the knowledge of the NZHPT.

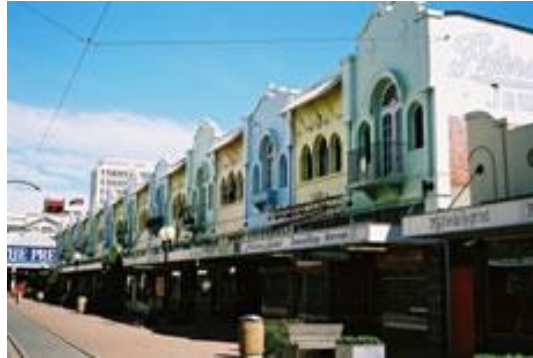
Construction: URM (solid interlocked brick walls with two layers of steel reinforcing mesh).

Strengthening history: In 1990, the NZHPT was informed by Paul Dunlop, Optometrist of New Regent Street, that the walls of his shop were found to be very difficult and costly to demolish for alterations. This was because of the solid interlocked brick walls with two layers of steel reinforcing mesh. Further, the walls on each ends of the shop rows have reinforced concrete beams.

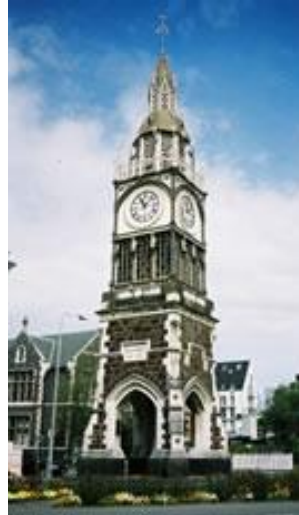
Significance: The Victoria Street Clock Tower was too heavy to ornament the Canterbury Provincial Council Chambers for which it was designed. The iron structure, imported from England, was finally set in place in 1897 on the corner of Manchester and High Streets to commemorate Queen Victoria's Diamond Jubilee and is a landmark in Christchurch. The tower was relocated and re-erected on its present position in 1930.

Construction: URM with cast iron frame

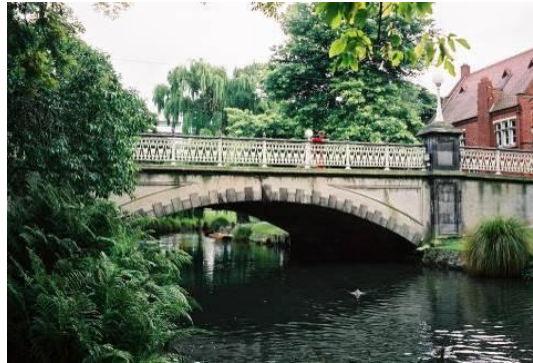
Worcester Street Bridge

Worcester Street
1885
Walkden Architect
Registered Category II historic place
Listed Group 2
Public ownership (Christchurch City Council)

Construction: Cast iron, brick and stone.

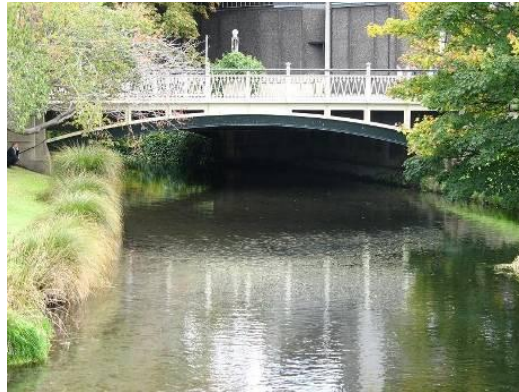
Significance: The first bridge across the Avon on Colombo Street was made of timber and erected in 1858. This survived until 1902, when it in turn was replaced - this time with a 44ft. 9 in. wide steel and concrete structure. This was probably designed by City Surveyor Arthur Dudley Dobson. With its fine cast iron railings, Colombo Street Bridge contributes much to the townscape and character of Christchurch.

Construction: Reinforced concrete and steel

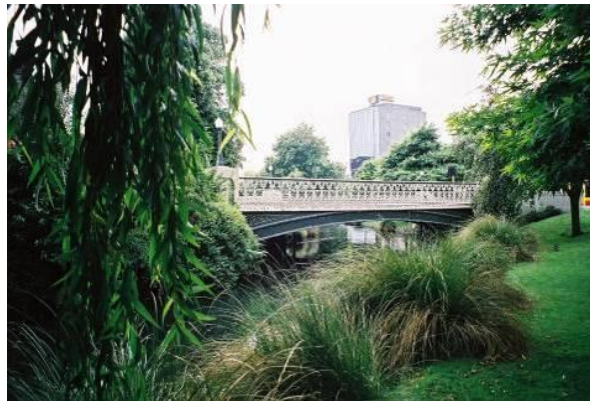
Significance: A suspension footbridge was erected at the Gloucester Street crossing of the Avon in 1862. Gothic in style to match the adjacent Provincial Government Buildings, the bridge may also have been designed by B.W. Mountfort. In 1886-7 it was replaced with a new iron road bridge. This bridge was designed by City Surveyor Charles Walkden. With its fine cast iron railings, Gloucester Street Bridge contributes much to the townscape and character of Christchurch.

Construction: Cast iron, reinforced concrete.

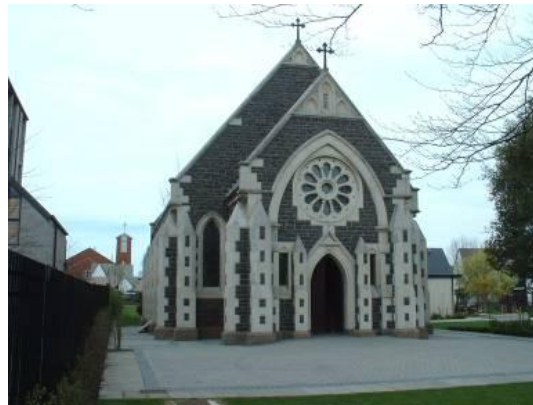
St Mary's Convent Chapel (Rose Chapel)

Construction: URM

- Repair of damaged walls and buttresses
- New steel tie rods and buttress ties.
- Grout filling of existing wall cavity.
- New steel ties from rafter to under-purlins.

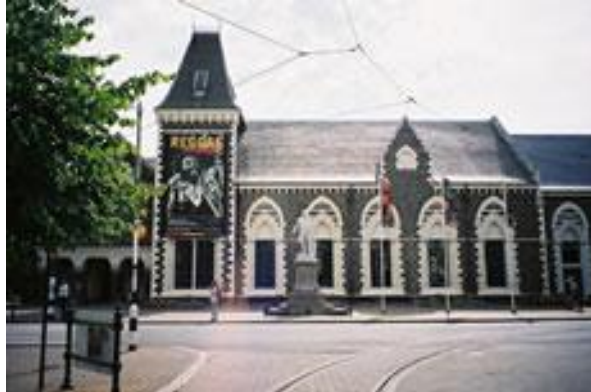
Construction: URM

The Canterbury Museum consists of the original 1870 building and a number of additions constructed in 1872, 1877, 1882, 1958 and 1977. The buildings dating from 1870-1882 are known as the Haastian building associated with the Museum's founding director, Julius Haast. All the Haastian buildings were constructed of unreinforced masonry in the gothic revival style. The conservation plan of 1992 noted that a 1869 earthquake prompted the architect, Mountfort to speculate:

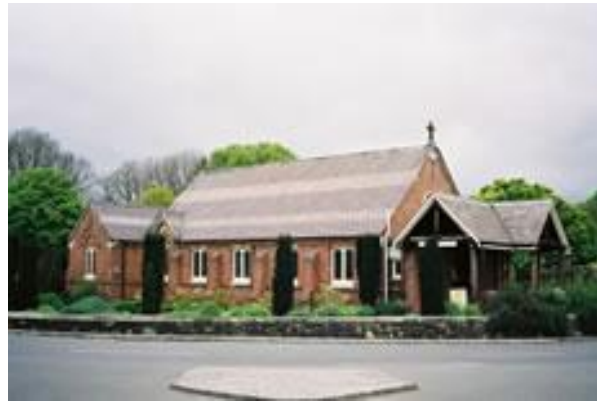
Construction: URM – cavity brick walls, brick buttresses, timber-framed roof, slate

January-June 2011: Moderate damage (cracking of brick work, west and east walls, damage to north wall and internal arch).
