# A review of post-earthquake building control policies with respect to the recovery of the Christchurch CBD

B.D. Galloway & H.J. Hare

*Holmes Consulting Group, Christchurch, New Zealand.*

2012 NZSEE  
Conference

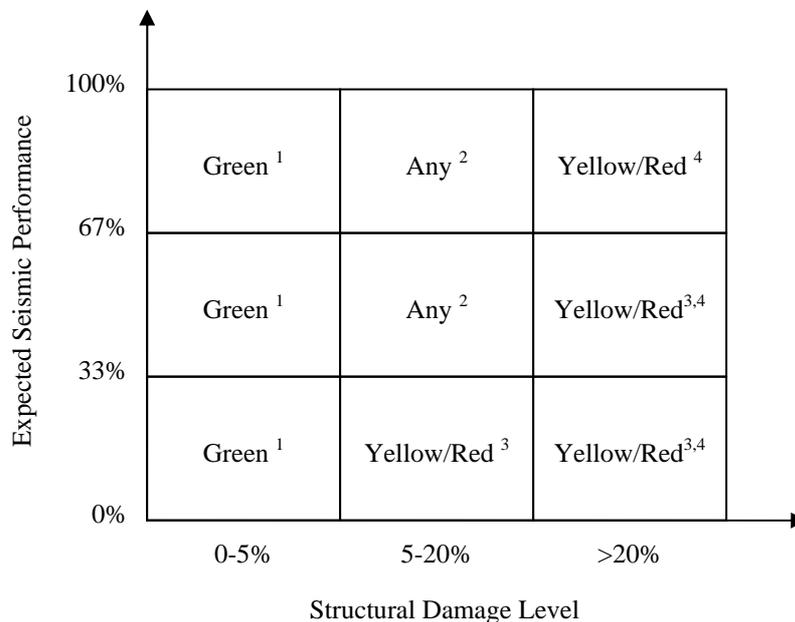
Figure 1 Indicative matrix for assigning placard

- Notes:
1. No significant structural damage observed
  2. Assign placard (green/yellow/red) based on damage observed
  3. Occupation not permitted due to poor expected seismic performance
  4. Green placard unlikely due to extent of damage

Depending on the degree of damage sustained by a building, and the expected seismic performance of the undamaged building, placards could be assigned based on a matrix as shown in Figure 1.

A benefit of this approach is that it easily allows for the placard status to be updated in accordance with the matrix if the damage is repaired, or if the building capacity is improved by strengthening.

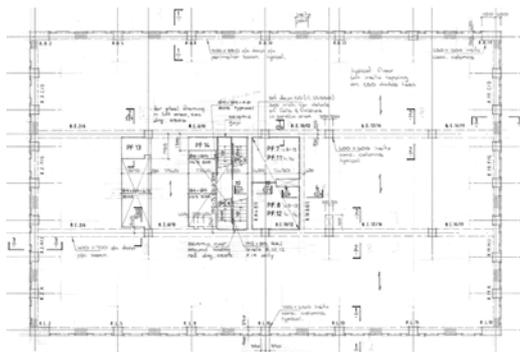
## Typical Floor Plan

The building is founded on driven concrete piles, founded at 8m – 12m depth.
