**Canterbury Earthquakes  
Royal Commission of Inquiry  
into the CTV Building Collapse**

Critique of

**CTV Site Examination and Materials Tests Report**  
by Hyland Fatigue + Earthquake Engineering  
*16 January 2012*

**CTV Building Collapse Investigation Report**  
by Hyland Fatigue + Earthquake Engineering/StructureSmith  
*25 January 2012*

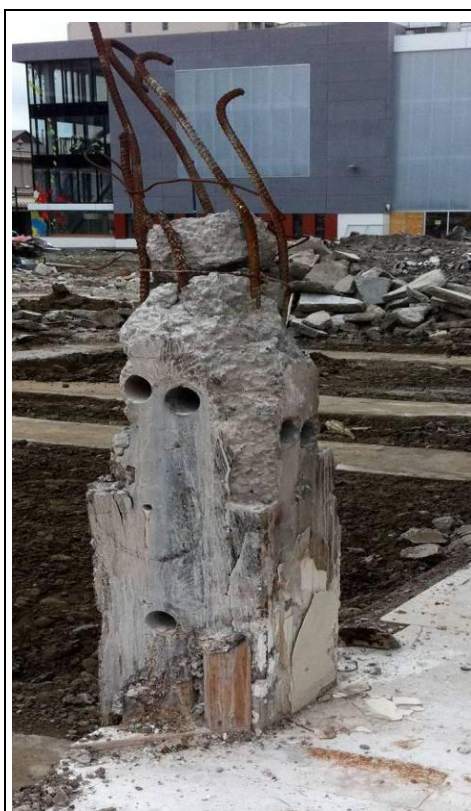
**Figure 1: Level One Column 18  
at Line 4 D/E**

In the Hyland Materials Report no consideration was given to excluding core results from damaged concrete in determining in-situ concrete strengths. The six cores taken from Level 1, shown in Figure 1 and Table 2 (CTV 1, 2 and 3) in particular, had fire damage and collapse damage, and the cores had to be trimmed to remove damaged concrete. The report says that difficulties were encountered in gaining suitable uncracked cores possibly because they were taken too close to the fractured zone. CCANZ considers that cores from these column remnants should not have been used in the analysis at all.

Sixteen of the 19 cores were 70 mm in diameter. EN 13791 clause A.3.1 requires six cores to be taken for each location for 70 mm diameter cores; typically most columns had two cores with only the level one column having the required six cores. However, these cores were from the column shown in Figure 1 which was damaged as outlined above.

Many of the cores were taken from columns which were cracked and damaged in the building collapse and the Hyland Reports state that concrete test results need to be interpreted in the light of this fact. However, the Hyland Reports do not exclude or factorise any of these compromised cores (See Figure 1).

3. Core strengths have been compromised by being taken from areas of distressed concrete as a result of the building collapse and fire damage. These cores should have been rejected.

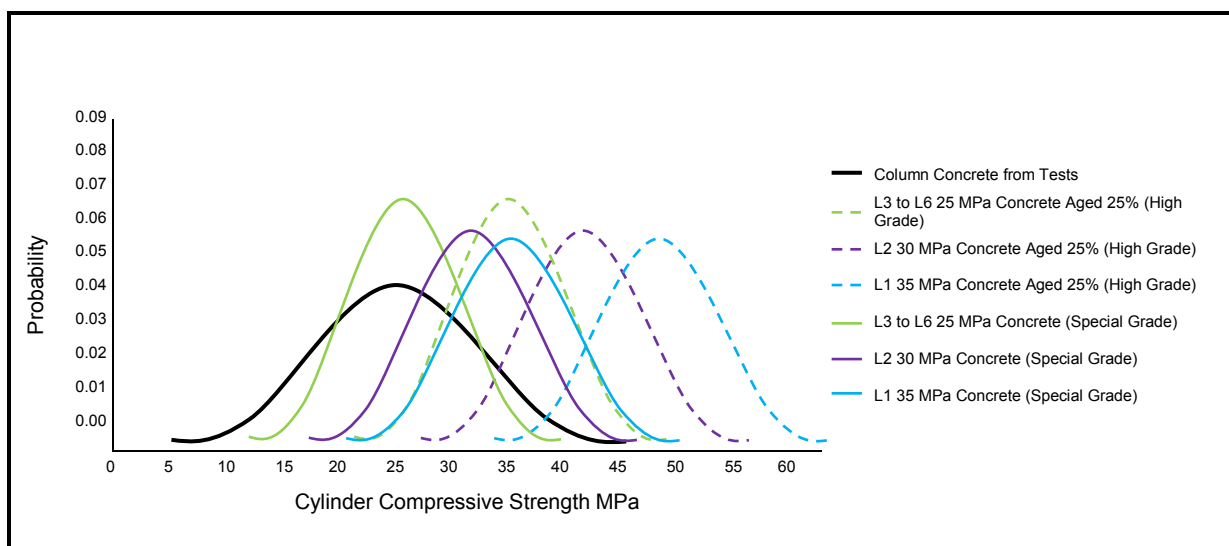
**Figure 2: Column test strength distribution. Special Grade Concrete versus High Grade Concrete aged 25%**

Table 1 and Figure 2 below show the revised target mean strengths for 25 MPa, 30 and 35 MPa specified strength by removing the ageing and target strength errors, and demonstrates the significance of the reduction.
