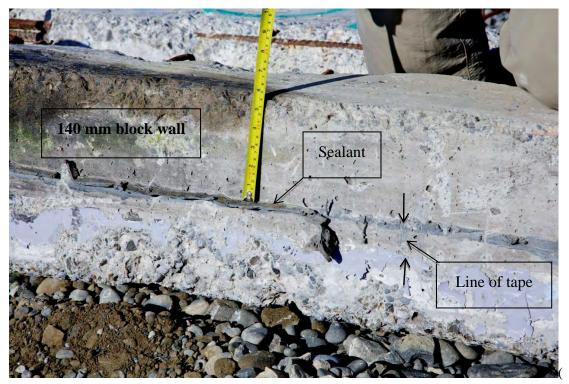
a) Remnant of sealant on face of rectangular column

Figure 2 Remnant of sealant between the rectangular columns and western the block wall

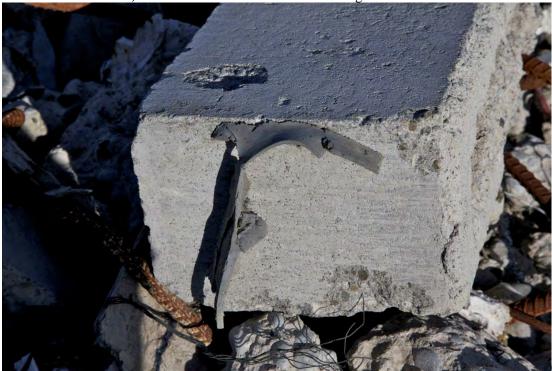
b) Remnant of sealant on reinforced core filled blocks
